Cite this: *Nanoscale*, 2018, **10**, 7058

## Non-destructive characterization of extended crystalline defects in confined semiconductor device structures†

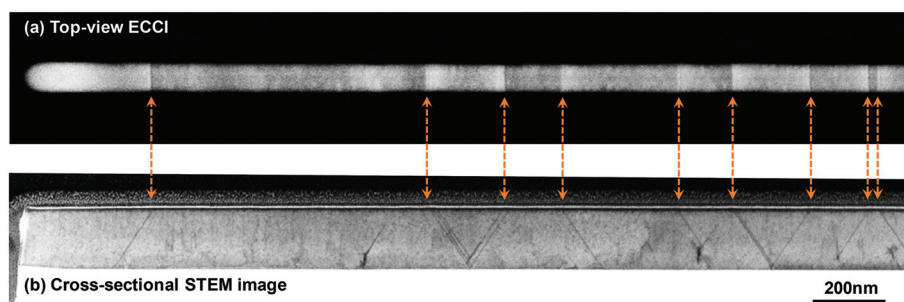
**Fig. 11** Correlation of (a) ECCI and (b) cross-sectional STEM analysis on the same selectively grown SiGe fin structure (75 nm wide, AR = 2.3). Each line-like feature in the top-view ECCI micrograph can be attributed to a stacking fault emerging at the surface of the SiGe fin.

In order to verify the origin of the line-like features observed by ECCI, we performed ECCI and subsequently cross-sectional STEM analysis on the very same fin structure (Fig. 11). Thereby, we could confirm an excellent correlation between planar defects emerging at the fin surface (as observed by cross-sectional STEM imaging – Fig. 11b) and the line-like features detected by ECCI (Fig. 11a).
