Cite this: *Nanoscale*, 2018, **10**, 7058

# Non-destructive characterization of extended crystalline defects in confined semiconductor device structures†

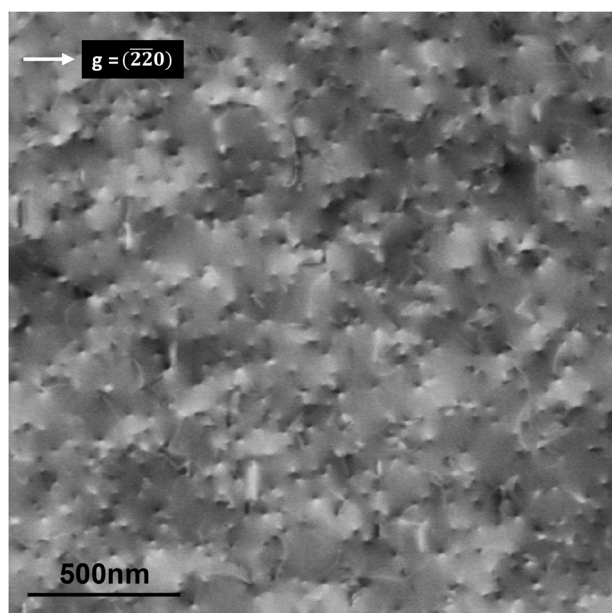
**Fig. 3** ECCI micrograph obtained on a  $\text{Si}_{0.3}\text{Ge}_{0.7}$  layer grown into a several micrometer large window. The selected diffraction condition (cf. Fig. 2) is indicated by the arrow in the upper left corner of the graph. The same diffraction condition and hence  $g$  vector have been used throughout the paper for all ECCI micrographs. Individual threading dislocations are clearly resolved. The layer exhibits a threading dislocation density of  $\sim 10^{10} \text{ cm}^{-2}$ .

In the first experiment, we acquired an ECCI micrograph (Fig. 3) on a several micrometer large area, which was fabricated by selective epitaxial growth of  $\text{Si}_{0.3}\text{Ge}_{0.7}$  into a large opening in the STI. Since the lateral dimensions of that area are much larger than the layer thickness ( $\sim 200$  nm as-grown), no defect trapping occurs and the structure is therefore equivalent to a blanket layer. Since the layer thickness exceeds the critical thickness and elastic relaxation can be excluded given the large lateral dimensions of the pad, the layer must be plastically relaxed. Indeed, the  $\text{Si}_{0.3}\text{Ge}_{0.7}$  peak position ( $\sim 3900$  arcsec) in the (004)  $\omega$ - $2\theta$  high-resolution X-ray diffraction (HRXRD) scan confirms the high degree of strain relaxation (Fig. 4).<sup>32,33</sup> Plastic relaxation is associated with misfit dislocations at the buried layer-substrate interface whereby the misfit dislocations accommodate the lattice mismatch between both materials in the direction perpendicular to the dislocation line.<sup>34</sup>

The stress fields associated with these threading dislocations cause a local deformation of the crystal lattice planes, which can be imaged using ECCI, as described in the Experimental section. As a consequence, each of the dot-like features visible in the ECCI micrograph shown in Fig. 3 can be attributed to a single threading dislocation intersecting with the layer surface. The number of these features and hence the density of threading dislocations on the surface can now be extracted straightforwardly, resulting in a value of  $10^{10} \text{ cm}^{-2}$ . The overall contrast variations which become apparent from the ECC image in Fig. 3 are due to the mosaicity and the associated lattice tilt of the material, which is caused by the high density of threading dislocations. The mosaicity and hence limited lateral coherence length of the layer causes a significant broadening of the HRXRD  $\omega$ -rocking curve (inset Fig. 4). It has been demonstrated that from this peak broadening, the threading dislocation density can be estimated for the case of highly defective materials.<sup>36</sup> Using the model of Ayers<sup>36</sup> and a full width at half maximum (FWHM) of  $1650$  arcsec (inset Fig. 4) we could derive a threading dislocation density of  $9.5 \times 10^9 \text{ cm}^{-2}$ , which is in good agreement with the aforementioned defect density obtained from the ECCI micrograph shown in Fig. 3.

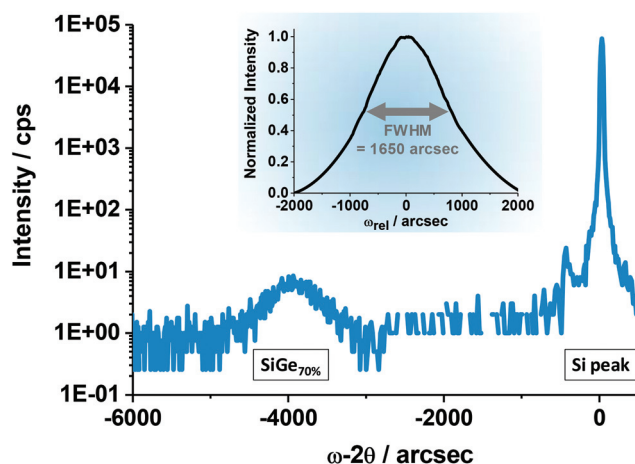
**Fig. 4** HRXRD (004)  $\omega$ - $2\theta$  scan acquired on the large  $\text{Si}_{0.3}\text{Ge}_{0.7}$  pad. The peak around  $-3900$  arcsec corresponds to fully relaxed  $\text{Si}_{0.3}\text{Ge}_{0.7}$ . The inset shows an  $\omega$  rocking curve obtained around the SiGe layer peak. The pronounced peak broadening with a FWHM value of  $1650$  arcsec is due to the high defect density and the associated mosaicity of the material.
