Non-destructive characterization of extended crystalline defects in confined semiconductor device structures†

Andreas Schulze,^a Libor Strakos,^b Tomas Vystavel,^b Roger Loo,^a
Antoine Pacco,^a Nadine Collaert,^a Wilfried Vandervorst^{a,c} and Matty Caymax^a

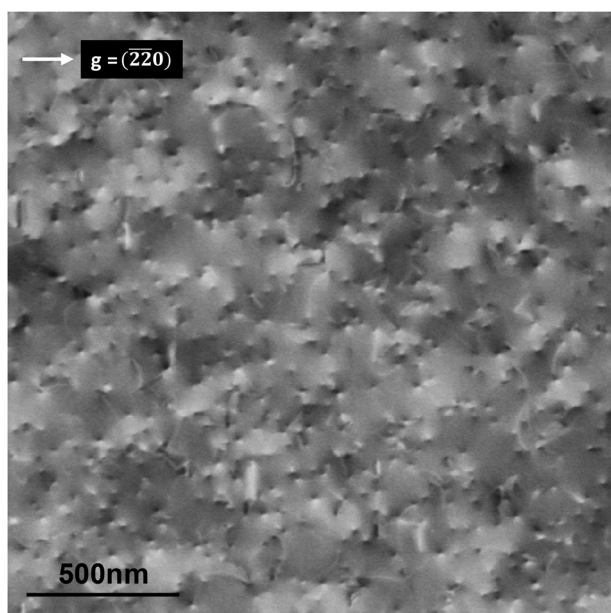
Fig. 3 ECCI micrograph obtained on a $\text{Si}_{0.3}\text{Ge}_{0.7}$ layer grown into a several micrometer large window. The selected diffraction condition (cf. Fig. 2) is indicated by the arrow in the upper left corner of the graph. The same diffraction condition and hence g vector have been used throughout the paper for all ECCI micrographs. Individual threading dislocations are clearly resolved. The layer exhibits a threading dislocation density of $\sim 10^{10} \text{ cm}^{-2}$.

In the first experiment, we acquired an ECCI micrograph (Fig. 3) on a several micrometer large area, which was fabricated by selective epitaxial growth of $\text{Si}_{0.3}\text{Ge}_{0.7}$ into a large opening in the STI. Since the lateral dimensions of that area are much larger than the layer thickness (~ 200 nm as-grown), no defect trapping occurs and the structure is therefore equivalent to a blanket layer. Since the layer thickness exceeds the critical thickness and elastic relaxation can be excluded given the large lateral dimensions of the pad, the layer must be plastically relaxed. Indeed, the $\text{Si}_{0.3}\text{Ge}_{0.7}$ peak position (~ 3900 arcsec) in the (004) ω - 2θ high-resolution X-ray diffraction (HRXRD) scan confirms the high degree of strain relaxation (Fig. 4).^{32,33} Plastic relaxation is associated with misfit dislocations at the buried layer-substrate interface whereby the misfit dislocations accommodate the lattice mismatch between both materials in the direction perpendicular to the dislocation line.³⁴

The stress fields associated with these threading dislocations cause a local deformation of the crystal lattice planes, which can be imaged using ECCI, as described in the Experimental section. As a consequence, each of the dot-like features visible in the ECCI micrograph shown in Fig. 3 can be attributed to a single threading dislocation intersecting with the layer surface. The number of these features and hence the density of threading dislocations on the surface can now be extracted straightforwardly, resulting in a value of 10^{10} cm^{-2} . The overall contrast variations which become apparent from the ECC image in Fig. 3 are due to the mosaicity and the associated lattice tilt of the material, which is caused by the high density of threading dislocations. The mosaicity and hence limited lateral coherence length of the layer causes a significant broadening of the HRXRD ω -rocking curve (inset Fig. 4). It has been demonstrated that from this peak broadening, the threading dislocation density can be estimated for the case of highly defective materials.³⁶ Using the model of Ayers³⁶ and a full width at half maximum (FWHM) of 1650 arcsec (inset Fig. 4) we could derive a threading dislocation density of $9.5 \times 10^9 \text{ cm}^{-2}$, which is in good agreement with the aforementioned defect density obtained from the ECCI micrograph shown in Fig. 3.

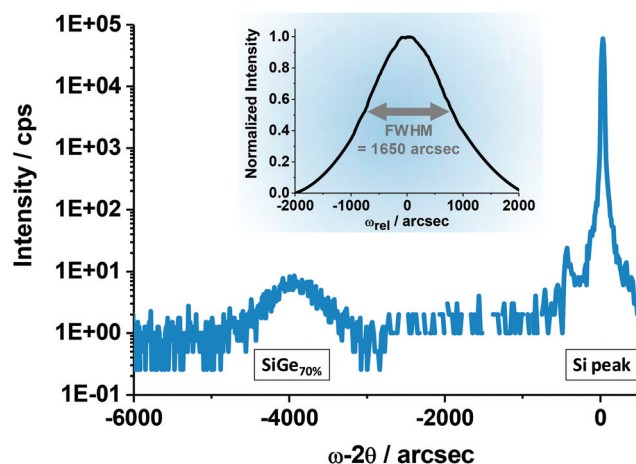
Fig. 4 HRXRD (004) ω - 2θ scan acquired on the large $\text{Si}_{0.3}\text{Ge}_{0.7}$ pad. The peak around -3900 arcsec corresponds to fully relaxed $\text{Si}_{0.3}\text{Ge}_{0.7}$. The inset shows an ω rocking curve obtained around the SiGe layer peak. The pronounced peak broadening with a FWHM value of 1650 arcsec is due to the high defect density and the associated mosaicity of the material.
