## Non-destructive characterization of extended crystalline defects in confined semiconductor device structures†

Semiconductor heterostructures are at the heart of most nanoelectronic and photonic devices such as advanced transistors, lasers, light emitting diodes, optical modulators and photo-detectors. However, the performance and reliability of the respective devices are often limited by the presence of crystalline defects which arise from plastic relaxation of misfit strain present in these heterogeneous systems. To date, characterizing the nature and distribution of such defects in 3D nanoscale devices precisely and non-destructively remains a critical metrology challenge. In this paper we demonstrate that electron channeling contrast imaging (ECCI) is capable of analyzing individual dislocations and stacking faults in confined 3D nanostructures, thereby fulfilling the aforementioned requirements. For this purpose we imaged the intensity of electrons backscattered from the sample under test under controlled diffraction conditions using a scanning electron microscope (SEM). In contrast to transmission electron microscopy (TEM) analysis, no electron transparent specimens need t

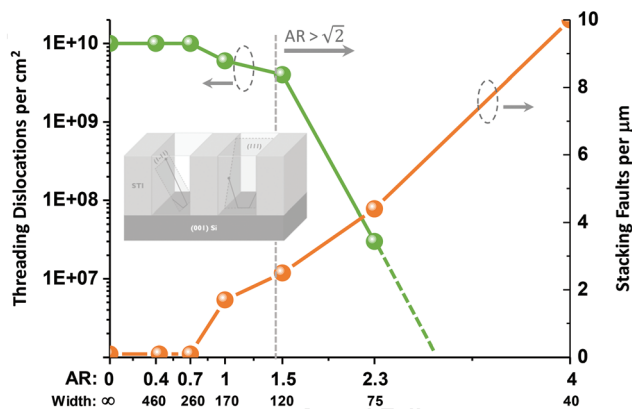
**Fig. 9** Areal density of threading dislocations (left y-axis) and the linear density of stacking faults (right y-axis) for fins of different widths as determined by ECCI. On the x-axis, the fin aspect ratio AR (height : width) as well as the fin width in nanometer are indicated. The inset schematically illustrates the trapping of threading dislocations at the STI sidewalls.

The threading dislocation densities obtained on the selectively grown SiGe fin structures of varying fin width (and hence aspect ratio AR) are summarized quantitatively in Fig. 9. The reason for the observed reduction in threading dislocation

density for larger aspect ratios can be attributed to the aspect ratio trapping mechanism.<sup>16</sup> Threading dislocations are connected to misfit dislocation lines in the (001) plane at the trench bottom (*i.e.* Si/SiGe interface) and they move towards the fin surface in the {111} planes. Since the angle between any {111} plane and the bottom of the trench (*i.e.* (001) plane) equals 54.7° in the case of a cubic crystal, any threading arm originating from the trench bottom and rising up in a ( $\bar{1}\bar{1}$ ) or ( $1\bar{1}\bar{1}$ ) plane will be blocked by the STI sidewalls if the aspect ratio of the trench exceeds  $\sqrt{2}$ . From Fig. 9 it becomes apparent that the threading dislocation density indeed drops significantly once the AR exceeds  $\sqrt{2}$ , although those threading arms rising upwards in the (111) or ( $1\bar{1}\bar{1}$ ) planes (which do not inter-

islands grow. Upon coalescence of these islands, stacking faults can form due to less perfect matching of the growth fronts of the islands at this position. The linear density of stacking faults for fins of different widths is summarized in Fig. 9. In contrast to the threading dislocation density, the number of planar defects increases for narrower trenches. This can be explained by the fact that the distance between nucleation islands is inversely related to the trench width,<sup>39</sup> for which reason islands in narrower trenches can grow bigger and hence are more prone to elastic distortions before they coalesce. This leads to an increased probability for the formation of stacking faults in narrower trenches. Moreover, after coalescence of the various nucleation islands, stacking faults can also arise higher up in the trench due to irregularities (*i.e.* roughness) at the STI trench sidewalls.<sup>32,40</sup> This mechanism can be neglected in wide structures, however, it becomes relevant in the case of narrower trenches exhibiting rougher sidewalls. Since the aspect ratio of these narrow trenches is higher than  $\sqrt{2}$ , planar defects oriented parallel to the (111) or (111̄) planes are efficiently trapped by the STI sidewalls. Hence, only stacking faults running parallel to the (111) or (111̄) planes do reach the fin surface leading to the observed line-like features oriented along the [110] direction in the top-view ECCI micrographs. Besides, it is worthwhile to note that the described lines and hence the associated planar defects in the under-
