Cite this: *Nanoscale*, 2018, **10**, 7058

Non-destructive characterization of extended crystalline defects in confined semiconductor device structures†

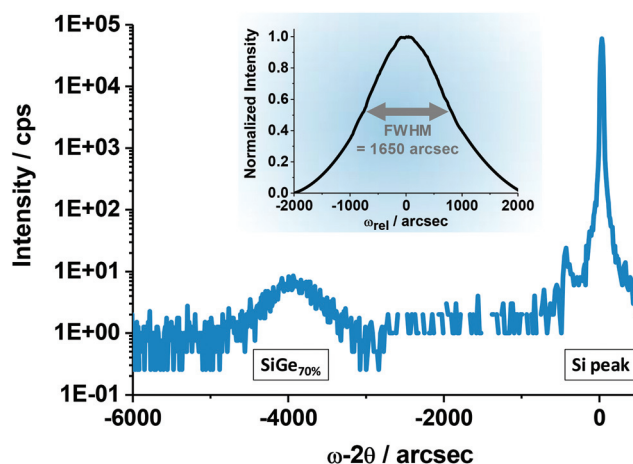
Fig. 4 HRXRD (004) ω - 2θ scan acquired on the large $\text{Si}_{0.3}\text{Ge}_{0.7}$ pad. The peak around -3900 arcsec corresponds to fully relaxed $\text{Si}_{0.3}\text{Ge}_{0.7}$. The inset shows an ω rocking curve obtained around the SiGe layer peak. The pronounced peak broadening with a FWHM value of 1650 arcsec is due to the high defect density and the associated mosaicity of the material.

The stress fields associated with these threading dislocations cause a local deformation of the crystal lattice planes, which can be imaged using ECCI, as described in the Experimental section. As a consequence, each of the dot-like features visible in the ECCI micrograph shown in Fig. 3 can be attributed to a single threading dislocation intersecting with the layer surface. The number of these features and hence the density of threading dislocations on the surface can now be extracted straightforwardly, resulting in a value of 10^{10} cm^{-2} . The overall contrast variations which become apparent from the ECC image in Fig. 3 are due to the mosaicity and the associated lattice tilt of the material, which is caused by the high density of threading dislocations. The mosaicity and hence limited lateral coherence length of the layer causes a significant broadening of the HRXRD ω -rocking curve (inset Fig. 4). It has been demonstrated that from this peak broadening, the threading dislocation density can be estimated for the case of highly defective materials.³⁶ Using the model of Ayers³⁶ and a full width at half maximum (FWHM) of 1650 arcsec (inset Fig. 4) we could derive a threading dislocation density of $9.5 \times 10^9 \text{ cm}^{-2}$, which is in good agreement with the aforementioned defect density obtained from the ECCI micrograph shown in Fig. 3.

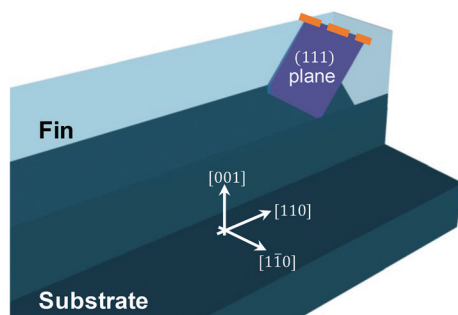
Fig. 10 Schematic illustrating the positioning of a (111) plane in a fin oriented along the [110] direction. Planar defects such as stacking faults are plane-parallel to the {111} planes in a diamond crystal structure. Independent of the fin's aspect ratio, planar defects in the (111) and ($\bar{1}\bar{1}\bar{1}$) plane (*i.e.* running perpendicular to the fin) are not trapped at the fin sidewall. The intersection of these planar defects with the fin top surface leads to a line-like feature (dashed orange line) oriented along the [110] direction.

As is already noted above, we furthermore identified line-like features on the surface of fins which are ≤ 170 nm in width (Fig. 7 and 8). As illustrated in Fig. 10, such a line in an ECCI micrograph can be explained by lattice distortions associated with planar defects such as stacking faults oriented parallel to the (111) or ($\bar{1}\bar{1}\bar{1}$) planes emerging at the fin surface.
