Cite this: *Nanoscale*, 2018, **10**, 7058

Non-destructive characterization of extended crystalline defects in confined semiconductor device structures†

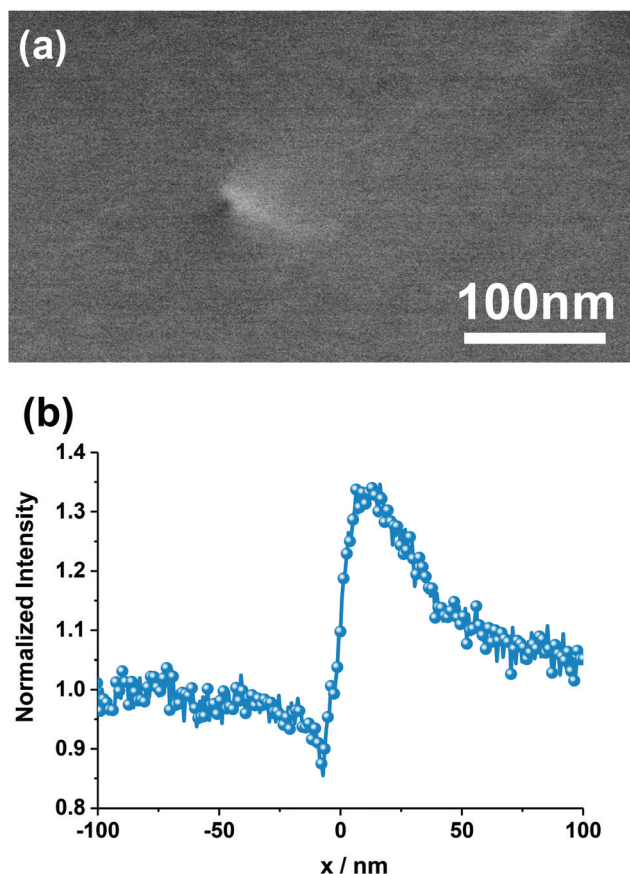
Fig. 1 (a) ECCI micrograph obtained on a lowly defective SiGe buffer layer showing a single threading dislocation emerging at the layer surface. The typical contrast inversion across the defect is clearly visible. (b) Horizontal line section through the defect illustrating the contrast inversion quantitatively (*i.e.* transition from reduced backscatter signal to an increased backscatter signal when crossing the defect from left to right).

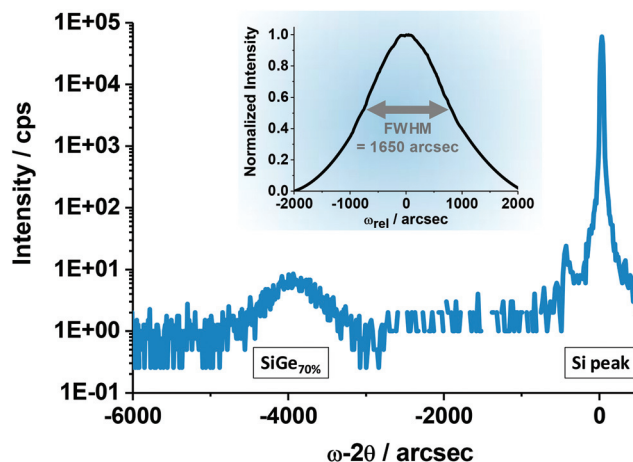
Fig. 4 HRXRD (004) ω - 2θ scan acquired on the large $\text{Si}_{0.3}\text{Ge}_{0.7}$ pad. The peak around -3900 arcsec corresponds to fully relaxed $\text{Si}_{0.3}\text{Ge}_{0.7}$. The inset shows an ω rocking curve obtained around the SiGe layer peak. The pronounced peak broadening with a FWHM value of 1650 arcsec is due to the high defect density and the associated mosaicity of the material.

The stress fields associated with these threading dislocations cause a local deformation of the crystal lattice planes, which can be imaged using ECCI, as described in the Experimental section. As a consequence, each of the dot-like features visible in the ECCI micrograph shown in Fig. 3 can be attributed to a single threading dislocation intersecting with the layer surface. The number of these features and hence the density of threading dislocations on the surface can now be extracted straightforwardly, resulting in a value of 10^{10} cm^{-2} . The overall contrast variations which become apparent from the ECC image in Fig. 3 are due to the mosaicity and the associated lattice tilt of the material, which is caused by the high density of threading dislocations. The mosaicity and hence limited lateral coherence length of the layer causes a significant broadening of the HRXRD ω -rocking curve (inset Fig. 4). It has been demonstrated that from this peak broadening, the threading dislocation density can be estimated for the case of highly defective materials.³⁶ Using the model of Ayers³⁶ and a full width at half maximum (FWHM) of 1650 arcsec (inset Fig. 4) we could derive a threading dislocation density of $9.5 \times 10^9 \text{ cm}^{-2}$, which is in good agreement with the aforementioned defect density obtained from the ECCI micrograph shown in Fig. 3.
