Cite this: *Nanoscale*, 2018, **10**, 7058

Non-destructive characterization of extended crystalline defects in confined semiconductor device structures†

Andreas Schulze,^a Libor Strakos,^b Tomas Vystavel,^b Roger Loo,^a
Antoine Pacco,^a Nadine Collaert,^a Wilfried Vandervorst^{a,c} and Matty Caymax^a

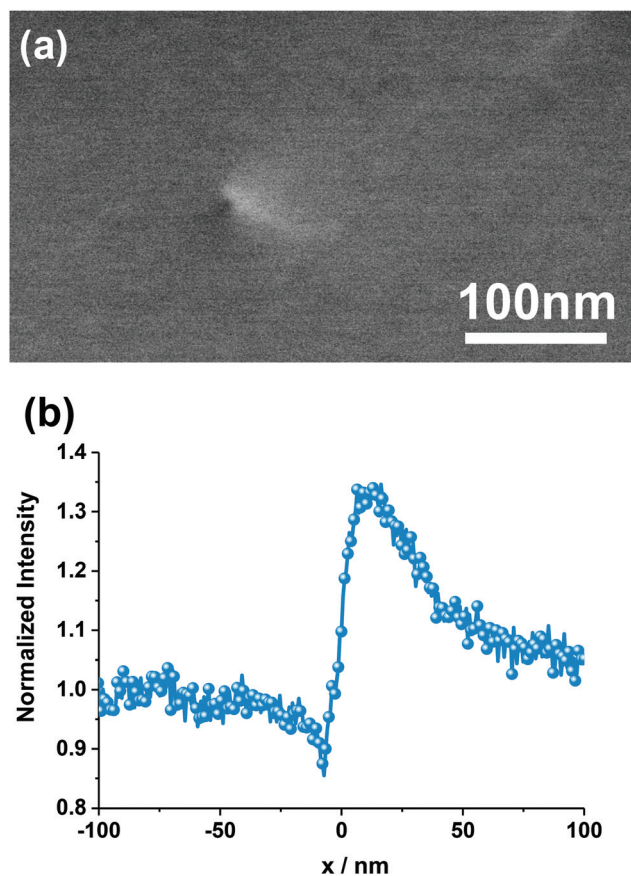
Fig. 1 (a) ECCI micrograph obtained on a lowly defective SiGe buffer layer showing a single threading dislocation emerging at the layer surface. The typical contrast inversion across the defect is clearly visible. (b) Horizontal line section through the defect illustrating the contrast inversion quantitatively (*i.e.* transition from reduced backscatter signal to an increased backscatter signal when crossing the defect from left to right).

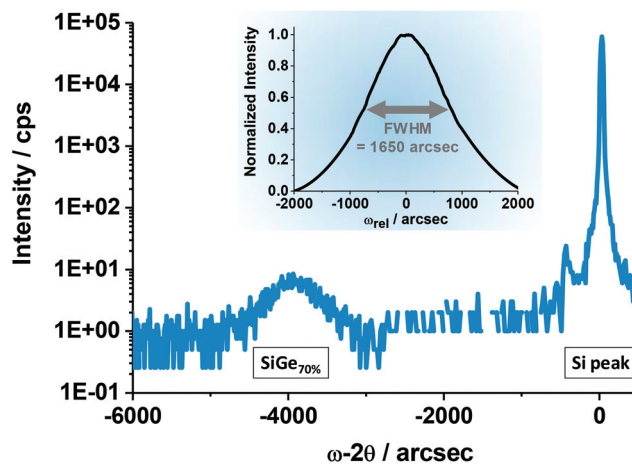
Fig. 4 HRXRD (004) ω - 2θ scan acquired on the large $\text{Si}_{0.3}\text{Ge}_{0.7}$ pad. The peak around -3900 arcsec corresponds to fully relaxed $\text{Si}_{0.3}\text{Ge}_{0.7}$. The inset shows an ω rocking curve obtained around the SiGe layer peak. The pronounced peak broadening with a FWHM value of 1650 arcsec is due to the high defect density and the associated mosaicity of the material.

The stress fields associated with these threading dislocations cause a local deformation of the crystal lattice planes, which can be imaged using ECCI, as described in the Experimental section. As a consequence, each of the dot-like features visible in the ECCI micrograph shown in Fig. 3 can be attributed to a single threading dislocation intersecting with the layer surface. The number of these features and hence the density of threading dislocations on the surface can now be extracted straightforwardly, resulting in a value of 10^{10} cm^{-2} . The overall contrast variations which become apparent from the ECC image in Fig. 3 are due to the mosaicity and the associated lattice tilt of the material, which is caused by the high density of threading dislocations. The mosaicity and hence limited lateral coherence length of the layer causes a significant broadening of the HRXRD ω -rocking curve (inset Fig. 4). It has been demonstrated that from this peak broadening, the threading dislocation density can be estimated for the case of highly defective materials.³⁶ Using the model of Ayers³⁶ and a full width at half maximum (FWHM) of 1650 arcsec (inset Fig. 4) we could derive a threading dislocation density of $9.5 \times 10^9 \text{ cm}^{-2}$, which is in good agreement with the aforementioned defect density obtained from the ECCI micrograph shown in Fig. 3.

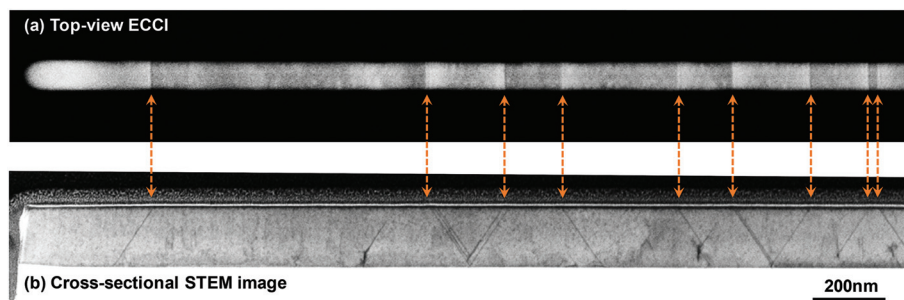
Fig. 11 Correlation of (a) ECCI and (b) cross-sectional STEM analysis on the same selectively grown SiGe fin structure (75 nm wide, AR = 2.3). Each line-like feature in the top-view ECCI micrograph can be attributed to a stacking fault emerging at the surface of the SiGe fin.

In order to verify the origin of the line-like features observed by ECCI, we performed ECCI and subsequently cross-sectional STEM analysis on the very same fin structure (Fig. 11). Thereby, we could confirm an excellent correlation between planar defects emerging at the fin surface (as observed by cross-sectional STEM imaging – Fig. 11b) and the line-like features detected by ECCI (Fig. 11a).
