Corrosion behaviour of welded low-carbon steel in the Arctic marine environment†

Arctic offshore sites have high potential for the exploration of energy resources; thus, data concerning the behaviour of structural materials in the Arctic environment are required. Here, we report the corrosive characteristics of welded low-carbon steels under simulated Arctic low-temperature conditions. The corrosion tendencies in the submerged and splash zones of offshore structures were investigated by immersion tests, salt spray tests (SST), and cyclic corrosion tests (CCT). The effects of decreasing seawater temperature on the corrosion were identified, and the differences in corrosion between the base metal (BM) and weld metal (WM) were analysed. In particular, the BM showed higher corrosion than the WM, indicating that the parent metal (PM) is corroded more than the fusion zone (FZ) in weld joints under severe corrosion conditions. Thus, we have identified the importance and influence of the thermal expansion of materials on corrosion under Arctic conditions.

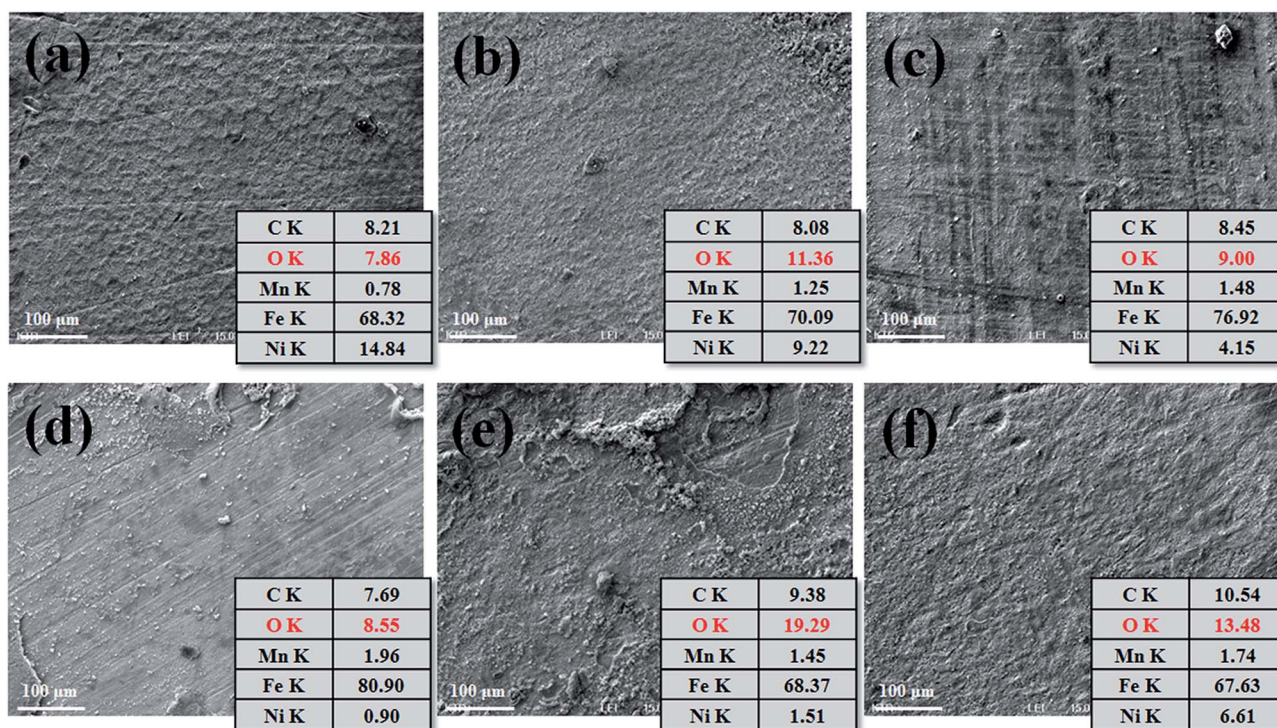
Fig. 4 SEM and EDS characterisation of the corroded surface of (a) FCAW-PM, (b) FCAW-HAZ, (c) FCAW-FZ, (d) SAW-PM, (e) SAW-HAZ and (f) SAW-FZ specimens after one cycle of CCT (wt%). The EDS data were obtained over the entire area shown in each SEM image.

Fig. 4 shows the surface morphology and EDS analysis results of FCAW and SAW specimens. In general, rust is comprised of various types of oxides: hydrated oxides, oxyhydroxides, and miscellaneous crystalline and amorphous substances, but all components are mainly composed of iron and oxide.²⁹ Therefore, measuring the oxygen ratio in the rust layer can provide information about the progression of corrosion under equal exposure conditions. Therefore, to understand the initial corrosion, the chemical composition of the rust layer was analysed at representative positions but excluding the severely corroded region after one cycle of CCT. As shown in Fig. 4, general corrosion occurred over the entire area. In both case of FCAW and SAW, corrosion progressed in the order of PM < FZ < HAZ. Therefore, we confirmed that the corrosion of the PM region progresses the least during the initial corrosion stage.

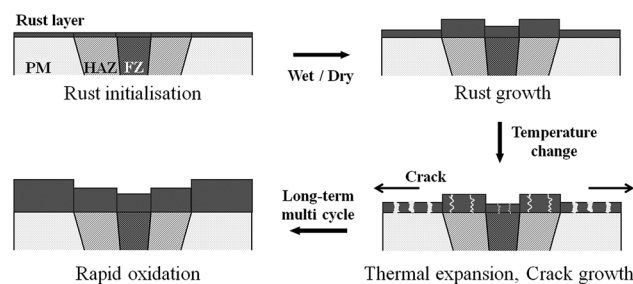
Fig. 6 Schematic of the rapid oxidation of the parent metal (PM), heat affected zone (HAZ), and fusion zone (FZ) under CCT conditions.

SAW were 12.00, 10.56, and 11.74 μm (m °C)⁻¹, respectively. Thus, the CTE of BM was highest. Because the CTEs of iron oxides are less than 8.5 μm (m °C)⁻¹ below 100 °C,³⁰ thermal stress occurs between the oxide and metallic layers. Therefore, it is expected that cracks will occur in the iron oxide layer at the locations where the stress is concentrated during corrosion. When the oxide layer on the surface is thick, the layer is damaged by the relatively high thermal deformation of the BM, and continuous corrosion will progress around the damaged locations. Fig. 6 illustrates the schematic corrosion progression pattern in the WM through the CCT. After the initial rust layer is formed, corrosion progresses in the order of PM < FZ < HAZ, depending on the corrosion potential. However, after a certain thickness of rust layer has developed, cracks with relatively high density occur in the PM, which ensures the most stress because of repeated temperature changes. These cracks provide paths for water, oxygen, and other corrosive substances to enter and cause additional corrosion. The protective density and adherence of the rust layer depend on the duration wetness;²⁹ thus, the existence of marine components (chloride) and long relatively long wet/dry cycles may produce unstable rust layers that possess many defects (holes and cracks). The defects inhibit the evaporation of trapped water; therefore, rapid oxidation occurs and reduces the compactness of the rust layer on carbon steel.³¹ Thus, when corrosion progresses in the medium- and long-term, corrosion mostly occurs in the PM as a result of the influence of stress due to the differences in the CTE of each specimen. This means that the importance of impact on the corrosion rate is

primarily affected by the compactness and adhesiveness of the rust layer than any other factors under severe corrosion conditions. Although many studies have dealt with the rust-expansion-induced cracking of steel bars in reinforced concrete structures,^{32,33} no studies have shown the difference in rust cracking between the PM and FZ in weld joint regions.
