Cite this: *RSC Adv.*, 2019, 9, 17040

Potential of dynamic bacterial communities in the bio-corrosion process: a proof study with surface morphology of metal coupons†

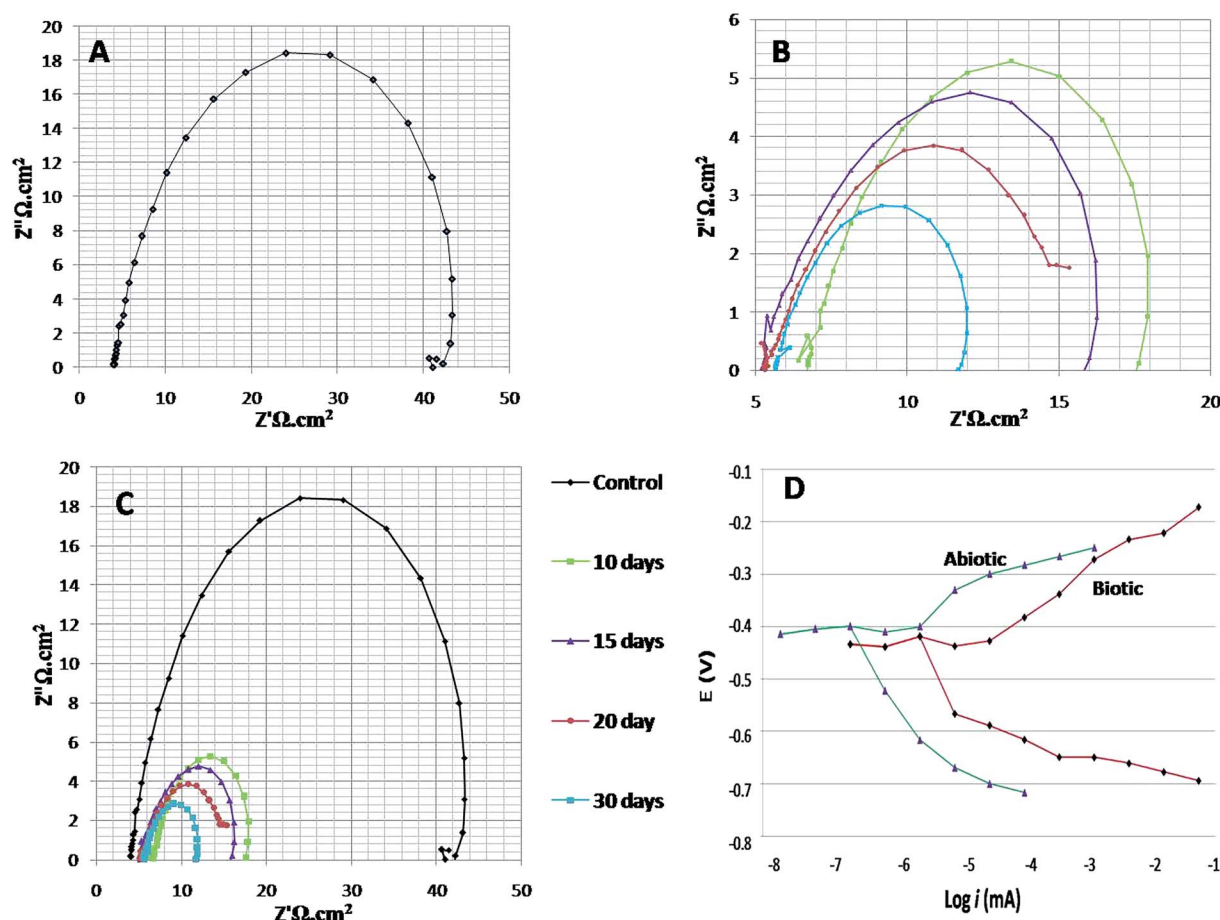
Fig. 4 The Nyquist and Tafel spectra. (A) Illustrates the spectra of the abiotic system, (B) illustrates the spectra of the biotic system for 7th, 14th, 21st and 28th days, (C) shows the combined spectra for both abiotic and biotic systems, and (D) elucidates the Tafel plots of the abiotic and biotic systems (on the 28th day).

EIS was recorded on every 7th day of the 28 days incubation period. The diameter of R_{ct} was observed to be maximum for control (Fig. 4A); as the environment was abiotic, there was no bacterial activity and the electron transfer was very low. Therefore, in the abiotic system, the chance of electro-biochemical reactions was negligible.

By studying the Nyquist loops of the biotic system, the corrosive nature of the sample can be justified. A significant difference was observed on comparing the diameters of the biotic and abiotic systems; a relatively reduced R_{ct} value was observed in the biotic system. The reduced diameter signified the role of bacterial activity in metal corrosion.³⁵ After exposing the coupons for different exposure times, it was observed that, as the incubation period increased, the corrosive behaviour caused by bacteria also increased. The diameter obtained on the

28th day was comparatively smaller than the diameter obtained on the 7th day of incubation (Fig. 4B and C). Fig. 4D illustrates the Tafel plots of the abiotic and biotic systems, corresponding to the occurrence of anodic and cathodic reactions, and the intersection in the graph gives the corrosion exchange current density. In the case of the biotic graph, the anodic and cathodic values are higher in comparison to the observations for the abiotic graph. This showed that the biotic system contained a corrosive environment. Study reported by Jia *et al.*,³⁶ similar Tafel plots were obtained; the abiotic system showed lesser corrosion values than the biotic system.

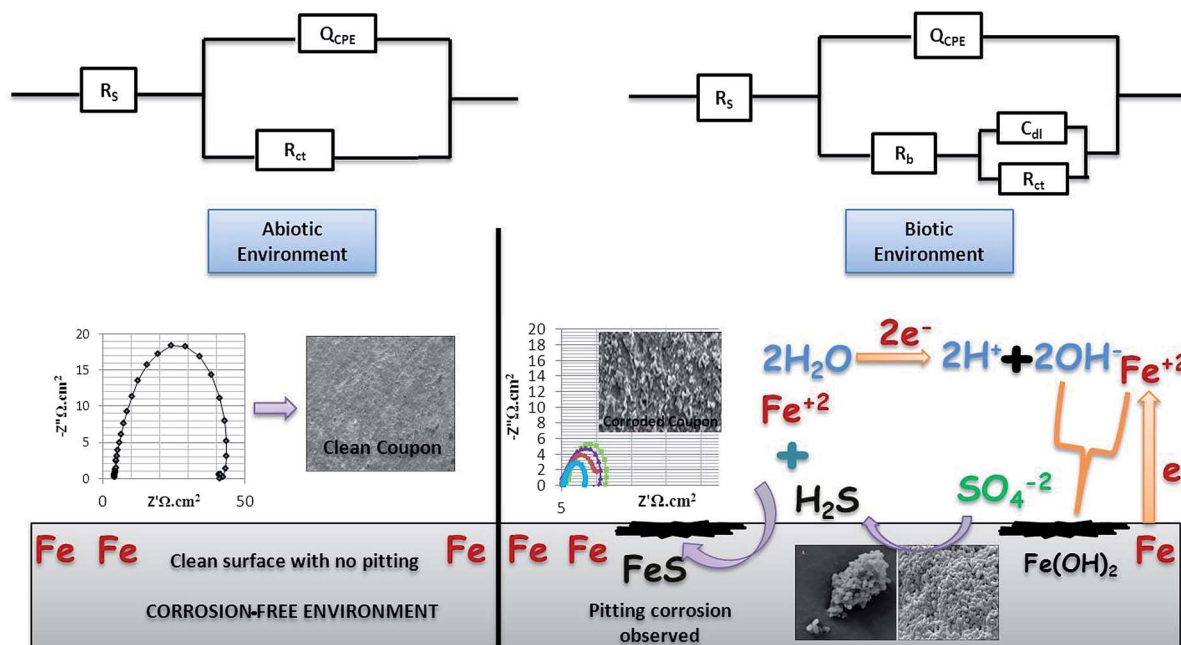
Fig. 5 The bio-electrochemical reactions of the abiotic and biotic systems. The biotic system is a potentially active system.

Fig. 5 shows the difference in the bio-electrochemistry of abiotic and biotic systems with the circuit model, where R_s denotes the resistance of the solution, R_b is the resistance created by the biofilm formed in the biotic system, and C_{dl} refers to the double layer capacitance. In the biotic system, the microorganisms accelerated the corrosion process by generating corrosive products on the metal coupons. The reciprocal of charge transfer resistance ($1/R_{ct}$) is known as the corrosion rate; the smaller the R_{ct} , the higher the rate of corrosion. It is evident that the diameter of the biotic semicircle decreases, which further reduces the polarization resistance. This suggests that the biotic system has a noticeable effect on corrosion growth by altering the surrounding environment; the metabolites produced (oxides of iron and sulfur) in the biotic system alter the electrochemical properties of the system, which further results in reduced polarization resistance.³⁷

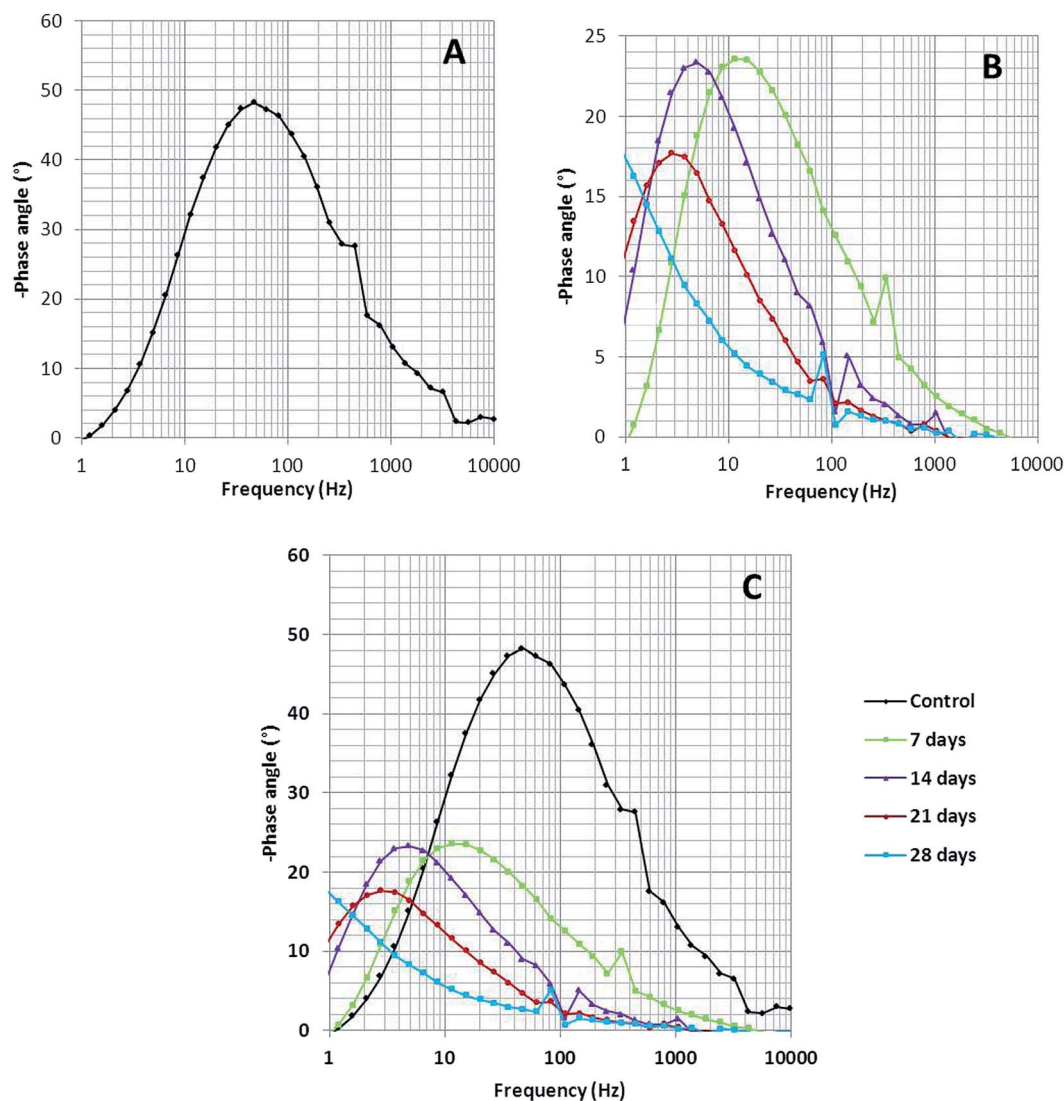
Fig. 6 The Bode phase spectra of (A) the abiotic system and (B) the biotic system on 7th, 14th, 21st and 28th days; (C) depicts the comparison of the abiotic and biotic systems.

Bode spectra (Fig. 6) are plotted in the orthogonal axis planes, in which the phase angle (degree) is on the ordinate axis and the logarithm of the frequency (Hertz) is on the abscissa axis. The phase angle spectrum of the biotic system is smaller than that of the abiotic system, which further represents that

the conductivity of the solution sample is high as compared to that of the control.³⁸ The higher conductivity clarified the presence of more free ions in the system, due to which the bacterial electric pathways become active and this will speed up the process of corrosion.

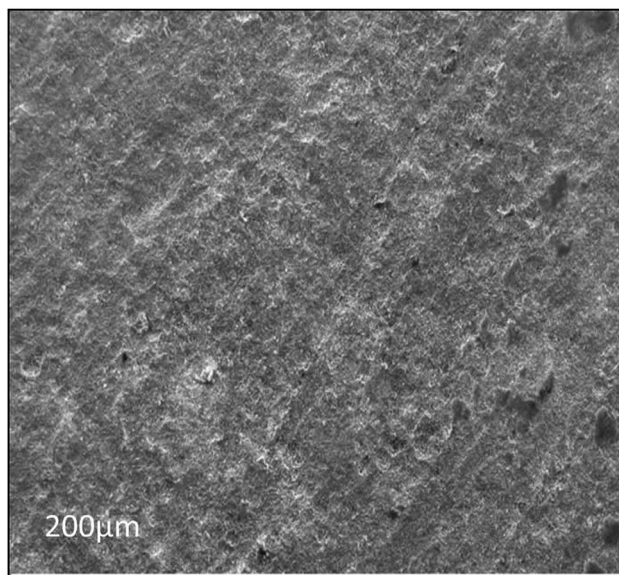
Fig. 11 The SEM image of the abiotic system, showing that the metal coupon surface is cleaned after the 28th day of incubation.

Furthermore, the level of the corrosive nature of samples was indicated by the scanning electron micrographs of the biotic coupons (Fig. 11–13). Fig. 11 represents the nature of the abiotic system (coupons in a sterile medium), whereas Fig. 12 and 13 illustrate the effect of the biotic system on the metal surface and the bacterial community responsible for corrosion. With respect to appearance, a significant difference was observed while comparing the coupons of the abiotic and biotic systems. The coupons in the abiotic system appeared clean and clear as compared to the coupons in the biotic system. In the biotic system, the bacterial community almost fully covered the coupon surface. While examining the images in Fig. 12(A–E), microscopic cracks and pits can be noticed, as indicated by the red arrows and boxes. Previous studies illustrated that corrosive bacterial species corroded the surfaces of the coupons by

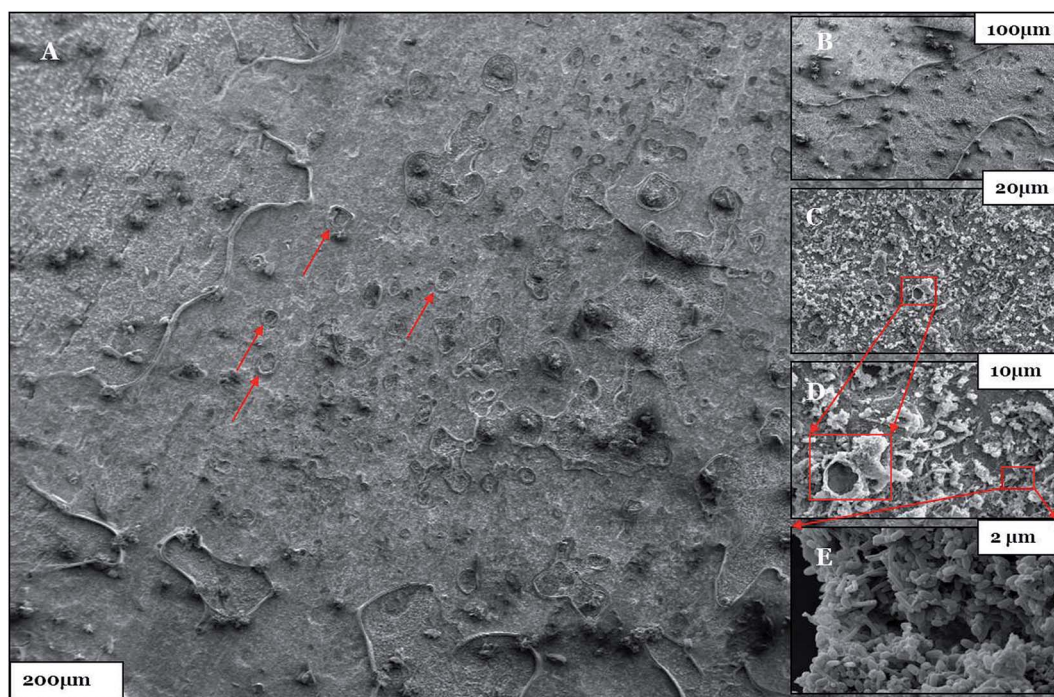
Fig. 12 (A–E) The SEM micrographs of the biotic system after the 28th day of incubation. Pit holes are shown by the red arrows and boxes.

producing large amounts of corrosion products mainly composed of iron oxide and an extracellular polymeric substance (EPS). Bacterial EPS mostly comprises polysaccharides, proteins, nucleic acids, phospholipids and humic substances. It supports the bacteria for holding on to the metal surface and is thought to play a significant role in the corrosion process.^{5,52,53}

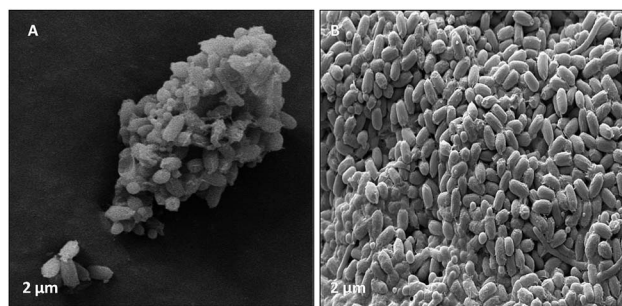
Fig. 13 (A) Illustrated the bacterial species had a cumulative effect on bio-corrosion. (B) Demonstrated the morphology (rod shape) of bacterial community associated with bio-corrosion.

Fig. 13 illustrates that bacteria work in a cumulative way to accelerate corrosion in the surrounding environment. By accumulating, they reduce the surface area with respect to the environment.⁵⁴ The possible reason for the pits could be elucidated by associating the data obtained from EIS, XRD, and FTIR as well as the APS reductase assay and community analysis, which provide evidence that the consortium contains corrosive anaerobic bacterial species and assists the process of corrosion synergistically.⁵⁵
