Cite this: *RSC Adv.*, 2019, 9, 17040

Potential of dynamic bacterial communities in the bio-corrosion process: a proof study with surface morphology of metal coupons†

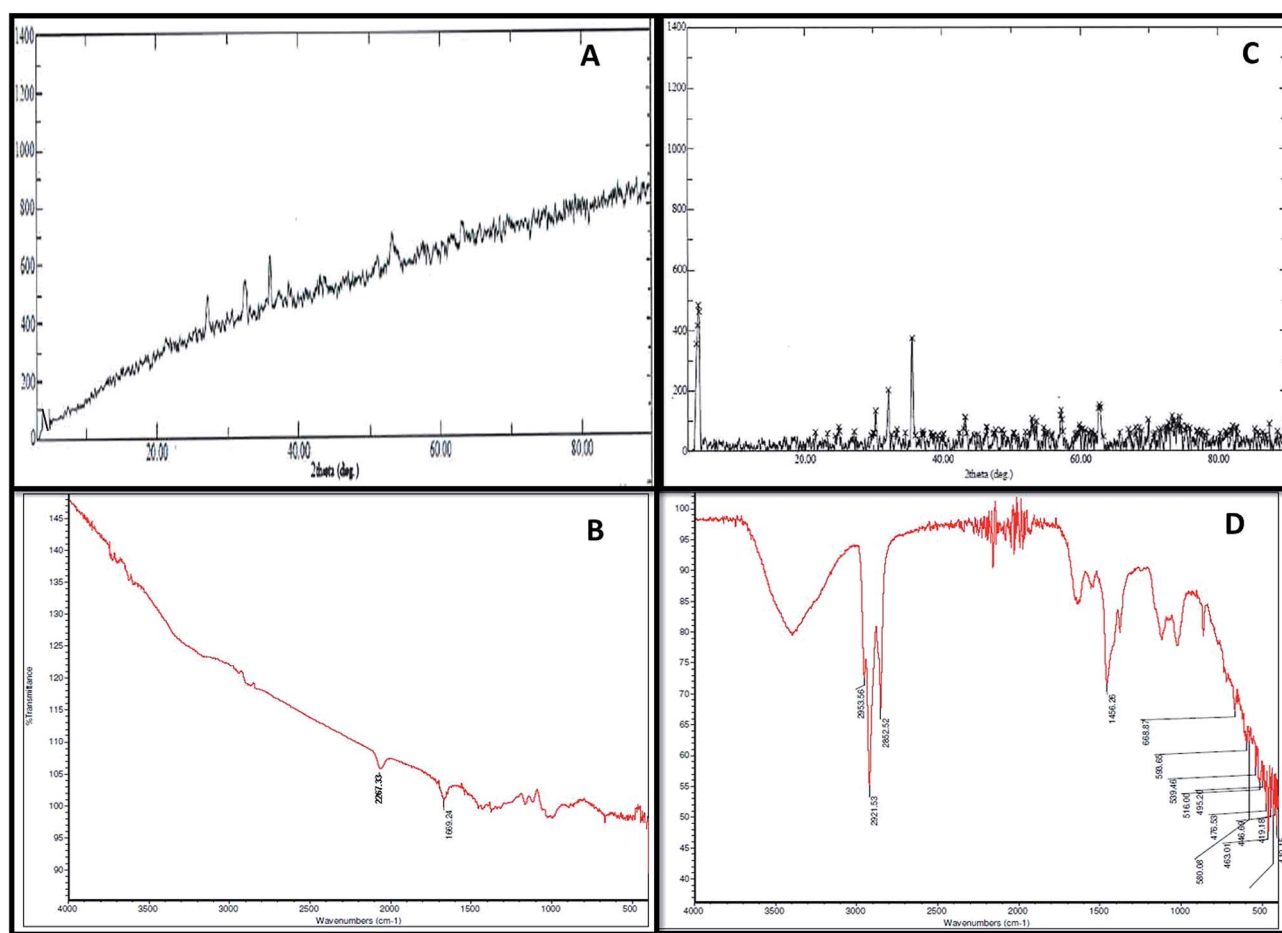
Fig. 3 The corrosive chemical composition produced in the abiotic and biotic systems illustrated by FT-IR and XRD spectra. (A and B) Represent the FT-IR and XRD results for the abiotic system, respectively. (C and D) Show the FT-IR and XRD results for the biotic system, respectively.

XRD and FTIR analyses provided information regarding the chemical composition and functional groups (oxides, sulphides and stretching of compounds) of the corrosive products deposited in the abiotic and biotic systems on the metal surface (Fig. 3A–D). The intensity of peaks in the abiotic system (control) was observed to be weak (Fig. 3A). The XRD spectra of the biotic system confirmed the presence of oxide and sulphide of iron (Fe_3O_4 and FeS) with high-intensity peaks; the pattern confirmed that the production of sulfide was biogenic in nature (Fig. 3C). Sulfate-reducing bacteria utilized the iron and sulfate (terminal electron acceptors) from the medium and finally altered them to iron sulfide (Fe_xS_y), which is considered as one of the most corrosive agents for pipelines.^{16,25} Similar spectra were reported by Parthipan *et al.*⁴ and Alabbas *et al.*²² The XRD data revealed the role of bacteria in mineral deposition on the metal surface, which were responsible for coupon corrosion.

As such, no major peaks were observed in the FTIR spectra of the abiotic system (control) (Fig. 3B). Only minor peaks at 1667–2300 cm^{-1} , which corresponded to the $-\text{C}=\text{C}$ conjugated

dienes and aliphatic groups, were noticed. Furthermore, the FT-IR spectra of the biotic system demonstrated vibrations ranging between 400 and 700 cm^{-1} , accounting for the $\text{Fe}-\text{O}$ stretching, which confirmed the presence of goethite ($\alpha\text{-FeOOH}$) and lepidocrocite ($\gamma\text{-FeOOH}$) (Fig. 3D). The presence of magnetite (Fe_3O_4) in the sample was shown by the peak at 580 cm^{-1} . The stretching at higher wavenumbers signified the presence of OH ,²⁶ whereas the stretching observed between 2500 and 3000 cm^{-1} was assigned to $\text{C}-\text{H}$ due to the polysaccharide bonds of sugar present in the bacterial biofilm. These compounds are indicated as the notable compounds for corroding a substance. The nature of stretching was described by Kumar and Balasubramaniam; they revealed the presence of similar compounds in Delhi iron pillar rust.^{27,28} The data of the biotic system obtained from XRD and FT-IR analyses indicated the presence of these compounds in major amounts, which are corrosive to their respective environments and play major roles in bio-corrosion.

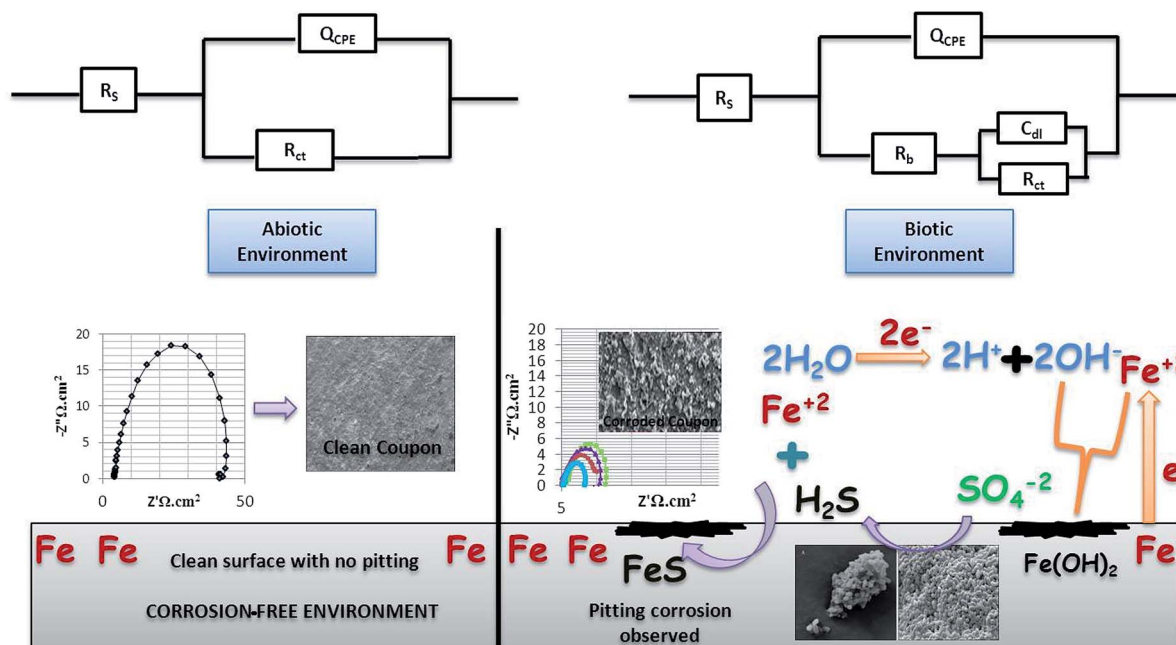
Fig. 5 The bio-electrochemical reactions of the abiotic and biotic systems. The biotic system is a potentially active system.

Fig. 5 shows the difference in the bio-electrochemistry of abiotic and biotic systems with the circuit model, where R_s denotes the resistance of the solution, R_b is the resistance created by the biofilm formed in the biotic system, and C_{dl} refers to the double layer capacitance. In the biotic system, the microorganisms accelerated the corrosion process by generating corrosive products on the metal coupons. The reciprocal of charge transfer resistance ($1/R_{ct}$) is known as the corrosion rate; the smaller the R_{ct} , the higher the rate of corrosion. It is evident that the diameter of the biotic semicircle decreases, which further reduces the polarization resistance. This suggests that the biotic system has a noticeable effect on corrosion growth by altering the surrounding environment; the metabolites produced (oxides of iron and sulfur) in the biotic system alter the electrochemical properties of the system, which further results in reduced polarization resistance.³⁷

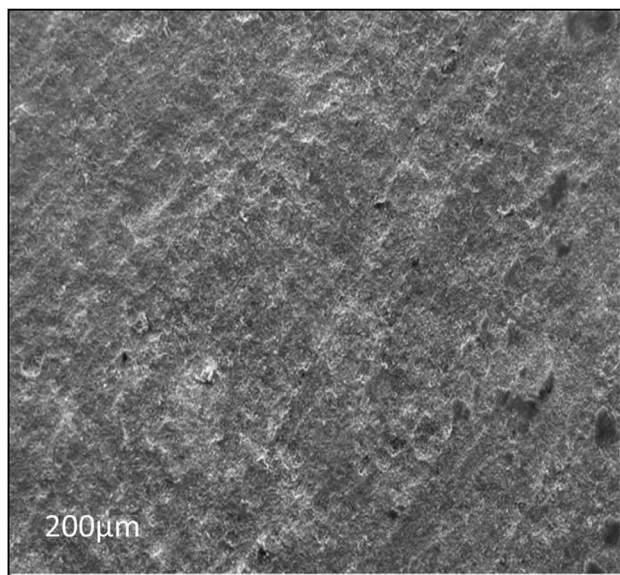
Fig. 11 The SEM image of the abiotic system, showing that the metal coupon surface is cleaned after the 28th day of incubation.

Furthermore, the level of the corrosive nature of samples was indicated by the scanning electron micrographs of the biotic coupons (Fig. 11–13). Fig. 11 represents the nature of the abiotic system (coupons in a sterile medium), whereas Fig. 12 and 13 illustrate the effect of the biotic system on the metal surface and the bacterial community responsible for corrosion. With respect to appearance, a significant difference was observed while comparing the coupons of the abiotic and biotic systems. The coupons in the abiotic system appeared clean and clear as compared to the coupons in the biotic system. In the biotic system, the bacterial community almost fully covered the coupon surface. While examining the images in Fig. 12(A–E), microscopic cracks and pits can be noticed, as indicated by the red arrows and boxes. Previous studies illustrated that corrosive bacterial species corroded the surfaces of the coupons by

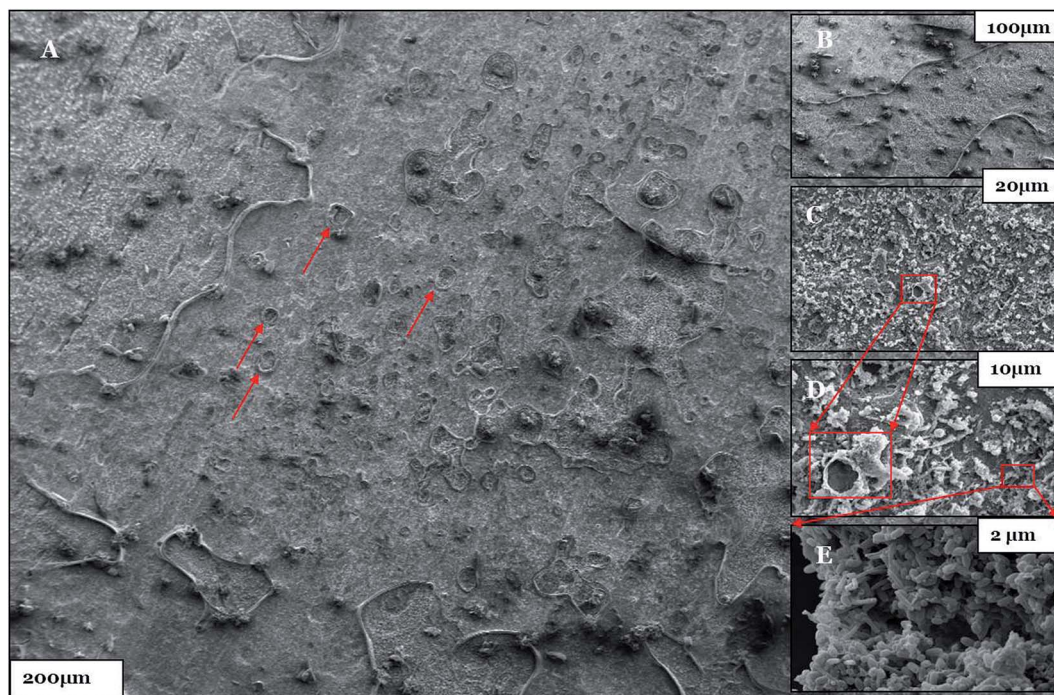
Fig. 12 (A–E) The SEM micrographs of the biotic system after the 28th day of incubation. Pit holes are shown by the red arrows and boxes.

producing large amounts of corrosion products mainly composed of iron oxide and an extracellular polymeric substance (EPS). Bacterial EPS mostly comprises polysaccharides, proteins, nucleic acids, phospholipids and humic substances. It supports the bacteria for holding on to the metal surface and is thought to play a significant role in the corrosion process.^{5,52,53}
