Potential of dynamic bacterial communities in the bio-corrosion process: a proof study with surface morphology of metal coupons†

Priyanka Basera, Meeta Lavania

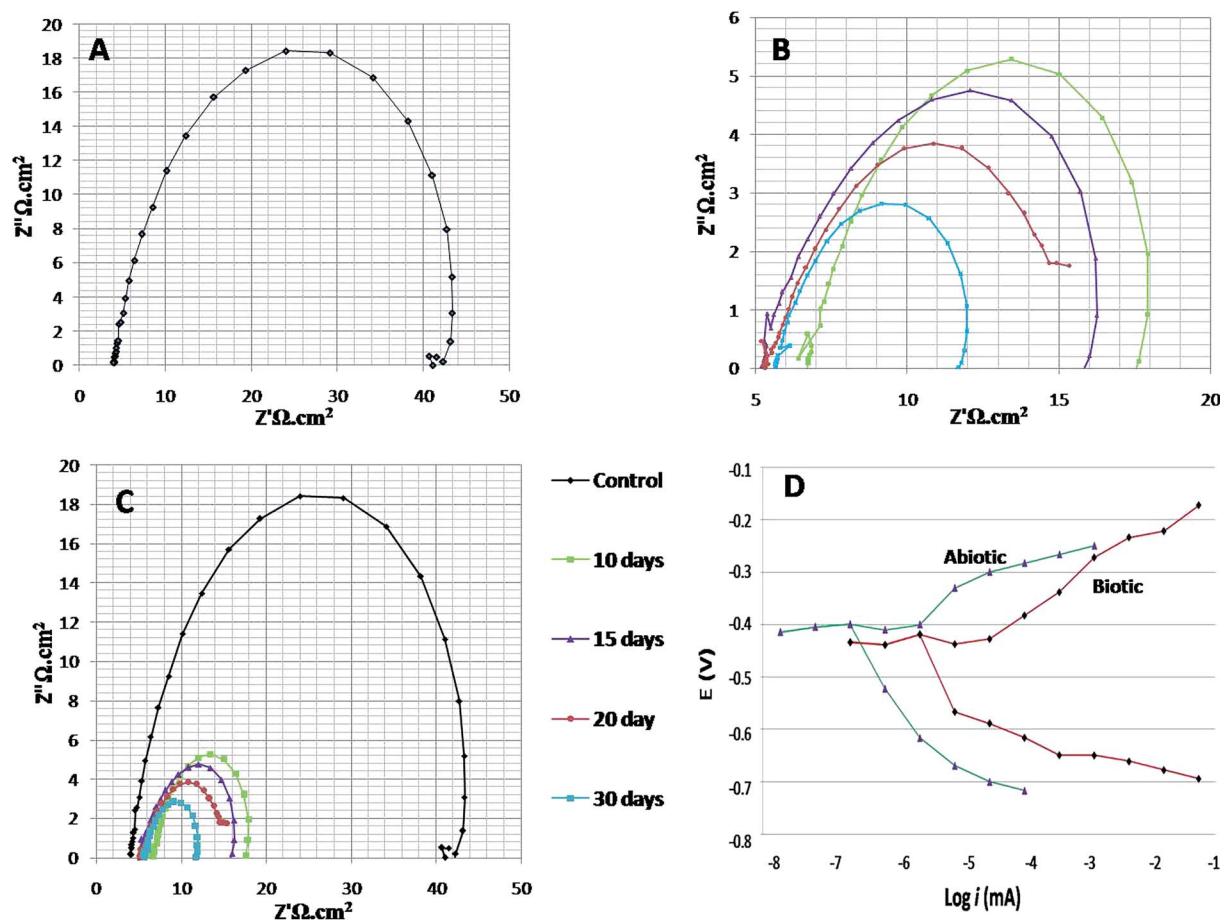
Fig. 4 The Nyquist and Tafel spectra. (A) Illustrates the spectra of the abiotic system, (B) illustrates the spectra of the biotic system for 7th, 14th, 21st and 28th days, (C) shows the combined spectra for both abiotic and biotic systems, and (D) elucidates the Tafel plots of the abiotic and biotic systems (on the 28th day).

EIS was recorded on every 7th day of the 28 days incubation period. The diameter of R_{ct} was observed to be maximum for control (Fig. 4A); as the environment was abiotic, there was no bacterial activity and the electron transfer was very low. Therefore, in the abiotic system, the chance of electro-biochemical reactions was negligible.

By studying the Nyquist loops of the biotic system, the corrosive nature of the sample can be justified. A significant difference was observed on comparing the diameters of the biotic and abiotic systems; a relatively reduced R_{ct} value was observed in the biotic system. The reduced diameter signified the role of bacterial activity in metal corrosion.³⁵ After exposing the coupons for different exposure times, it was observed that, as the incubation period increased, the corrosive behaviour caused by bacteria also increased. The diameter obtained on the

28th day was comparatively smaller than the diameter obtained on the 7th day of incubation (Fig. 4B and C). Fig. 4D illustrates the Tafel plots of the abiotic and biotic systems, corresponding to the occurrence of anodic and cathodic reactions, and the intersection in the graph gives the corrosion exchange current density. In the case of the biotic graph, the anodic and cathodic values are higher in comparison to the observations for the abiotic graph. This showed that the biotic system contained a corrosive environment. Study reported by Jia *et al.*,³⁶ similar Tafel plots were obtained; the abiotic system showed lesser corrosion values than the biotic system.

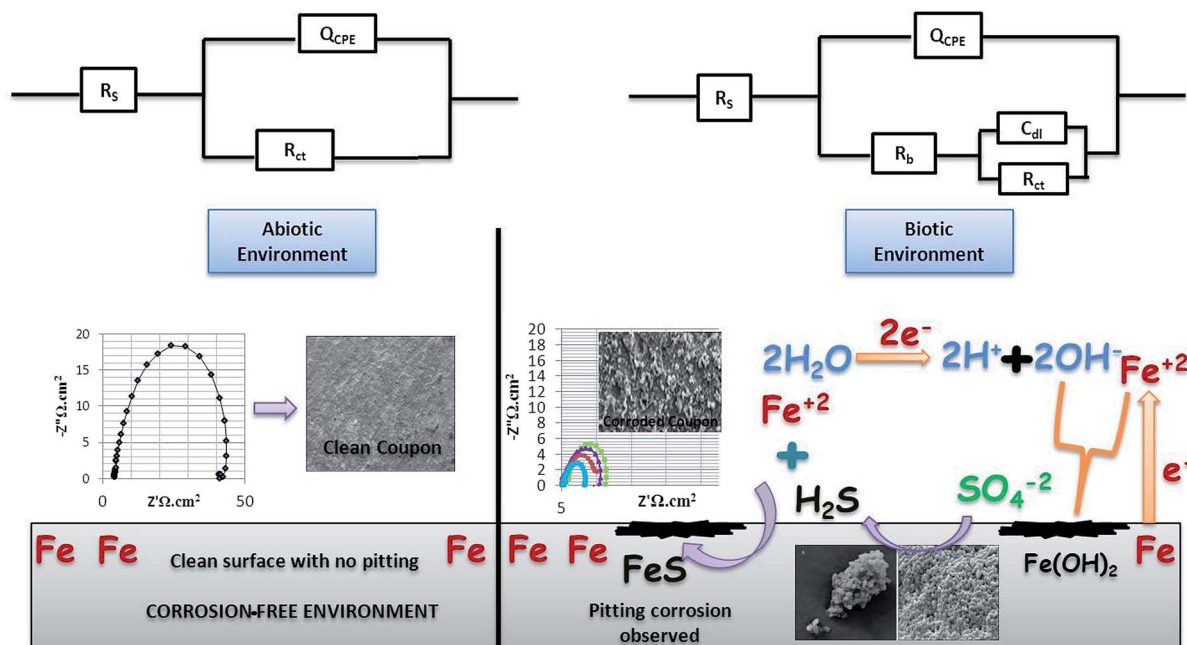
Fig. 5 The bio-electrochemical reactions of the abiotic and biotic systems. The biotic system is a potentially active system.

Fig. 5 shows the difference in the bio-electrochemistry of abiotic and biotic systems with the circuit model, where R_s denotes the resistance of the solution, R_b is the resistance created by the biofilm formed in the biotic system, and C_{dl} refers to the double layer capacitance. In the biotic system, the microorganisms accelerated the corrosion process by generating corrosive products on the metal coupons. The reciprocal of charge transfer resistance ($1/R_{ct}$) is known as the corrosion rate; the smaller the R_{ct} , the higher the rate of corrosion. It is evident that the diameter of the biotic semicircle decreases, which further reduces the polarization resistance. This suggests that the biotic system has a noticeable effect on corrosion growth by altering the surrounding environment; the metabolites produced (oxides of iron and sulfur) in the biotic system alter the electrochemical properties of the system, which further results in reduced polarization resistance.³⁷

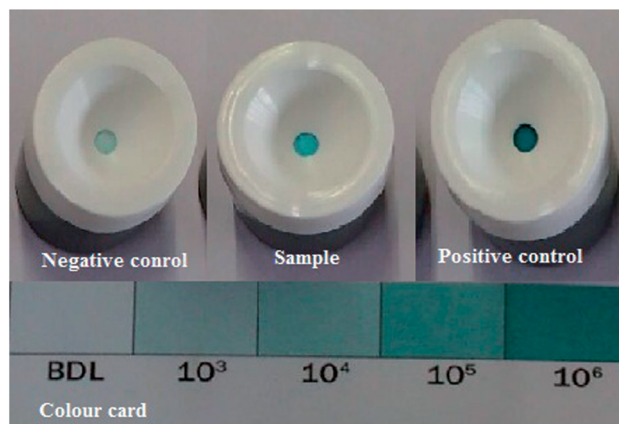
Fig. 7 APS Reductase test. The negative control falls in the BDL range (Below Detection Limit), whereas the positive control and the sample show positive responses towards the reaction. All the experiments were performed in triplicate. The data points are the average of the triplicate \pm standard deviation (less than 5% of average).

The biotic sample was subjected to the APS reductase assay, which involved a 15 minutes reaction. This assay indicated the presence of APS reductase enzyme in the sample. The kit contained an antibody against the enzyme adenosine-5'-phosphosulfate (APS) reductase, which is common to all strains of SRB. The detection of the enzyme can be examined by the appearance of blue colour on the membrane device after the addition of a chromogen (provided with the kit). Darker shades of blue signify the presence of a higher count of SRB in the sample, which can be inspected by matching the colour card (as per the manufacturer guidelines).¹⁸ For the present analysis, positive and negative controls were prepared. The negative control fell into BDL range (Below Detection Limit), whereas the sample showed a positive response towards the reaction with $10^5 \pm 1.5$ cell per mL and the positive control showed $10^6 \pm 1.5$ cell per mL bacterial count, as depicted in Fig. 7.

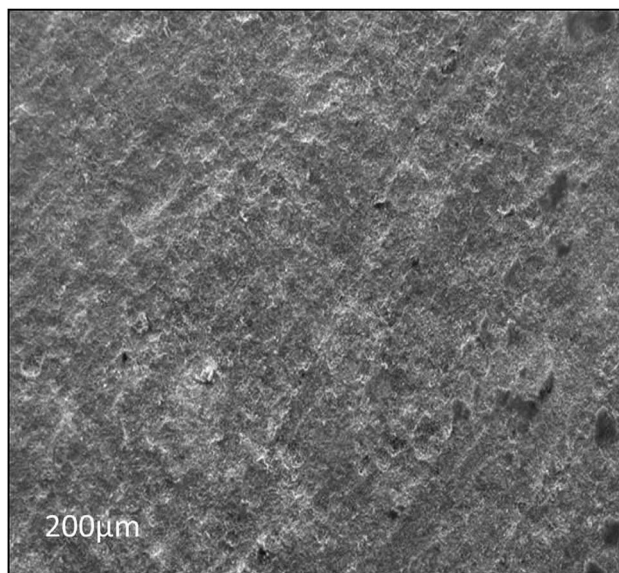
Fig. 11 The SEM image of the abiotic system, showing that the metal coupon surface is cleaned after the 28th day of incubation.

Furthermore, the level of the corrosive nature of samples was indicated by the scanning electron micrographs of the biotic coupons (Fig. 11–13). Fig. 11 represents the nature of the abiotic system (coupons in a sterile medium), whereas Fig. 12 and 13 illustrate the effect of the biotic system on the metal surface and the bacterial community responsible for corrosion. With respect to appearance, a significant difference was observed while comparing the coupons of the abiotic and biotic systems. The coupons in the abiotic system appeared clean and clear as compared to the coupons in the biotic system. In the biotic system, the bacterial community almost fully covered the coupon surface. While examining the images in Fig. 12(A–E), microscopic cracks and pits can be noticed, as indicated by the red arrows and boxes. Previous studies illustrated that corrosive bacterial species corroded the surfaces of the coupons by

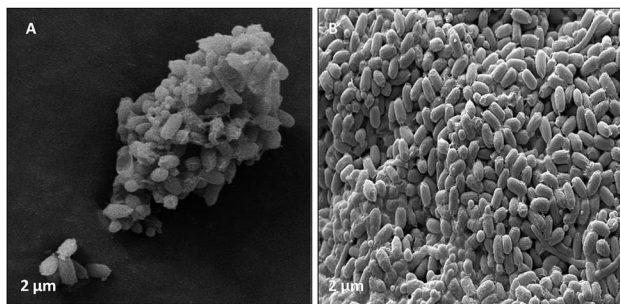
Fig. 13 (A) Illustrated the bacterial species had a cumulative effect on bio-corrosion. (B) Demonstrated the morphology (rod shape) of bacterial community associated with bio-corrosion.

Fig. 13 illustrates that bacteria work in a cumulative way to accelerate corrosion in the surrounding environment. By accumulating, they reduce the surface area with respect to the environment.⁵⁴ The possible reason for the pits could be elucidated by associating the data obtained from EIS, XRD, and FTIR as well as the APS reductase assay and community analysis, which provide evidence that the consortium contains corrosive anaerobic bacterial species and assists the process of corrosion synergistically.⁵⁵
