A study on the properties and working mechanism of a waterborne polyurethane-modified silicate-based coating

Herein, the effects of the amount of waterborne polyurethane, silica sol and fillers on the compressive and bending strength, temperature resistance and acid resistance of waterborne polyurethane-modified silicate-based coatings were investigated. The results indicated that the modified coating showed higher mechanical properties, impermeability and bonding properties when the amounts of polyurethane and silica sol were 10% and 4%, respectively. The room temperature strength, temperature resistance and acid resistance of the modified coating were 25.1%, 34.1% and 32.4% higher than those of unmodified coatings, respectively. Moreover, the flexibility of the coating was significantly improved. The compression–bend ratio of the modified coating was 7% higher than that of the unmodified coating. The impermeability of the modified coating was 53% higher than that of the unmodified coating. The bond strengths of the modified coatings with a concrete and an acid-resistant ceramic tile were 3.08 MPa and 5.84 MPa, respectively, which were higher than the standard value of 1.2 MPa. S

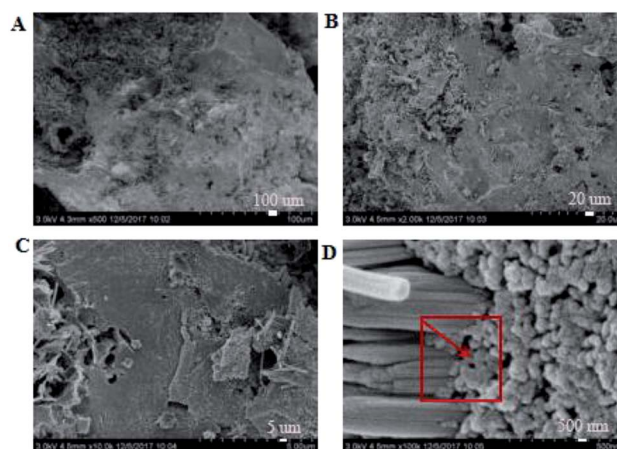
Fig. 4 SEM images of the modified coating after acid storage at the magnifications of $\times 500$ (A), $\times 2000$ (B), $\times 10\,000$ (C) and $\times 100\,000$ (D).

It was observed from Fig. 4 and 7 that after the coatings were immersed in a 50% sulfuric acid solution for 30 days, the interpenetrating network structure formed by the organic–

inorganic coating of the modified group coating, as shown in Fig. 4, had no obvious corrosion phenomenon, and only a small number of small voids generated by corrosion existed. The overall structure was still dense. However, the unmodified group coating, as shown in Fig. 7, was obviously dissolved, some structures were corroded, and the gap was further enlarged and deepened. The residual structure was sandy with only a small amount of adhesives to maintain the strength of the structure, and the contact area was small.

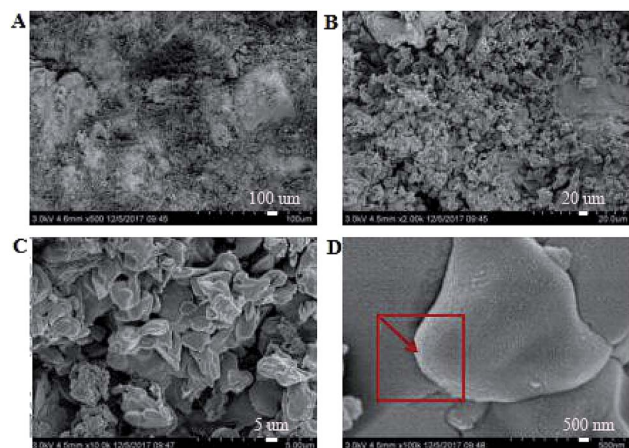
Fig. 7 SEM images of the coating belonging to the blank group after acid storage at the magnifications of $\times 500$ (A), $\times 2000$ (B), $\times 10\,000$ (C) and $\times 100\,000$ (D).

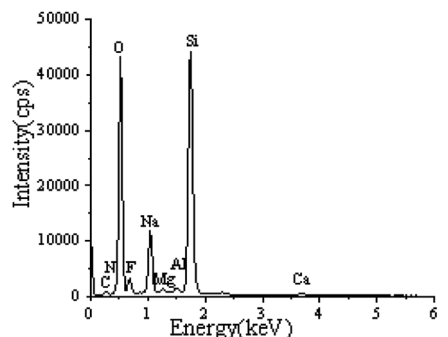
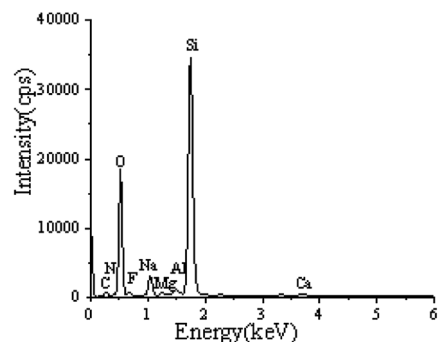
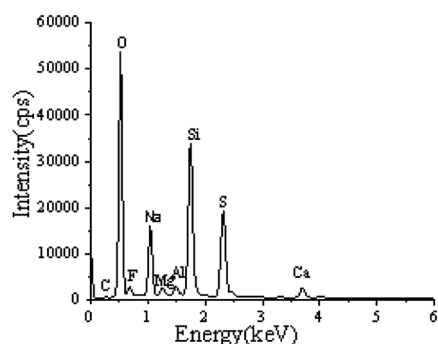
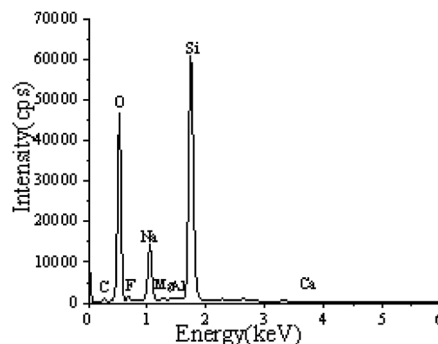
(a) Modified group at room temperature

(b) Modified group after acid resistance

(c) Blank group after acid storage

(d) Blank group at room temperature

Fig. 8 Energy spectra of the coatings at normal temperature and after the acid resistance test.

3.3.2. Composition analysis. EDS tests were carried out in the red area marked in the (d) chart in Fig. 2, 4, 5 and 7. It could be observed from Fig. 8 and Table 3 that after storage in sulfuric acid at a 50% concentration for 30 days, no sulfur atom was detected in the modified group coating. However, the sulfur atom percentage of the unmodified group coating was 6.73%. Moreover, the coating sample was 10 mm away from the surface of the test piece; this indicated that the corrosive substance had not intruded into the interior of the modified group but had intruded into the blank group coating. In Table 3, it is shown that the total mass percentage of silicon and oxygen in the modified group increases

from 76.28% to 79.26%. However, the total mass percentage of silicon in the blank group decreases from 81.39% to 72.13%. Moreover, it was shown that the modified group obviously resisted

corrosion, whereas the unmodified coating was subjected to more severe corrosion in the corrosive solution, resulting in a decrease in the quality of the main bonding element silicon oxide. This was in line with the findings of previous immersion acid strength test, whereby the blank group coating strength decreased significantly and the modified group coating strength remained stable.

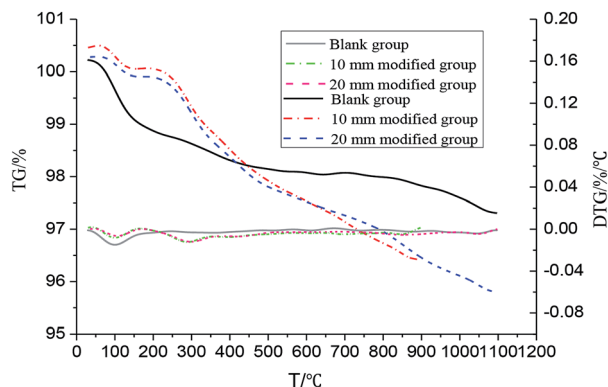
Fig. 11 The TG and DTG curves of the coating.

The TG and DTG curves of the coatings are shown in Fig. 11. As observed from Fig. 11, the coating had an obvious weight loss at 70–140 $^{\circ}\text{C}$. This may be due to the evaporation of trace amount of free water from the sample and the condensation reaction of water in the water glass when the residual portion of the silicic acid gel is increased during curing; in addition, the moisture is further removed, resulting in an obvious weight loss step. However, the weight loss of the modified coating was less obvious than that of the blank coating; this might be because

the addition of polyurethane to a certain extent limited the removal of water. The coating of the blank group tended to be stable, and no obvious weight loss phenomenon was found; this was because the coating of the blank group was composed of a filler with excellent temperature resistance and an inorganic adhesive. However, the weight loss of the modified coating at different depths was obvious in the range of 260–380 °C; this was mainly due to the decomposition of polyurethane in the coating. The weight loss curves of the two groups almost coincided; this indicated that polyurethane was evenly distributed in the coating. The weight loss of the modified coating occurred slightly below 250 °C, and the performance of the coating was stable. The results indicated that the modified coating could fully meet the requirement of temperature resistance at 250 °C.
