Cite this: *RSC Adv.*, 2019, 9, 26817

A study on the properties and working mechanism of a waterborne polyurethane-modified silicate-based coating

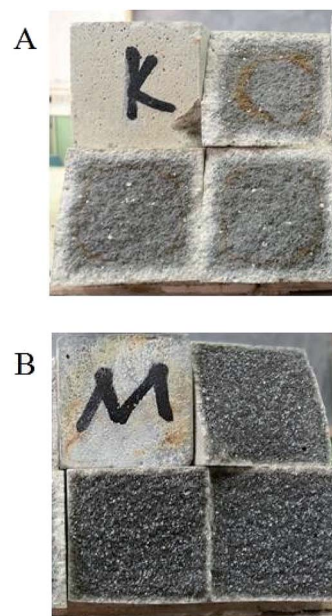
Fig. 1 Sectional view of the coatings after acid storage: (A) blank group and (B) modified group.

In Table 1, it is also shown that after the samples are stored in 40% sulfuric acid for 30 days, the strength of the modified group decreases slightly and that of the blank group decreases significantly. The average compressive strength of the modified group after acid storage was 27.21 MPa, which was 32.4% higher than that of the blank group (20.55 MPa). Therefore, the modified coating has excellent acid resistance, and the strength change value is 11% higher than the standard value of 0.9. The appearances of the coating specimens after acid storage are shown in Fig. 1. It was clearly observed that the acid corrosion layer of the modified coating was relatively thin, which indicates that the modified coating has excellent acid resistance. However, the corrosive medium had penetrated the blank coating to a great extent. Moreover, the modified coating did not

show any signs of corrosion, peeling, cracks, expansion and partial bubbling. Therefore, the acid resistance performance of the modified coating was stable.

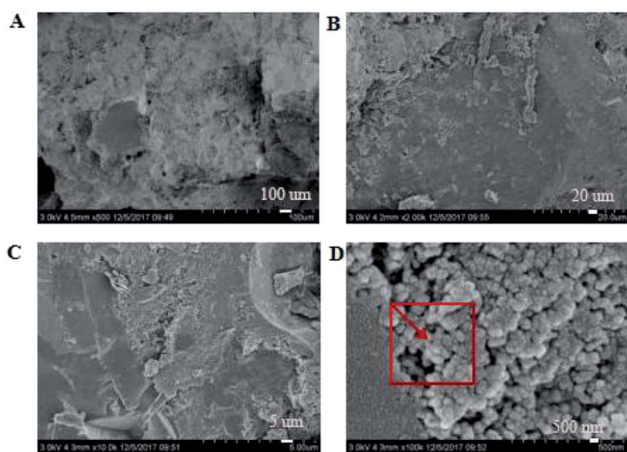
Fig. 2 SEM images of the modified coating at normal temperature at the magnifications of $\times 500$ (A), $\times 2000$ (B), $\times 10\,000$ (C) and $\times 100\,000$ (D).

3.3.1. Micro-topography of the coating. SEM images of the coating section obtained at room temperature are shown in Fig. 2 and 5. It can be observed from Fig. 2(C) and (D) that water glass and polyurethane of the modified group coating are well integrated to form an interpenetrating network structure that is tightly wrapped with the filler to form a dense structural system. The void

was significantly smaller than that in the case of the blank coating. Therefore, the strength of the coating was improved. This was also in accordance with the strength of the previously modified coating, which was 25% higher than that of the unmodified coating. The water glass adhesive connected the blank group coating. There were a lot of voids in the coating, and the adhesive could not wrap the filler well. Therefore, the coating was not sufficiently dense and strong. SEM images of the coating section obtained at resistance temperature are shown in Fig. 3 and 6. It can be observed from Fig. 3 that polyurethane of the modified group coating does not decompose at the high temperature of 250 °C. The filler still wraps the binder phase tightly, and the high temperature does not destroy the organic–inorganic interpenetrating network. However, it can be observed from Fig. 6 that water in the water glass of the blank group may be further removed due to high temperature, and this may form a large number of irregular honeycomb-like pores, resulting in poor compactness.

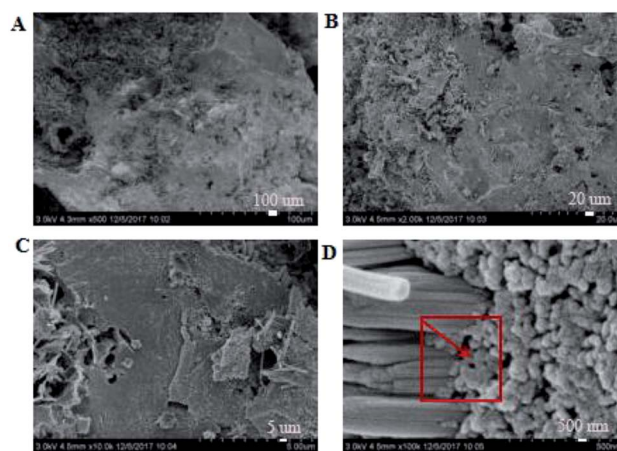
Fig. 4 SEM images of the modified coating after acid storage at the magnifications of $\times 500$ (A), $\times 2000$ (B), $\times 10\,000$ (C) and $\times 100\,000$ (D).

It was observed from Fig. 4 and 7 that after the coatings were immersed in a 50% sulfuric acid solution for 30 days, the interpenetrating network structure formed by the organic–

inorganic coating of the modified group coating, as shown in Fig. 4, had no obvious corrosion phenomenon, and only a small number of small voids generated by corrosion existed. The overall structure was still dense. However, the unmodified group coating, as shown in Fig. 7, was obviously dissolved, some structures were corroded, and the gap was further enlarged and deepened. The residual structure was sandy with only a small amount of adhesives to maintain the strength of the structure, and the contact area was small.

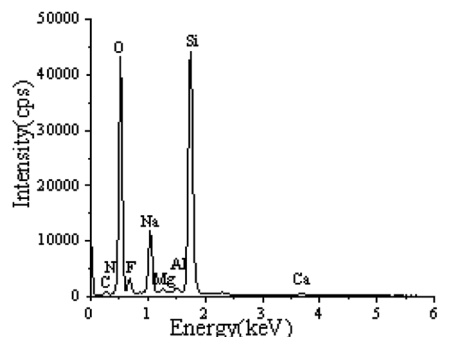
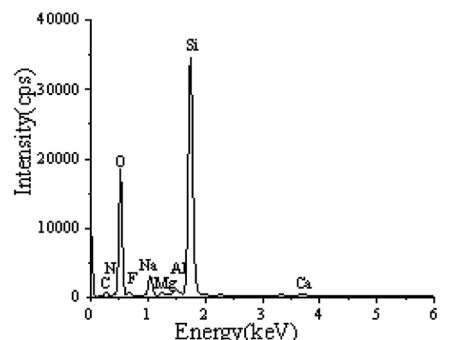
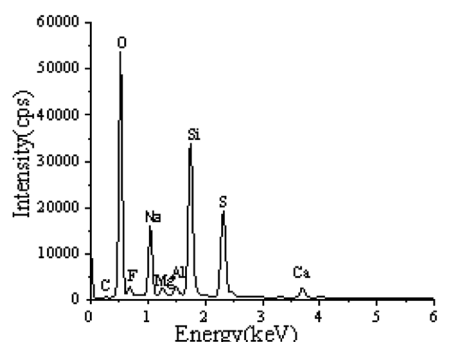
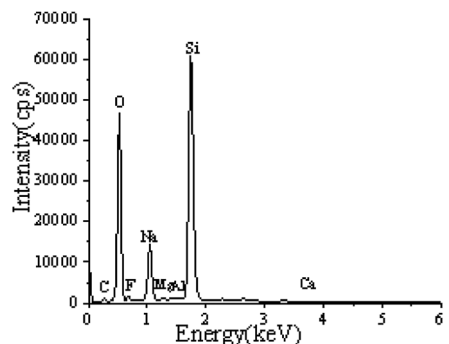
(a) Modified group at room temperature

(b) Modified group after acid resistance

(c) Blank group after acid storage

(d) Blank group at room temperature

Fig. 8 Energy spectra of the coatings at normal temperature and after the acid resistance test.

3.3.2. Composition analysis. EDS tests were carried out in the red area marked in the (d) chart in Fig. 2, 4, 5 and 7. It could be observed from Fig. 8 and Table 3 that after storage in sulfuric acid at a 50% concentration for 30 days, no sulfur atom was detected in the modified group coating. However, the sulfur atom percentage of the unmodified group coating was 6.73%. Moreover, the coating sample was 10 mm away from the surface of the test piece; this indicated that the corrosive substance had not intruded into the interior of the modified group but had intruded into the blank group coating. In Table 3, it is shown that the total mass percentage of silicon and oxygen in the modified group increases

from 76.28% to 79.26%. However, the total mass percentage of silicon in the blank group decreases from 81.39% to 72.13%. Moreover, it was shown that the modified group obviously resisted

corrosion, whereas the unmodified coating was subjected to more severe corrosion in the corrosive solution, resulting in a decrease in the quality of the main bonding element silicon oxide. This was in line with the findings of previous immersion acid strength test, whereby the blank group coating strength decreased significantly and the modified group coating strength remained stable.

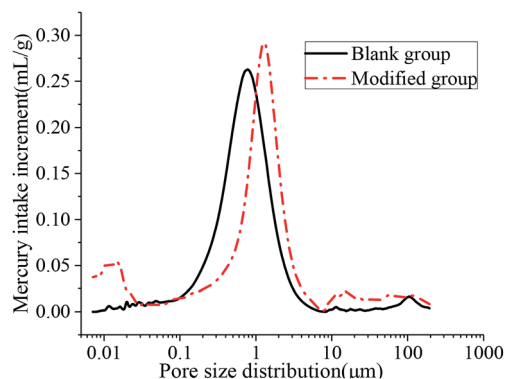
Fig. 9 Aperture differential distribution curve.

The aperture differential distribution curve and the pore cumulative distribution curve are shown in Fig. 9 and 10, respectively. As observed from Fig. 9, the coating pores were mainly provided by the pores with diameters between 0.1 μm and 3 μm . The peak value of the coatings in the modified group was obvious at the pore diameters between 8 nm and 12 nm, which indicated that waterborne polyurethane could refine the

macro-porous structure of the modified group coating to a certain extent and increase the number of the medium holes. However, the porosity of the blank group and the modified group was 33.91% and 33.78%, respectively, and was not significantly changed. The porosities of the blank group and the modified group did not change significantly, and the porosities were 33.91% and 33.78% respectively. Due to the addition of polyurethane, micro-bubbles were produced during the preparation of the coating. The pore size between 10 μm and 100 μm for the modified coating was more than that of the blank coating, resulting in no significant change in the final porosity. Therefore, defoaming agents should be added appropriately during the preparation of the coating. Fig. 10 shows that the cumulative pore size distribution curve of the blank group coating does not change significantly when the pore diameter is less than 100 nm. However, the volume of the modified coating changed obviously; this indicated that the addition of polyurethane reduced the pore size and increased the content of the medium holes; this resulted in higher content of pores with sizes less than 100 nm in the modified coating as compared to that in the blank coating.

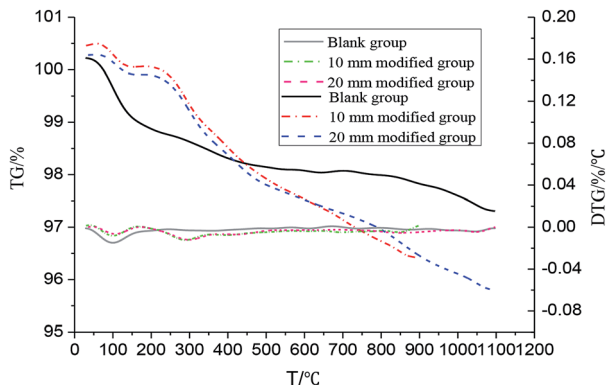
Fig. 11 The TG and DTG curves of the coating.

The TG and DTG curves of the coatings are shown in Fig. 11. As observed from Fig. 11, the coating had an obvious weight loss at 70–140 $^{\circ}\text{C}$. This may be due to the evaporation of trace amount of free water from the sample and the condensation reaction of water in the water glass when the residual portion of the silicic acid gel is increased during curing; in addition, the moisture is further removed, resulting in an obvious weight loss step. However, the weight loss of the modified coating was less obvious than that of the blank coating; this might be because

the addition of polyurethane to a certain extent limited the removal of water. The coating of the blank group tended to be stable, and no obvious weight loss phenomenon was found; this was because the coating of the blank group was composed of a filler with excellent temperature resistance and an inorganic adhesive. However, the weight loss of the modified coating at different depths was obvious in the range of 260–380 °C; this was mainly due to the decomposition of polyurethane in the coating. The weight loss curves of the two groups almost coincided; this indicated that polyurethane was evenly distributed in the coating. The weight loss of the modified coating occurred slightly below 250 °C, and the performance of the coating was stable. The results indicated that the modified coating could fully meet the requirement of temperature resistance at 250 °C.
