Cite this: *RSC Adv.*, 2019, 9, 26817

A study on the properties and working mechanism of a waterborne polyurethane-modified silicate-based coating

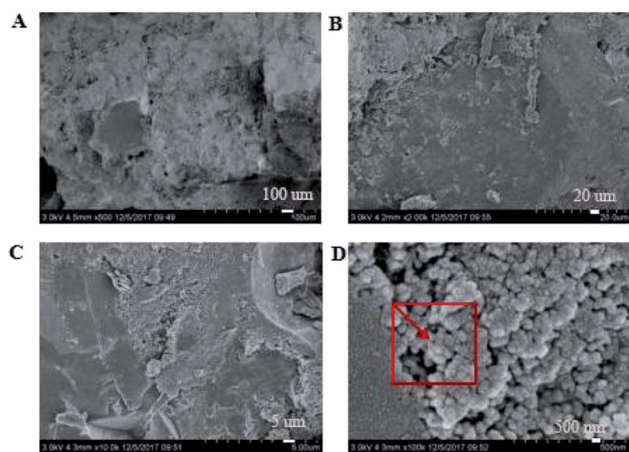
Fig. 2 SEM images of the modified coating at normal temperature at the magnifications of $\times 500$ (A), $\times 2000$ (B), $\times 10\,000$ (C) and $\times 100\,000$ (D).

3.3.1. Micro-topography of the coating. SEM images of the coating section obtained at room temperature are shown in Fig. 2 and 5. It can be observed from Fig. 2(C) and (D) that water glass and polyurethane of the modified group coating are well integrated to form an interpenetrating network structure that is tightly wrapped with the filler to form a dense structural system. The void

was significantly smaller than that in the case of the blank coating. Therefore, the strength of the coating was improved. This was also in accordance with the strength of the previously modified coating, which was 25% higher than that of the unmodified coating. The water glass adhesive connected the blank group coating. There were a lot of voids in the coating, and the adhesive could not wrap the filler well. Therefore, the coating was not sufficiently dense and strong. SEM images of the coating section obtained at resistance temperature are shown in Fig. 3 and 6. It can be observed from Fig. 3 that polyurethane of the modified group coating does not decompose at the high temperature of 250 °C. The filler still wraps the binder phase tightly, and the high temperature does not destroy the organic–inorganic interpenetrating network. However, it can be observed from Fig. 6 that water in the water glass of the blank group may be further removed due to high temperature, and this may form a large number of irregular honeycomb-like pores, resulting in poor compactness.

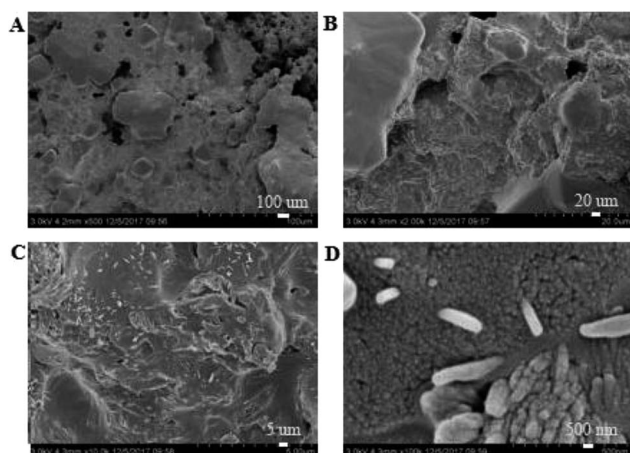
Fig. 3 SEM images of the modified coating at resistance temperature at the magnifications of $\times 500$ (A), $\times 2000$ (B), $\times 10\,000$ (C) and $\times 100\,000$ (D).

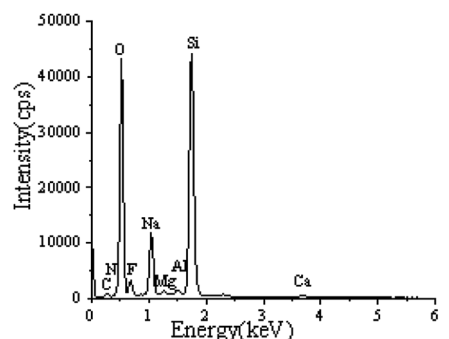
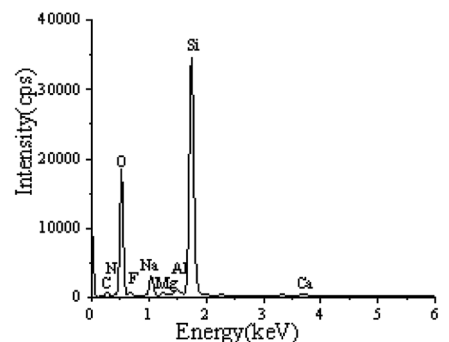
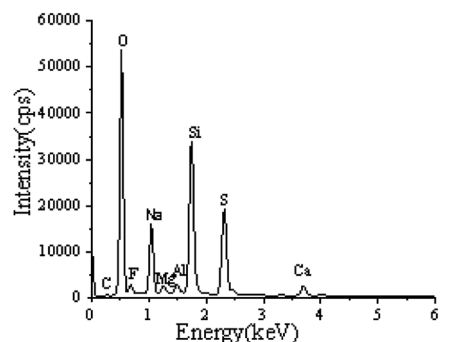
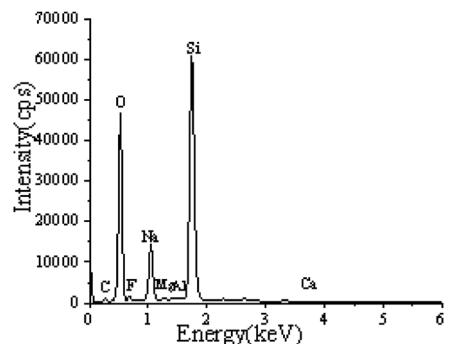
(a) Modified group at room temperature

(b) Modified group after acid resistance

(c) Blank group after acid storage

(d) Blank group at room temperature

Fig. 8 Energy spectra of the coatings at normal temperature and after the acid resistance test.

3.3.2. Composition analysis. EDS tests were carried out in the red area marked in the (d) chart in Fig. 2, 4, 5 and 7. It could be observed from Fig. 8 and Table 3 that after storage in sulfuric acid at a 50% concentration for 30 days, no sulfur atom was detected in the modified group coating. However, the sulfur atom percentage of the unmodified group coating was 6.73%. Moreover, the coating sample was 10 mm away from the surface of the test piece; this indicated that the corrosive substance had not intruded into the interior of the modified group but had intruded into the blank group coating. In Table 3, it is shown that the total mass percentage of silicon and oxygen in the modified group increases

from 76.28% to 79.26%. However, the total mass percentage of silicon in the blank group decreases from 81.39% to 72.13%. Moreover, it was shown that the modified group obviously resisted

corrosion, whereas the unmodified coating was subjected to more severe corrosion in the corrosive solution, resulting in a decrease in the quality of the main bonding element silicon oxide. This was in line with the findings of previous immersion acid strength test, whereby the blank group coating strength decreased significantly and the modified group coating strength remained stable.

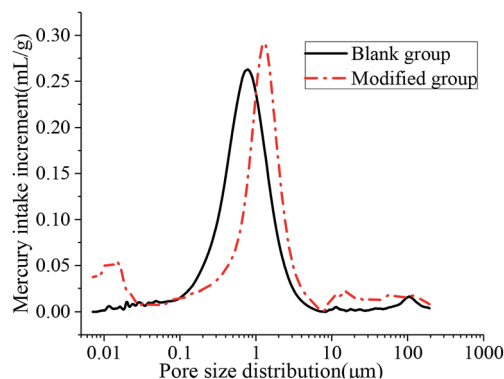
Fig. 9 Aperture differential distribution curve.

The aperture differential distribution curve and the pore cumulative distribution curve are shown in Fig. 9 and 10, respectively. As observed from Fig. 9, the coating pores were mainly provided by the pores with diameters between 0.1 μm and 3 μm . The peak value of the coatings in the modified group was obvious at the pore diameters between 8 nm and 12 nm, which indicated that waterborne polyurethane could refine the

macro-porous structure of the modified group coating to a certain extent and increase the number of the medium holes. However, the porosity of the blank group and the modified group was 33.91% and 33.78%, respectively, and was not significantly changed. The porosities of the blank group and the modified group did not change significantly, and the porosities were 33.91% and 33.78% respectively. Due to the addition of polyurethane, micro-bubbles were produced during the preparation of the coating. The pore size between 10 μm and 100 μm for the modified coating was more than that of the blank coating, resulting in no significant change in the final porosity. Therefore, defoaming agents should be added appropriately during the preparation of the coating. Fig. 10 shows that the cumulative pore size distribution curve of the blank group coating does not change significantly when the pore diameter is less than 100 nm. However, the volume of the modified coating changed obviously; this indicated that the addition of polyurethane reduced the pore size and increased the content of the medium holes; this resulted in higher content of pores with sizes less than 100 nm in the modified coating as compared to that in the blank coating.
