Virtual unrolling of spirally-wound lithium-ion cells for  
correlative degradation studies and predictive fault detection

## Virtual unrolling of spirally-wound lithium-ion cells for correlative degradation studies and predictive fault detection†

A spirally-wound LG 18650 MJ1 lithium-ion battery was imaged in 3D before and after 1061 cycles using X-ray computed tomography. The battery's capacity had faded to 79% of its initial value and some of that fade was attributed to delamination in the innermost region of the 'jelly-roll' structure. A method for virtually unrolling the jelly-roll and analysing it in different coordinates is presented. The method allows efficient comparison of the position and shape of the electrodes at different times and highlights imperfections present in the jelly-roll before cycling which were shown to nucleate the delamination of the electrode.

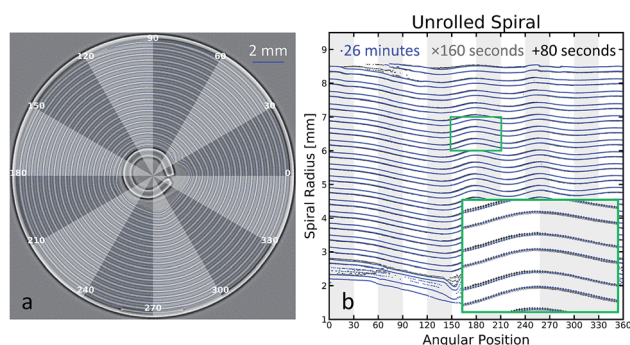
Fig. 1 (a) Example of an orthoslice after edge enhancement, the blue line shows the contour. (b) A plot of the radius of the spiral *versus* the angular position for three different length acquisition times. The inset image shows the plot in higher resolution.

The radius ( $r$ ) plotted *versus* the angle ( $\phi$ ) would produce a series of straight lines, each representing a different loop of the spiral. Fig. 1(b) demonstrates this trend between 0 and 270 degrees.

where the zero subscript indicates the coordinates at the centre of the casing. An example of an extracted spiral can be seen in Fig. 1(a and b) shows the unrolled electrode contour for a number of different scan times.

Fig. 1(b) also highlights the efficacy of this method for rapid in-line quality assurance. The inset image shows that essentially identical unrolled contours can be extracted with an 80 second or 26 minute acquisition. Coupled with computationally efficient methods presented here, the full shape of a spiral wound electrode can be imaged and analysed in under two minutes representing a substantial improvement in characterisation times using more traditional methods, which would require qualitatively analysing the greyscale images of the battery to assess the shape and quality of the jelly roll. Additionally these methods are completely non-destructive and non-intrusive.

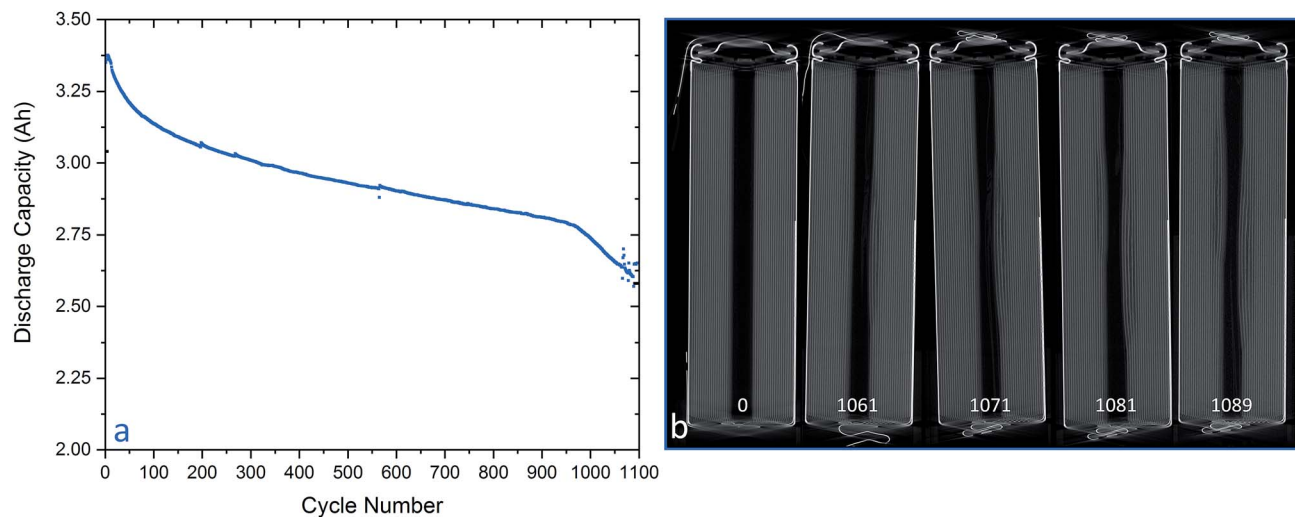
Fig. 2 (a) Capacity fade of the MJ1 cell over 1097 cycles. (b) A series of orthoslices of the cell over time, showing the gradual increase in the size of the large deformation on the inner portion of the jelly roll.

Fig. 2(a) shows the capacity fade if the MJ1 over the first 1097 cycles and Fig. 2(b) a series of orthoslices from tomograms at times between 0 and 1089 cycles. When comparing these two images it is clear there is a strong correlation between the

amount of deformation in the centre of the jelly roll and the capacity loss experienced by the cell.

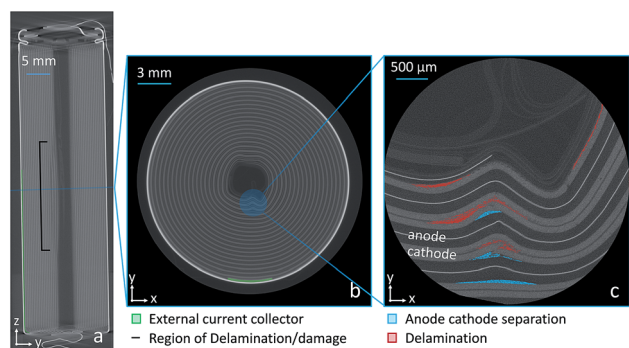
Fig. 3 (a) YZ orthoslice showing the 18650 interior after 1061 cycles. (b) Higher-resolution tomography of the cell. (c) Higher-resolution tomography of the specific ROI.

Fig. 3 shows a progression of orthoslices from tomography performed at this point. Fig. 3(a) is a YZ orthoslice showing the deformation of the jelly-roll, the most prominent feature is the damage to the jelly roll. The middle image Fig. 3(b) shows an XY orthoslice through the area that shows the most significant deformation and the right side Fig. 3(c) is a region-of-interest (ROI) scan of the most affected region of the jelly-roll. The capacity loss observed is likely from the delamination of and damage to the electrodes. The active materials in both electrodes are no longer in good electrical contact with one another, with the electrochemical pathways significantly elongated as a result of the delamination. The 'kink' or deformation in the coil is relatively small; however, it spans a region of more than 25 mm inside the electrode itself, which results in noticeable capacity fade. Lastly, the high-resolution ROI scan shows the cathode inside the kink has fractured and delaminated from the current collector, further reducing the available active mass in the battery.

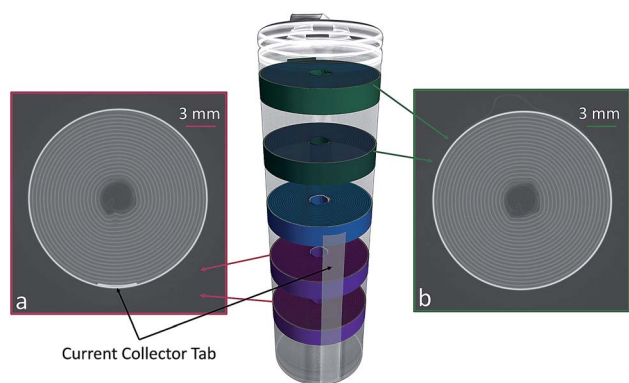
Fig. 4 Schematic detailing the different regions analysed in this study. The bottom (a) has an external current collector while the top (b) does not. The middle region (in blue) has the end of the current collector.

The 'top' regions, shown in Fig. 4(b) are not influenced directly by the presence of the current collector while the bottom regions are Fig. 4(a). The middle region, shown in blue spans the edge of the current collector tab, with roughly half above and half below its end. The data obtained from each of these regions is presented by extracting the coordinates of the unrolled electrode for each of the 100 slices and then overlaying the results on top of each other.

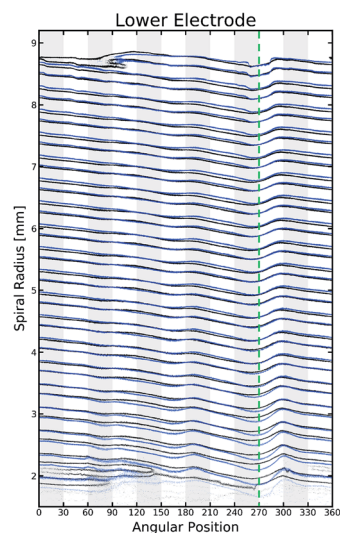
Fig. 5 The unrolled jelly-roll of the lowest region in the electrode. The black points show the electrode before cycling and the blue after. The dashed green line indicates the position of the current collector tab.

Fig. 5 provides a direct insight into the cause of the delamination. The pristine electrode (black) has a small point of inflection or imperfection near the location of the external current collector (270 degrees). The cycling of the cell (blue) clearly increases the magnitude of the inflection, with the eventual deformation of the jelly-roll and delamination of the electrodes taking place exactly in line with the imperfection. The large macro deformation inside the coil is the most obvious change in the electrode but Fig. 5 also shows there is significant deformation in large portions of the jelly-roll. The outermost layer of the electrode, shows significant deformation around the current collector. The constant expansion and contraction of the electrode during cycling forced the layer to fold around the irregular shaped tab.

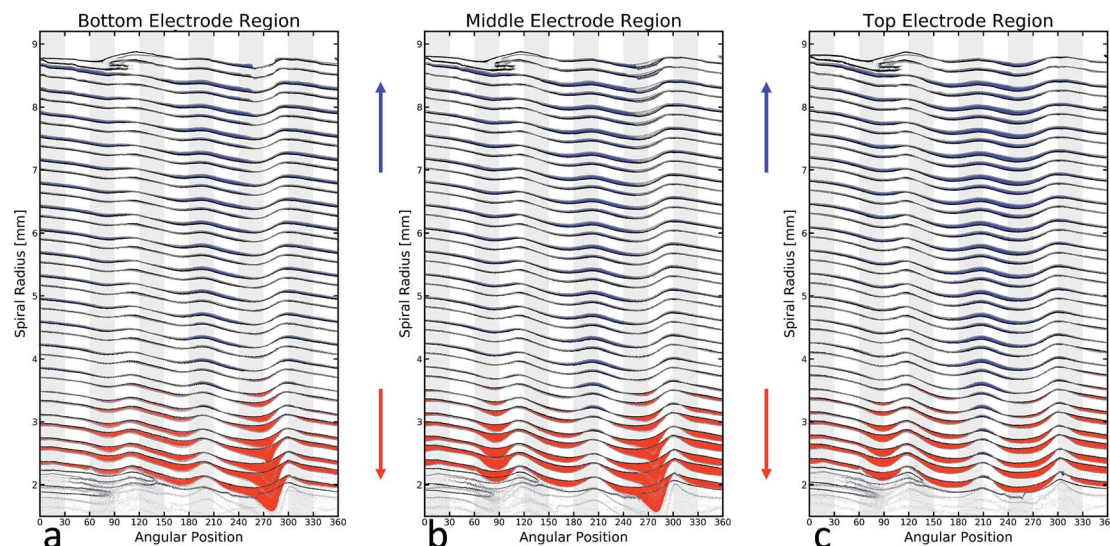
Fig. 6 Deformation patterns in three different regions of the cell after cycling. (a) The bottom electrode region, (b) the middle of the electrode and (c) the top. Blue regions indicate net outward deformation and red net inward.

Fig. 6 presents the deformation patterns in the jelly-roll for the bottom Fig. 6(a), middle Fig. 6(b) and top Fig. 6(c) of the cell. The electrode position before and after cycling are presented in black and grey, respectively. The coloured areas represent

regions of significant deformation during cycling. Red regions show inward movement, such as the 'kink' visible after cycling while blue areas indicate a net outward deformation. The shape

of these deformation patterns helps explain the nature of these processes within the cell. While cycling the individual electrodes expand and contract as a function of state of charge. Theoretically at a given state of charge the electrode position should remain identical, regardless of cycle number, but this is not the case. Over extended cycling, architectural anomalies within the cell (for example the current collector tab), act as anchor points, constraining 'jelly-roll' movement. By contrast, other features (for example the free volume in the centre of the cell) provide freedom for electrode movement; consequently there is a differential displacement depending both on angular and radial position. We would expect that these irreversible deformations would form faster for a battery being cycled at higher rates and slower for a battery cycled at lower rates.

The major changes in the jelly-roll can be seen most clearly through the red and blue regions in Fig. 6. The jelly-roll irreversibly deforms outwardly (blue) into any space left available during the initial winding of the battery. These spaces are created by inconsistent surfaces external to the jelly-roll. The bottom of the battery imaged here is being influenced by two of these features. The first is the external current collector, visible at 270 degrees. On either side of the collector, there is significant outward deformation in the jelly-roll. The second feature is the end of the spiral electrode, which is visible between 90 and 120 degrees, near the top of the figure. Again, after cycling the electrode migrates and deforms into this space. In the top of the cell, the external current collector is no longer present but still has a significant effect. While not an inconsistency in the manner described above, the end of the current collecting tab is a very significant discontinuity in the electrode, and its abrupt termination leads to a very significant void to expand into. Wherever the electrode was unable to deform outwardly it will deform inwardly (red). This leads to the most significant inward deformation to be located in line with the anchor points described above. If sufficiently high forces are applied to inward deformation, a delamination event will occur, as is clearly evident in the cell demonstrated here. This will occur where the highest stresses are being generated which will likely be in line (radially) with the current collector.
