Virtual unrolling of spirally-wound lithium-ion cells for  
correlative degradation studies and predictive fault detection

## Virtual unrolling of spirally-wound lithium-ion cells for correlative degradation studies and predictive fault detection†

A spirally-wound LG 18650 MJ1 lithium-ion battery was imaged in 3D before and after 1061 cycles using X-ray computed tomography. The battery's capacity had faded to 79% of its initial value and some of that fade was attributed to delamination in the innermost region of the 'jelly-roll' structure. A method for virtually unrolling the jelly-roll and analysing it in different coordinates is presented. The method allows efficient comparison of the position and shape of the electrodes at different times and highlights imperfections present in the jelly-roll before cycling which were shown to nucleate the delamination of the electrode.

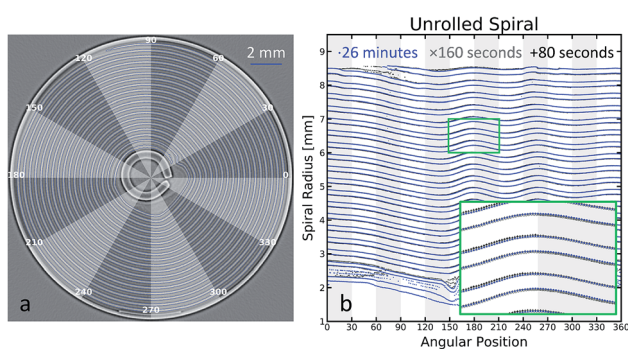
Fig. 1 (a) Example of an orthoslice after edge enhancement, the blue line shows the contour. (b) A plot of the radius of the spiral *versus* the angular position for three different length acquisition times. The inset image shows the plot in higher resolution.

The radius ( $r$ ) plotted *versus* the angle ( $\phi$ ) would produce a series of straight lines, each representing a different loop of the spiral. Fig. 1(b) demonstrates this trend between 0 and 270 degrees.

where the zero subscript indicates the coordinates at the centre of the casing. An example of an extracted spiral can be seen in Fig. 1(a and b) shows the unrolled electrode contour for a number of different scan times.

Fig. 1(b) also highlights the efficacy of this method for rapid in-line quality assurance. The inset image shows that essentially identical unrolled contours can be extracted with an 80 second or 26 minute acquisition. Coupled with computationally efficient methods presented here, the full shape of a spiral wound electrode can be imaged and analysed in under two minutes representing a substantial improvement in characterisation times using more traditional methods, which would require qualitatively analysing the greyscale images of the battery to assess the shape and quality of the jelly roll. Additionally these methods are completely non-destructive and non-intrusive.

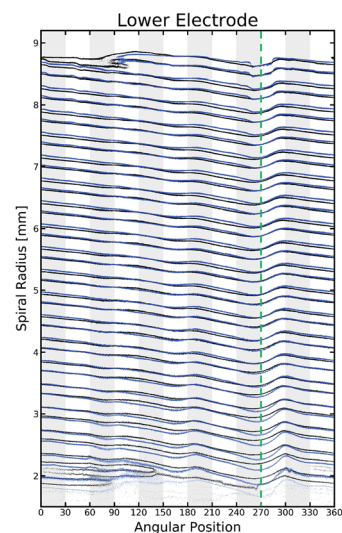
Fig. 5 The unrolled jelly-roll of the lowest region in the electrode. The black points show the electrode before cycling and the blue after. The dashed green line indicates the position of the current collector tab.

Fig. 5 provides a direct insight into the cause of the delamination. The pristine electrode (black) has a small point of inflection or imperfection near the location of the external current collector (270 degrees). The cycling of the cell (blue) clearly increases the magnitude of the inflection, with the eventual deformation of the jelly-roll and delamination of the electrodes taking place exactly in line with the imperfection. The large macro deformation inside the coil is the most obvious change in the electrode but Fig. 5 also shows there is significant deformation in large portions of the jelly-roll. The outermost layer of the electrode, shows significant deformation around the current collector. The constant expansion and contraction of the electrode during cycling forced the layer to fold around the irregular shaped tab.

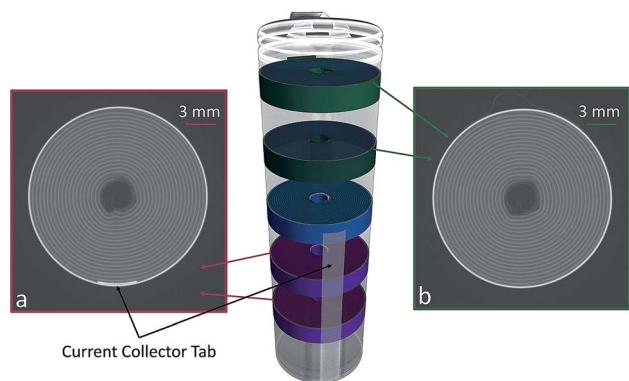
Fig. 4 Schematic detailing the different regions analysed in this study. The bottom (a) has an external current collector while the top (b) does not. The middle region (in blue) has the end of the current collector.

The 'top' regions, shown in Fig. 4(b) are not influenced directly by the presence of the current collector while the bottom regions are Fig. 4(a). The middle region, shown in blue spans the edge of the current collector tab, with roughly half above and half below its end. The data obtained from each of these regions is presented by extracting the coordinates of the unrolled electrode for each of the 100 slices and then overlaying the results on top of each other.

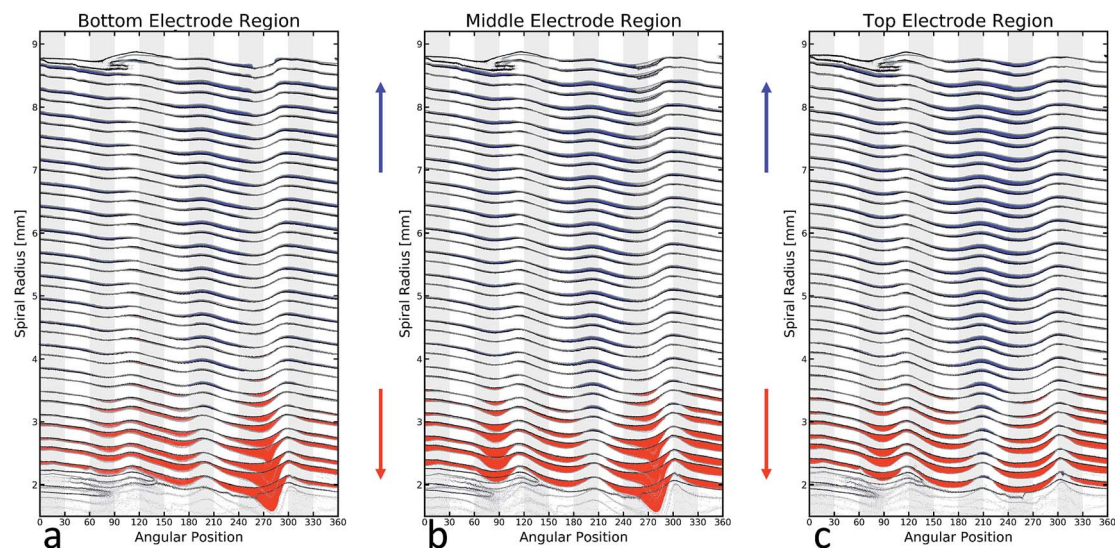
Fig. 6 Deformation patterns in three different regions of the cell after cycling. (a) The bottom electrode region, (b) the middle of the electrode and (c) the top. Blue regions indicate net outward deformation and red net inward.

Fig. 6 presents the deformation patterns in the jelly-roll for the bottom Fig. 6(a), middle Fig. 6(b) and top Fig. 6(c) of the cell. The electrode position before and after cycling are presented in black and grey, respectively. The coloured areas represent

regions of significant deformation during cycling. Red regions show inward movement, such as the 'kink' visible after cycling while blue areas indicate a net outward deformation. The shape

of these deformation patterns helps explain the nature of these processes within the cell. While cycling the individual electrodes expand and contract as a function of state of charge. Theoretically at a given state of charge the electrode position should remain identical, regardless of cycle number, but this is not the case. Over extended cycling, architectural anomalies within the cell (for example the current collector tab), act as anchor points, constraining 'jelly-roll' movement. By contrast, other features (for example the free volume in the centre of the cell) provide freedom for electrode movement; consequently there is a differential displacement depending both on angular and radial position. We would expect that these irreversible deformations would form faster for a battery being cycled at higher rates and slower for a battery cycled at lower rates.

The major changes in the jelly-roll can be seen most clearly through the red and blue regions in Fig. 6. The jelly-roll irreversibly deforms outwardly (blue) into any space left available during the initial winding of the battery. These spaces are created by inconsistent surfaces external to the jelly-roll. The bottom of the battery imaged here is being influenced by two of these features. The first is the external current collector, visible at 270 degrees. On either side of the collector, there is significant outward deformation in the jelly-roll. The second feature is the end of the spiral electrode, which is visible between 90 and 120 degrees, near the top of the figure. Again, after cycling the electrode migrates and deforms into this space. In the top of the cell, the external current collector is no longer present but still has a significant effect. While not an inconsistency in the manner described above, the end of the current collecting tab is a very significant discontinuity in the electrode, and its abrupt termination leads to a very significant void to expand into. Wherever the electrode was unable to deform outwardly it will deform inwardly (red). This leads to the most significant inward deformation to be located in line with the anchor points described above. If sufficiently high forces are applied to inward deformation, a delamination event will occur, as is clearly evident in the cell demonstrated here. This will occur where the highest stresses are being generated which will likely be in line (radially) with the current collector.
