# Sustainable Energy & Fuels

Virtual unrolling of spirally-wound lithium-ion cells for  
correlative degradation studies and predictive fault detection

## Virtual unrolling of spirally-wound lithium-ion cells for correlative degradation studies and predictive fault detection†

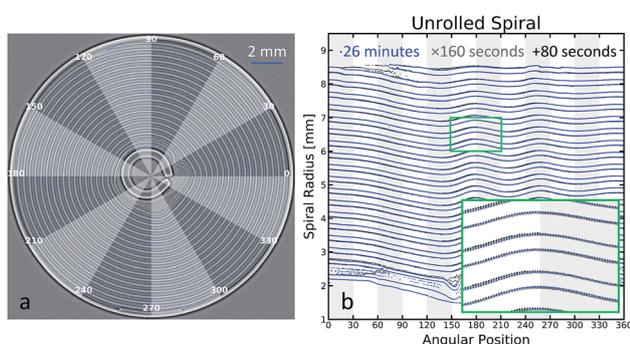
Fig. 1 (a) Example of an orthoslice after edge enhancement, the blue line shows the contour. (b) A plot of the radius of the spiral *versus* the angular position for three different length acquisition times. The inset image shows the plot in higher resolution.

The radius ( $r$ ) plotted *versus* the angle ( $\phi$ ) would produce a series of straight lines, each representing a different loop of the spiral. Fig. 1(b) demonstrates this trend between 0 and 270 degrees.

where the zero subscript indicates the coordinates at the centre of the casing. An example of an extracted spiral can be seen in Fig. 1(a and b) shows the unrolled electrode contour for a number of different scan times.

Fig. 1(b) also highlights the efficacy of this method for rapid in-line quality assurance. The inset image shows that essentially identical unrolled contours can be extracted with an 80 second or 26 minute acquisition. Coupled with computationally efficient methods presented here, the full shape of a spiral wound electrode can be imaged and analysed in under two minutes representing a substantial improvement in characterisation times using more traditional methods, which would require qualitatively analysing the greyscale images of the battery to assess the shape and quality of the jelly roll. Additionally these methods are completely non-destructive and non-intrusive.

The mechanism of this deformation and delamination can be explored by analysing the unrolled jelly-roll as seen in Fig. 1(b) before and after cycling. Comparing the results one orthoslice at a time would be very arduous, so the analysis was simplified by dividing the jelly-roll into different equal-sized layers of interest. Here, five different regions are presented, each representing 100 orthoslices, totalling 3.6 mm of electrode, each. The electrode was divided into these regions based on the location of the external current collector tab which can be seen at the 270 degree position (bottom) of the orthoslice in Fig. 3(b).

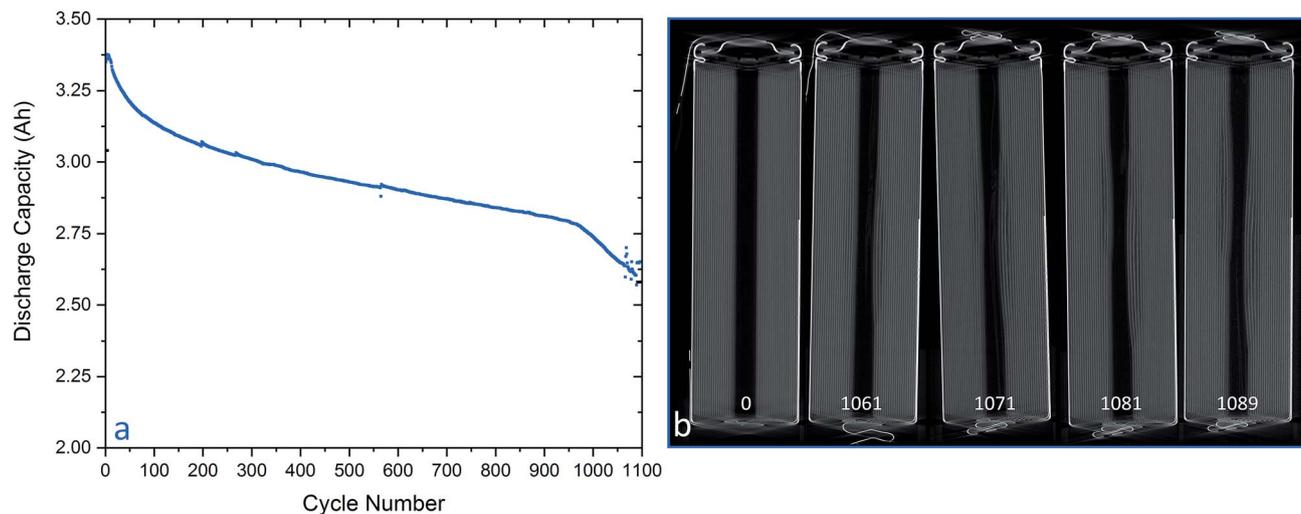
Fig. 2 (a) Capacity fade of the MJ1 cell over 1097 cycles. (b) A series of orthoslices of the cell over time, showing the gradual increase in the size of the large deformation on the inner portion of the jelly roll.

Fig. 2(a) shows the capacity fade if the MJ1 over the first 1097 cycles and Fig. 2(b) a series of orthoslices from tomograms at times between 0 and 1089 cycles. When comparing these two images it is clear there is a strong correlation between the

amount of deformation in the centre of the jelly roll and the capacity loss experienced by the cell.

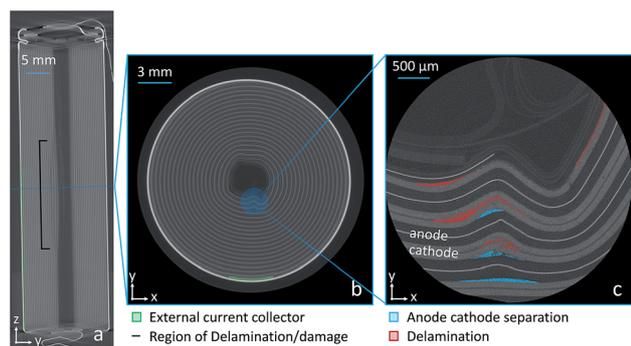
Fig. 3 (a) YZ orthoslice showing the 18650 interior after 1061 cycles. (b) Higher-resolution tomography of the cell. (c) Higher-resolution tomography of the specific ROI.

Fig. 3 shows a progression of orthoslices from tomography performed at this point. Fig. 3(a) is a YZ orthoslice showing the deformation of the jelly-roll, the most prominent feature is the damage to the jelly roll. The middle image Fig. 3(b) shows an XY orthoslice through the area that shows the most significant deformation and the right side Fig. 3(c) is a region-of-interest (ROI) scan of the most affected region of the jelly-roll. The capacity loss observed is likely from the delamination of and damage to the electrodes. The active materials in both electrodes are no longer in good electrical contact with one another, with the electrochemical pathways significantly elongated as a result of the delamination. The 'kink' or deformation in the coil is relatively small; however, it spans a region of more than 25 mm inside the electrode itself, which results in noticeable capacity fade. Lastly, the high-resolution ROI scan shows the cathode inside the kink has fractured and delaminated from the current collector, further reducing the available active mass in the battery.

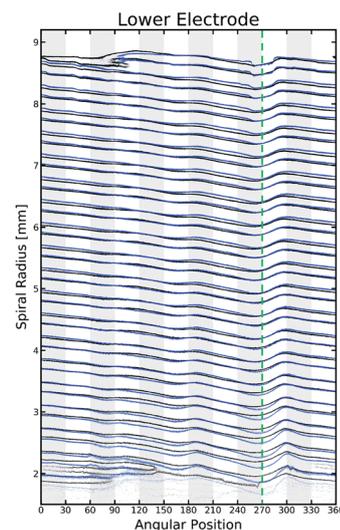
Fig. 5 The unrolled jelly-roll of the lowest region in the electrode. The black points show the electrode before cycling and the blue after. The dashed green line indicates the position of the current collector tab.

Fig. 5 provides a direct insight into the cause of the delamination. The pristine electrode (black) has a small point of inflection or imperfection near the location of the external current collector (270 degrees). The cycling of the cell (blue) clearly increases the magnitude of the inflection, with the eventual deformation of the jelly-roll and delamination of the electrodes taking place exactly in line with the imperfection. The large macro deformation inside the coil is the most obvious change in the electrode but Fig. 5 also shows there is significant deformation in large portions of the jelly-roll. The outermost layer of the electrode, shows significant deformation around the current collector. The constant expansion and contraction of the electrode during cycling forced the layer to fold around the irregular shaped tab.

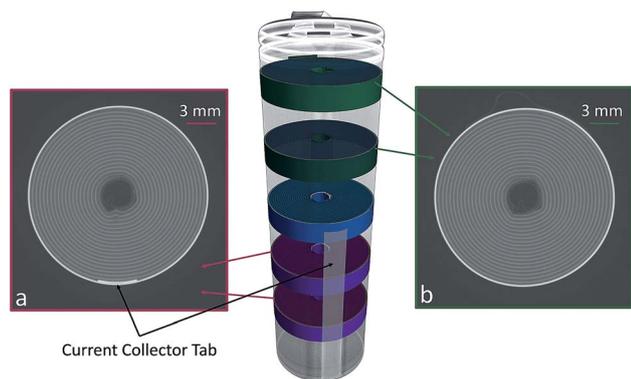
Fig. 4 Schematic detailing the different regions analysed in this study. The bottom (a) has an external current collector while the top (b) does not. The middle region (in blue) has the end of the current collector.

The 'top' regions, shown in Fig. 4(b) are not influenced directly by the presence of the current collector while the bottom regions are Fig. 4(a). The middle region, shown in blue spans the edge of the current collector tab, with roughly half above and half below its end. The data obtained from each of these regions is presented by extracting the coordinates of the unrolled electrode for each of the 100 slices and then overlaying the results on top of each other.

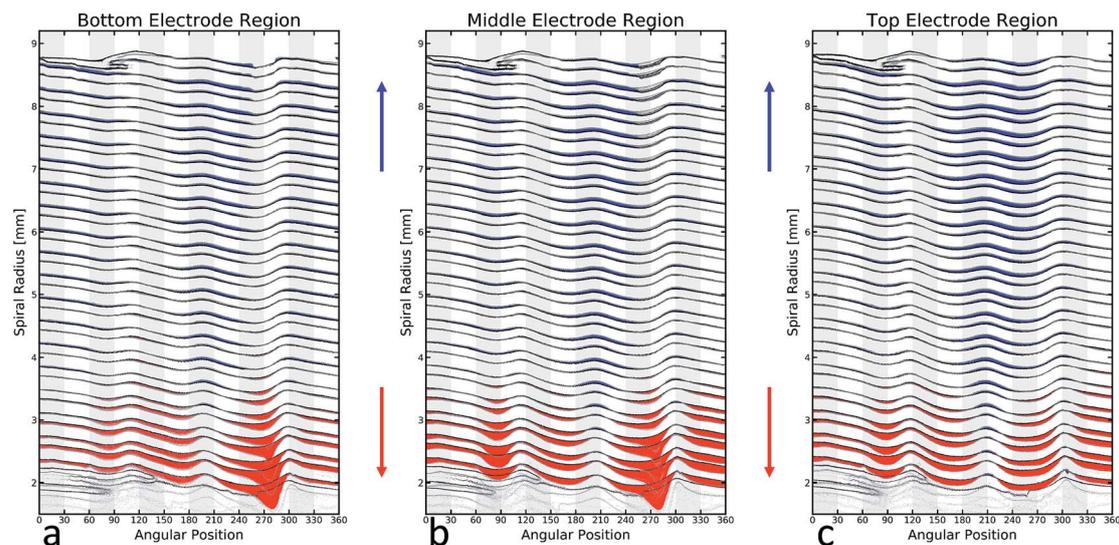
Fig. 6 Deformation patterns in three different regions of the cell after cycling. (a) The bottom electrode region, (b) the middle of the electrode and (c) the top. Blue regions indicate net outward deformation and red net inward.

Fig. 6 presents the deformation patterns in the jelly-roll for the bottom Fig. 6(a), middle Fig. 6(b) and top Fig. 6(c) of the cell. The electrode position before and after cycling are presented in black and grey, respectively. The coloured areas represent

regions of significant deformation during cycling. Red regions show inward movement, such as the 'kink' visible after cycling while blue areas indicate a net outward deformation. The shape

of these deformation patterns helps explain the nature of these processes within the cell. While cycling the individual electrodes expand and contract as a function of state of charge. Theoretically at a given state of charge the electrode position should remain identical, regardless of cycle number, but this is not the case. Over extended cycling, architectural anomalies within the cell (for example the current collector tab), act as anchor points, constraining 'jelly-roll' movement. By contrast, other features (for example the free volume in the centre of the cell) provide freedom for electrode movement; consequently there is a differential displacement depending both on angular and radial position. We would expect that these irreversible deformations would form faster for a battery being cycled at higher rates and slower for a battery cycled at lower rates.

The major changes in the jelly-roll can be seen most clearly through the red and blue regions in Fig. 6. The jelly-roll irreversibly deforms outwardly (blue) into any space left available during the initial winding of the battery. These spaces are created by inconsistent surfaces external to the jelly-roll. The bottom of the battery imaged here is being influenced by two of these features. The first is the external current collector, visible at 270 degrees. On either side of the collector, there is significant outward deformation in the jelly-roll. The second feature is the end of the spiral electrode, which is visible between 90 and 120 degrees, near the top of the figure. Again, after cycling the electrode migrates and deforms into this space. In the top of the cell, the external current collector is no longer present but still has a significant effect. While not an inconsistency in the manner described above, the end of the current collecting tab is a very significant discontinuity in the electrode, and its abrupt termination leads to a very significant void to expand into. Wherever the electrode was unable to deform outwardly it will deform inwardly (red). This leads to the most significant inward deformation to be located in line with the anchor points described above. If sufficiently high forces are applied to inward deformation, a delamination event will occur, as is clearly evident in the cell demonstrated here. This will occur where the highest stresses are being generated which will likely be in line (radially) with the current collector.
