Virtual unrolling of spirally-wound lithium-ion cells for  
correlative degradation studies and predictive fault detection

## Virtual unrolling of spirally-wound lithium-ion cells for correlative degradation studies and predictive fault detection†

A spirally-wound LG 18650 MJ1 lithium-ion battery was imaged in 3D before and after 1061 cycles using X-ray computed tomography. The battery's capacity had faded to 79% of its initial value and some of that fade was attributed to delamination in the innermost region of the 'jelly-roll' structure. A method for virtually unrolling the jelly-roll and analysing it in different coordinates is presented. The method allows efficient comparison of the position and shape of the electrodes at different times and highlights imperfections present in the jelly-roll before cycling which were shown to nucleate the delamination of the electrode.

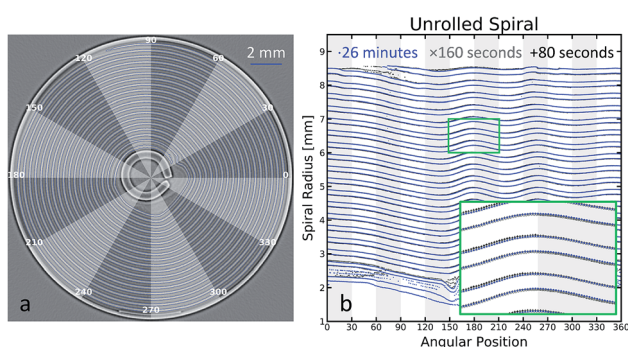
Fig. 1 (a) Example of an orthoslice after edge enhancement, the blue line shows the contour. (b) A plot of the radius of the spiral *versus* the angular position for three different length acquisition times. The inset image shows the plot in higher resolution.

The radius ( $r$ ) plotted *versus* the angle ( $\phi$ ) would produce a series of straight lines, each representing a different loop of the spiral. Fig. 1(b) demonstrates this trend between 0 and 270 degrees.

where the zero subscript indicates the coordinates at the centre of the casing. An example of an extracted spiral can be seen in Fig. 1(a and b) shows the unrolled electrode contour for a number of different scan times.

Fig. 1(b) also highlights the efficacy of this method for rapid in-line quality assurance. The inset image shows that essentially identical unrolled contours can be extracted with an 80 second or 26 minute acquisition. Coupled with computationally efficient methods presented here, the full shape of a spiral wound electrode can be imaged and analysed in under two minutes representing a substantial improvement in characterisation times using more traditional methods, which would require qualitatively analysing the greyscale images of the battery to assess the shape and quality of the jelly roll. Additionally these methods are completely non-destructive and non-intrusive.

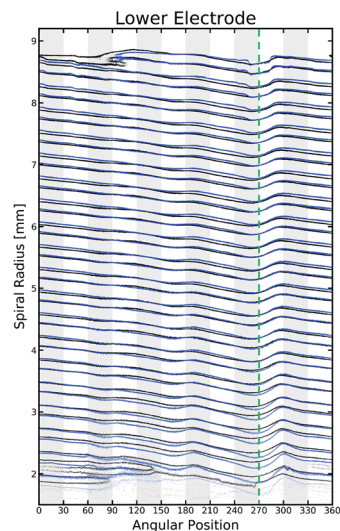
Fig. 5 The unrolled jelly-roll of the lowest region in the electrode. The black points show the electrode before cycling and the blue after. The dashed green line indicates the position of the current collector tab.

Fig. 5 provides a direct insight into the cause of the delamination. The pristine electrode (black) has a small point of inflection or imperfection near the location of the external current collector (270 degrees). The cycling of the cell (blue) clearly increases the magnitude of the inflection, with the eventual deformation of the jelly-roll and delamination of the electrodes taking place exactly in line with the imperfection. The large macro deformation inside the coil is the most obvious change in the electrode but Fig. 5 also shows there is significant deformation in large portions of the jelly-roll. The outermost layer of the electrode, shows significant deformation around the current collector. The constant expansion and contraction of the electrode during cycling forced the layer to fold around the irregular shaped tab.

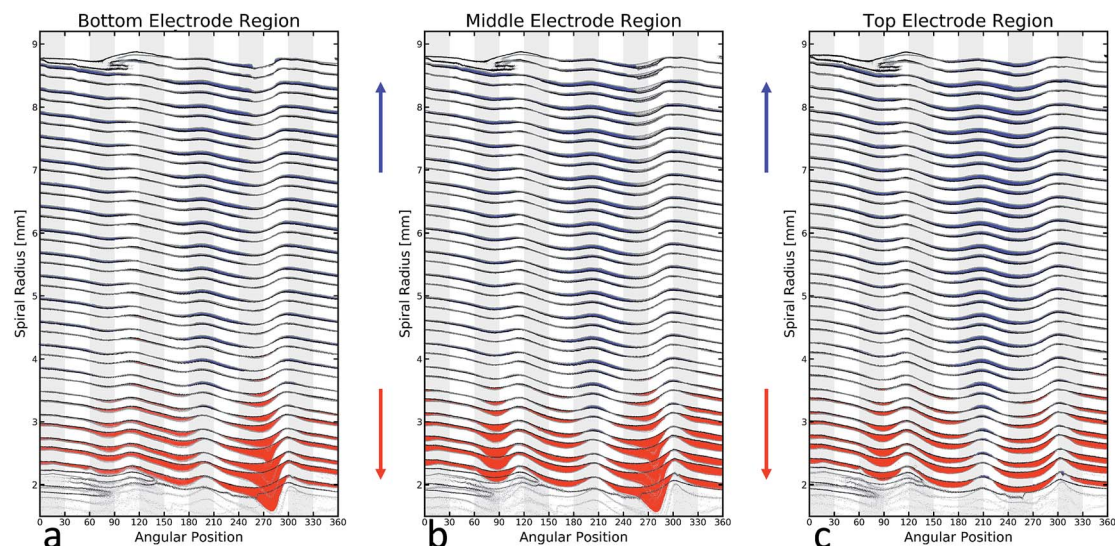
Fig. 6 Deformation patterns in three different regions of the cell after cycling. (a) The bottom electrode region, (b) the middle of the electrode and (c) the top. Blue regions indicate net outward deformation and red net inward.

Fig. 6 presents the deformation patterns in the jelly-roll for the bottom Fig. 6(a), middle Fig. 6(b) and top Fig. 6(c) of the cell. The electrode position before and after cycling are presented in black and grey, respectively. The coloured areas represent

regions of significant deformation during cycling. Red regions show inward movement, such as the 'kink' visible after cycling while blue areas indicate a net outward deformation. The shape

of these deformation patterns helps explain the nature of these processes within the cell. While cycling the individual electrodes expand and contract as a function of state of charge. Theoretically at a given state of charge the electrode position should remain identical, regardless of cycle number, but this is not the case. Over extended cycling, architectural anomalies within the cell (for example the current collector tab), act as anchor points, constraining 'jelly-roll' movement. By contrast, other features (for example the free volume in the centre of the cell) provide freedom for electrode movement; consequently there is a differential displacement depending both on angular and radial position. We would expect that these irreversible deformations would form faster for a battery being cycled at higher rates and slower for a battery cycled at lower rates.

The major changes in the jelly-roll can be seen most clearly through the red and blue regions in Fig. 6. The jelly-roll irreversibly deforms outwardly (blue) into any space left available during the initial winding of the battery. These spaces are created by inconsistent surfaces external to the jelly-roll. The bottom of the battery imaged here is being influenced by two of these features. The first is the external current collector, visible at 270 degrees. On either side of the collector, there is significant outward deformation in the jelly-roll. The second feature is the end of the spiral electrode, which is visible between 90 and 120 degrees, near the top of the figure. Again, after cycling the electrode migrates and deforms into this space. In the top of the cell, the external current collector is no longer present but still has a significant effect. While not an inconsistency in the manner described above, the end of the current collecting tab is a very significant discontinuity in the electrode, and its abrupt termination leads to a very significant void to expand into. Wherever the electrode was unable to deform outwardly it will deform inwardly (red). This leads to the most significant inward deformation to be located in line with the anchor points described above. If sufficiently high forces are applied to inward deformation, a delamination event will occur, as is clearly evident in the cell demonstrated here. This will occur where the highest stresses are being generated which will likely be in line (radially) with the current collector.
