# Sustainable Energy & Fuels

Virtual unrolling of spirally-wound lithium-ion cells for  
correlative degradation studies and predictive fault detection

## Virtual unrolling of spirally-wound lithium-ion cells for correlative degradation studies and predictive fault detection†

A spirally-wound LG 18650 MJ1 lithium-ion battery was imaged in 3D before and after 1061 cycles using X-ray computed tomography. The battery's capacity had faded to 79% of its initial value and some of that fade was attributed to delamination in the innermost region of the 'jelly-roll' structure. A method for virtually unrolling the jelly-roll and analysing it in different coordinates is presented. The method allows efficient comparison of the position and shape of the electrodes at different times and highlights imperfections present in the jelly-roll before cycling which were shown to nucleate the delamination of the electrode.

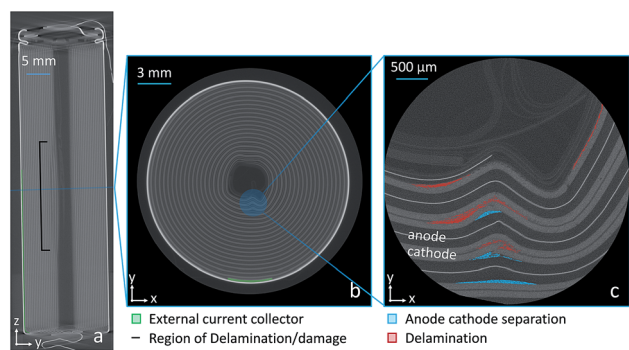
Fig. 3 (a) YZ orthoslice showing the 18650 interior after 1061 cycles. (b) Higher-resolution tomography of the cell. (c) Higher-resolution tomography of the specific ROI.

Fig. 3 shows a progression of orthoslices from tomography performed at this point. Fig. 3(a) is a YZ orthoslice showing the deformation of the jelly-roll, the most prominent feature is the damage to the jelly roll. The middle image Fig. 3(b) shows an XY orthoslice through the area that shows the most significant deformation and the right side Fig. 3(c) is a region-of-interest (ROI) scan of the most affected region of the jelly-roll. The capacity loss observed is likely from the delamination of and damage to the electrodes. The active materials in both electrodes are no longer in good electrical contact with one another, with the electrochemical pathways significantly elongated as a result of the delamination. The 'kink' or deformation in the coil is relatively small; however, it spans a region of more than 25 mm inside the electrode itself, which results in noticeable capacity fade. Lastly, the high-resolution ROI scan shows the cathode inside the kink has fractured and delaminated from the current collector, further reducing the available active mass in the battery.
