Virtual unrolling of spirally-wound lithium-ion cells for  
correlative degradation studies and predictive fault detection

## Virtual unrolling of spirally-wound lithium-ion cells for correlative degradation studies and predictive fault detection†

A spirally-wound LG 18650 MJ1 lithium-ion battery was imaged in 3D before and after 1061 cycles using X-ray computed tomography. The battery's capacity had faded to 79% of its initial value and some of that fade was attributed to delamination in the innermost region of the 'jelly-roll' structure. A method for virtually unrolling the jelly-roll and analysing it in different coordinates is presented. The method allows efficient comparison of the position and shape of the electrodes at different times and highlights imperfections present in the jelly-roll before cycling which were shown to nucleate the delamination of the electrode.

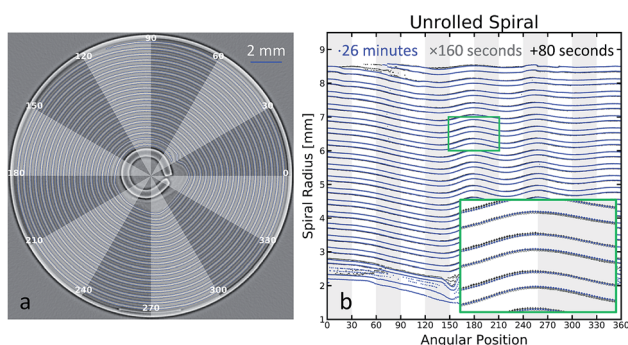
Fig. 1 (a) Example of an orthoslice after edge enhancement, the blue line shows the contour. (b) A plot of the radius of the spiral *versus* the angular position for three different length acquisition times. The inset image shows the plot in higher resolution.

The radius ( $r$ ) plotted *versus* the angle ( $\phi$ ) would produce a series of straight lines, each representing a different loop of the spiral. Fig. 1(b) demonstrates this trend between 0 and 270 degrees.

where the zero subscript indicates the coordinates at the centre of the casing. An example of an extracted spiral can be seen in Fig. 1(a and b) shows the unrolled electrode contour for a number of different scan times.

Fig. 1(b) also highlights the efficacy of this method for rapid in-line quality assurance. The inset image shows that essentially identical unrolled contours can be extracted with an 80 second or 26 minute acquisition. Coupled with computationally efficient methods presented here, the full shape of a spiral wound electrode can be imaged and analysed in under two minutes representing a substantial improvement in characterisation times using more traditional methods, which would require qualitatively analysing the greyscale images of the battery to assess the shape and quality of the jelly roll. Additionally these methods are completely non-destructive and non-intrusive.

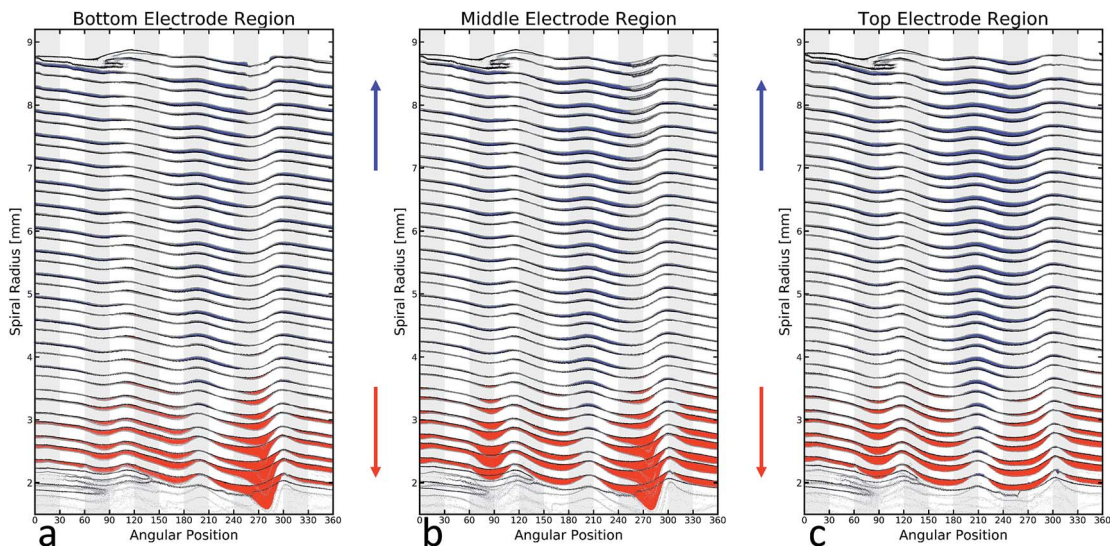
Fig. 6 Deformation patterns in three different regions of the cell after cycling. (a) The bottom electrode region, (b) the middle of the electrode and (c) the top. Blue regions indicate net outward deformation and red net inward.

Fig. 6 presents the deformation patterns in the jelly-roll for the bottom Fig. 6(a), middle Fig. 6(b) and top Fig. 6(c) of the cell. The electrode position before and after cycling are presented in black and grey, respectively. The coloured areas represent

regions of significant deformation during cycling. Red regions show inward movement, such as the 'kink' visible after cycling while blue areas indicate a net outward deformation. The shape

The major changes in the jelly-roll can be seen most clearly through the red and blue regions in Fig. 6. The jelly-roll irreversibly deforms outwardly (blue) into any space left available during the initial winding of the battery. These spaces are created by inconsistent surfaces external to the jelly-roll. The bottom of the battery imaged here is being influenced by two of these features. The first is the external current collector, visible at 270 degrees. On either side of the collector, there is significant outward deformation in the jelly-roll. The second feature is the end of the spiral electrode, which is visible between 90 and 120 degrees, near the top of the figure. Again, after cycling the electrode migrates and deforms into this space. In the top of the cell, the external current collector is no longer present but still has a significant effect. While not an inconsistency in the manner described above, the end of the current collecting tab is a very significant discontinuity in the electrode, and its abrupt termination leads to a very significant void to expand into. Wherever the electrode was unable to deform outwardly it will deform inwardly (red). This leads to the most significant inward deformation to be located in line with the anchor points described above. If sufficiently high forces are applied to inward deformation, a delamination event will occur, as is clearly evident in the cell demonstrated here. This will occur where the highest stresses are being generated which will likely be in line (radially) with the current collector.
