# Effects of electrical-hydrothermal aging degradation on dielectric and trap properties of high temperature vulcanized silicone rubber materials

Huasong Xu, Congzhen Xie,\* Rui Wang,

In this paper, a new aging platform combined the high voltage electric field and the hydrothermal environment was built. To investigate the aging mechanism, physicochemical, dielectric and trap properties of HTV SR before and after electrical-hydrothermal aging for 24 days were discussed. The results indicated that, compared with hydrothermal aging, more cracks and holes appeared on the surface of HTV SR after electrical-hydrothermal aging, and the content of flame retardant decreased significantly. Due to the main chain and side chain scission of PDMS, lots of low weight molecular (LWM) substances and free radicals were produced. And the tensile strength and elongation at break significantly decreased. Various physical and chemical defects appeared in the HTV SR specimen in the process of electrical-hydrothermal degradation, as a result of which, the dielectric constant significantly increased and the peak trap density increased by about 2.5 times compared to the virgin sample. The increase in trap

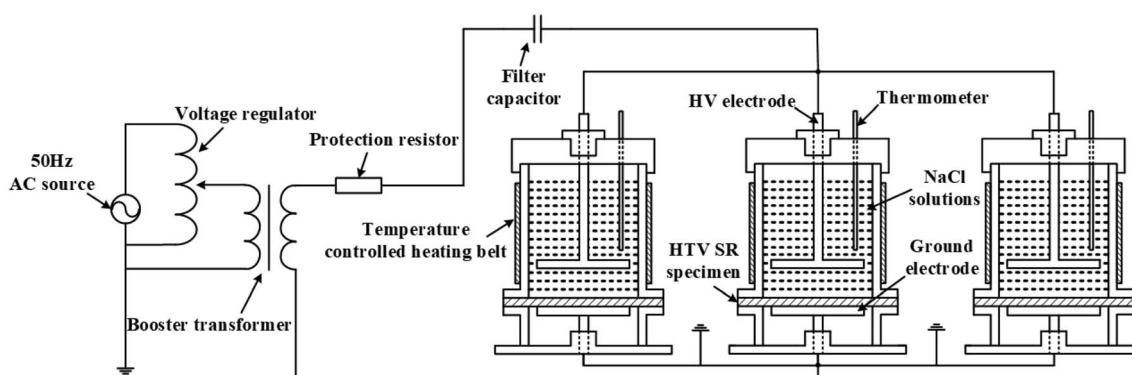
The experimental set up for investigating the electrical-hydrothermal aging effect is shown in Fig. 1. It is composed of AC power box, rod-plate electrode, quartz tube and heating plate. Saline solutions were prepared as the conductive solution and the salt contaminant. The high voltage electrode, when immersed in the saline solutions, will provide a uniform and stable electric field on the HTV SR. To verify the electric field uniformity, the simulation model was established using the COMSOL and the results were shown in Fig. 2. As shown in Fig. 2, the HTV SR specimens were in a uniform electric field. In the electrical-hydrothermal aging test, the temperature of the heating plate was controlled at 30 °C, 60 °C, 80 °C and the electric field intensity was 0 kV cm<sup>-1</sup> (equivalent to hydrothermal aging), 15 kV cm<sup>-1</sup> and 25 kV cm<sup>-1</sup>. For comparison, the temperature of the saline solutions in the hydrothermal aging test was also controlled at 30 °C, 60 °C and 80 °C.

**Fig. 1** The experimental set up for the electrical-hydrothermal aging effect.

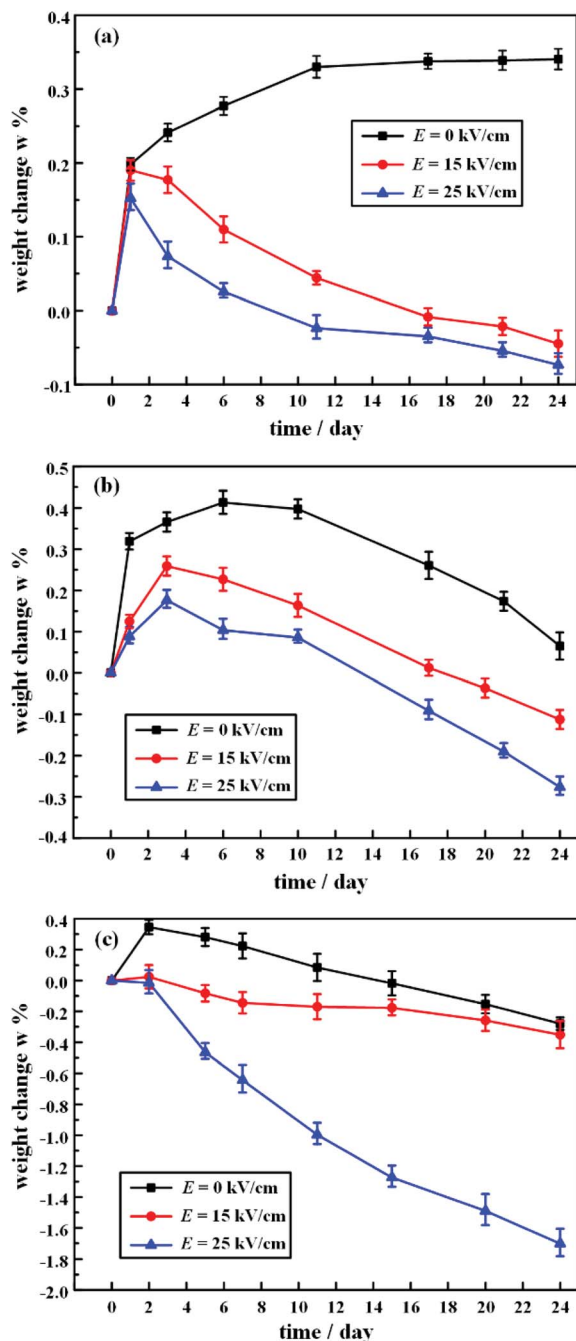
Fig. 4 shows the relative weight change of HTV SR after electrical-hydrothermal aging under different electric field intensity at varying temperatures. As shown in Fig. 4, in the absence of an electric field, the weights of HTV SR specimens immersed in saline solutions at  $30 \text{ }^\circ\text{C}$  increased rapidly at first and then slowly increased within 24 days. However, when immersed in saline solutions at  $60 \text{ }^\circ\text{C}$  and  $80 \text{ }^\circ\text{C}$ , the weight of HTV SR increased rapidly and then decreased. This phenomenon might result from the increase of temperature and the invasion of water accelerating the hydrothermal aging effect of the HTV SR specimen. The relative weight change of HTV SR specimen depended on the competition between the invasion of water and the extraction of the low-molecular-weight (LMW) substances and the filler particles. Both process was influenced by water temperature. During the immersion for 24 days at  $30 \text{ }^\circ\text{C}$ , the weight increased because of the invasion of water over counteracted the weight decrease caused by the extraction of the LMW substances and the filler particles. However, at  $60 \text{ }^\circ\text{C}$  and  $80 \text{ }^\circ\text{C}$ , the weight of HTV SR decreased rapidly because the oxidation decomposition of HTV SR specimen and the extraction of the LMW substances and the filler particles over counteracted the weight increase due to the diffusion of water into HTV SR.

Fig. 4 Relative weight change of HTV SR after electrical-hydrothermal aging under different electrical field intensity at (a) 30 °C, (b) 60 °C, and (c) 80 °C.

When considering the electric field, the weight of the HTV SR samples was obviously decreased. With the increase of electric field intensity, the final mass loss rate was significantly higher

than that of the HTV SR samples without an electric field. The final relative weight change of the hydrothermal aging samples at 80 °C was 0.27%, while the relative weight change rate reached  $-1.71\%$  under the 80 °C and  $25 \text{ kV cm}^{-1}$  electrical-hydrothermal aging condition. Therefore, there was a synergistic effect of mutual enhancement of electrical-hydrothermal aging process, which significantly accelerated the weight reduction of HTV SR specimens. The presence of an electric field accelerated the hydrothermal aging process, which in turn

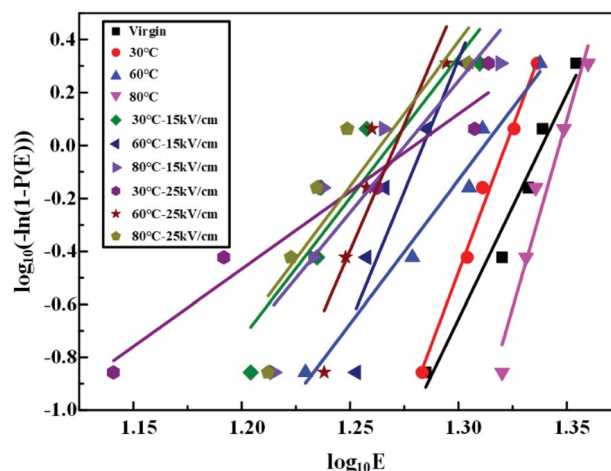
The AC breakdown characteristic of all samples under Weibull distribution is presented in Fig. 5. According to eqn (3), the value of the shape parameter  $\beta$  was calculated and listed in Table 2. Coppard<sup>22</sup> *et al.* believed that the shape parameter  $\beta$  represented the distribution of defects and filling particles. However, as seen in Table 2, the value of  $\beta$  did not show obvious

Fig. 5 Curve of the Weibull statistical distribution of the breakdown field strength of before and after aging samples.

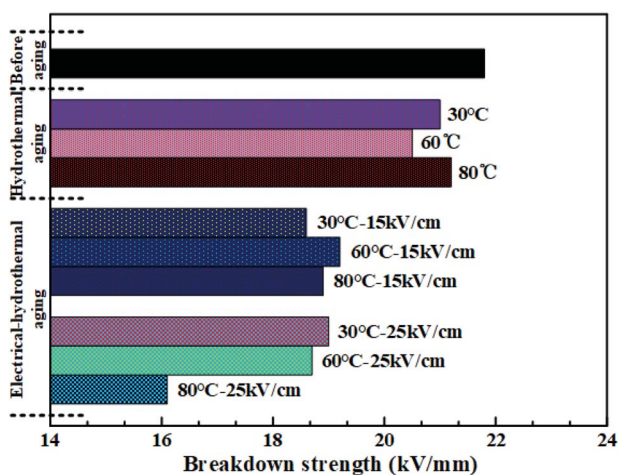
Fig. 6 The breakdown field strength of HTV SR specimens under different aging conditions.

regularity but presented a great fluctuation. It indicated that there were complex reactions in HTV SR after hydrothermal and electrical-hydrothermal aging processes. Due to high temperature and high electric field, severe degradation occurred in HTV SR and various physical and chemical defects were produced. Therefore, the change in the shape parameter  $\beta$  showed large variation in dispersity of electrical weak points in the aging samples. Then the value of breakdown field strength under different aging conditions is shown in Fig. 6. As shown in Fig. 6, compared to the virgin sample and hydrothermal aging sample, the breakdown field strength of the electrical-hydrothermal (80  $^{\circ}\text{C} - 25 \text{ kV cm}^{-1}$ ) sample was significantly decreased from 21.8  $\text{kV mm}^{-1}$  to 16.1  $\text{kV mm}^{-1}$ . It indicated that there was obvious synergistic aging effect of electric, water and temperature. The change of breakdown field strength caused by electrical-hydrothermal aging was much greater than that caused by hydrothermal aging. The combined effect significantly accelerated the decrease of breakdown field strength. To further explore the combined aging effect, the microscopic analysis was studied below.

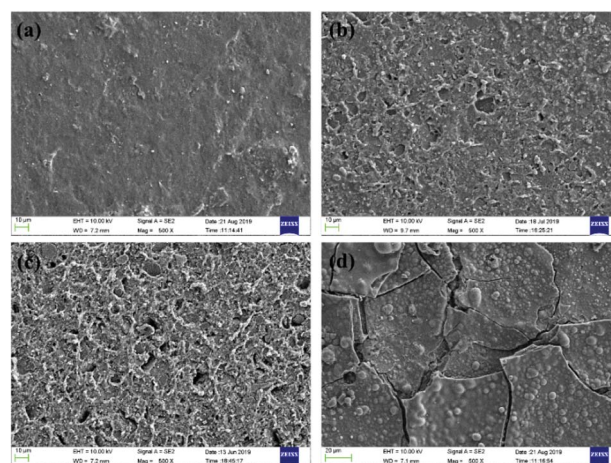
Fig. 8 SEM photos of HTV SR specimens after electrical-hydrothermal aging at varying temperature under 25  $\text{kV cm}^{-1}$  for 24 days: (a) virgin HTV SR, (b) 30  $^{\circ}\text{C}$ , (c) 60  $^{\circ}\text{C}$ , (d) 80  $^{\circ}\text{C}$ .

**3.3.1 SEM and EDAX analysis.** Fig. 7 and 8 present the SEM photos of HTV SR specimens before and after electrical-hydrothermal aging at varying electrical field intensity and varying temperatures for 24 days. It showed that the surface of the virgin HTV SR was smooth, on which there were no holes, cracks and obvious particles. Under the hydrothermal aging

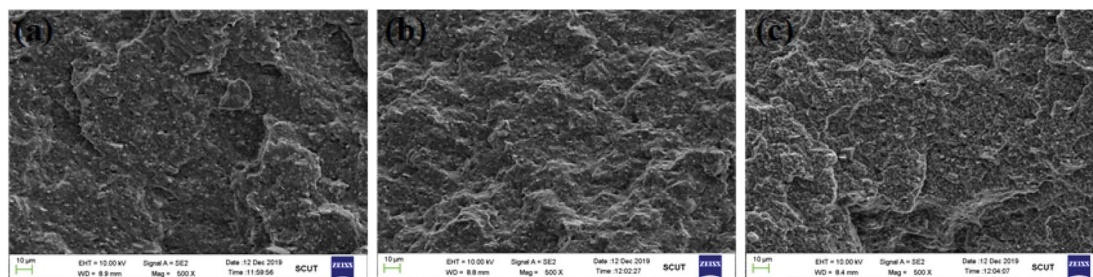
Fig. 9 SEM photos of the cross-sections of HTV SR specimens before and after aging in different conditions for 24 days: (a) virgin HTV SR, (b) hydrothermal aging at 80 °C, (c) electrical-hydrothermal aging at 80 °C – 25 kV cm<sup>-1</sup>.

To examine the cross-sections of the HTV SR, SEM photos of specimens aging in different conditions to verify the depth of the damage was presented in Fig. 9. It indicated that the cross-sections of the virgin HTV SR was relatively smooth and presented little cracks, holes and particles compared to the aging samples. Then the cross-section of the HTV SR specimen became rough after hydrothermal aging. With the addition of electric field, a large number of microscopic cracks and holes appeared in the HTV SR specimen in Fig. 9(c). It can be concluded that the electrical-hydrothermal aging degradation occurred not only on the surface but also in the interior. However, the degradation on the surface showed much more serious than the interior. It indicated that the initial deterioration process began on the surface of the samples.

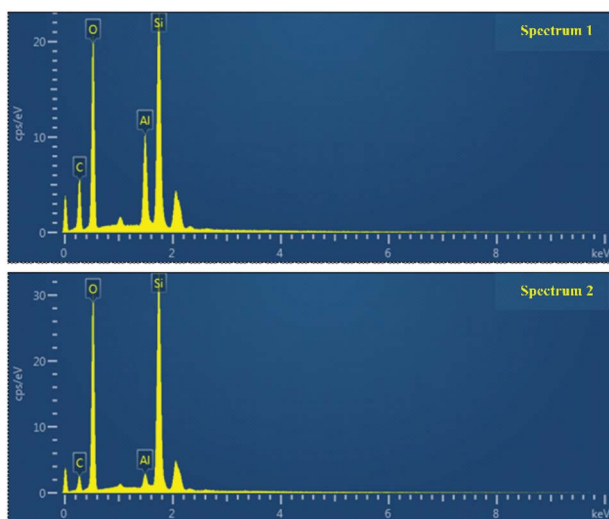
At the same time, EDAX was conducted to recognize the elements present over the HTV SR surface. Fig. 10 presents the EDAX of the virgin HTV SR (spectrum 1) and the electrical-hydrothermal aged (80 °C – 25 kV cm<sup>-1</sup>) HTV SR (spectrum 2). Because the test mainly studied the variation rules of surface elements on HTV SR after electrical-hydrothermal aging, various trace elements in the filler were neglected. As shown in Fig. 10, silicon (Si), carbon (C), oxygen (O) and aluminum (Al) were the main elements on the surface of the HTV SR specimen. After electrical-hydrothermal aging (80 °C – 25 kV cm<sup>-1</sup>) for 24 days, the content of elements C and Al decreased significantly. It represented the side chain scission of PDMS molecules, and the LMW substances would be extracted, resulting in a decline of C content. Moreover, Al content was also significantly reduced due to acidic substances generated by discharge. The generated acidic substances would react with the flame retardant aluminum hydroxide. The analysis could be further proved in the FTIR below.

Fig. 10 EDAX of the virgin HTV SR (spectrum 1) and the electrical-hydrothermal aged (80 °C – 25 kV cm<sup>-1</sup>) HTV SR (spectrum 2).

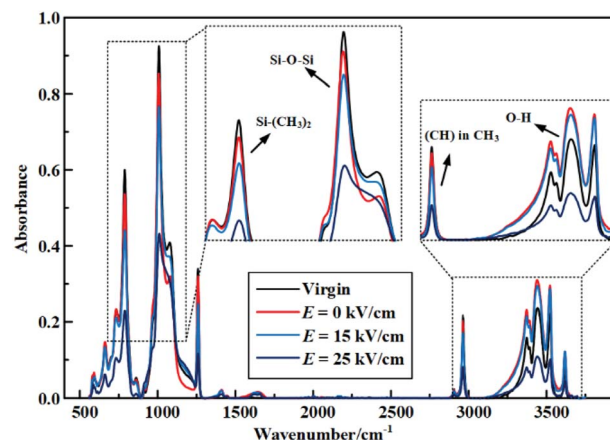
**3.3.2 FTIR analysis.** After hydrothermal aging and electrical-hydrothermal aging for 24 days, the IR absorbance spectra for the fresh and after aged specimens were obtained (Fig. 11 and 12). Table 3 lists the characteristic IR absorption bands in HTV. Fig. 11 shows the FTIR of HTV SR before and after electrical-hydrothermal aging at 80 °C for 24 days. As shown in Fig. 11, with the increase of electric field intensity, the

Fig. 11 FTIR of HTV SR before and after electrical-hydrothermal aging at 80 °C for 24 days (varying electric field intensity).

peak of the main chain Si-O-Si, side chain Si- $\text{CH}_3$  and Si-( $\text{CH}_3$ )<sub>2</sub> of PDMS in HTV SR specimen showed a downward trend. When the electric field intensity reached  $25 \text{ kV cm}^{-1}$ , the absorption peak of the main chain and each side chain showed a remarkable reduction. For the hydroxyl absorption peak in the wavenumber range from  $3200 \text{ cm}^{-1}$  to  $3700 \text{ cm}^{-1}$ , it fluctuated with the increase of field intensity. It was caused by the complex reaction processes such as oxidation,<sup>14</sup> cracking,<sup>23</sup> cross-linking<sup>24,25</sup> and condensation<sup>26</sup> that occurred in the electrical-hydrothermal aging process of HTV SR samples, resulting in the fluctuating tendency of hydroxyl peak. Fig. 12 shows the FTIR of HTV SR before and after electrical-hydrothermal aging at  $25 \text{ kV cm}^{-1}$  for 24 days. Similar to the downward trend in Fig. 11, when the electric field intensity was  $25 \text{ kV cm}^{-1}$ , the peak of each organic group decreased significantly with the increase of the temperature in electrical-hydrothermal aging processes. Therefore, it indicated that the PDMS on the HTV SR surface severely degraded when the electric field intensity or the temperature increased.

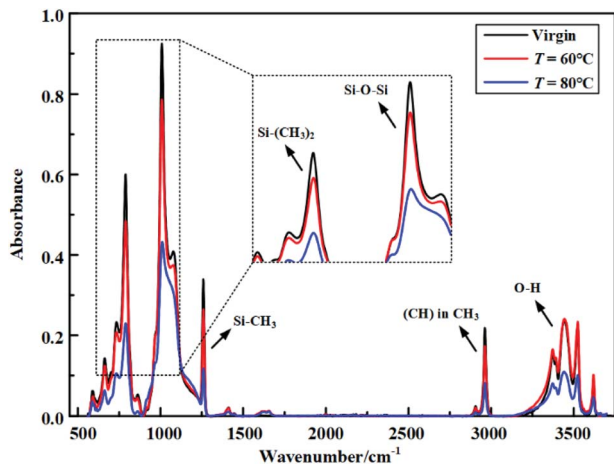
Fig. 12 FTIR of HTV SR before and after electrical-hydrothermal aging at  $25 \text{ kV cm}^{-1}$  for 24 days (varying temperature).

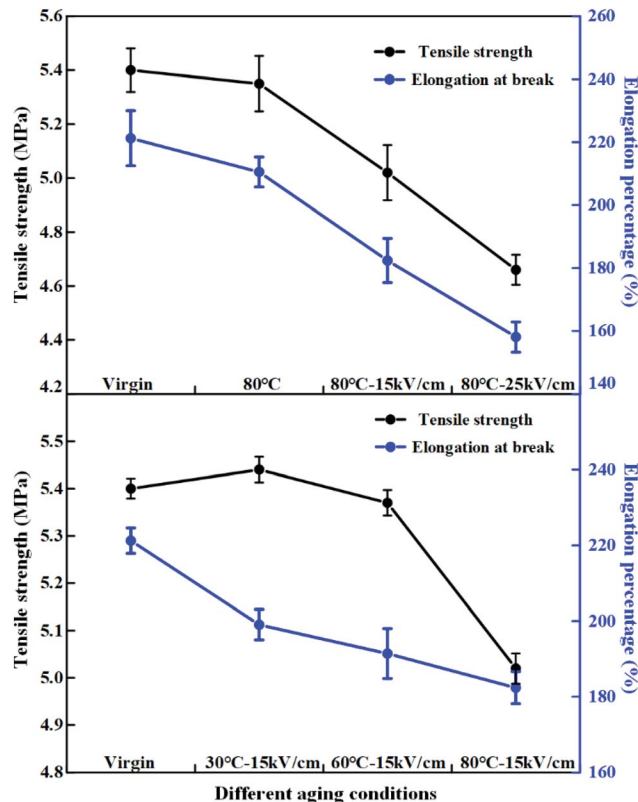
**3.3.3 Tensile properties analysis.** The mechanical property is an important index to evaluate the aging characteristics of insulating materials. Fig. 13 and 14 present the change of the tensile strength, the elongation at break and the Young's modulus in different aging conditions after hydrothermal and electrical-hydrothermal aging. As shown in Fig. 13 and 14, the tensile strength and the elongation at break decreased and the Young's modulus increased with the increase of the electric field strength. In the presence of an electric field, the change of

Fig. 13 Tensile properties of HTV SR before and after aging in different conditions.

the tensile strength, the elongation at break and the Young's modulus of the aging HTV SR specimens were much greater than that of the hydrothermal aging samples. The deterioration in tensile properties after aging is normally related to linkages scission and main chain scission. According to FTIR results, the peak of the main chain Si-O-Si, side chain Si- $\text{CH}_3$  and Si-( $\text{CH}_3$ )<sub>2</sub> of PDMS in HTV SR specimen showed a downward trend. The crosslinking structure was destroyed after electrical-hydrothermal aging. However, the change of tensile strength and Young's modulus at varying temperature presented different trends in electrical-hydrothermal aged specimens. At  $30^\circ\text{C} - 15 \text{ kV cm}^{-1}$  and  $60^\circ\text{C} - 15 \text{ kV cm}^{-1}$ , the tensile strength and the Young's modulus did not show obvious change. When temperature reached  $80^\circ\text{C}$ , the tensile strength significantly decreased and the Young's modulus significantly increased. It revealed that when the temperature did not reach the threshold, the temperature would not promote the electrical aging process.

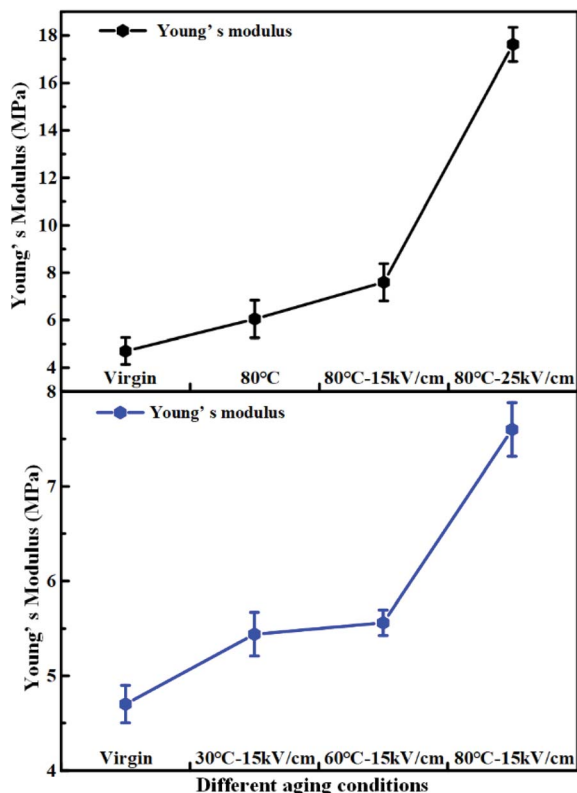
Fig. 14 Young's modulus of HTV SR before and after aging in different conditions.

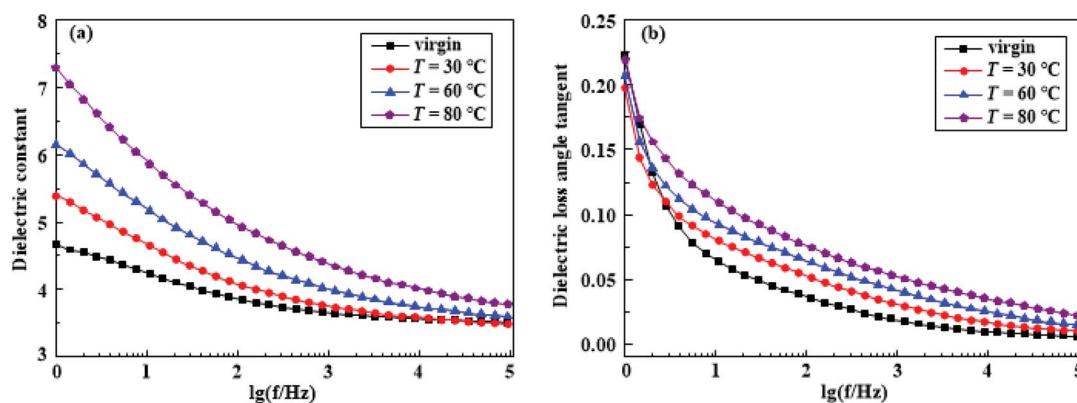
In this section, the data of  $80^\circ\text{C}$  and  $15 \text{ kV cm}^{-1}$  after electrical-hydrothermal aging for 24 days were selected for analysis. Fig. 15(a) and (b) shows the change of dielectric constant and the dielectric loss of HTV SR at varying temperature after electrical-hydrothermal aging at  $15 \text{ kV cm}^{-1}$  for 24 days.

As shown in Fig. 15(a), it indicated that the dielectric constant of the aging samples in the whole frequency range

Fig. 15 The dielectric constant (a) and the dielectric loss angle tangent (b) of HTV SR before and after electrical-hydrothermal aging at  $15 \text{ kV cm}^{-1}$  for 24 days (varying temperature).

significantly increased with the rise of temperature, especially at low frequency. However, in the high frequency band ( $10^4$  Hz to  $10^5$  Hz), the curve tended to a constant, which might be caused by electron polarization or molecular chain vibration of HTV SR media under the influence of the electric field. Fig. 15(b) shows that the dielectric loss of HTV SR specimen increased with the rise of temperature in the middle and high frequency band, while in the low frequency band, the dielectric loss of the electrical-hydrothermal aging samples was lower than that of the initial samples.

This phenomenon can be attributed to the following aspects. First of all, according to Debye relaxation theory, the dielectric loss of HTV SR samples at low frequency band is mainly caused by the DC conductance loss. With the increase of frequency, the polarization loss of different relaxations tends to play an important role and gradually becomes dominant. Secondly, in literature,<sup>27</sup> the dielectric properties of silicone rubber sleeve were measured by the non-contact dielectric spectrum, and the various relaxation processes of silicone rubber were analyzed in detail by using the modified Cole-Cole model. The polarization processes were divided into macroscopic interface polarization, microscopic interface polarization and dipole polarization. Considering that the contact dielectric spectrum was selected in this test, the macroscopic interface polarization process can be neglected. Therefore, the dielectric loss of silicone rubber samples was mainly caused by the microscopic interface polarization and dipole polarization. According to the SEM analysis, the polarization loss at the microscopic interface enlarged with the increase of physical and chemical defects such as holes and cracks on the surface of HTV SR and the loss of packing. Combined with the infrared spectrum characteristics, it can be seen that the rise of temperature aggravated the damage degree of the molecular main chain and decomposed to produce more LMW substances, leading to the increase of dipoles and dipole polarization loss.

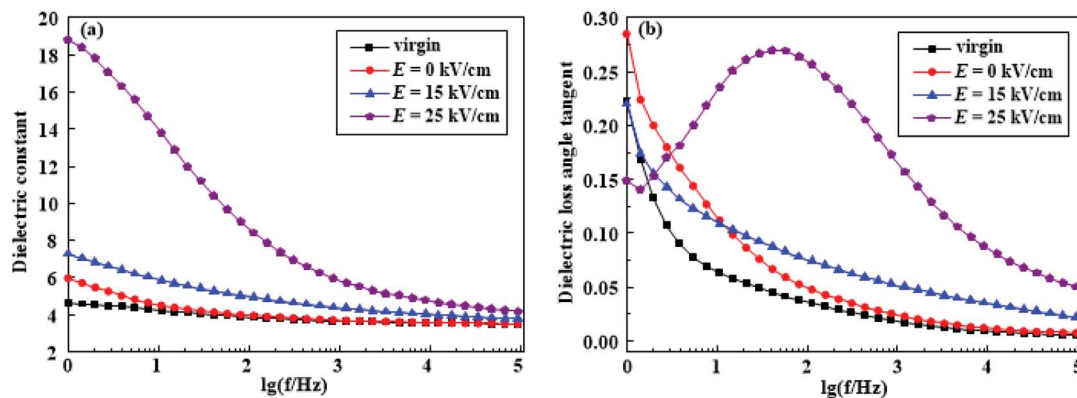
Fig. 16(a) and (b) shows the change of dielectric constant and the dielectric loss of HTV SR under different electric field intensity after electrical-hydrothermal aging at  $80^\circ\text{C}$  for 24 days. As seen in Fig. 16(a), the dielectric constant behave similarly for the HTV SR of the aged and the virgin sample, and increased with decreasing frequency. Especially in the low frequency band, the increase became faster because of the space charge polarization or the effect of interfacial polarization. Due to the appearance of various physical and chemical defects on the surface and inside of HTV SR, as well as the increase of particles shown by SEM results, the interface polarization was significantly enhanced. The highest observed values (dielectric constant) were for the samples after electrical-hydrothermal aging at  $80^\circ\text{C} - 25 \text{ kV cm}^{-1}$ . As compared to the

Fig. 16 The dielectric constant (a) and the dielectric loss angle tangent (b) of HTV SR before and after electrical-hydrothermal aging at 80 °C for 24 days (varying electric field intensity).

virgin sample, there was an obvious increase in dielectric constant almost along the entire frequency range for hydrothermal and electrical-hydrothermal aged HTV SR specimen. This might be due to the increase in mobility of the polymer chains by the breakage of bonds caused by applied electric and hydrothermal stress.

As regards the dielectric loss angle tangent, in Fig. 16(b), it presented different and interesting phenomenon. In the middle frequency region (10 Hz to  $10^3$  Hz), there was an obvious dielectric loss peak in the HTV SR specimen after electrical-hydrothermal aging at 80 °C – 25 kV  $\text{cm}^{-1}$  for 24 days. It might be caused by the orientation of greater dipolar groups. A large amount of broken PDMS molecular chains led to the increase of free radicals in the material and the enhancement of dipole polarization, presenting the apparent loss peak in the dielectric frequency response. However, in the low frequency region, the dielectric loss angle tangent of the electrical-hydrothermal aging samples showed different change rules. Because there was another dielectric relaxation process in the dielectric loss curve at low frequency band in addition to the DC conductivity,<sup>27</sup> and they worked together in the low frequency region of the dielectric loss curve.

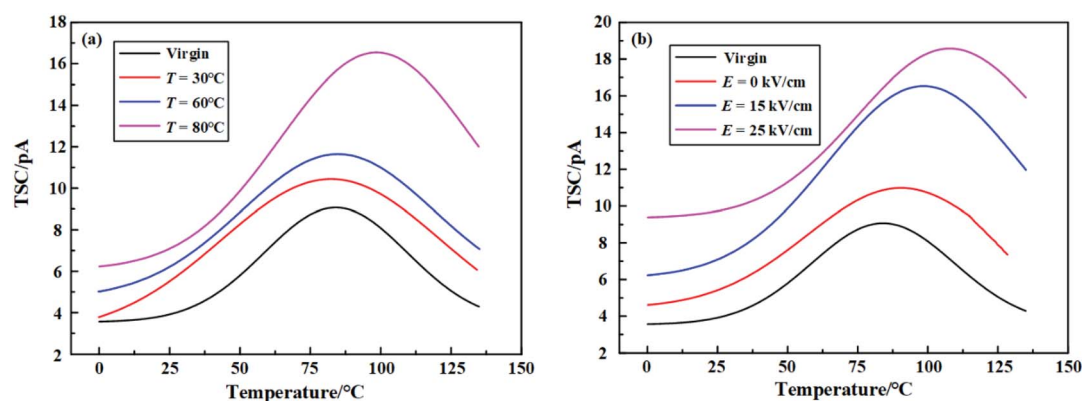
It is commonly acknowledged that the aging performance of the polymer material is related to the accumulation of space charge or the trap characteristics. Fig. 17 shows the TSC curve of unaged, the hydrothermal aged and electrical-hydrothermal aged samples. In order to analyze trap properties, the amount of trap charge can be calculated by eqn (5). Then the amount of trap charge, the peak current and the peak current temperature can be listed in Table 3.

As shown in Fig. 17, it indicated that the TSC curve of all HTV SR samples presented a main current peak. With the increase of the temperature or the electric field strength of electrical-hydrothermal aging, the peak current increased continuously and tended to drift towards the high temperature region. As listed in Table 4, the trap charge of the electrical-hydrothermal aging samples was significantly more than that of the unaged and after hydrothermal aged samples. Similarly, the trap charge also increased with the rising temperature and electric field

Fig. 17 TSC measurement before and after electrical-hydrothermal aging for 24 days: (a)  $E = 15 \text{ kV cm}^{-1}$ , varying temperature; (b)  $T = 80 \text{ °C}$ , varying electric field intensity.

strength. Because there were more physical and chemical defects generated in the HTV SR specimen, and the deterioration degree was deepened, which led to the increase of trap and trap charge.

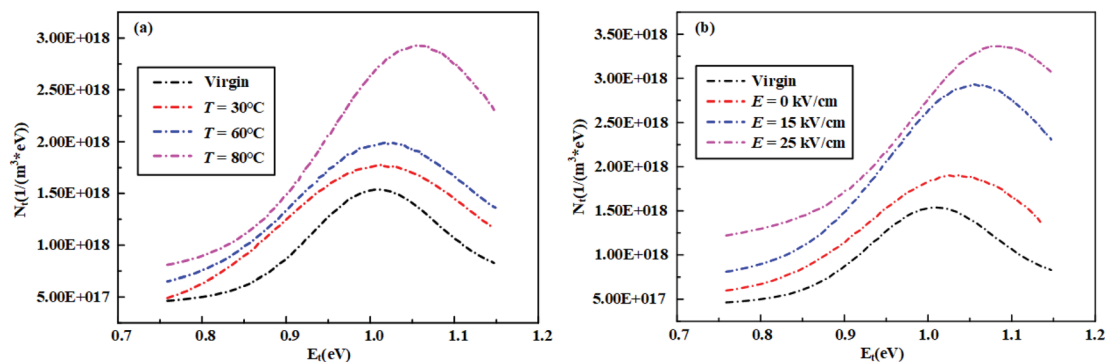
Then, the trap level distribution from TSC measurement can be calculated by eqn (6) based on MATLAB numerical calculation. Fig. 18 shows the trap level distributions of the virgin and aging samples. It shows that the trap density of the virgin was relatively low. With the rise of temperature and electric field intensity, the trap density increased and the trap energy level corresponding to the peak of trap density became deeper. The peak density of traps could reach about 2.5 times larger than that of the virgin sample under the condition of 80 °C – 25

Fig. 18 Trap level distributions before and after electrical-hydrothermal aging for 24 days: (a)  $E = 15 \text{ kV cm}^{-1}$ , varying temperature; (b)  $T = 80^\circ\text{C}$ , varying electric field intensity.

kV cm<sup>-1</sup> electrical-hydrothermal aging. The phenomenon can be explained by the following aspects. Firstly, with the combination of electrical-hydrothermal aging, more defects were produced inside the HTV SR, which enhanced the electron trapping ability and increased the trap density. Secondly, it is well known that traps can be divided into deep traps and shallow traps according to the trap level. The current peak at low temperature is mainly contributed by the charge decapitation in shallow traps, while the current peak at high temperature corresponds to the charge decapitation in deep traps. As shown in Fig. 18, compared to the virgin sample, more deep traps were generated in the process of electrical-hydrothermal aging. Deep traps bound carrier migration, leading to local charge accumulation and rising local electric field strength. When the threshold was exceeded, the polymer breakdown might occur finally.

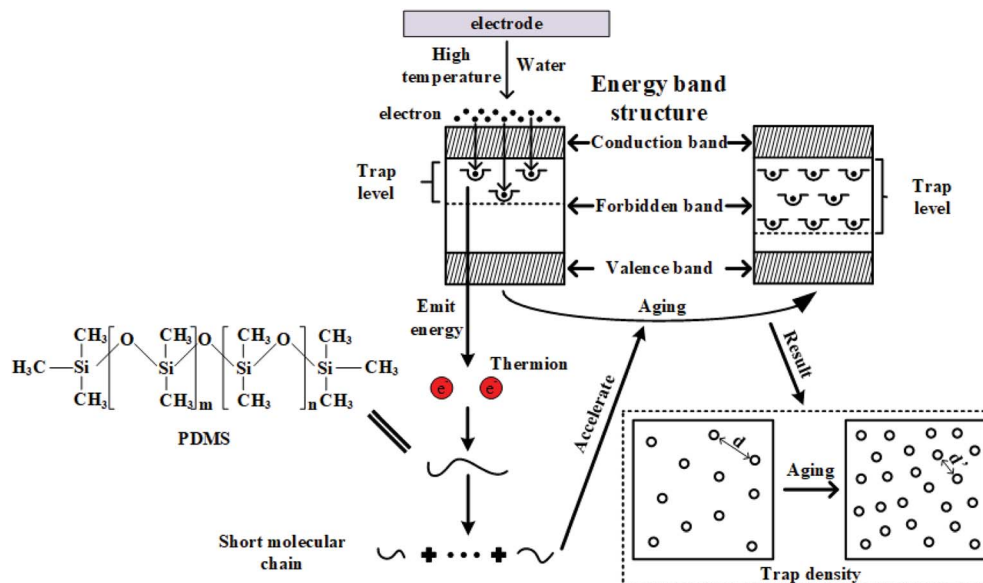
Fig. 19 Electrical-hydrothermal combined aging mechanism.

Combined with the test results above, the mechanism of electrical-hydrothermal aging can be summarized in Fig. 19. First of all, when the HTV SR specimen is subjected to hydrothermal aging effects, the main and side chains scission on PDMS molecular chain occurred, producing free radical and LMW substances. With the aging process going on, more physical and chemical defects are formed in the material. The oxidation decomposition reaction in the aging process promotes the formation of more free molecules and traps, leading to the increase of dielectric constant, loss tangent  $\tan \delta$ , trap energy level and trap density.

Then, when the electric field is added, electrons would be injected into the HTV SR from the electrode, and some electrons are trapped by the polymer. The trapped electron becomes the recombination center of the hole, releasing large amounts of energy and transferring it to other electrons to produce thermions. The hydrothermal aging condition provides convenience for electron injection. More thermions will bombard the molecular chain, creating more traps. On the other hand, the dipole polarization loss generates thermal power, which aggravates the deterioration of insulating materials. Therefore, according to the trap properties during the aging process, producing nanocomposites can be an available way. The addition of nanoparticles can reduce the number of traps in the material and enhance breakdown strength. By adjusting the charge transport characteristics, the breakdown probability can be lowered down.
