# Effects of electrical-hydrothermal aging degradation on dielectric and trap properties of high temperature vulcanized silicone rubber materials

In this paper, a new aging platform combined the high voltage electric field and the hydrothermal environment was built. To investigate the aging mechanism, physicochemical, dielectric and trap properties of HTV SR before and after electrical-hydrothermal aging for 24 days were discussed. The results indicated that, compared with hydrothermal aging, more cracks and holes appeared on the surface of HTV SR after electrical-hydrothermal aging, and the content of flame retardant decreased significantly. Due to the main chain and side chain scission of PDMS, lots of low weight molecular (LWM) substances and free radicals were produced. And the tensile strength and elongation at break significantly decreased. Various physical and chemical defects appeared in the HTV SR specimen in the process of electrical-hydrothermal degradation, as a result of which, the dielectric constant significantly increased and the peak trap density increased by about 2.5 times compared to the virgin sample. The increase in trap density in turn accelerated the charge

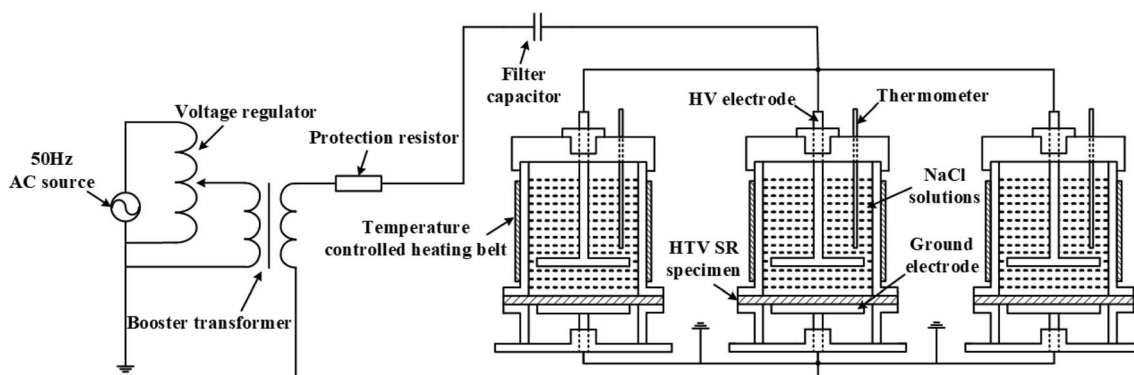
**Fig. 1** The experimental set up for the electrical-hydrothermal aging effect.

The experimental set up for investigating the electrical-hydrothermal aging effect is shown in Fig. 1. It is composed of AC power box, rod-plate electrode, quartz tube and heating plate. Saline solutions were prepared as the conductive solution and the salt contaminant. The high voltage electrode, when immersed in the saline solutions, will provide a uniform and stable electric field on the HTV SR. To verify the electric field uniformity, the simulation model was established using the COMSOL and the results were shown in Fig. 2. As shown in Fig. 2, the HTV SR specimens were in a uniform electric field. In the electrical-hydrothermal aging test, the temperature of the heating plate was controlled at 30 °C, 60 °C, 80 °C and the electric field intensity was 0 kV cm<sup>-1</sup> (equivalent to hydrothermal aging), 15 kV cm<sup>-1</sup> and 25 kV cm<sup>-1</sup>. For comparison, the temperature of the saline solutions in the hydrothermal aging test was also controlled at 30 °C, 60 °C and 80 °C.

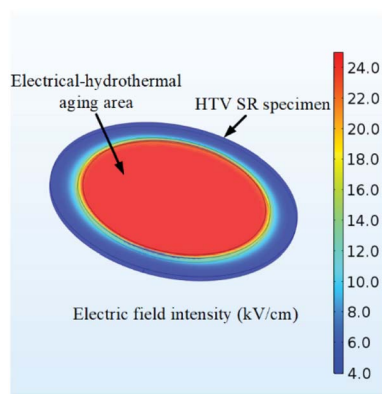
Fig. 2 Characteristics of the surface electric field intensity at  $25 \text{ kV cm}^{-1}$  on the HTV SR specimen.

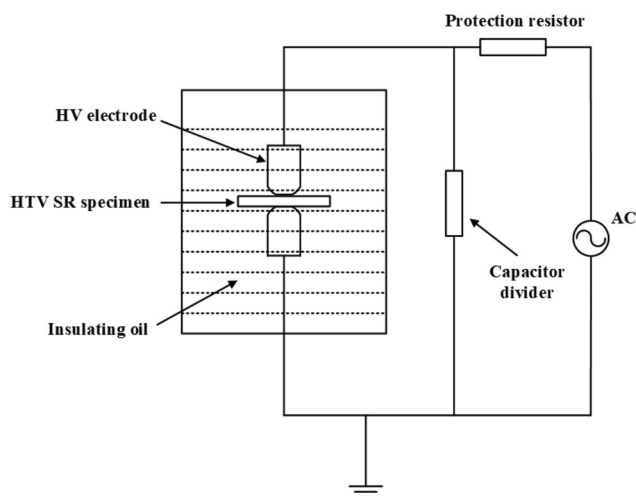
Fig. 3 Experimental setup for the AC breakdown studies.

specimens. In the measurement of AC breakdown voltage, a set of 5 samples with a diameter of 100 mm and a thickness of 2 mm were tested to calculate the breakdown field strength. The experimental setup for the AC breakdown voltage was shown in Fig. 3. The aging specimens are placed in the plate to plate arrangement, and placed into a vessel containing filling with insulation oil to avoid surface discharges. During the test, the voltage is increasing step by step until the breakdown occurs. The voltage was rising at the rate of  $500 \text{ V s}^{-1}$ . When the breakdown occurs, the AC breakdown stress can be calculated according to the equation  $E = V/d$ , where  $V$  is the breakdown voltage and  $d$  is the thickness of the aging specimen in the breakdown point.

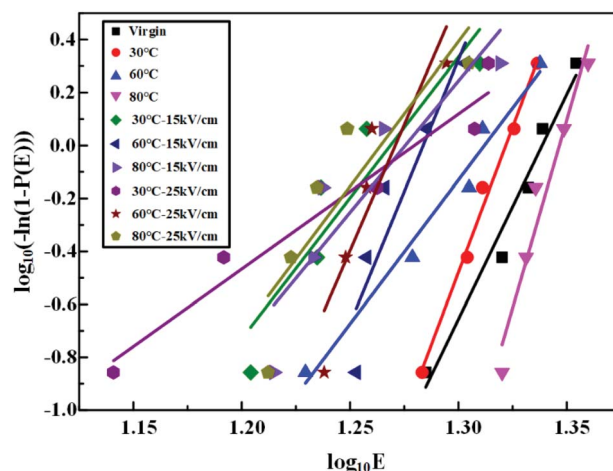
Fig. 5 Curve of the Weibull statistical distribution of the breakdown field strength of before and after aging samples.

The AC breakdown characteristic of all samples under Weibull distribution is presented in Fig. 5. According to eqn (3), the value of the shape parameter  $\beta$  was calculated and listed in Table 2. Coppard<sup>22</sup> *et al.* believed that the shape parameter  $\beta$  represented the distribution of defects and filling particles. However, as seen in Table 2, the value of  $\beta$  did not show obvious

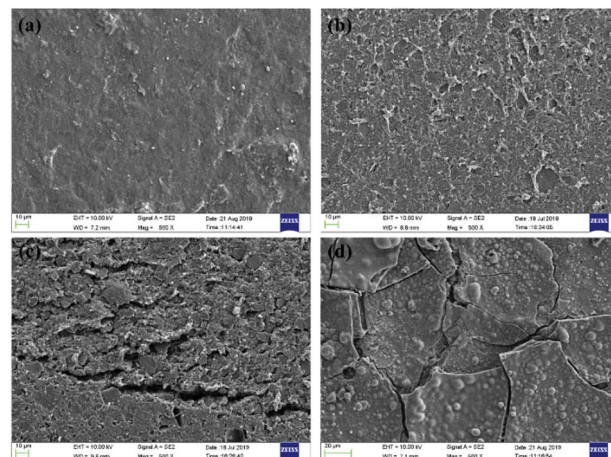
Fig. 7 SEM photos of HTV SR specimens before and after electrical-hydrothermal aging in varying electrical field intensity at 80  $^{\circ}\text{C}$  for 24 days: (a) virgin HTV SR, (b) 0  $\text{kV cm}^{-1}$ , (c) 15  $\text{kV cm}^{-1}$ , (d) 25  $\text{kV cm}^{-1}$ .

**3.3.1 SEM and EDAX analysis.** Fig. 7 and 8 present the SEM photos of HTV SR specimens before and after electrical-hydrothermal aging at varying electrical field intensity and varying temperatures for 24 days. It showed that the surface of the virgin HTV SR was smooth, on which there were no holes, cracks and obvious particles. Under the hydrothermal aging

condition of 80  $^{\circ}\text{C}$ , the surface of HTV SR samples became rough and appeared a few holes. However, cracks appeared on HTV SR with the addition of electric field. When the electric field strength reached 25  $\text{kV cm}^{-1}$ , derived cracks developed on the surface of HTV SR in different orientation. It reflected that water tended to diffuse into the HTV SR at 80  $^{\circ}\text{C}$ , making it easier for electrons to inject into the material and accelerating the chain scission and the degradation process. Due to the irregularity of the self-diffusion of water, cracks appeared and

developed in different directions after electrical-hydrothermal aging. Furthermore, the phenomenon was more obvious with the increase of electric field strength. Similarly, the rise of temperature promoted the growth of cracks and the increase of holes under the condition of electrical-hydrothermal aging at 25 kV cm<sup>-1</sup>. It was due to the synergism of electrical-hydrothermal aging, which accelerated the decomposition of PDMS molecules and the dissolution of fillers, resulting in severe degradation of HTV SR specimen.

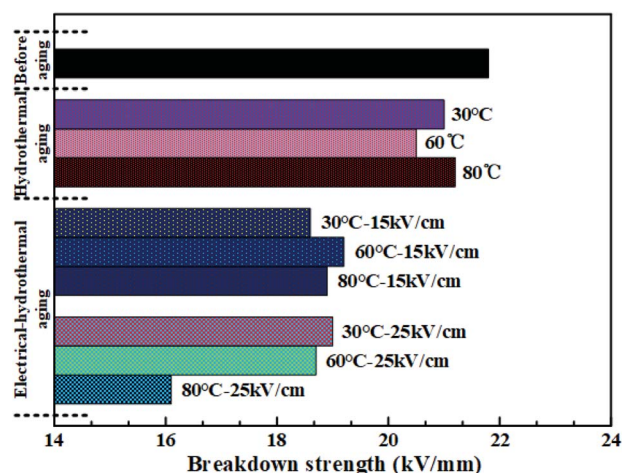
Fig. 6 The breakdown field strength of HTV SR specimens under different aging conditions.

regularity but presented a great fluctuation. It indicated that there were complex reactions in HTV SR after hydrothermal and electrical-hydrothermal aging processes. Due to high temperature and high electric field, severe degradation occurred in HTV SR and various physical and chemical defects were produced. Therefore, the change in the shape parameter  $\beta$  showed large variation in dispersity of electrical weak points in the aging samples. Then the value of breakdown field strength under different aging conditions is shown in Fig. 6. As shown in Fig. 6, compared to the virgin sample and hydrothermal aging sample, the breakdown field strength of the electrical-hydrothermal (80  $^{\circ}\text{C} - 25 \text{ kV cm}^{-1}$ ) sample was significantly decreased from 21.8  $\text{kV mm}^{-1}$  to 16.1  $\text{kV mm}^{-1}$ . It indicated that there was obvious synergistic aging effect of electric, water and temperature. The change of breakdown field strength caused by electrical-hydrothermal aging was much greater than that caused by hydrothermal aging. The combined effect significantly accelerated the decrease of breakdown field strength. To further explore the combined aging effect, the microscopic analysis was studied below.

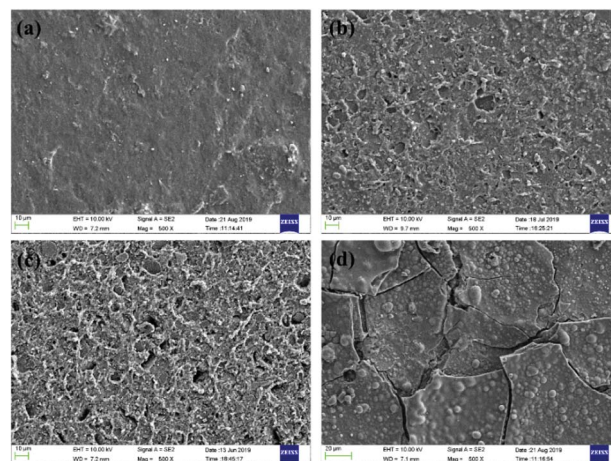
Fig. 8 SEM photos of HTV SR specimens after electrical-hydrothermal aging at varying temperature under 25  $\text{kV cm}^{-1}$  for 24 days: (a) virgin HTV SR, (b) 30  $^{\circ}\text{C}$ , (c) 60  $^{\circ}\text{C}$ , (d) 80  $^{\circ}\text{C}$ .

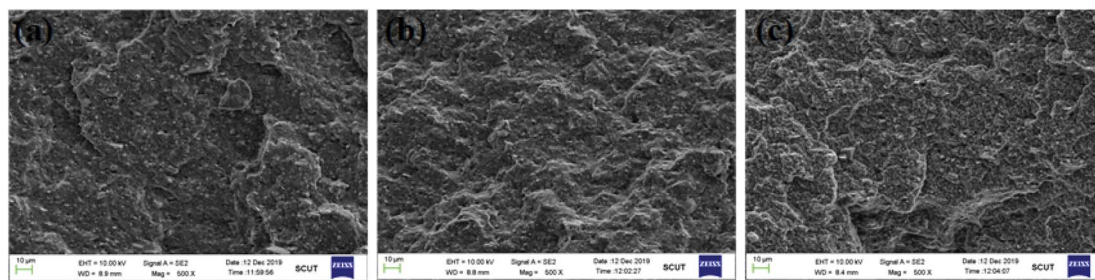
Fig. 9 SEM photos of the cross-sections of HTV SR specimens before and after aging in different conditions for 24 days: (a) virgin HTV SR, (b) hydrothermal aging at 80 °C, (c) electrical-hydrothermal aging at 80 °C – 25 kV cm<sup>-1</sup>.

To examine the cross-sections of the HTV SR, SEM photos of specimens aging in different conditions to verify the depth of the damage was presented in Fig. 9. It indicated that the cross-sections of the virgin HTV SR was relatively smooth and presented little cracks, holes and particles compared to the aging samples. Then the cross-section of the HTV SR specimen became rough after hydrothermal aging. With the addition of electric field, a large number of microscopic cracks and holes appeared in the HTV SR specimen in Fig. 9(c). It can be concluded that the electrical-hydrothermal aging degradation occurred not only on the surface but also in the interior. However, the degradation on the surface showed much more serious than the interior. It indicated that the initial deterioration process began on the surface of the samples.

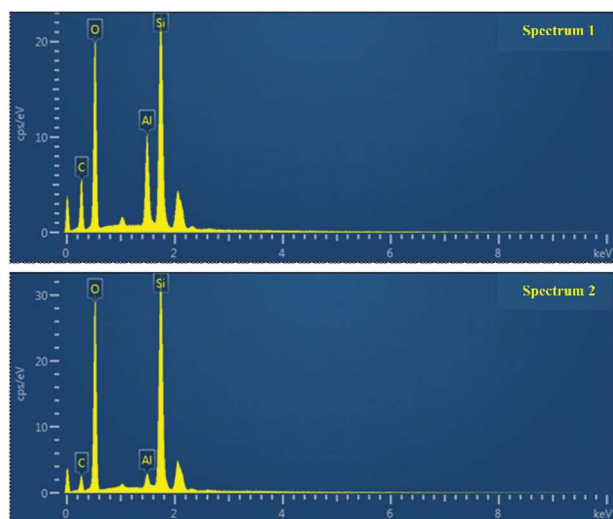
Fig. 10 EDAX of the virgin HTV SR (spectrum 1) and the electrical-hydrothermal aged (80 °C – 25 kV cm<sup>-1</sup>) HTV SR (spectrum 2).

At the same time, EDAX was conducted to recognize the elements present over the HTV SR surface. Fig. 10 presents the EDAX of the virgin HTV SR (spectrum 1) and the electrical-hydrothermal aged (80 °C – 25 kV cm<sup>-1</sup>) HTV SR (spectrum 2). Because the test mainly studied the variation rules of surface elements on HTV SR after electrical-hydrothermal aging, various trace elements in the filler were neglected. As shown in Fig. 10, silicon (Si), carbon (C), oxygen (O) and aluminum (Al) were the main elements on the surface of the HTV SR specimen. After electrical-hydrothermal aging (80 °C – 25 kV cm<sup>-1</sup>) for 24 days, the content of elements C and Al decreased significantly. It represented the side chain scission of PDMS molecules, and the LMW substances would be extracted, resulting in a decline of C content. Moreover, Al content was also significantly reduced due to acidic substances generated by discharge. The generated acidic substances would react with the flame retardant aluminum hydroxide. The analysis could be further proved in the FTIR below.

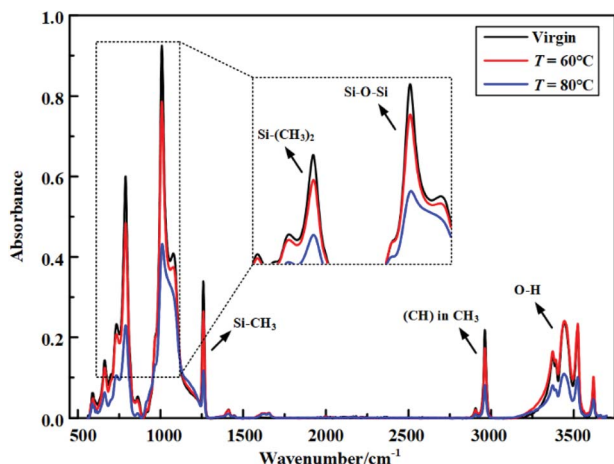
Fig. 12 FTIR of HTV SR before and after electrical-hydrothermal aging at 25 kV cm<sup>-1</sup> for 24 days (varying temperature).

peak of the main chain Si-O-Si, side chain Si-CH<sub>3</sub> and Si-(CH<sub>3</sub>)<sub>2</sub> of PDMS in HTV SR specimen showed a downward trend. When the electric field intensity reached 25 kV cm<sup>-1</sup>, the absorption peak of the main chain and each side chain showed a remarkable reduction. For the hydroxyl absorption peak in the wavenumber range from 3200 cm<sup>-1</sup> to 3700 cm<sup>-1</sup>, it fluctuated with the increase of field intensity. It was caused by the complex reaction processes such as oxidation,<sup>14</sup> cracking,<sup>23</sup> cross-linking<sup>24,25</sup> and condensation<sup>26</sup> that occurred in the electrical-hydrothermal aging process of HTV SR samples, resulting in the fluctuating tendency of hydroxyl peak. Fig. 12 shows the FTIR of HTV SR before and after electrical-hydrothermal aging at 25 kV cm<sup>-1</sup> for 24 days. Similar to the downward trend in Fig. 11, when the electric field intensity was 25 kV cm<sup>-1</sup>, the peak of each organic group decreased significantly with the increase of the temperature in electrical-hydrothermal aging processes. Therefore, it indicated that the PDMS on the HTV SR surface severely degraded when the electric field intensity or the temperature increased.

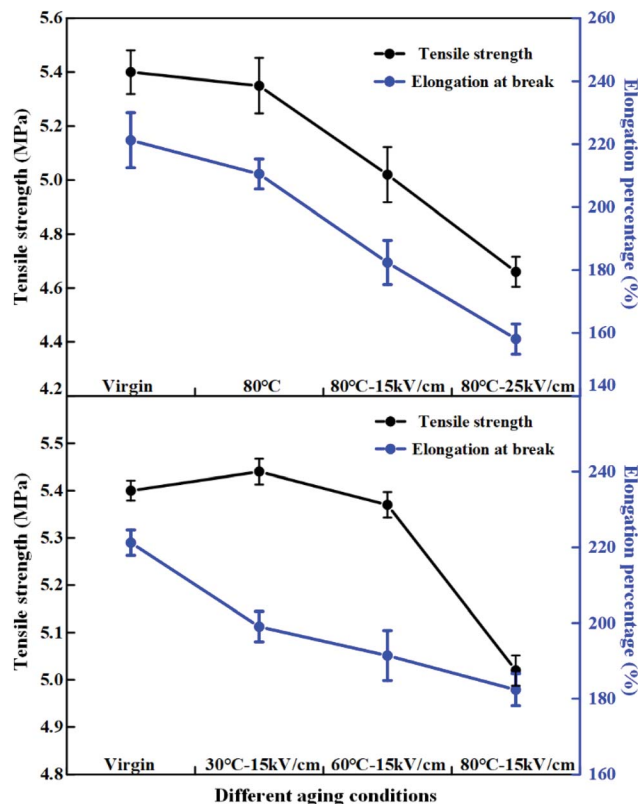
Fig. 13 Tensile properties of HTV SR before and after aging in different conditions.

**3.3.3 Tensile properties analysis.** The mechanical property is an important index to evaluate the aging characteristics of insulating materials. Fig. 13 and 14 present the change of the tensile strength, the elongation at break and the Young's modulus in different aging conditions after hydrothermal and electrical-hydrothermal aging. As shown in Fig. 13 and 14, the tensile strength and the elongation at break decreased and the Young's modulus increased with the increase of the electric field strength. In the presence of an electric field, the change of

the tensile strength, the elongation at break and the Young's modulus of the aging HTV SR specimens were much greater than that of the hydrothermal aging samples. The deterioration in tensile properties after aging is normally related to linkages scission and main chain scission. According to FTIR results, the peak of the main chain Si-O-Si, side chain Si-CH<sub>3</sub> and Si-(CH<sub>3</sub>)<sub>2</sub> of PDMS in HTV SR specimen showed a downward trend. The crosslinking structure was destroyed after electrical-hydrothermal aging. However, the change of tensile strength and Young's modulus at varying temperature presented different trends in electrical-hydrothermal aged specimens. At 30 °C – 15 kV cm<sup>-1</sup> and 60 °C – 15 kV cm<sup>-1</sup>, the tensile strength and the Young's modulus did not show obvious change. When temperature reached 80 °C, the tensile strength significantly decreased and the Young's modulus significantly increased. It revealed that when the temperature did not reach the threshold, the temperature would not promote the electrical aging process.

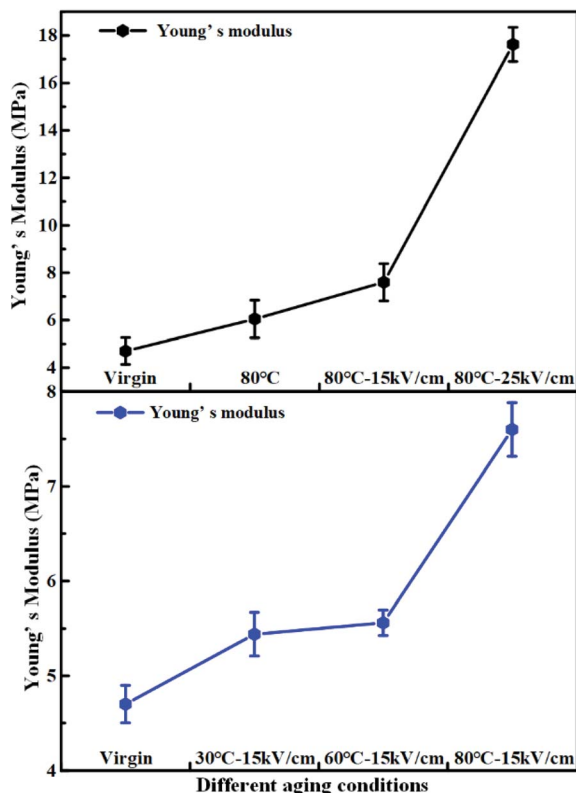
Fig. 14 Young's modulus of HTV SR before and after aging in different conditions.

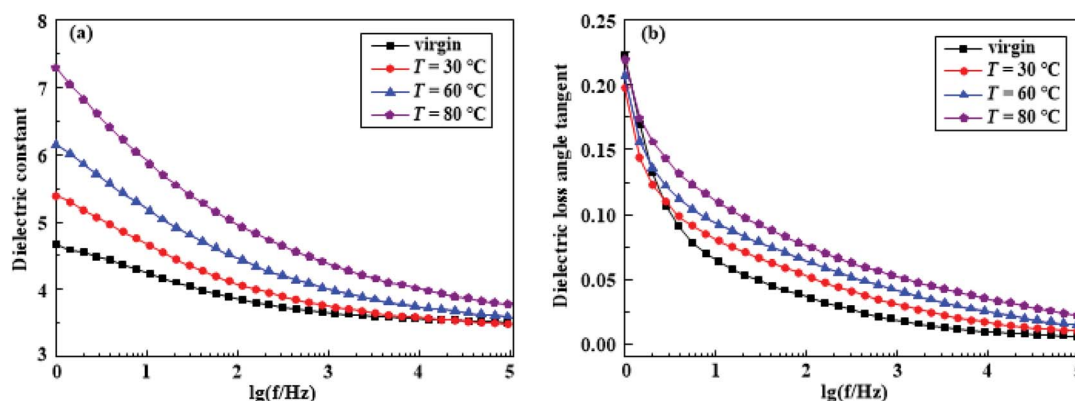
Fig. 15 The dielectric constant (a) and the dielectric loss angle tangent (b) of HTV SR before and after electrical-hydrothermal aging at  $15 \text{ kV cm}^{-1}$  for 24 days (varying temperature).

In this section, the data of 80 °C and 15 kV cm<sup>-1</sup> after electrical-hydrothermal aging for 24 days were selected for analysis. Fig. 15(a) and (b) shows the change of dielectric constant and the dielectric loss of HTV SR at varying temperature after electrical-hydrothermal aging at 15 kV cm<sup>-1</sup> for 24 days.

As shown in Fig. 15(a), it indicated that the dielectric constant of the aging samples in the whole frequency range

significantly increased with the rise of temperature, especially at low frequency. However, in the high frequency band ( $10^4$  Hz to  $10^5$  Hz), the curve tended to a constant, which might be caused by electron polarization or molecular chain vibration of HTV SR media under the influence of the electric field. Fig. 15(b) shows that the dielectric loss of HTV SR specimen increased with the rise of temperature in the middle and high frequency band, while in the low frequency band, the dielectric loss of the electrical-hydrothermal aging samples was lower than that of the initial samples.

This phenomenon can be attributed to the following aspects. First of all, according to Debye relaxation theory, the dielectric loss of HTV SR samples at low frequency band is mainly caused by the DC conductance loss. With the increase of frequency, the polarization loss of different relaxations tends to play an important role and gradually becomes dominant. Secondly, in literature,<sup>27</sup> the dielectric properties of silicone rubber sleeve were measured by the non-contact dielectric spectrum, and the various relaxation processes of silicone rubber were analyzed in detail by using the modified Cole-Cole model. The polarization processes were divided into macroscopic interface polarization, microscopic interface polarization and dipole polarization. Considering that the contact dielectric spectrum was selected in this test, the macroscopic interface polarization process can be neglected. Therefore, the dielectric loss of silicone rubber samples was mainly caused by the microscopic interface polarization and dipole polarization. According to the SEM analysis, the polarization loss at the microscopic interface enlarged with the increase of physical and chemical defects such as holes and cracks on the surface of HTV SR and the loss of packing. Combined with the infrared spectrum characteristics, it can be seen that the rise of temperature aggravated the damage degree of the molecular main chain and decomposed to produce more LMW substances, leading to the increase of dipoles and dipole polarization loss.

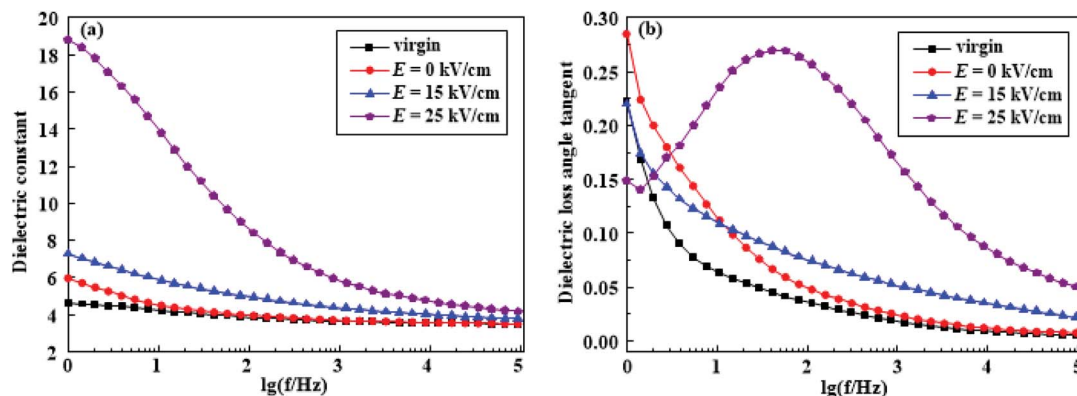
Fig. 16 The dielectric constant (a) and the dielectric loss angle tangent (b) of HTV SR before and after electrical-hydrothermal aging at 80 °C for 24 days (varying electric field intensity).

Fig. 16(a) and (b) shows the change of dielectric constant and the dielectric loss of HTV SR under different electric field intensity after electrical-hydrothermal aging at  $80^\circ\text{C}$  for 24 days. As seen in Fig. 16(a), the dielectric constant behave similarly for the HTV SR of the aged and the virgin sample, and increased with decreasing frequency. Especially in the low frequency band, the increase became faster because of the space charge polarization or the effect of interfacial polarization. Due to the appearance of various physical and chemical defects on the surface and inside of HTV SR, as well as the increase of particles shown by SEM results, the interface polarization was significantly enhanced. The highest observed values (dielectric constant) were for the samples after electrical-hydrothermal aging at  $80^\circ\text{C} - 25 \text{ kV cm}^{-1}$ . As compared to the

virgin sample, there was an obvious increase in dielectric constant almost along the entire frequency range for hydrothermal and electrical-hydrothermal aged HTV SR specimen. This might be due to the increase in mobility of the polymer chains by the breakage of bonds caused by applied electric and hydrothermal stress.

As regards the dielectric loss angle tangent, in Fig. 16(b), it presented different and interesting phenomenon. In the middle frequency region (10 Hz to  $10^3$  Hz), there was an obvious dielectric loss peak in the HTV SR specimen after electrical-hydrothermal aging at 80 °C – 25 kV cm<sup>-1</sup> for 24 days. It might be caused by the orientation of greater dipolar groups. A large amount of broken PDMS molecular chains led to the increase of free radicals in the material and the enhancement of dipole polarization, presenting the apparent loss peak in the dielectric frequency response. However, in the low frequency region, the dielectric loss angle tangent of the electrical-hydrothermal aging samples showed different change rules. Because there was another dielectric relaxation process in the dielectric loss curve at low frequency band in addition to the DC conductivity,<sup>27</sup> and they worked together in the low frequency region of the dielectric loss curve.

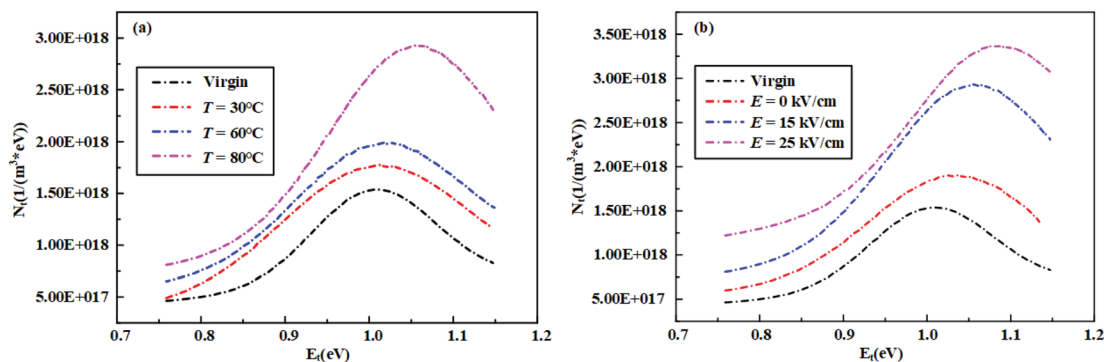
Fig. 18 Trap level distributions before and after electrical-hydrothermal aging for 24 days: (a)  $E = 15 \text{ kV cm}^{-1}$ , varying temperature; (b)  $T = 80^\circ\text{C}$ , varying electric field intensity.

Then, the trap level distribution from TSC measurement can be calculated by eqn (6) based on MATLAB numerical calculation. Fig. 18 shows the trap level distributions of the virgin and aging samples. It shows that the trap density of the virgin was relatively low. With the rise of temperature and electric field intensity, the trap density increased and the trap energy level corresponding to the peak of trap density became deeper. The peak density of traps could reach about 2.5 times larger than that of the virgin sample under the condition of 80 °C – 25

kV cm<sup>-1</sup> electrical-hydrothermal aging. The phenomenon can be explained by the following aspects. Firstly, with the combination of electrical-hydrothermal aging, more defects were produced inside the HTV SR, which enhanced the electron trapping ability and increased the trap density. Secondly, it is well known that traps can be divided into deep traps and shallow traps according to the trap level. The current peak at low temperature is mainly contributed by the charge decapitation in shallow traps, while the current peak at high temperature corresponds to the charge decapitation in deep traps. As shown in Fig. 18, compared to the virgin sample, more deep traps were generated in the process of electrical-hydrothermal aging. Deep traps bound carrier migration, leading to local charge accumulation and rising local electric field strength. When the threshold was exceeded, the polymer breakdown might occur finally.

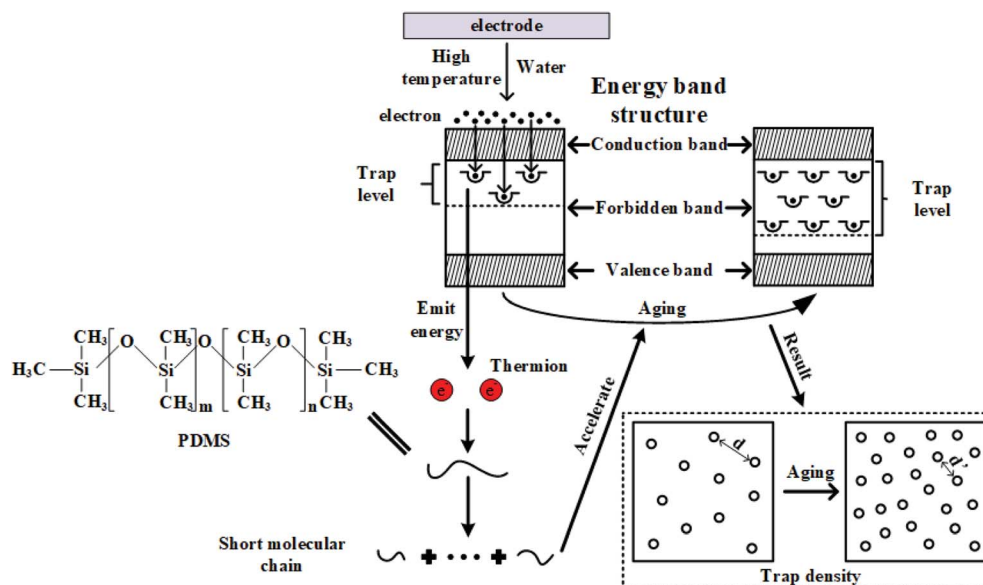
Fig. 19 Electrical-hydrothermal combined aging mechanism.

Combined with the test results above, the mechanism of electrical-hydrothermal aging can be summarized in Fig. 19. First of all, when the HTV SR specimen is subjected to hydrothermal aging effects, the main and side chains scission on PDMS molecular chain occurred, producing free radical and LMW substances. With the aging process going on, more physical and chemical defects are formed in the material. The oxidation decomposition reaction in the aging process promotes the formation of more free molecules and traps, leading to the increase of dielectric constant, loss tangent  $\tan \delta$ , trap energy level and trap density.

Then, when the electric field is added, electrons would be injected into the HTV SR from the electrode, and some electrons are trapped by the polymer. The trapped electron becomes the recombination center of the hole, releasing large amounts of energy and transferring it to other electrons to produce thermions. The hydrothermal aging condition provides convenience for electron injection. More thermions will bombard the molecular chain, creating more traps. On the other hand, the dipole polarization loss generates thermal power, which aggravates the deterioration of insulating materials. Therefore, according to the trap properties during the aging process, producing nanocomposites can be an available way. The addition of nanoparticles can reduce the number of traps in the material and enhance breakdown strength. By adjusting the charge transport characteristics, the breakdown probability can be lowered down.
