# Effects of electrical-hydrothermal aging degradation on dielectric and trap properties of high temperature vulcanized silicone rubber materials

In this paper, a new aging platform combined the high voltage electric field and the hydrothermal environment was built. To investigate the aging mechanism, physicochemical, dielectric and trap properties of HTV SR before and after electrical-hydrothermal aging for 24 days were discussed. The results indicated that, compared with hydrothermal aging, more cracks and holes appeared on the surface of HTV SR after electrical-hydrothermal aging, and the content of flame retardant decreased significantly. Due to the main chain and side chain scission of PDMS, lots of low weight molecular (LWM) substances and free radicals were produced. And the tensile strength and elongation at break significantly decreased. Various physical and chemical defects appeared in the HTV SR specimen in the process of electrical-hydrothermal degradation, as a result of which, the dielectric constant significantly increased and the peak trap density increased by about 2.5 times compared to the virgin sample. The increase in trap density in turn accelerated the charge

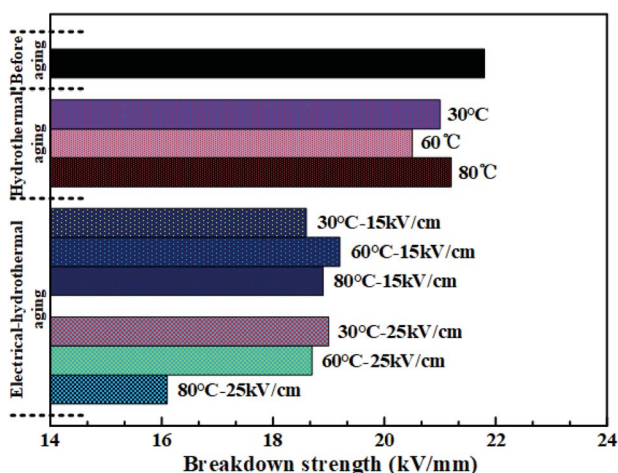
Fig. 6 The breakdown field strength of HTV SR specimens under different aging conditions.

regularity but presented a great fluctuation. It indicated that there were complex reactions in HTV SR after hydrothermal and electrical-hydrothermal aging processes. Due to high temperature and high electric field, severe degradation occurred in HTV SR and various physical and chemical defects were produced. Therefore, the change in the shape parameter  $\beta$  showed large variation in dispersity of electrical weak points in the aging samples. Then the value of breakdown field strength under different aging conditions is shown in Fig. 6. As shown in Fig. 6, compared to the virgin sample and hydrothermal aging sample, the breakdown field strength of the electrical-hydrothermal (80  $^{\circ}\text{C} - 25 \text{ kV cm}^{-1}$ ) sample was significantly decreased from 21.8  $\text{kV mm}^{-1}$  to 16.1  $\text{kV mm}^{-1}$ . It indicated that there was obvious synergistic aging effect of electric, water and temperature. The change of breakdown field strength caused by electrical-hydrothermal aging was much greater than that caused by hydrothermal aging. The combined effect significantly accelerated the decrease of breakdown field strength. To further explore the combined aging effect, the microscopic analysis was studied below.

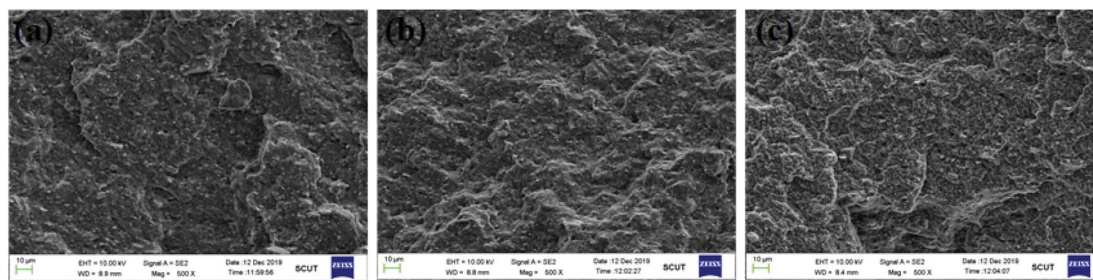
Fig. 9 SEM photos of the cross-sections of HTV SR specimens before and after aging in different conditions for 24 days: (a) virgin HTV SR, (b) hydrothermal aging at 80 °C, (c) electrical-hydrothermal aging at 80 °C – 25 kV cm<sup>-1</sup>.

To examine the cross-sections of the HTV SR, SEM photos of specimens aging in different conditions to verify the depth of the damage was presented in Fig. 9. It indicated that the cross-sections of the virgin HTV SR was relatively smooth and presented little cracks, holes and particles compared to the aging samples. Then the cross-section of the HTV SR specimen became rough after hydrothermal aging. With the addition of electric field, a large number of microscopic cracks and holes appeared in the HTV SR specimen in Fig. 9(c). It can be concluded that the electrical-hydrothermal aging degradation occurred not only on the surface but also in the interior. However, the degradation on the surface showed much more serious than the interior. It indicated that the initial deterioration process began on the surface of the samples.

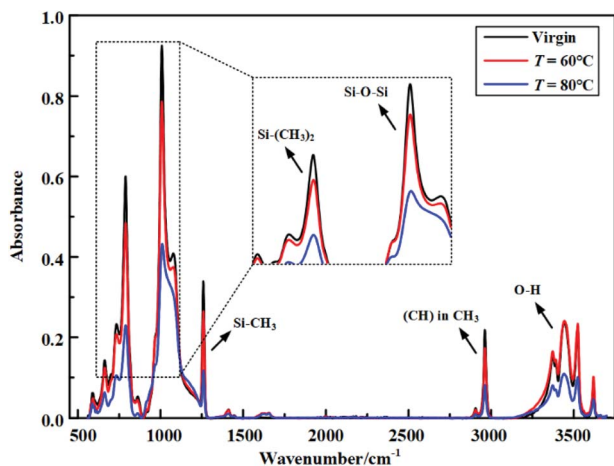
Fig. 12 FTIR of HTV SR before and after electrical-hydrothermal aging at  $25 \text{ kV cm}^{-1}$  for 24 days (varying temperature).

peak of the main chain Si-O-Si, side chain Si- $\text{CH}_3$  and Si-( $\text{CH}_3$ )<sub>2</sub> of PDMS in HTV SR specimen showed a downward trend. When the electric field intensity reached  $25 \text{ kV cm}^{-1}$ , the absorption peak of the main chain and each side chain showed a remarkable reduction. For the hydroxyl absorption peak in the wavenumber range from  $3200 \text{ cm}^{-1}$  to  $3700 \text{ cm}^{-1}$ , it fluctuated with the increase of field intensity. It was caused by the complex reaction processes such as oxidation,<sup>14</sup> cracking,<sup>23</sup> cross-linking<sup>24,25</sup> and condensation<sup>26</sup> that occurred in the electrical-hydrothermal aging process of HTV SR samples, resulting in the fluctuating tendency of hydroxyl peak. Fig. 12 shows the FTIR of HTV SR before and after electrical-hydrothermal aging at  $25 \text{ kV cm}^{-1}$  for 24 days. Similar to the downward trend in Fig. 11, when the electric field intensity was  $25 \text{ kV cm}^{-1}$ , the peak of each organic group decreased significantly with the increase of the temperature in electrical-hydrothermal aging processes. Therefore, it indicated that the PDMS on the HTV SR surface severely degraded when the electric field intensity or the temperature increased.

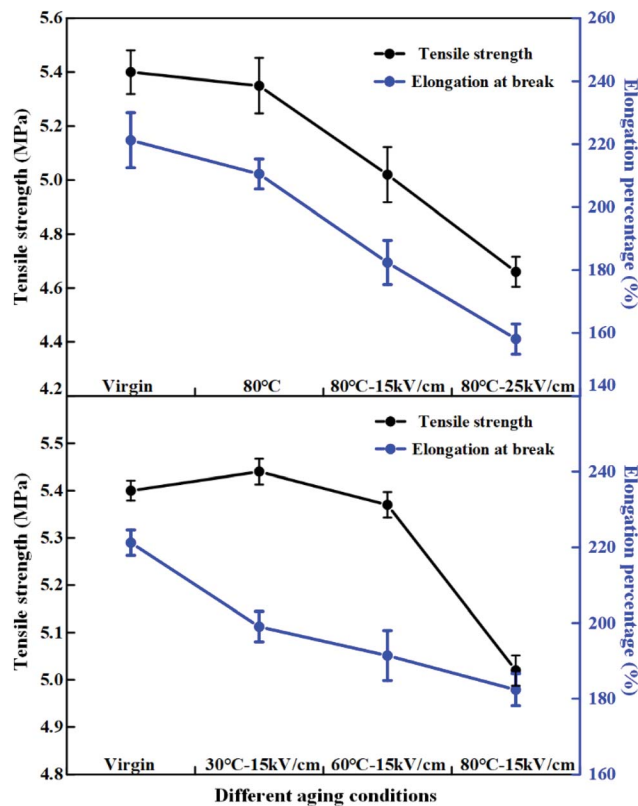
Fig. 13 Tensile properties of HTV SR before and after aging in different conditions.

**3.3.3 Tensile properties analysis.** The mechanical property is an important index to evaluate the aging characteristics of insulating materials. Fig. 13 and 14 present the change of the tensile strength, the elongation at break and the Young's modulus in different aging conditions after hydrothermal and electrical-hydrothermal aging. As shown in Fig. 13 and 14, the tensile strength and the elongation at break decreased and the Young's modulus increased with the increase of the electric field strength. In the presence of an electric field, the change of

the tensile strength, the elongation at break and the Young's modulus of the aging HTV SR specimens were much greater than that of the hydrothermal aging samples. The deterioration in tensile properties after aging is normally related to linkages scission and main chain scission. According to FTIR results, the peak of the main chain Si-O-Si, side chain Si- $\text{CH}_3$  and Si-( $\text{CH}_3$ )<sub>2</sub> of PDMS in HTV SR specimen showed a downward trend. The crosslinking structure was destroyed after electrical-hydrothermal aging. However, the change of tensile strength and Young's modulus at varying temperature presented different trends in electrical-hydrothermal aged specimens. At  $30^\circ\text{C} - 15 \text{ kV cm}^{-1}$  and  $60^\circ\text{C} - 15 \text{ kV cm}^{-1}$ , the tensile strength and the Young's modulus did not show obvious change. When temperature reached  $80^\circ\text{C}$ , the tensile strength significantly decreased and the Young's modulus significantly increased. It revealed that when the temperature did not reach the threshold, the temperature would not promote the electrical aging process.

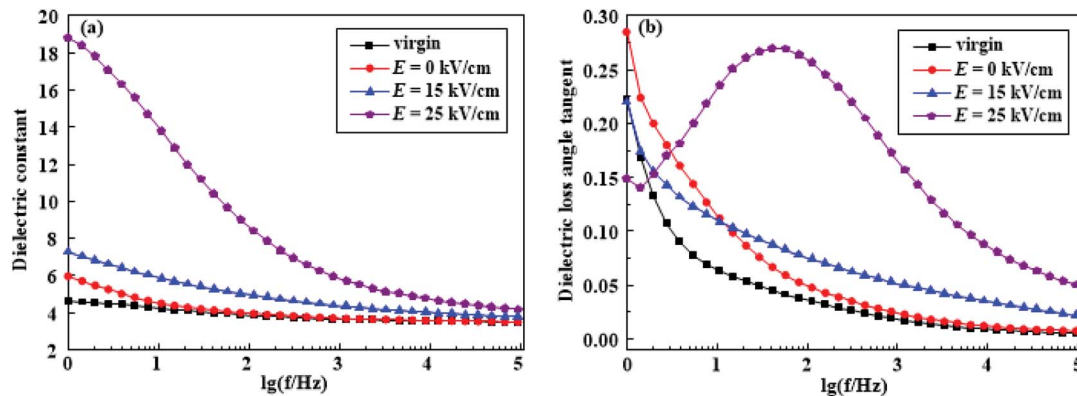
Fig. 16 The dielectric constant (a) and the dielectric loss angle tangent (b) of HTV SR before and after electrical-hydrothermal aging at 80 °C for 24 days (varying electric field intensity).

Fig. 16(a) and (b) shows the change of dielectric constant and the dielectric loss of HTV SR under different electric field intensity after electrical-hydrothermal aging at  $80^\circ\text{C}$  for 24 days. As seen in Fig. 16(a), the dielectric constant behave similarly for the HTV SR of the aged and the virgin sample, and increased with decreasing frequency. Especially in the low frequency band, the increase became faster because of the space charge polarization or the effect of interfacial polarization. Due to the appearance of various physical and chemical defects on the surface and inside of HTV SR, as well as the increase of particles shown by SEM results, the interface polarization was significantly enhanced. The highest observed values (dielectric constant) were for the samples after electrical-hydrothermal aging at  $80^\circ\text{C} - 25 \text{ kV cm}^{-1}$ . As compared to the

virgin sample, there was an obvious increase in dielectric constant almost along the entire frequency range for hydrothermal and electrical-hydrothermal aged HTV SR specimen. This might be due to the increase in mobility of the polymer chains by the breakage of bonds caused by applied electric and hydrothermal stress.

As regards the dielectric loss angle tangent, in Fig. 16(b), it presented different and interesting phenomenon. In the middle frequency region (10 Hz to  $10^3$  Hz), there was an obvious dielectric loss peak in the HTV SR specimen after electrical-hydrothermal aging at 80 °C – 25 kV  $\text{cm}^{-1}$  for 24 days. It might be caused by the orientation of greater dipolar groups. A large amount of broken PDMS molecular chains led to the increase of free radicals in the material and the enhancement of dipole polarization, presenting the apparent loss peak in the dielectric frequency response. However, in the low frequency region, the dielectric loss angle tangent of the electrical-hydrothermal aging samples showed different change rules. Because there was another dielectric relaxation process in the dielectric loss curve at low frequency band in addition to the DC conductivity,<sup>27</sup> and they worked together in the low frequency region of the dielectric loss curve.

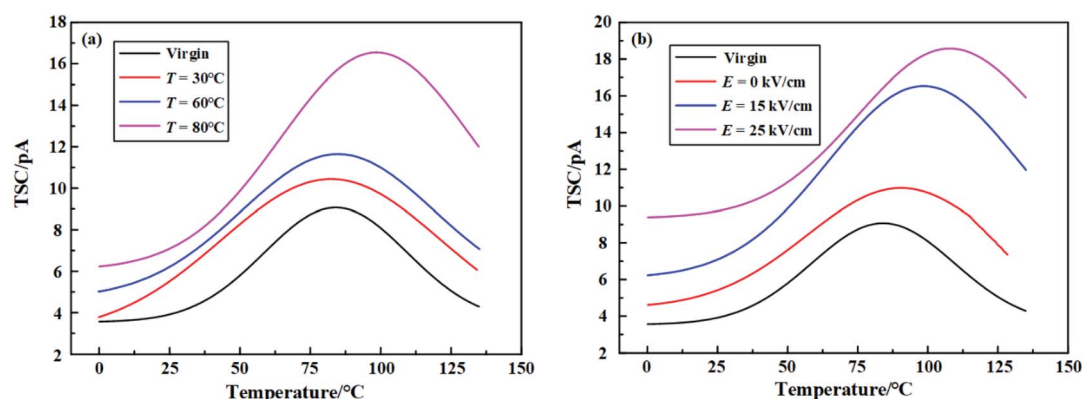
Fig. 17 TSC measurement before and after electrical-hydrothermal aging for 24 days: (a)  $E = 15 \text{ kV cm}^{-1}$ , varying temperature; (b)  $T = 80 \text{ °C}$ , varying electric field intensity.

It is commonly acknowledged that the aging performance of the polymer material is related to the accumulation of space charge or the trap characteristics. Fig. 17 shows the TSC curve of unaged, the hydrothermal aged and electrical-hydrothermal aged samples. In order to analyze trap properties, the amount of trap charge can be calculated by eqn (5). Then the amount of trap charge, the peak current and the peak current temperature can be listed in Table 3.

As shown in Fig. 17, it indicated that the TSC curve of all HTV SR samples presented a main current peak. With the increase of the temperature or the electric field strength of electrical-hydrothermal aging, the peak current increased continuously and tended to drift towards the high temperature region. As listed in Table 4, the trap charge of the electrical-hydrothermal aging samples was significantly more than that of the unaged and after hydrothermal aged samples. Similarly, the trap charge also increased with the rising temperature and electric field

However, it is almost difficult to obtain the trap density and trap energy level distribution of the HTV SR specimen directly before and after aging from Fig. 17. According to the TSC theory, the TSC caused by the de-trapping process of the captured charges can be expressed as the following function:<sup>28</sup>

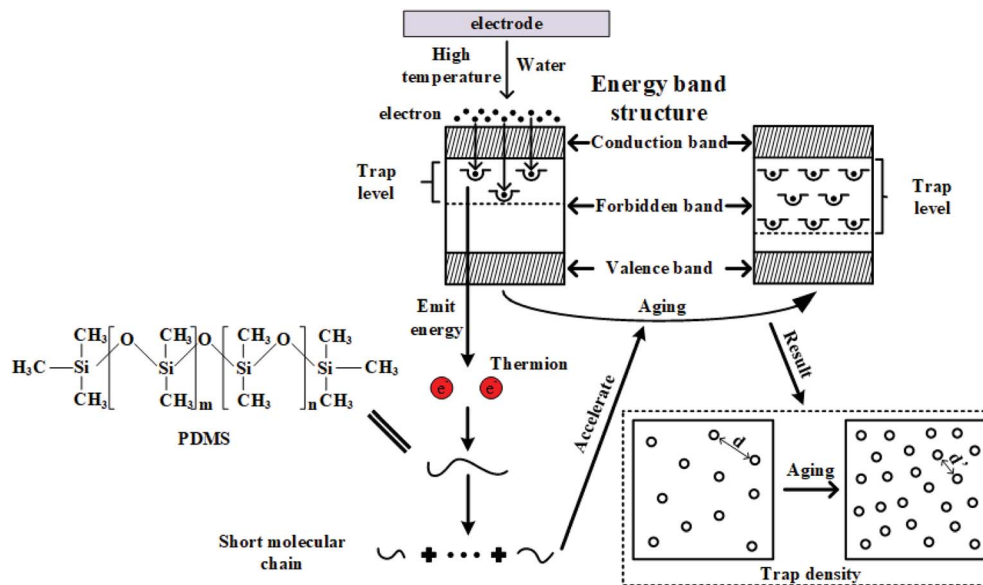
Fig. 19 Electrical-hydrothermal combined aging mechanism.

Combined with the test results above, the mechanism of electrical-hydrothermal aging can be summarized in Fig. 19. First of all, when the HTV SR specimen is subjected to hydrothermal aging effects, the main and side chains scission on PDMS molecular chain occurred, producing free radical and LMW substances. With the aging process going on, more physical and chemical defects are formed in the material. The oxidation decomposition reaction in the aging process promotes the formation of more free molecules and traps, leading to the increase of dielectric constant, loss tangent  $\tan \delta$ , trap energy level and trap density.

Then, when the electric field is added, electrons would be injected into the HTV SR from the electrode, and some electrons are trapped by the polymer. The trapped electron becomes the recombination center of the hole, releasing large amounts of energy and transferring it to other electrons to produce thermions. The hydrothermal aging condition provides convenience for electron injection. More thermions will bombard the molecular chain, creating more traps. On the other hand, the dipole polarization loss generates thermal power, which aggravates the deterioration of insulating materials. Therefore, according to the trap properties during the aging process, producing nanocomposites can be an available way. The addition of nanoparticles can reduce the number of traps in the material and enhance breakdown strength. By adjusting the charge transport characteristics, the breakdown probability can be lowered down.
