Effects of electrical-hydrothermal aging degradation on dielectric and trap properties of high temperature vulcanized silicone rubber materials

In this paper, a new aging platform combined the high voltage electric field and the hydrothermal environment was built. To investigate the aging mechanism, physicochemical, dielectric and trap properties of HTV SR before and after electrical-hydrothermal aging for 24 days were discussed. The results indicated that, compared with hydrothermal aging, more cracks and holes appeared on the surface of HTV SR after electrical-hydrothermal aging, and the content of flame retardant decreased significantly. Due to the main chain and side chain scission of PDMS, lots of low weight molecular (LWM) substances and free radicals were produced. And the tensile strength and elongation at break significantly decreased. Various physical and chemical defects appeared in the HTV SR specimen in the process of electrical-hydrothermal degradation, as a result of which, the dielectric constant significantly increased and the peak trap density increased by about 2.5 times compared to the virgin sample. The increase in trap density in turn accelerated the charge a

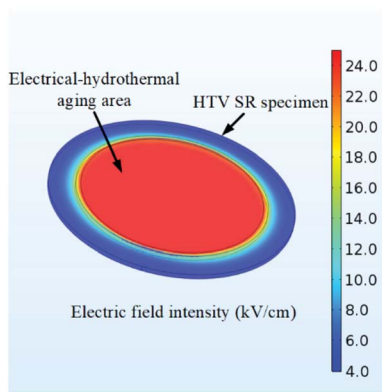
Fig. 2 Characteristics of the surface electric field intensity at 25 kV cm^{-1} on the HTV SR specimen.

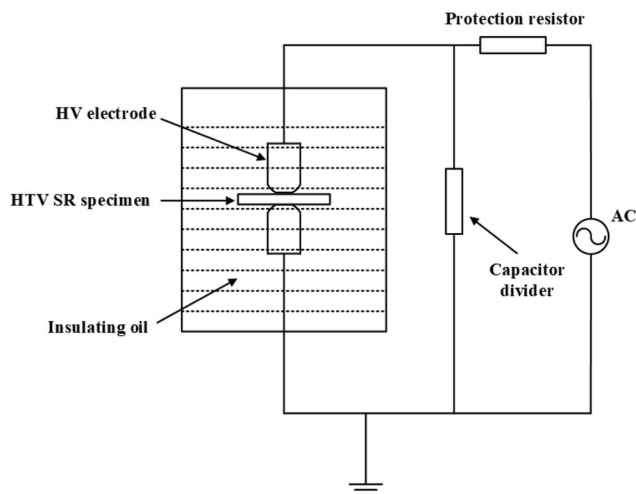
Fig. 3 Experimental setup for the AC breakdown studies.

specimens. In the measurement of AC breakdown voltage, a set of 5 samples with a diameter of 100 mm and a thickness of 2 mm were tested to calculate the breakdown field strength. The experimental setup for the AC breakdown voltage was shown in Fig. 3. The aging specimens are placed in the plate to plate arrangement, and placed into a vessel containing filling with insulation oil to avoid surface discharges. During the test, the voltage is increasing step by step until the breakdown occurs. The voltage was rising at the rate of 500 V s^{-1} . When the breakdown occurs, the AC breakdown stress can be calculated according to the equation $E = V/d$, where V is the breakdown voltage and d is the thickness of the aging specimen in the breakdown point.

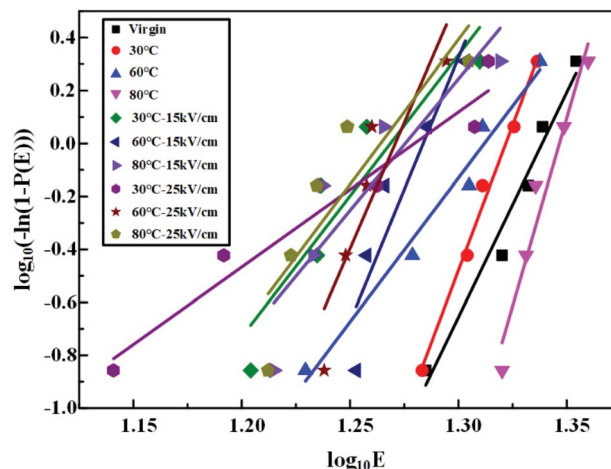
Fig. 5 Curve of the Weibull statistical distribution of the breakdown field strength of before and after aging samples.

The AC breakdown characteristic of all samples under Weibull distribution is presented in Fig. 5. According to eqn (3), the value of the shape parameter β was calculated and listed in Table 2. Coppard²² *et al.* believed that the shape parameter β represented the distribution of defects and filling particles. However, as seen in Table 2, the value of β did not show obvious

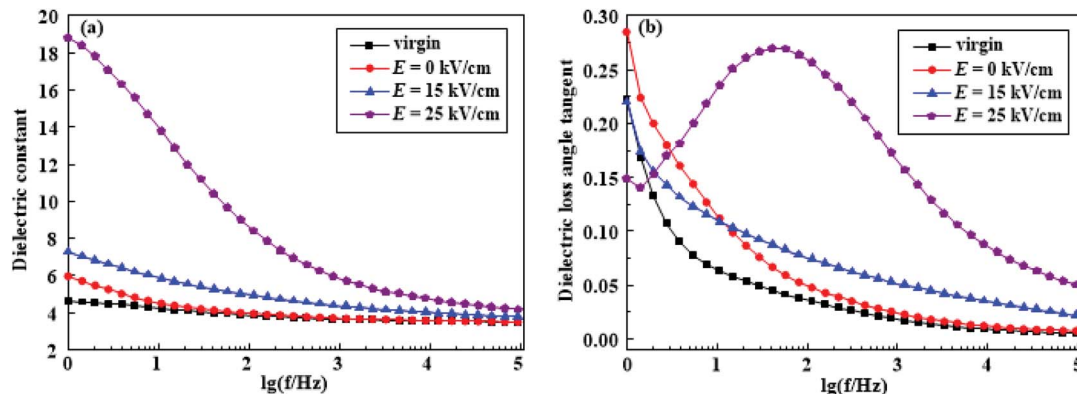
Fig. 16 The dielectric constant (a) and the dielectric loss angle tangent (b) of HTV SR before and after electrical-hydrothermal aging at 80 °C for 24 days (varying electric field intensity).

Fig. 16(a) and (b) shows the change of dielectric constant and the dielectric loss of HTV SR under different electric field intensity after electrical-hydrothermal aging at 80°C for 24 days. As seen in Fig. 16(a), the dielectric constant behave similarly for the HTV SR of the aged and the virgin sample, and increased with decreasing frequency. Especially in the low frequency band, the increase became faster because of the space charge polarization or the effect of interfacial polarization. Due to the appearance of various physical and chemical defects on the surface and inside of HTV SR, as well as the increase of particles shown by SEM results, the interface polarization was significantly enhanced. The highest observed values (dielectric constant) were for the samples after electrical-hydrothermal aging at $80^\circ\text{C} - 25 \text{ kV cm}^{-1}$. As compared to the

virgin sample, there was an obvious increase in dielectric constant almost along the entire frequency range for hydrothermal and electrical-hydrothermal aged HTV SR specimen. This might be due to the increase in mobility of the polymer chains by the breakage of bonds caused by applied electric and hydrothermal stress.

As regards the dielectric loss angle tangent, in Fig. 16(b), it presented different and interesting phenomenon. In the middle frequency region (10 Hz to 10^3 Hz), there was an obvious dielectric loss peak in the HTV SR specimen after electrical-hydrothermal aging at 80 °C – 25 kV cm^{-1} for 24 days. It might be caused by the orientation of greater dipolar groups. A large amount of broken PDMS molecular chains led to the increase of free radicals in the material and the enhancement of dipole polarization, presenting the apparent loss peak in the dielectric frequency response. However, in the low frequency region, the dielectric loss angle tangent of the electrical-hydrothermal aging samples showed different change rules. Because there was another dielectric relaxation process in the dielectric loss curve at low frequency band in addition to the DC conductivity,²⁷ and they worked together in the low frequency region of the dielectric loss curve.

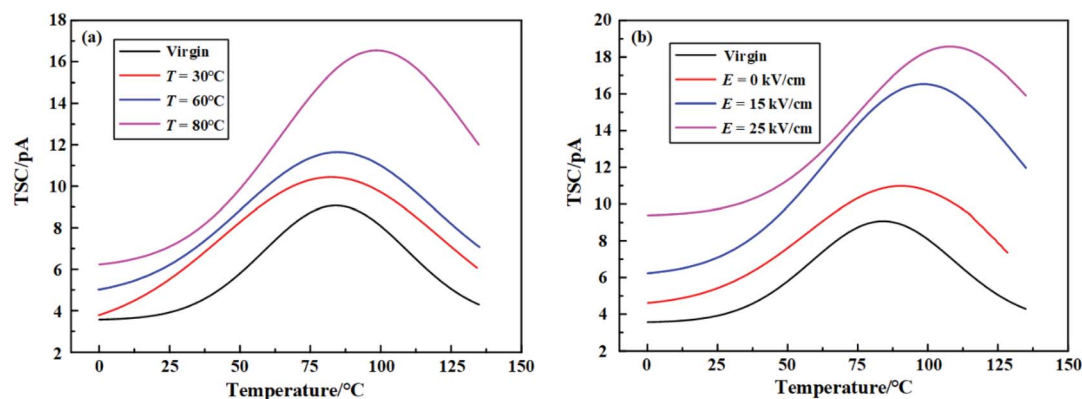
Fig. 17 TSC measurement before and after electrical-hydrothermal aging for 24 days: (a) $E = 15 \text{ kV cm}^{-1}$, varying temperature; (b) $T = 80 \text{ °C}$, varying electric field intensity.

It is commonly acknowledged that the aging performance of the polymer material is related to the accumulation of space charge or the trap characteristics. Fig. 17 shows the TSC curve of unaged, the hydrothermal aged and electrical-hydrothermal aged samples. In order to analyze trap properties, the amount of trap charge can be calculated by eqn (5). Then the amount of trap charge, the peak current and the peak current temperature can be listed in Table 3.

As shown in Fig. 17, it indicated that the TSC curve of all HTV SR samples presented a main current peak. With the increase of the temperature or the electric field strength of electrical-hydrothermal aging, the peak current increased continuously and tended to drift towards the high temperature region. As listed in Table 4, the trap charge of the electrical-hydrothermal aging samples was significantly more than that of the unaged and after hydrothermal aged samples. Similarly, the trap charge also increased with the rising temperature and electric field

However, it is almost difficult to obtain the trap density and trap energy level distribution of the HTV SR specimen directly before and after aging from Fig. 17. According to the TSC theory, the TSC caused by the de-trapping process of the captured charges can be expressed as the following function:²⁸
