# Effects of electrical-hydrothermal aging degradation on dielectric and trap properties of high temperature vulcanized silicone rubber materials

Huasong Xu, Congzhen Xie,\* Rui Wang, Bin Gou, Shoukang Luo and Jiangang Zhou

In this paper, a new aging platform combined the high voltage electric field and the hydrothermal environment was built. To investigate the aging mechanism, physicochemical, dielectric and trap properties of HTV SR before and after electrical-hydrothermal aging for 24 days were discussed. The results indicated that, compared with hydrothermal aging, more cracks and holes appeared on the surface of HTV SR after electrical-hydrothermal aging, and the content of flame retardant decreased significantly. Due to the main chain and side chain scission of PDMS, lots of low weight molecular (LWM) substances and free radicals were produced. And the tensile strength and elongation at break significantly decreased. Various physical and chemical defects appeared in the HTV SR specimen in the process of electrical-hydrothermal degradation, as a result of which, the dielectric constant significantly increased and the peak trap density increased by about 2.5 times compared to

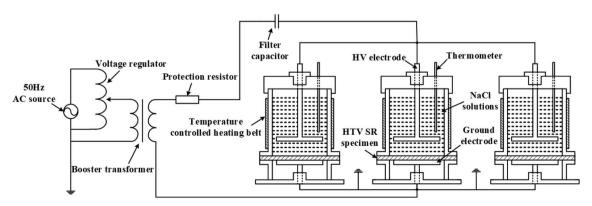
The experimental set up for investigating the electricalhydrothermal aging effect is shown in Fig. 1. It is composed of AC power box, rod-plate electrode, quartz tube and heating plate. Saline solutions were prepared as the conductive solution and the salt contaminant. The high voltage electrode, when immersed in the saline solutions, will provide a uniform and stable electric field on the HTV SR. To verify the electric field uniformity, the simulation model was established using the COMSOL and the results were shown in Fig. 2. As shown in Fig. 2, the HTV SR specimens were in a uniform electric field. In the electrical-hydrothermal aging test, the temperature of the heating plate was controlled at 30 °C, 60 °C, 80 °C and the electric field intensity was 0 kV cm<sup>-1</sup> (equivalent to hydrothermal aging), 15 kV cm<sup>-1</sup> and 25 kV cm<sup>-1</sup>. For comparison, the temperature of the saline solutions in the hydrothermal aging test was also controlled at 30 °C, 60 °C and 80 °C.

Fig. 1 The experimental set up for the electrical-hydrothermal aging effect.

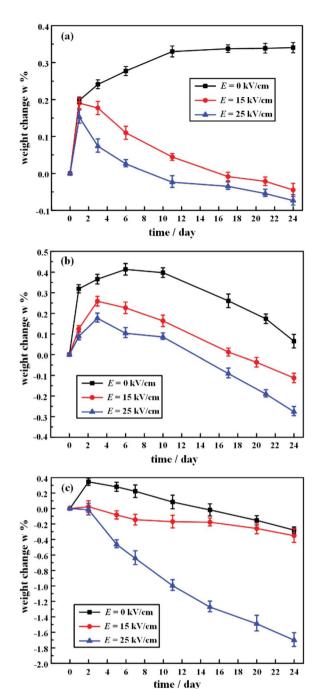
Fig. 4 shows the relative weight change of HTV SR after electrical-hydrothermal aging under different electric field intensity at varying temperatures. As shown in Fig. 4, in the absence of an electric field, the weights of HTV SR specimens immersed in saline solutions at 30 °C increased rapidly at first and then slowly increased within 24 days. However, when immersed in saline solutions at 60 °C and 80 °C, the weight of HTV SR increased rapidly and then decreased. This phenomenon might result from the increase of temperature and the invasion of water accelerating the hydrothermal aging effect of the HTV SR specimen. The relative weight change of HTV SR specimen depended on the competition between the invasion of water and the extraction of the low-molecular-weight (LMW) substances and the filler particles. Both process was influenced by water temperature. During the immersion for 24 days at 30 °C, the weight increased because of the invasion of water over counteracted the weight decrease caused by the extraction of the LMW substances and the filler particles. However, at 60 °C and 80 °C, the weight of HTV SR decreased rapidly because the oxidation decomposition of HTV SR specimen and the extraction of the LMW substances and the filler particles over counteracted the weight increase due to the diffusion of water into HTV SR.

When considering the electric field, the weight of the HTV SR samples was obviously decreased. With the increase of electric field intensity, the final mass loss rate was significantly higher

Fig. 4 Relative weight change of HTV SR after electrical-hydrothermal aging under different electrical field intensity at (a) 30  $^{\circ}$ C, (b) 60  $^{\circ}$ C, and (c) 80  $^{\circ}$ C.

than that of the HTV SR samples without an electric field. The final relative weight change of the hydrothermal aging samples at 80 °C was 0.27%, while the relative weight change rate reached -1.71% under the 80 °C and 25 kV cm<sup>-1</sup> electrical-hydrothermal aging condition. Therefore, there was a synergistic effect of mutual enhancement of electrical-hydrothermal aging process, which significantly accelerated the weight reduction of HTV SR specimens. The presence of an electric field accelerated the hydrothermal aging process, which in turn

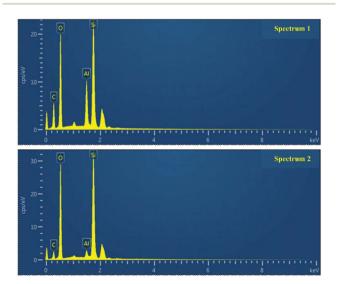
Fig. 10 EDAX of the virgin HTV SR (spectrum 1) and the electrical-hydrothermal aged (80  $^{\circ}\text{C}$  – 25 kV cm $^{-1})$  HTV SR (spectrum 2).

At the same time, EDAX was conducted to recognize the elements present over the HTV SR surface. Fig. 10 presents the EDAX of the virgin HTV SR (spectrum 1) and the electricalhydrothermal aged (80 °C - 25 kV cm<sup>-1</sup>) HTV SR (spectrum 2). Because the test mainly studied the variation rules of surface elements on HTV SR after electrical-hydrothermal aging, various trace elements in the filler were neglected. As shown in Fig. 10, silicon (Si), carbon (C), oxygen (O) and aluminum (Al) were the main elements on the surface of the HTV SR specimen. After electrical-hydrothermal aging (80 °C - 25 kV cm<sup>-1</sup>) for 24 days, the content of elements C and Al decreased significantly. It represented the side chain scission of PDMS molecules, and the LMW substances would be extracted, resulting in a decline of C content. Moreover, Al content was also significantly reduced due to acidic substances generated by discharge. The generated acidic substances would react with the flame retardant aluminum hydroxide. The analysis could be further proved in the FTIR below.

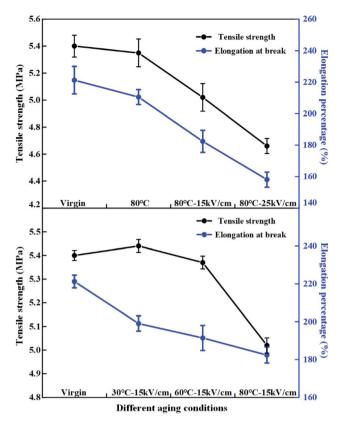
3.3.3 Tensile properties analysis. The mechanical property is an important index to evaluate the aging characteristics of insulating materials. Fig. 13 and 14 present the change of the tensile strength, the elongation at break and the Young's modulus in different aging conditions after hydrothermal and electrical-hydrothermal aging. As shown in Fig. 13 and 14, the tensile strength and the elongation at break decreased and the Young's modulus increased with the increase of the electric field strength. In the presence of an electric field, the change of

Fig. 13 Tensile properties of HTV SR before and after aging in different conditions

the tensile strength, the elongation at break and the Young's modulus of the aging HTV SR specimens were much greater than that of the hydrothermal aging samples. The deterioration in tensile properties after aging is normally related to linkages scission and main chain scission. According to FTIR results, the peak of the main chain Si-O-Si, side chain Si-CH<sub>3</sub> and Si-(CH<sub>3</sub>)<sub>2</sub> of PDMS in HTV SR specimen showed a downward trend. The crosslinking structure was destroyed after electrical-hydrothermal aging. However, the change of tensile strength and Young's modulus at varying temperature presented different trends in electrical-hydrothermal aged specimens. At  $30 \,^{\circ}\text{C} - 15 \,\text{kV} \,\text{cm}^{-1}$  and  $60 \,^{\circ}\text{C} - 15 \,\text{kV} \,\text{cm}^{-1}$ , the tensile strength and the Young's modulus did not show obvious change. When temperature reached 80 °C, the tensile strength significantly decreased and the Young's modulus significantly increased. It revealed that when the temperature did not reach the threshold, the temperature would not promote the electrical aging process.

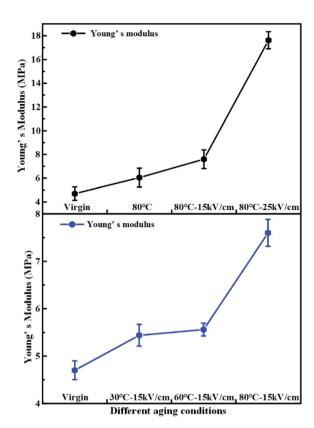
Fig. 14 Young's modulus of HTV SR before and after aging in different conditions.

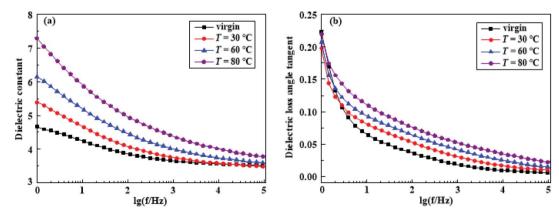
In this section, the data of 80 °C and 15 kV cm<sup>-1</sup> after electricalhydrothermal aging for 24 days were selected for analysis. Fig. 15(a) and (b) shows the change of dielectric constant and the dielectric loss of HTV SR at varying temperature after electrical-hydrothermal aging at 15 kV cm<sup>-1</sup> for 24 days.

As shown in Fig. 15(a), it indicated that the dielectric constant of the aging samples in the whole frequency range

significantly increased with the rise of temperature, especially at low frequency. However, in the high frequency band (10<sup>4</sup> Hz to 10<sup>5</sup> Hz), the curve tended to a constant, which might be caused by electron polarization or molecular chain vibration of HTV SR media under the influence of the electric field. Fig. 15(b) shows that the dielectric loss of HTV SR specimen increased with the rise of temperature in the middle and high frequency band, while in the low frequency band, the dielectric loss of the electrical-hydrothermal aging samples was lower than that of the initial samples.

Fig. 15 The dielectric constant (a) and the dielectric loss angle tangent (b) of HTV SR before and after electrical-hydrothermal aging at 15 kV cm<sup>-1</sup> for 24 days (varying temperature).

This phenomenon can be attributed to the following aspects. First of all, according to Debye relaxation theory, the dielectric loss of HTV SR samples at low frequency band is mainly caused by the DC conductance loss. With the increase of frequency, the polarization loss of different relaxations tends to play an important role and gradually becomes dominant. Secondly, in literature,27 the dielectric properties of silicone rubber sleeve were measured by the non-contact dielectric spectrum, and the various relaxation processes of silicone rubber were analyzed in detail by using the modified Cole-Cole model. The polarization processes were divided into macroscopic interface polarization, microscopic interface polarization and dipole polarization. Considering that the contact dielectric spectrum was selected in this test, the macroscopic interface polarization process can be neglected. Therefore, the dielectric loss of silicone rubber samples was mainly caused by the microscopic interface polarization and dipole polarization. According to the SEM analysis, the polarization loss at the microscopic interface enlarged with the increase of physical and chemical defects such as holes and cracks on the surface of HTV SR and the loss of packing. Combined with the infrared spectrum characteristics, it can be seen that the rise of temperature aggravated the damage degree of the molecular main chain and decomposed to produce more LMW substances, leading to the increase of dipoles and dipole polarization loss.

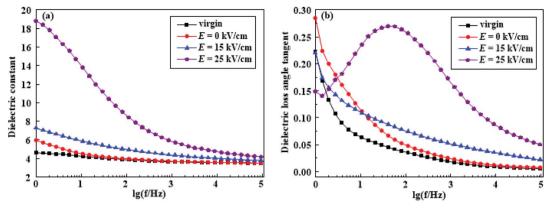
Fig. 16(a) and (b) shows the change of dielectric constant and the dielectric loss of HTV SR under different electric field intensity after electrical-hydrothermal aging at 80 °C for 24 days. As seen in Fig. 16(a), the dielectric constant behave similarly for the HTV SR of the aged and the virgin sample, and increased with decreasing frequency. Especially in the low frequency band, the increase became faster because of the space charge polarization or the effect of interfacial polarization. Due to the appearance of various physical and chemical defects on the surface and inside of HTV SR, as well as the increase of particles shown by SEM results, the interface polarization was significantly enhanced. The highest observed values (dielectric constant) were for the samples after electrical-hydrothermal aging at 80 °C – 25 kV cm<sup>-1</sup>. As compared to the

Fig. 16 The dielectric constant (a) and the dielectric loss angle tangent (b) of HTV SR before and after electrical-hydrothermal aging at 80 °C for 24 days (varying electric field intensity).

virgin sample, there was an obvious increase in dielectric constant almost along the entire frequency range for hydrothermal and electrical-hydrothermal aged HTV SR specimen. This might be due to the increase in mobility of the polymer chains by the breakage of bonds caused by applied electric and hydrothermal stress.

As regards the dielectric loss angle tangent, in Fig. 16(b), it presented different and interesting phenomenon. In the middle frequency region (10 Hz to 103 Hz), there was an obvious dielectric loss peak in the HTV SR specimen after electricalhydrothermal aging at 80 °C - 25 kV cm<sup>-1</sup> for 24 days. It might be caused by the orientation of greater dipolar groups. A large amount of broken PDMS molecular chains led to the increase of free radicals in the material and the enhancement of dipole polarization, presenting the apparent loss peak in the dielectric frequency response. However, in the low frequency region, the dielectric loss angle tangent of the electricalhydrothermal aging samples showed different change rules. Because there was another dielectric relaxation process in the dielectric loss curve at low frequency band in addition to the DC conductivity,27 and they worked together in the low frequency region of the dielectric loss curve.

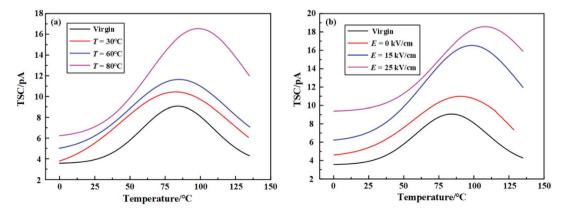
It is commonly acknowledged that the aging performance of the polymer material is related to the accumulation of space charge or the trap characteristics. Fig. 17 shows the TSC curve of unaged, the hydrothermal aged and electrical-hydrothermal aged samples. In order to analyze trap properties, the amount of trap charge can be calculated by eqn (5). Then the amount of trap charge, the peak current and the peak current temperature can be listed in Table 3.

As shown in Fig. 17, it indicated that the TSC curve of all HTV SR samples presented a main current peak. With the increase of the temperature or the electric field strength of electrical-hydrothermal aging, the peak current increased continuously and tended to drift towards the high temperature region. As listed in Table 4, the trap charge of the electrical-hydrothermal aging samples was significantly more than that of the unaged and after hydrothermal aged samples. Similarly, the trap charge also increased with the rising temperature and electric field

Fig. 17 TSC measurement before and after electrical-hydrothermal aging for 24 days: (a)  $E = 15 \text{ kV cm}^{-1}$ , varying temperature; (b)  $T = 80 \, ^{\circ}\text{C}$ , varying electric field intensity.

However, it is almost difficult to obtain the trap density and trap energy level distribution of the HTV SR specimen directly before and after aging from Fig. 17. According to the TSC theory, the TSC caused by the de-trapping process of the captured charges can be expressed as the following function:<sup>28</sup>

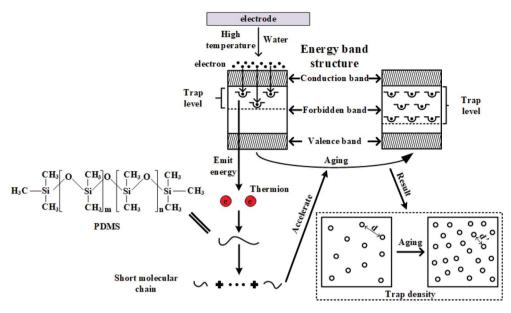
Fig. 19 Electrical-hydrothermal combined aging mechanism.

Combined with the test results above, the mechanism of electrical-hydrothermal aging can be summarized in Fig. 19. First of all, when the HTV SR specimen is subjected to hydrothermal aging effects, the main and side chains scission on PDMS molecular chain occurred, producing free radical and LMW substances. With the aging process going on, more physical and chemical defects are formed in the material. The oxidation decomposition reaction in the aging process promotes the formation of more free molecules and traps, leading to the increase of dielectric constant, loss tangent tan  $\delta$ , trap energy level and trap density.

Then, when the electric field is added, electrons would be injected into the HTV SR from the electrode, and some electrons are trapped by the polymer. The trapped electron becomes the recombination center of the hole, releasing large amounts of energy and transferring it to other electrons to produce thermions. The hydrothermal aging condition provides convenience for electron injection. More thermions will bombard the molecular chain, creating more traps. On the other hand, the dipole polarization loss generates thermal power, which aggravates the deterioration of insulating materials. Therefore, according to the trap properties during the aging process, producing nanocomposites can be an available way. The addition of nanoparticles can reduce the number of traps in the material and enhance breakdown strength. By adjusting the charge transport characteristics, the breakdown probability can be lowered down.
