# Effects of electrical-hydrothermal aging degradation on dielectric and trap properties of high temperature vulcanized silicone rubber materials

In this paper, a new aging platform combined the high voltage electric field and the hydrothermal environment was built. To investigate the aging mechanism, physicochemical, dielectric and trap properties of HTV SR before and after electrical-hydrothermal aging for 24 days were discussed. The results indicated that, compared with hydrothermal aging, more cracks and holes appeared on the surface of HTV SR after electrical-hydrothermal aging, and the content of flame retardant decreased significantly. Due to the main chain and side chain scission of PDMS, lots of low weight molecular (LWM) substances and free radicals were produced. And the tensile strength and elongation at break significantly decreased. Various physical and chemical defects appeared in the HTV SR specimen in the process of electrical-hydrothermal degradation, as a result of which, the dielectric constant significantly increased and the peak trap density increased by about 2.5 times compared to the virgin sample. The increase in trap density in turn accelerated the charge

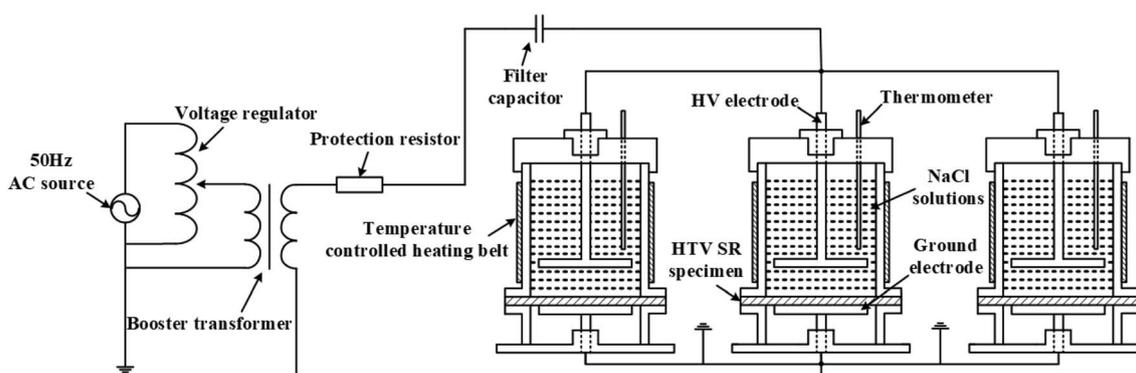
The experimental set up for investigating the electrical-hydrothermal aging effect is shown in Fig. 1. It is composed of AC power box, rod-plate electrode, quartz tube and heating plate. Saline solutions were prepared as the conductive solution and the salt contaminant. The high voltage electrode, when immersed in the saline solutions, will provide a uniform and stable electric field on the HTV SR. To verify the electric field uniformity, the simulation model was established using the COMSOL and the results were shown in Fig. 2. As shown in Fig. 2, the HTV SR specimens were in a uniform electric field. In the electrical-hydrothermal aging test, the temperature of the heating plate was controlled at 30 °C, 60 °C, 80 °C and the electric field intensity was 0 kV cm<sup>-1</sup> (equivalent to hydrothermal aging), 15 kV cm<sup>-1</sup> and 25 kV cm<sup>-1</sup>. For comparison, the temperature of the saline solutions in the hydrothermal aging test was also controlled at 30 °C, 60 °C and 80 °C.

**Fig. 1** The experimental set up for the electrical-hydrothermal aging effect.

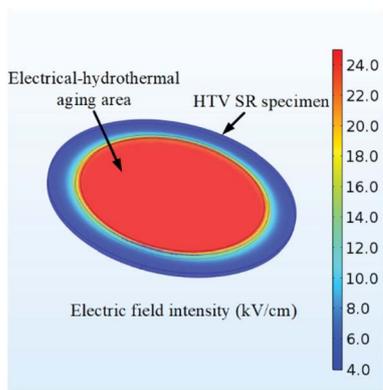
Fig. 2 Characteristics of the surface electric field intensity at  $25 \text{ kV cm}^{-1}$  on the HTV SR specimen.

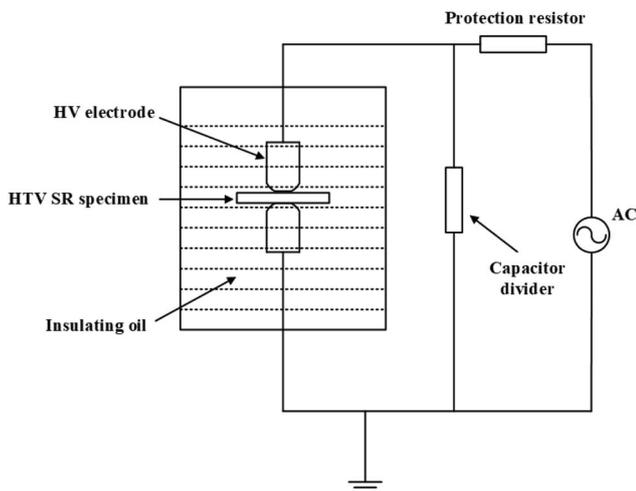
Fig. 3 Experimental setup for the AC breakdown studies.

specimens. In the measurement of AC breakdown voltage, a set of 5 samples with a diameter of 100 mm and a thickness of 2 mm were tested to calculate the breakdown field strength. The experimental setup for the AC breakdown voltage was shown in Fig. 3. The aging specimens are placed in the plate to plate arrangement, and placed into a vessel containing filling with insulation oil to avoid surface discharges. During the test, the voltage is increasing step by step until the breakdown occurs. The voltage was rising at the rate of  $500 \text{ V s}^{-1}$ . When the breakdown occurs, the AC breakdown stress can be calculated according to the equation  $E = V/d$ , where  $V$  is the breakdown voltage and  $d$  is the thickness of the aging specimen in the breakdown point.

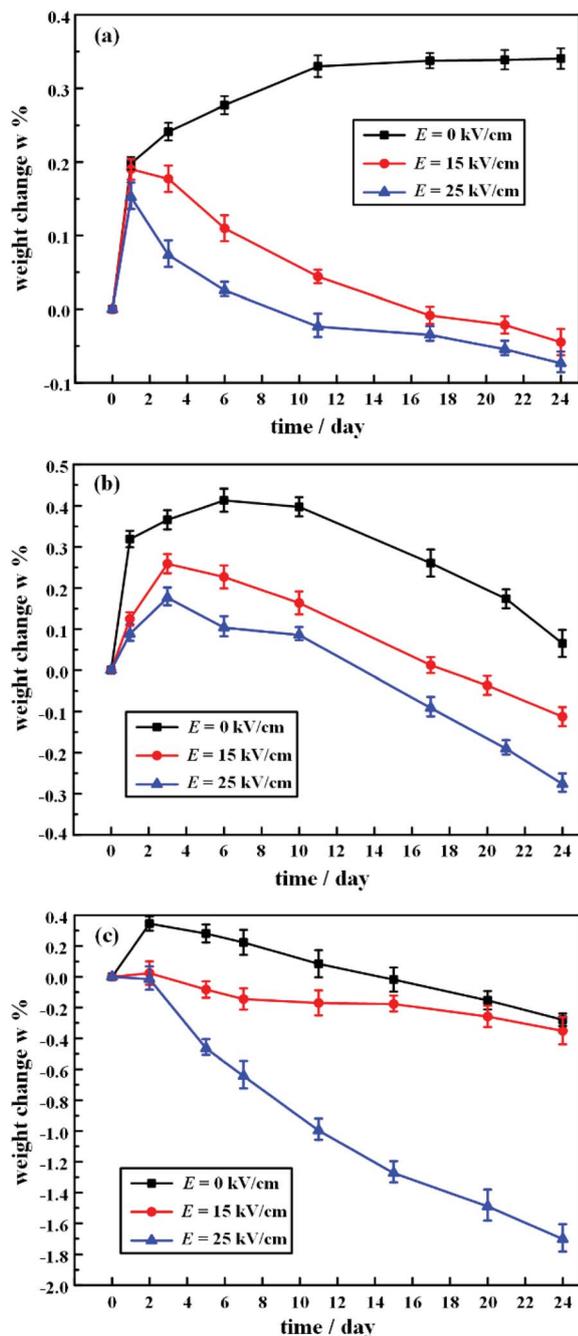
Fig. 4 shows the relative weight change of HTV SR after electrical-hydrothermal aging under different electric field intensity at varying temperatures. As shown in Fig. 4, in the absence of an electric field, the weights of HTV SR specimens immersed in saline solutions at  $30 \text{ }^\circ\text{C}$  increased rapidly at first and then slowly increased within 24 days. However, when immersed in saline solutions at  $60 \text{ }^\circ\text{C}$  and  $80 \text{ }^\circ\text{C}$ , the weight of HTV SR increased rapidly and then decreased. This phenomenon might result from the increase of temperature and the invasion of water accelerating the hydrothermal aging effect of the HTV SR specimen. The relative weight change of HTV SR specimen depended on the competition between the invasion of water and the extraction of the low-molecular-weight (LMW) substances and the filler particles. Both process was influenced by water temperature. During the immersion for 24 days at  $30 \text{ }^\circ\text{C}$ , the weight increased because of the invasion of water over counteracted the weight decrease caused by the extraction of the LMW substances and the filler particles. However, at  $60 \text{ }^\circ\text{C}$  and  $80 \text{ }^\circ\text{C}$ , the weight of HTV SR decreased rapidly because the oxidation decomposition of HTV SR specimen and the extraction of the LMW substances and the filler particles over counteracted the weight increase due to the diffusion of water into HTV SR.

When considering the electric field, the weight of the HTV SR samples was obviously decreased. With the increase of electric field intensity, the final mass loss rate was significantly higher

Fig. 4 Relative weight change of HTV SR after electrical-hydrothermal aging under different electrical field intensity at (a) 30 °C, (b) 60 °C, and (c) 80 °C.

than that of the HTV SR samples without an electric field. The final relative weight change of the hydrothermal aging samples at 80 °C was 0.27%, while the relative weight change rate reached  $-1.71\%$  under the 80 °C and  $25 \text{ kV cm}^{-1}$  electrical-hydrothermal aging condition. Therefore, there was a synergistic effect of mutual enhancement of electrical-hydrothermal aging process, which significantly accelerated the weight reduction of HTV SR specimens. The presence of an electric field accelerated the hydrothermal aging process, which in turn

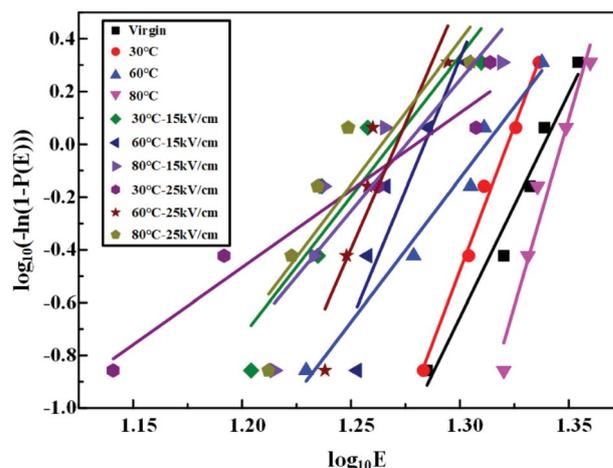
The AC breakdown characteristic of all samples under Weibull distribution is presented in Fig. 5. According to eqn (3), the value of the shape parameter  $\beta$  was calculated and listed in Table 2. Coppard<sup>22</sup> *et al.* believed that the shape parameter  $\beta$  represented the distribution of defects and filling particles. However, as seen in Table 2, the value of  $\beta$  did not show obvious

Fig. 5 Curve of the Weibull statistical distribution of the breakdown field strength of before and after aging samples.

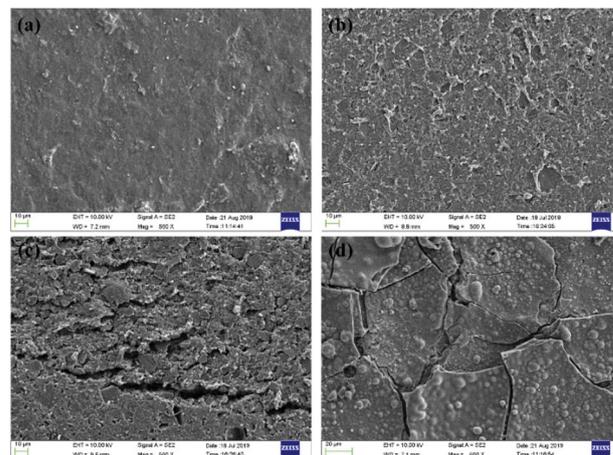
**3.3.1 SEM and EDAX analysis.** Fig. 7 and 8 present the SEM photos of HTV SR specimens before and after electrical-hydrothermal aging at varying electrical field intensity and varying temperatures for 24 days. It showed that the surface of the virgin HTV SR was smooth, on which there were no holes, cracks and obvious particles. Under the hydrothermal aging

Fig. 7 SEM photos of HTV SR specimens before and after electrical-hydrothermal aging in varying electrical field intensity at 80  $^{\circ}\text{C}$  for 24 days: (a) virgin HTV SR, (b) 0  $\text{kV cm}^{-1}$ , (c) 15  $\text{kV cm}^{-1}$ , (d) 25  $\text{kV cm}^{-1}$ .

condition of 80  $^{\circ}\text{C}$ , the surface of HTV SR samples became rough and appeared a few holes. However, cracks appeared on HTV SR with the addition of electric field. When the electric field strength reached 25  $\text{kV cm}^{-1}$ , derived cracks developed on the surface of HTV SR in different orientation. It reflected that water tended to diffuse into the HTV SR at 80  $^{\circ}\text{C}$ , making it easier for electrons to inject into the material and accelerating the chain scission and the degradation process. Due to the irregularity of the self-diffusion of water, cracks appeared and

developed in different directions after electrical-hydrothermal aging. Furthermore, the phenomenon was more obvious with the increase of electric field strength. Similarly, the rise of temperature promoted the growth of cracks and the increase of holes under the condition of electrical-hydrothermal aging at 25 kV cm<sup>-1</sup>. It was due to the synergism of electrical-hydrothermal aging, which accelerated the decomposition of PDMS molecules and the dissolution of fillers, resulting in severe degradation of HTV SR specimen.

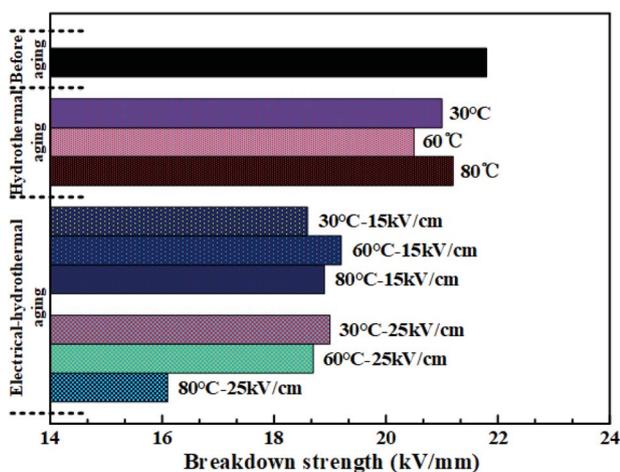
Fig. 6 The breakdown field strength of HTV SR specimens under different aging conditions.

regularity but presented a great fluctuation. It indicated that there were complex reactions in HTV SR after hydrothermal and electrical-hydrothermal aging processes. Due to high temperature and high electric field, severe degradation occurred in HTV SR and various physical and chemical defects were produced. Therefore, the change in the shape parameter  $\beta$  showed large variation in dispersity of electrical weak points in the aging samples. Then the value of breakdown field strength under different aging conditions is shown in Fig. 6. As shown in Fig. 6, compared to the virgin sample and hydrothermal aging sample, the breakdown field strength of the electrical-hydrothermal (80  $^{\circ}\text{C} - 25 \text{ kV cm}^{-1}$ ) sample was significantly decreased from 21.8  $\text{kV mm}^{-1}$  to 16.1  $\text{kV mm}^{-1}$ . It indicated that there was obvious synergistic aging effect of electric, water and temperature. The change of breakdown field strength caused by electrical-hydrothermal aging was much greater than that caused by hydrothermal aging. The combined effect significantly accelerated the decrease of breakdown field strength. To further explore the combined aging effect, the microscopic analysis was studied below.

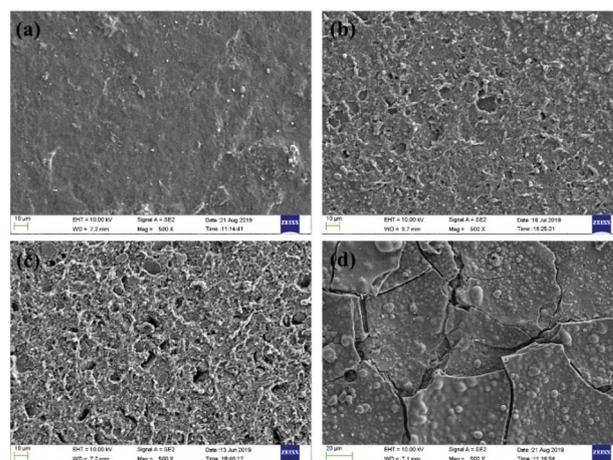
Fig. 8 SEM photos of HTV SR specimens after electrical-hydrothermal aging at varying temperature under 25  $\text{kV cm}^{-1}$  for 24 days: (a) virgin HTV SR, (b) 30  $^{\circ}\text{C}$ , (c) 60  $^{\circ}\text{C}$ , (d) 80  $^{\circ}\text{C}$ .

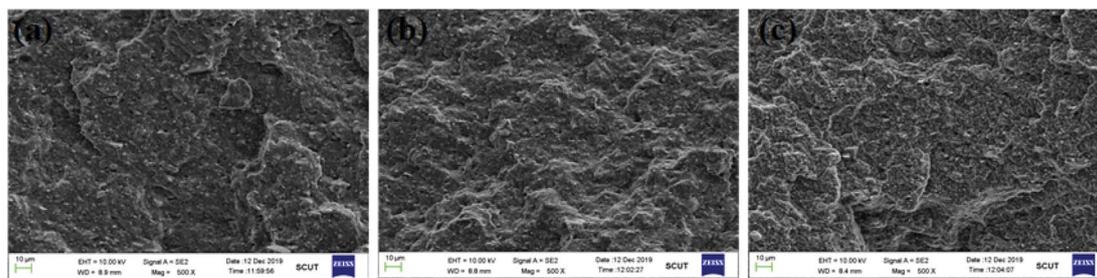
Fig. 9 SEM photos of the cross-sections of HTV SR specimens before and after aging in different conditions for 24 days: (a) virgin HTV SR, (b) hydrothermal aging at 80 °C, (c) electrical-hydrothermal aging at 80 °C – 25 kV cm<sup>-1</sup>.

To examine the cross-sections of the HTV SR, SEM photos of specimens aging in different conditions to verify the depth of the damage was presented in Fig. 9. It indicated that the cross-sections of the virgin HTV SR was relatively smooth and presented little cracks, holes and particles compared to the aging samples. Then the cross-section of the HTV SR specimen became rough after hydrothermal aging. With the addition of electric field, a large number of microscopic cracks and holes appeared in the HTV SR specimen in Fig. 9(c). It can be concluded that the electrical-hydrothermal aging degradation occurred not only on the surface but also in the interior. However, the degradation on the surface showed much more serious than the interior. It indicated that the initial deterioration process began on the surface of the samples.

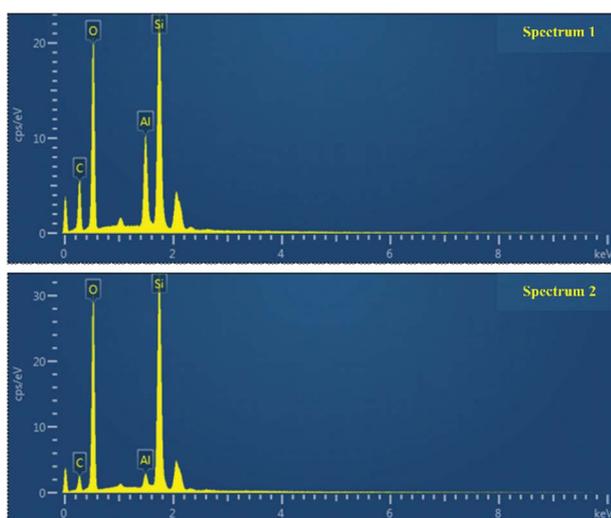
At the same time, EDAX was conducted to recognize the elements present over the HTV SR surface. Fig. 10 presents the EDAX of the virgin HTV SR (spectrum 1) and the electrical-hydrothermal aged (80 °C – 25 kV cm<sup>-1</sup>) HTV SR (spectrum 2). Because the test mainly studied the variation rules of surface elements on HTV SR after electrical-hydrothermal aging, various trace elements in the filler were neglected. As shown in Fig. 10, silicon (Si), carbon (C), oxygen (O) and aluminum (Al) were the main elements on the surface of the HTV SR specimen. After electrical-hydrothermal aging (80 °C – 25 kV cm<sup>-1</sup>) for 24 days, the content of elements C and Al decreased significantly. It represented the side chain scission of PDMS molecules, and the LMW substances would be extracted, resulting in a decline of C content. Moreover, Al content was also significantly reduced due to acidic substances generated by discharge. The generated acidic substances would react with the flame retardant aluminum hydroxide. The analysis could be further proved in the FTIR below.

Fig. 10 EDAX of the virgin HTV SR (spectrum 1) and the electrical-hydrothermal aged (80 °C – 25 kV cm<sup>-1</sup>) HTV SR (spectrum 2).

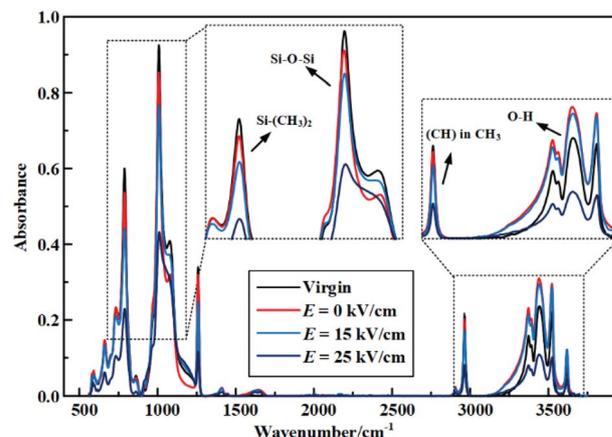
**3.3.2 FTIR analysis.** After hydrothermal aging and electrical-hydrothermal aging for 24 days, the IR absorbance spectra for the fresh and after aged specimens were obtained (Fig. 11 and 12). Table 3 lists the characteristic IR absorption bands in HTV. Fig. 11 shows the FTIR of HTV SR before and after electrical-hydrothermal aging at 80 °C for 24 days. As shown in Fig. 11, with the increase of electric field intensity, the

Fig. 11 FTIR of HTV SR before and after electrical-hydrothermal aging at 80 °C for 24 days (varying electric field intensity).

peak of the main chain Si-O-Si, side chain Si- $\text{CH}_3$  and Si-( $\text{CH}_3$ )<sub>2</sub> of PDMS in HTV SR specimen showed a downward trend. When the electric field intensity reached  $25 \text{ kV cm}^{-1}$ , the absorption peak of the main chain and each side chain showed a remarkable reduction. For the hydroxyl absorption peak in the wavenumber range from  $3200 \text{ cm}^{-1}$  to  $3700 \text{ cm}^{-1}$ , it fluctuated with the increase of field intensity. It was caused by the complex reaction processes such as oxidation,<sup>14</sup> cracking,<sup>23</sup> cross-linking<sup>24,25</sup> and condensation<sup>26</sup> that occurred in the electrical-hydrothermal aging process of HTV SR samples, resulting in the fluctuating tendency of hydroxyl peak. Fig. 12 shows the FTIR of HTV SR before and after electrical-hydrothermal aging at  $25 \text{ kV cm}^{-1}$  for 24 days. Similar to the downward trend in Fig. 11, when the electric field intensity was  $25 \text{ kV cm}^{-1}$ , the peak of each organic group decreased significantly with the increase of the temperature in electrical-hydrothermal aging processes. Therefore, it indicated that the PDMS on the HTV SR surface severely degraded when the electric field intensity or the temperature increased.

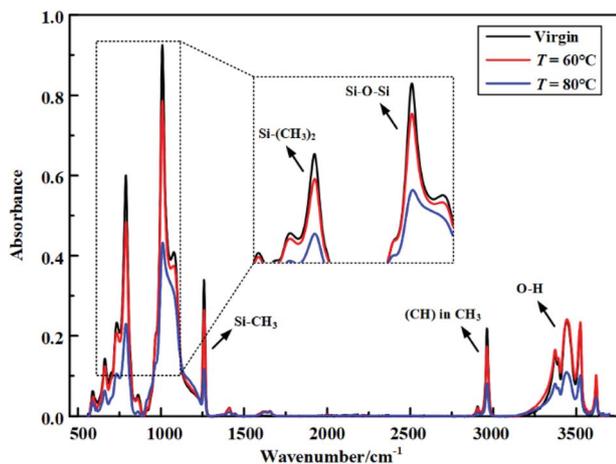
Fig. 12 FTIR of HTV SR before and after electrical-hydrothermal aging at  $25 \text{ kV cm}^{-1}$  for 24 days (varying temperature).

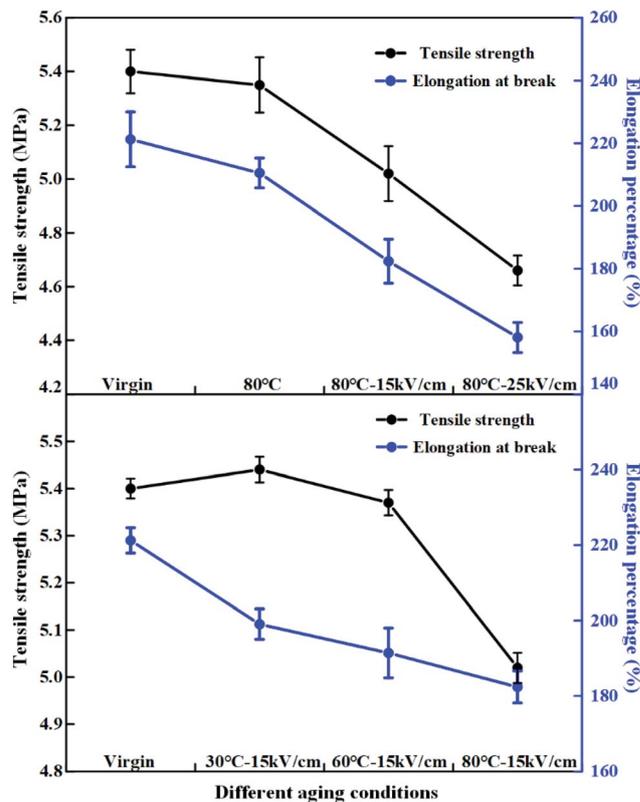
**3.3.3 Tensile properties analysis.** The mechanical property is an important index to evaluate the aging characteristics of insulating materials. Fig. 13 and 14 present the change of the tensile strength, the elongation at break and the Young's modulus in different aging conditions after hydrothermal and electrical-hydrothermal aging. As shown in Fig. 13 and 14, the tensile strength and the elongation at break decreased and the Young's modulus increased with the increase of the electric field strength. In the presence of an electric field, the change of

Fig. 13 Tensile properties of HTV SR before and after aging in different conditions.

the tensile strength, the elongation at break and the Young's modulus of the aging HTV SR specimens were much greater than that of the hydrothermal aging samples. The deterioration in tensile properties after aging is normally related to linkages scission and main chain scission. According to FTIR results, the peak of the main chain Si-O-Si, side chain Si- $\text{CH}_3$  and Si-( $\text{CH}_3$ )<sub>2</sub> of PDMS in HTV SR specimen showed a downward trend. The crosslinking structure was destroyed after electrical-hydrothermal aging. However, the change of tensile strength and Young's modulus at varying temperature presented different trends in electrical-hydrothermal aged specimens. At  $30^\circ\text{C} - 15 \text{ kV cm}^{-1}$  and  $60^\circ\text{C} - 15 \text{ kV cm}^{-1}$ , the tensile strength and the Young's modulus did not show obvious change. When temperature reached  $80^\circ\text{C}$ , the tensile strength significantly decreased and the Young's modulus significantly increased. It revealed that when the temperature did not reach the threshold, the temperature would not promote the electrical aging process.

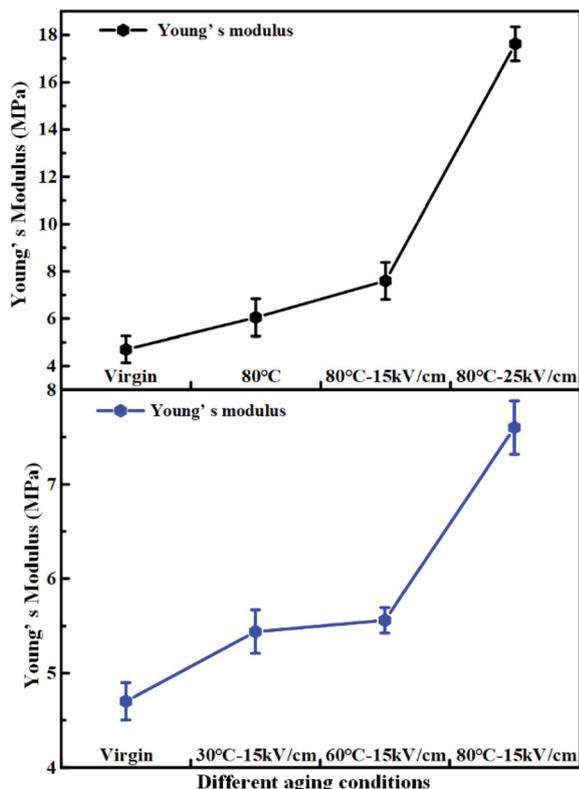
Fig. 14 Young's modulus of HTV SR before and after aging in different conditions.

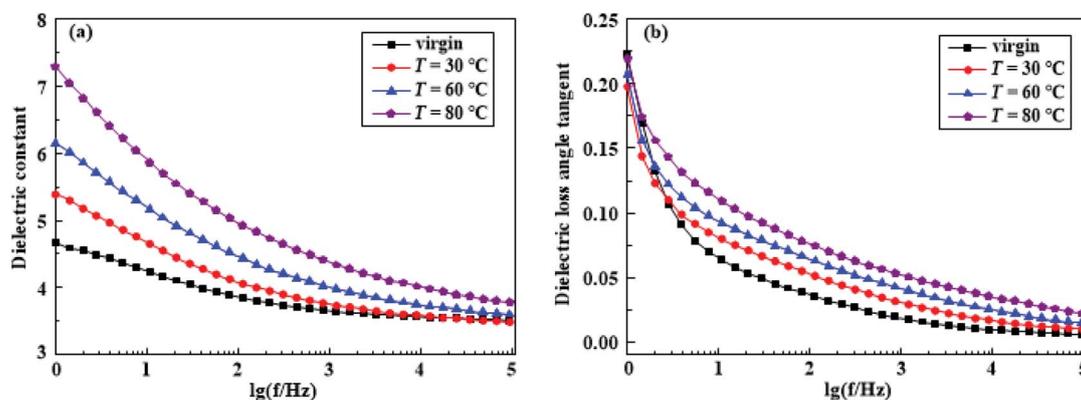
In this section, the data of  $80^\circ\text{C}$  and  $15 \text{ kV cm}^{-1}$  after electrical-hydrothermal aging for 24 days were selected for analysis. Fig. 15(a) and (b) shows the change of dielectric constant and the dielectric loss of HTV SR at varying temperature after electrical-hydrothermal aging at  $15 \text{ kV cm}^{-1}$  for 24 days.

As shown in Fig. 15(a), it indicated that the dielectric constant of the aging samples in the whole frequency range

significantly increased with the rise of temperature, especially at low frequency. However, in the high frequency band ( $10^4$  Hz to  $10^5$  Hz), the curve tended to a constant, which might be caused by electron polarization or molecular chain vibration of HTV SR media under the influence of the electric field. Fig. 15(b) shows that the dielectric loss of HTV SR specimen increased with the rise of temperature in the middle and high frequency band, while in the low frequency band, the dielectric loss of the electrical-hydrothermal aging samples was lower than that of the initial samples.

Fig. 15 The dielectric constant (a) and the dielectric loss angle tangent (b) of HTV SR before and after electrical-hydrothermal aging at  $15 \text{ kV cm}^{-1}$  for 24 days (varying temperature).

This phenomenon can be attributed to the following aspects. First of all, according to Debye relaxation theory, the dielectric loss of HTV SR samples at low frequency band is mainly caused by the DC conductance loss. With the increase of frequency, the polarization loss of different relaxations tends to play an important role and gradually becomes dominant. Secondly, in literature,<sup>27</sup> the dielectric properties of silicone rubber sleeve were measured by the non-contact dielectric spectrum, and the various relaxation processes of silicone rubber were analyzed in detail by using the modified Cole-Cole model. The polarization processes were divided into macroscopic interface polarization, microscopic interface polarization and dipole polarization. Considering that the contact dielectric spectrum was selected in this test, the macroscopic interface polarization process can be neglected. Therefore, the dielectric loss of silicone rubber samples was mainly caused by the microscopic interface polarization and dipole polarization. According to the SEM analysis, the polarization loss at the microscopic interface enlarged with the increase of physical and chemical defects such as holes and cracks on the surface of HTV SR and the loss of packing. Combined with the infrared spectrum characteristics, it can be seen that the rise of temperature aggravated the damage degree of the molecular main chain and decomposed to produce more LMW substances, leading to the increase of dipoles and dipole polarization loss.

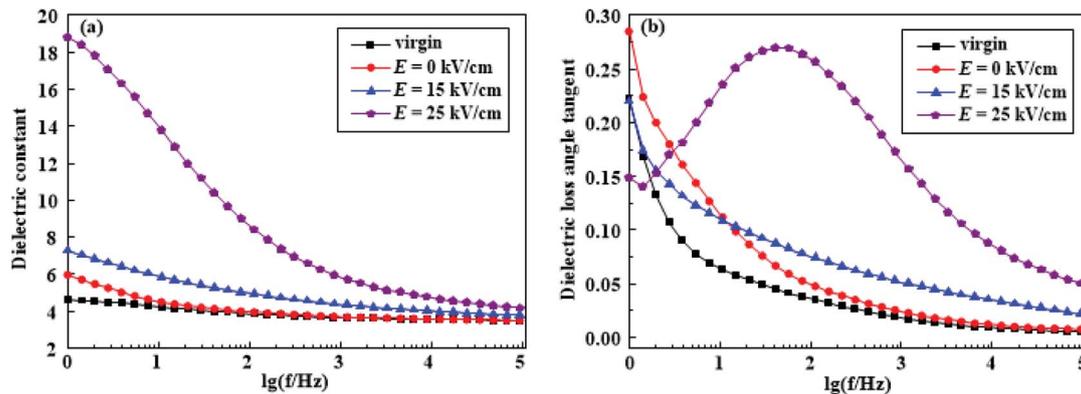
Fig. 16(a) and (b) shows the change of dielectric constant and the dielectric loss of HTV SR under different electric field intensity after electrical-hydrothermal aging at  $80^\circ\text{C}$  for 24 days. As seen in Fig. 16(a), the dielectric constant behave similarly for the HTV SR of the aged and the virgin sample, and increased with decreasing frequency. Especially in the low frequency band, the increase became faster because of the space charge polarization or the effect of interfacial polarization. Due to the appearance of various physical and chemical defects on the surface and inside of HTV SR, as well as the increase of particles shown by SEM results, the interface polarization was significantly enhanced. The highest observed values (dielectric constant) were for the samples after electrical-hydrothermal aging at  $80^\circ\text{C} - 25 \text{ kV cm}^{-1}$ . As compared to the

Fig. 16 The dielectric constant (a) and the dielectric loss angle tangent (b) of HTV SR before and after electrical-hydrothermal aging at 80 °C for 24 days (varying electric field intensity).

virgin sample, there was an obvious increase in dielectric constant almost along the entire frequency range for hydrothermal and electrical-hydrothermal aged HTV SR specimen. This might be due to the increase in mobility of the polymer chains by the breakage of bonds caused by applied electric and hydrothermal stress.

As regards the dielectric loss angle tangent, in Fig. 16(b), it presented different and interesting phenomenon. In the middle frequency region (10 Hz to  $10^3$  Hz), there was an obvious dielectric loss peak in the HTV SR specimen after electrical-hydrothermal aging at 80 °C – 25 kV  $\text{cm}^{-1}$  for 24 days. It might be caused by the orientation of greater dipolar groups. A large amount of broken PDMS molecular chains led to the increase of free radicals in the material and the enhancement of dipole polarization, presenting the apparent loss peak in the dielectric frequency response. However, in the low frequency region, the dielectric loss angle tangent of the electrical-hydrothermal aging samples showed different change rules. Because there was another dielectric relaxation process in the dielectric loss curve at low frequency band in addition to the DC conductivity,<sup>27</sup> and they worked together in the low frequency region of the dielectric loss curve.

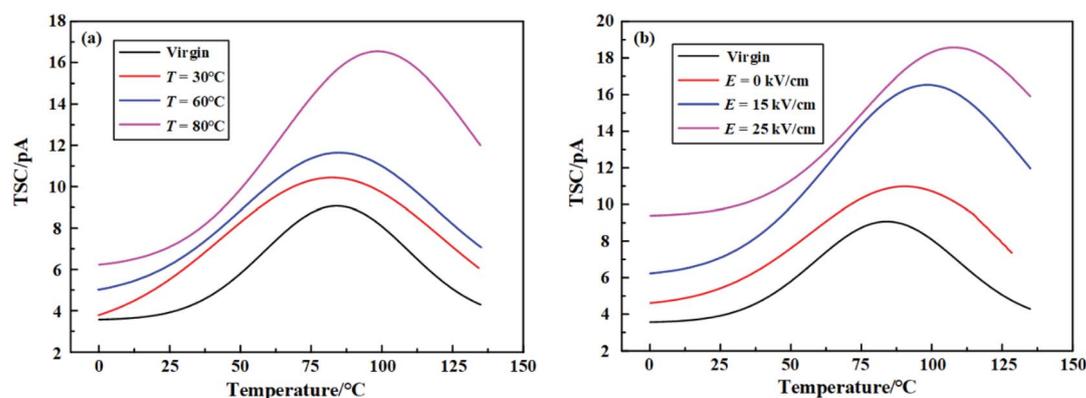
It is commonly acknowledged that the aging performance of the polymer material is related to the accumulation of space charge or the trap characteristics. Fig. 17 shows the TSC curve of unaged, the hydrothermal aged and electrical-hydrothermal aged samples. In order to analyze trap properties, the amount of trap charge can be calculated by eqn (5). Then the amount of trap charge, the peak current and the peak current temperature can be listed in Table 3.

As shown in Fig. 17, it indicated that the TSC curve of all HTV SR samples presented a main current peak. With the increase of the temperature or the electric field strength of electrical-hydrothermal aging, the peak current increased continuously and tended to drift towards the high temperature region. As listed in Table 4, the trap charge of the electrical-hydrothermal aging samples was significantly more than that of the unaged and after hydrothermal aged samples. Similarly, the trap charge also increased with the rising temperature and electric field

Fig. 17 TSC measurement before and after electrical-hydrothermal aging for 24 days: (a)  $E = 15 \text{ kV cm}^{-1}$ , varying temperature; (b)  $T = 80 \text{ °C}$ , varying electric field intensity.

strength. Because there were more physical and chemical defects generated in the HTV SR specimen, and the deterioration degree was deepened, which led to the increase of trap and trap charge.

However, it is almost difficult to obtain the trap density and trap energy level distribution of the HTV SR specimen directly before and after aging from Fig. 17. According to the TSC theory, the TSC caused by the de-trapping process of the captured charges can be expressed as the following function:<sup>28</sup>

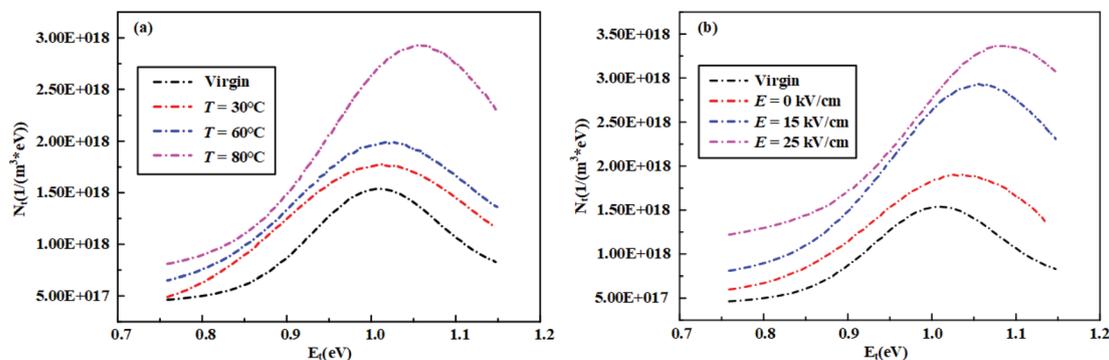
Then, the trap level distribution from TSC measurement can be calculated by eqn (6) based on MATLAB numerical calculation. Fig. 18 shows the trap level distributions of the virgin and aging samples. It shows that the trap density of the virgin was relatively low. With the rise of temperature and electric field intensity, the trap density increased and the trap energy level corresponding to the peak of trap density became deeper. The peak density of traps could reach about 2.5 times larger than that of the virgin sample under the condition of 80 °C – 25

kV cm<sup>-1</sup> electrical-hydrothermal aging. The phenomenon can be explained by the following aspects. Firstly, with the combination of electrical-hydrothermal aging, more defects were produced inside the HTV SR, which enhanced the electron trapping ability and increased the trap density. Secondly, it is well known that traps can be divided into deep traps and shallow traps according to the trap level. The current peak at low temperature is mainly contributed by the charge decapitation in shallow traps, while the current peak at high temperature corresponds to the charge decapitation in deep traps. As shown in Fig. 18, compared to the virgin sample, more deep traps were generated in the process of electrical-hydrothermal aging. Deep traps bound carrier migration, leading to local charge accumulation and rising local electric field strength. When the threshold was exceeded, the polymer breakdown might occur finally.

Fig. 18 Trap level distributions before and after electrical-hydrothermal aging for 24 days: (a)  $E = 15 \text{ kV cm}^{-1}$ , varying temperature; (b)  $T = 80 \text{ °C}$ , varying electric field intensity.

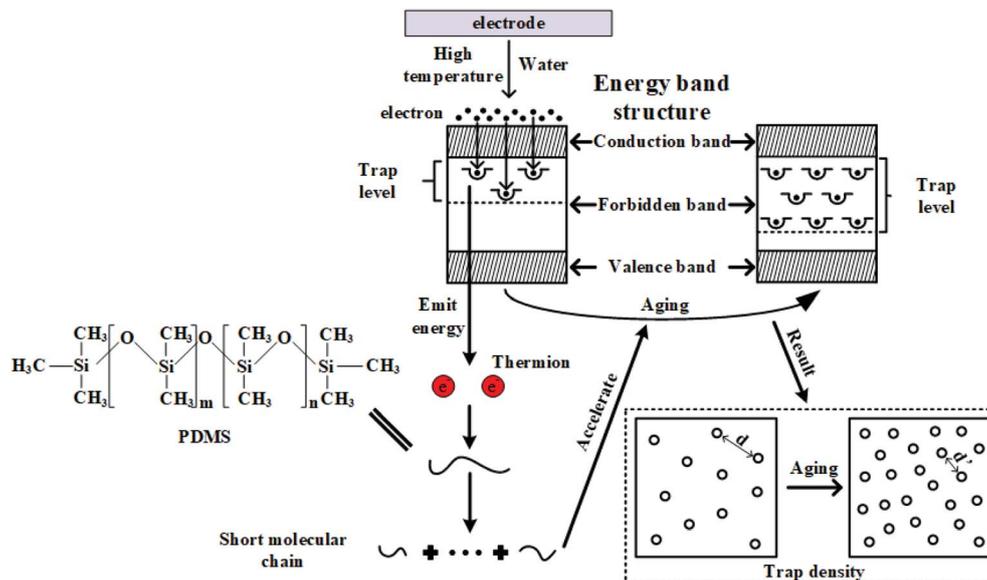
Fig. 19 Electrical-hydrothermal combined aging mechanism.

Combined with the test results above, the mechanism of electrical-hydrothermal aging can be summarized in Fig. 19. First of all, when the HTV SR specimen is subjected to hydrothermal aging effects, the main and side chains scission on PDMS molecular chain occurred, producing free radical and LMW substances. With the aging process going on, more physical and chemical defects are formed in the material. The oxidation decomposition reaction in the aging process promotes the formation of more free molecules and traps, leading to the increase of dielectric constant, loss tangent  $\tan \delta$ , trap energy level and trap density.

Then, when the electric field is added, electrons would be injected into the HTV SR from the electrode, and some electrons are trapped by the polymer. The trapped electron becomes the recombination center of the hole, releasing large amounts of energy and transferring it to other electrons to produce thermions. The hydrothermal aging condition provides convenience for electron injection. More thermions will bombard the molecular chain, creating more traps. On the other hand, the dipole polarization loss generates thermal power, which aggravates the deterioration of insulating materials. Therefore, according to the trap properties during the aging process, producing nanocomposites can be an available way. The addition of nanoparticles can reduce the number of traps in the material and enhance breakdown strength. By adjusting the charge transport characteristics, the breakdown probability can be lowered down.
