# Effects of electrical-hydrothermal aging degradation on dielectric and trap properties of high temperature vulcanized silicone rubber materials

Huasong Xu, Congzhen Xie,\* Rui Wang, Bin Gou, Shoukang Luo and Jiangang Zhou

In this paper, a new aging platform combined the high voltage electric field and the hydrothermal environment was built. To investigate the aging mechanism, physicochemical, dielectric and trap properties of HTV SR before and after electrical-hydrothermal aging for 24 days were discussed. The results indicated that, compared with hydrothermal aging, more cracks and holes appeared on the surface of HTV SR after electrical-hydrothermal aging, and the content of flame retardant decreased significantly. Due to the main chain and side chain scission of PDMS, lots of low weight molecular (LWM) substances and free radicals were produced. And the tensile strength and elongation at break significantly decreased. Various physical and chemical defects appeared in the HTV SR specimen in the process of electrical-hydrothermal degradation, as a result of which, the dielectric constant significantly increased and the peak trap density increased by about 2.5 times compared to

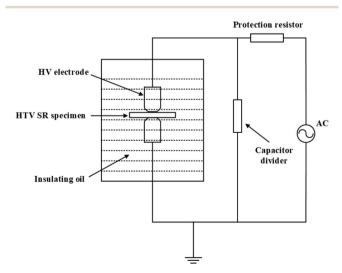
Fig. 3 Experimental setup for the AC breakdown studies.

specimens. In the measurement of AC breakdown voltage, a set of 5 samples with a diameter of 100 mm and a thickness of 2 mm were tested to calculate the breakdown field strength. The experimental setup for the AC breakdown voltage was shown in Fig. 3. The aging specimens are placed in the plate to plate arrangement, and placed into a vessel containing filling with insulation oil to avoid surface discharges. During the test, the voltage is increasing step by step until the breakdown occurs. The voltage was rising at the rate of 500 V s<sup>-1</sup>. When the breakdown occurs, the AC breakdown stress can be calculated according to the equation E = V/d, where V is the breakdown voltage and d is the thickness of the aging specimen in the breakdown point.

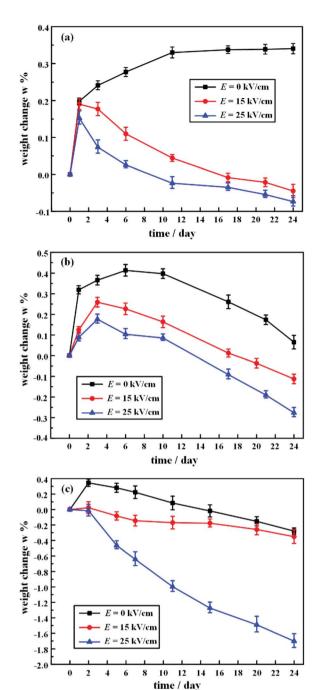
Fig. 4 Relative weight change of HTV SR after electrical-hydrothermal aging under different electrical field intensity at (a) 30  $^{\circ}$ C, (b) 60  $^{\circ}$ C, and (c) 80  $^{\circ}$ C.

Fig. 4 shows the relative weight change of HTV SR after electrical-hydrothermal aging under different electric field intensity at varying temperatures. As shown in Fig. 4, in the absence of an electric field, the weights of HTV SR specimens immersed in saline solutions at 30 °C increased rapidly at first and then slowly increased within 24 days. However, when immersed in saline solutions at 60 °C and 80 °C, the weight of HTV SR increased rapidly and then decreased. This phenomenon might result from the increase of temperature and the invasion of water accelerating the hydrothermal aging effect of the HTV SR specimen. The relative weight change of HTV SR specimen depended on the competition between the invasion of water and the extraction of the low-molecular-weight (LMW) substances and the filler particles. Both process was influenced by water temperature. During the immersion for 24 days at 30 °C, the weight increased because of the invasion of water over counteracted the weight decrease caused by the extraction of the LMW substances and the filler particles. However, at 60 °C and 80 °C, the weight of HTV SR decreased rapidly because the oxidation decomposition of HTV SR specimen and the extraction of the LMW substances and the filler particles over counteracted the weight increase due to the diffusion of water into HTV SR.

When considering the electric field, the weight of the HTV SR samples was obviously decreased. With the increase of electric field intensity, the final mass loss rate was significantly higher

than that of the HTV SR samples without an electric field. The final relative weight change of the hydrothermal aging samples at 80 °C was 0.27%, while the relative weight change rate reached -1.71% under the 80 °C and 25 kV cm<sup>-1</sup> electrical-hydrothermal aging condition. Therefore, there was a synergistic effect of mutual enhancement of electrical-hydrothermal aging process, which significantly accelerated the weight reduction of HTV SR specimens. The presence of an electric field accelerated the hydrothermal aging process, which in turn

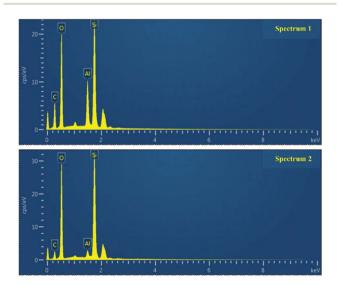
Fig. 10 EDAX of the virgin HTV SR (spectrum 1) and the electrical-hydrothermal aged (80  $^{\circ}\text{C}$  – 25 kV cm $^{-1}$ ) HTV SR (spectrum 2).

At the same time, EDAX was conducted to recognize the elements present over the HTV SR surface. Fig. 10 presents the EDAX of the virgin HTV SR (spectrum 1) and the electricalhydrothermal aged (80 °C - 25 kV cm<sup>-1</sup>) HTV SR (spectrum 2). Because the test mainly studied the variation rules of surface elements on HTV SR after electrical-hydrothermal aging, various trace elements in the filler were neglected. As shown in Fig. 10, silicon (Si), carbon (C), oxygen (O) and aluminum (Al) were the main elements on the surface of the HTV SR specimen. After electrical-hydrothermal aging (80 °C - 25 kV cm<sup>-1</sup>) for 24 days, the content of elements C and Al decreased significantly. It represented the side chain scission of PDMS molecules, and the LMW substances would be extracted, resulting in a decline of C content. Moreover, Al content was also significantly reduced due to acidic substances generated by discharge. The generated acidic substances would react with the flame retardant aluminum hydroxide. The analysis could be further proved in the FTIR below.

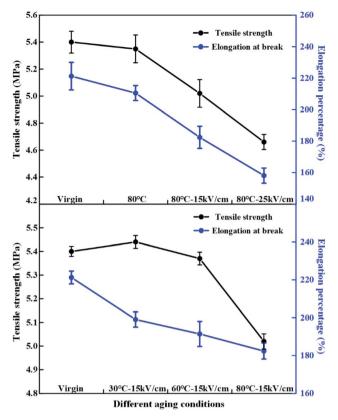
Fig. 13 Tensile properties of HTV SR before and after aging in different conditions.

3.3.3 Tensile properties analysis. The mechanical property is an important index to evaluate the aging characteristics of insulating materials. Fig. 13 and 14 present the change of the tensile strength, the elongation at break and the Young's modulus in different aging conditions after hydrothermal and electrical-hydrothermal aging. As shown in Fig. 13 and 14, the tensile strength and the elongation at break decreased and the Young's modulus increased with the increase of the electric field strength. In the presence of an electric field, the change of

the tensile strength, the elongation at break and the Young's modulus of the aging HTV SR specimens were much greater than that of the hydrothermal aging samples. The deterioration in tensile properties after aging is normally related to linkages scission and main chain scission. According to FTIR results, the peak of the main chain Si-O-Si, side chain Si-CH<sub>3</sub> and Si-(CH<sub>3</sub>)<sub>2</sub> of PDMS in HTV SR specimen showed a downward trend. The crosslinking structure was destroyed after electrical-hydrothermal aging. However, the change of tensile strength and Young's modulus at varying temperature presented different trends in electrical-hydrothermal aged specimens. At  $30 \,^{\circ}\text{C} - 15 \,\text{kV} \,\text{cm}^{-1}$  and  $60 \,^{\circ}\text{C} - 15 \,\text{kV} \,\text{cm}^{-1}$ , the tensile strength and the Young's modulus did not show obvious change. When temperature reached 80 °C, the tensile strength significantly decreased and the Young's modulus significantly increased. It revealed that when the temperature did not reach the threshold, the temperature would not promote the electrical aging process.

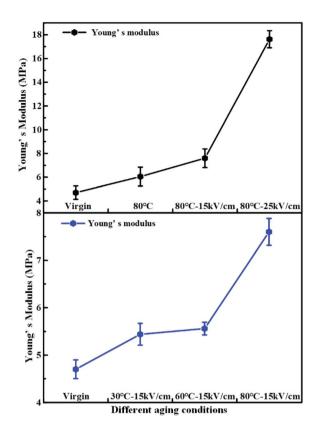
Fig. 14 Young's modulus of HTV SR before and after aging in different conditions.

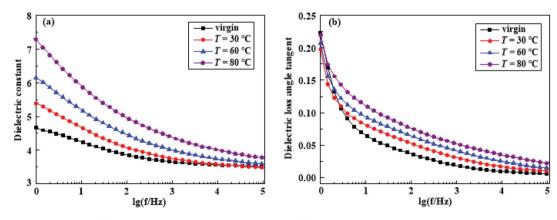
Fig. 15 The dielectric constant (a) and the dielectric loss angle tangent (b) of HTV SR before and after electrical-hydrothermal aging at 15 kV cm<sup>-1</sup> for 24 days (varying temperature).

In this section, the data of 80  $^{\circ}$ C and 15 kV cm<sup>-1</sup> after electrical-hydrothermal aging for 24 days were selected for analysis. Fig. 15(a) and (b) shows the change of dielectric constant and the dielectric loss of HTV SR at varying temperature after electrical-hydrothermal aging at 15 kV cm<sup>-1</sup> for 24 days.

As shown in Fig. 15(a), it indicated that the dielectric constant of the aging samples in the whole frequency range

significantly increased with the rise of temperature, especially at low frequency. However, in the high frequency band ( $10^4$  Hz to  $10^5$  Hz), the curve tended to a constant, which might be caused by electron polarization or molecular chain vibration of HTV SR media under the influence of the electric field. Fig. 15(b) shows that the dielectric loss of HTV SR specimen increased with the rise of temperature in the middle and high frequency band, while in the low frequency band, the dielectric loss of the electrical-hydrothermal aging samples was lower than that of the initial samples.

This phenomenon can be attributed to the following aspects. First of all, according to Debye relaxation theory, the dielectric loss of HTV SR samples at low frequency band is mainly caused by the DC conductance loss. With the increase of frequency, the polarization loss of different relaxations tends to play an important role and gradually becomes dominant. Secondly, in literature,27 the dielectric properties of silicone rubber sleeve were measured by the non-contact dielectric spectrum, and the various relaxation processes of silicone rubber were analyzed in detail by using the modified Cole-Cole model. The polarization processes were divided into macroscopic interface polarization, microscopic interface polarization and dipole polarization. Considering that the contact dielectric spectrum was selected in this test, the macroscopic interface polarization process can be neglected. Therefore, the dielectric loss of silicone rubber samples was mainly caused by the microscopic interface polarization and dipole polarization. According to the SEM analysis, the polarization loss at the microscopic interface enlarged with the increase of physical and chemical defects such as holes and cracks on the surface of HTV SR and the loss of packing. Combined with the infrared spectrum characteristics, it can be seen that the rise of temperature aggravated the damage degree of the molecular main chain and decomposed to produce more LMW substances, leading to the increase of dipoles and dipole polarization loss.

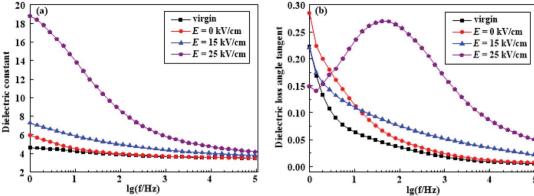
Fig. 16 The dielectric constant (a) and the dielectric loss angle tangent (b) of HTV SR before and after electrical-hydrothermal aging at 80 °C for 24 days (varying electric field intensity).

Fig. 16(a) and (b) shows the change of dielectric constant and the dielectric loss of HTV SR under different electric field intensity after electrical-hydrothermal aging at 80 °C for 24 days. As seen in Fig. 16(a), the dielectric constant behave similarly for the HTV SR of the aged and the virgin sample, and increased with decreasing frequency. Especially in the low frequency band, the increase became faster because of the space charge polarization or the effect of interfacial polarization. Due to the appearance of various physical and chemical defects on the surface and inside of HTV SR, as well as the increase of particles shown by SEM results, the interface polarization was significantly enhanced. The highest observed values (dielectric constant) were for the samples after electrical-hydrothermal aging at 80 °C – 25 kV cm<sup>-1</sup>. As compared to the

virgin sample, there was an obvious increase in dielectric constant almost along the entire frequency range for hydrothermal and electrical-hydrothermal aged HTV SR specimen. This might be due to the increase in mobility of the polymer chains by the breakage of bonds caused by applied electric and hydrothermal stress.

As regards the dielectric loss angle tangent, in Fig. 16(b), it presented different and interesting phenomenon. In the middle frequency region (10 Hz to 103 Hz), there was an obvious dielectric loss peak in the HTV SR specimen after electricalhydrothermal aging at 80 °C - 25 kV cm<sup>-1</sup> for 24 days. It might be caused by the orientation of greater dipolar groups. A large amount of broken PDMS molecular chains led to the increase of free radicals in the material and the enhancement of dipole polarization, presenting the apparent loss peak in the dielectric frequency response. However, in the low frequency region, the dielectric loss angle tangent of the electricalhydrothermal aging samples showed different change rules. Because there was another dielectric relaxation process in the dielectric loss curve at low frequency band in addition to the DC conductivity,27 and they worked together in the low frequency region of the dielectric loss curve.

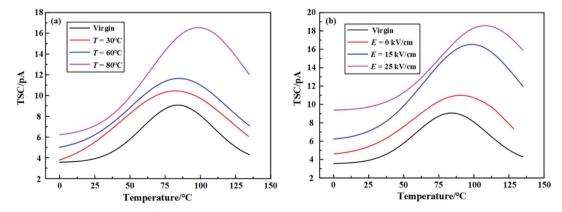
Fig. 17 TSC measurement before and after electrical-hydrothermal aging for 24 days: (a)  $E = 15 \text{ kV cm}^{-1}$ , varying temperature; (b)  $T = 80 \, ^{\circ}\text{C}$ , varying electric field intensity.

It is commonly acknowledged that the aging performance of the polymer material is related to the accumulation of space charge or the trap characteristics. Fig. 17 shows the TSC curve of unaged, the hydrothermal aged and electrical-hydrothermal aged samples. In order to analyze trap properties, the amount of trap charge can be calculated by eqn (5). Then the amount of trap charge, the peak current and the peak current temperature can be listed in Table 3.

As shown in Fig. 17, it indicated that the TSC curve of all HTV SR samples presented a main current peak. With the increase of the temperature or the electric field strength of electrical-hydrothermal aging, the peak current increased continuously and tended to drift towards the high temperature region. As listed in Table 4, the trap charge of the electrical-hydrothermal aging samples was significantly more than that of the unaged and after hydrothermal aged samples. Similarly, the trap charge also increased with the rising temperature and electric field

However, it is almost difficult to obtain the trap density and trap energy level distribution of the HTV SR specimen directly before and after aging from Fig. 17. According to the TSC theory, the TSC caused by the de-trapping process of the captured charges can be expressed as the following function:<sup>28</sup>

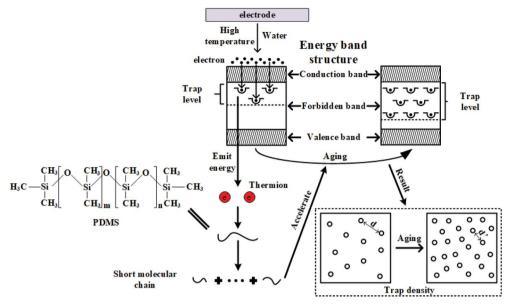
Fig. 19 Electrical-hydrothermal combined aging mechanism.

Combined with the test results above, the mechanism of electrical-hydrothermal aging can be summarized in Fig. 19. First of all, when the HTV SR specimen is subjected to hydrothermal aging effects, the main and side chains scission on PDMS molecular chain occurred, producing free radical and LMW substances. With the aging process going on, more physical and chemical defects are formed in the material. The oxidation decomposition reaction in the aging process promotes the formation of more free molecules and traps, leading to the increase of dielectric constant, loss tangent tan  $\delta$ , trap energy level and trap density.

Then, when the electric field is added, electrons would be injected into the HTV SR from the electrode, and some electrons are trapped by the polymer. The trapped electron becomes the recombination center of the hole, releasing large amounts of energy and transferring it to other electrons to produce thermions. The hydrothermal aging condition provides convenience for electron injection. More thermions will bombard the molecular chain, creating more traps. On the other hand, the dipole polarization loss generates thermal power, which aggravates the deterioration of insulating materials. Therefore, according to the trap properties during the aging process, producing nanocomposites can be an available way. The addition of nanoparticles can reduce the number of traps in the material and enhance breakdown strength. By adjusting the charge transport characteristics, the breakdown probability can be lowered down.
