# Novel micron-thick brick cladding of polyfluorosilicone acrylates, a case study of conservation of historic brick wall in Hongcun village†

A micron-thick (3–5  $\mu\text{m}$ ) and transparent cladding technique based on the environment friendly dimethyl carbonate solution of newly developed polyfluorosilicone acrylates was successfully applied to restore the surface of brick walls of a historic house which has been severely eroded by damp and mildew for more than 300 years in Hongcun village, one of the World Heritage sites in China. The restoration followed the rule of repairing old as old before. The cladding made from the copolymerized polyfluorosilicone acrylate resin, which mainly contained the chain fragments of dodecafluoroheptyl methacrylate and 3-(trimethoxysilyl) propyl methacrylate, permeated through the surface of old brick with an average depth of 14.5 mm in this case study, and provided an ultrathin and efficient covering of the microstructure of the shallow surface layer of old bricks and resulted excellent water-proof, moisture-proof, mildew-proof and long-lasting weather resistance effects. The water contact angle of the treated surface of the old bricks reached

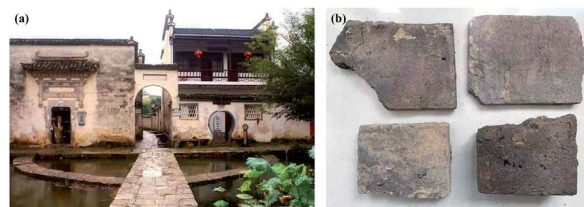
Fig. 1 (a) Hongcun village of Anhui province; (b) the brick samples were from a historic house in Hongcun village, Anhui province, there was no difference between the four bricks, the water content of four bricks was 13 wt%.
