Cite this: *RSC Adv.*, 2021, 11, 28271

Surface alloying of FeCoCrNiMn particles on Inconel-718 using plasma-transferred arc technique: microstructure and wear characteristics

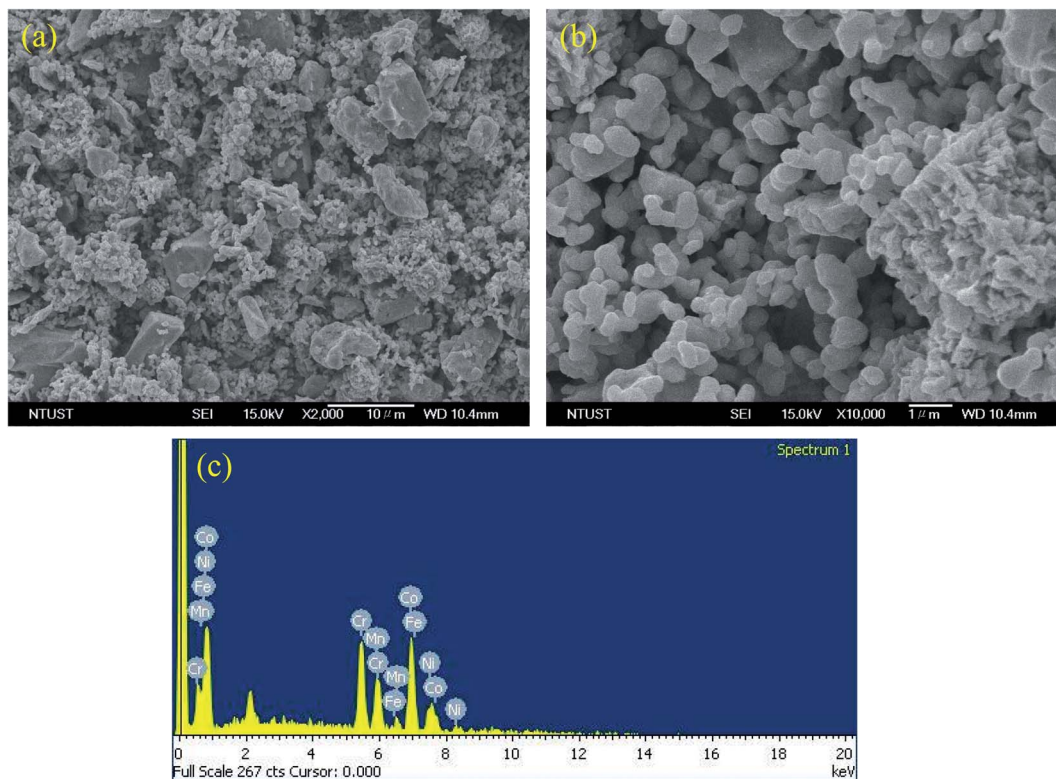
Fig. 1 (a) FESEM picture of mechanically ball-milled powder, (b) magnified view of (a), and their corresponding elemental analysis graph (c).

after 12 h is shown in Fig. 1. It mixes the different particle size powders through the mechanical alloying process. Each particle underwent multiple plastic deformations during the ball-milling process. The microstructure and morphology of the alloy particles were mixed thoroughly due to the leading role of friction and shear deformation. The results of the processing alloy powder in this ball mill process were reducing the particle size, as well as the blending of particles into new phases. Repeated processes, such as welding, fracturing and rewelding of powder particles, were involved during this blending process. Changes of the kinetic energy of the milling powder were induced by the total amount of energy transferred to the alloy powder particles from balls during the milling process.

variation in the particles size due to variation in the hardness of the particles. The hardness of the Cr and Co elements were higher than that of the other alloying elements. The dispersal of Cr and Co powders did not exhibit any improvement with the increase of the milling time to 12 h because it was difficult to crush this element in these powders. Furthermore, we were unable to make them small due to their high hardness, causing heterogenization. As a result, the uneven distribution of the particles appeared in the FESEM image of the ball-milled powder (Fig. 1).

The EDS analysis shows that the ball-milled powders contain all essential chemical elements, such as Fe, Co, Cr, Ni and Mn. The cross-section of the PTA-alloyed region is shown in Fig. 5. Fig. 5(a) was taken by using an optical micrograph, whereas Fig. 5(b and c) were taken by using field emission-scanning electron microscopy. The cross-section of the PTA-treated sample contained the PTA-alloyed region, interface region and substrate region. The thickness of the alloyed region was measured along the line perpendicular to the direction of the movement of the PTA torch. The measured thickness of the alloyed region was 200 μm , which is clearly visible in Fig. 5(a). Fig. 5(b) shows the interface region of the PTA-alloyed region and substrate region. This interface region contained both alloying elements and substrate material. Based on the EDS analysis, the dark gray color areas in Fig. 5(b) were rich in Co

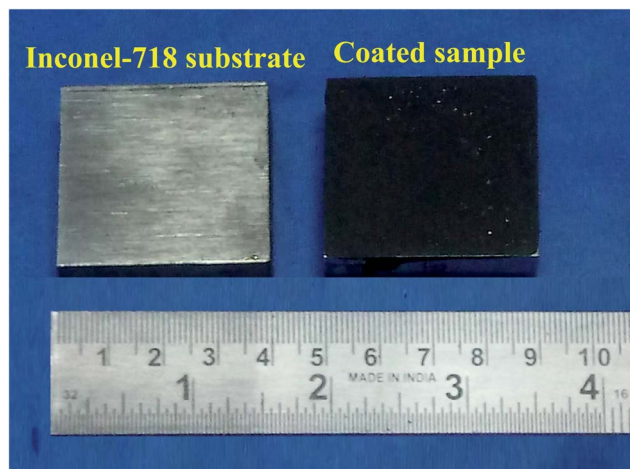
Fig. 2 Macropicture of Inconel-718 substrate and coated samples.

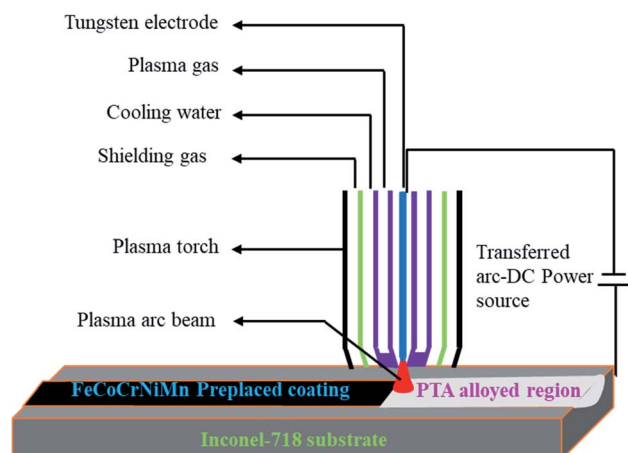
Fig. 3 Schematic representation of PTA alloying process.

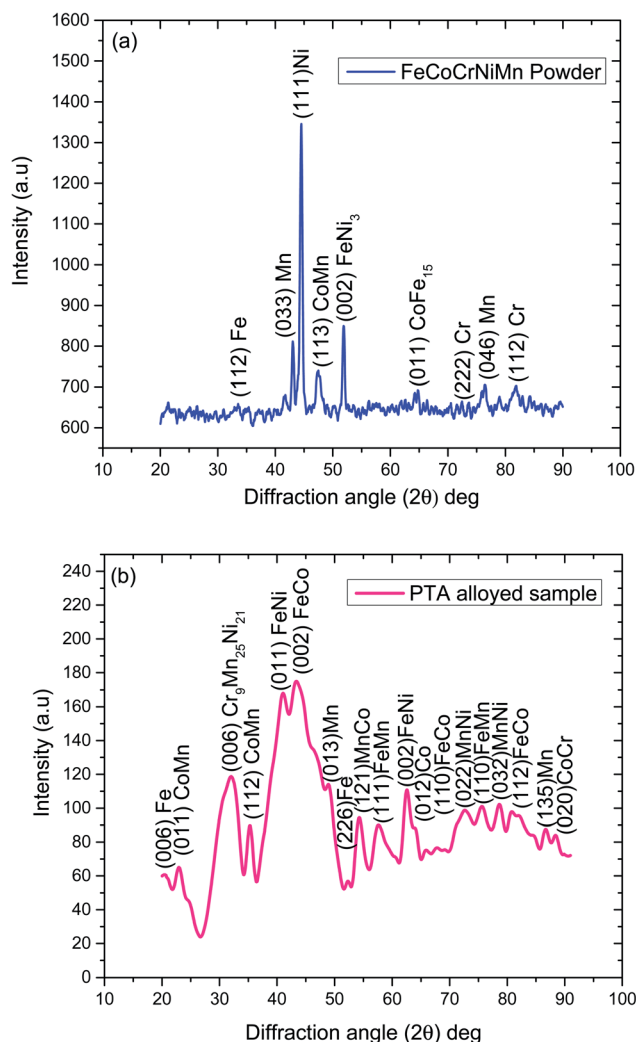
Fig. 4 XRD analysis of: (a) FeCoCrNiMn powder, (b) PTA alloyed sample.

XRD analysis was performed on the ball-milled FeCoCrNiMn particles, and their corresponding peak locations were studied. The ball-milled powders induced frictional collision between the elements in the alloy system. This frictional collision resulted in the formation of some secondary phase particles. Notably, a few broadened peaks were observed at about $2\theta = 40^\circ$ to 55° . Moreover, it confirmed the presence of all alloying elements in the ball-milled powder. Some compound phases, such as CoMn, FeNi₃ and CoFe₁₅, were also traced in this XRD analysis. Fig. 4(a) shows the XRD spectrum of the powder materials.

Fig. 4(b) shows the XRD analysis of the PTA alloyed surface. During the PTA alloying process, the preplaced FeCoCrNiMn coating and the top surface of the Inconel-718 substrate were molten simultaneously. The molten pool of the preplaced coating, along with the dilution of top surface of the Inconel-718 substrate, was formed rapidly. The alloying elements Fe, Co, Cr, Ni and Mn in the preplaced coating were very rapidly dissolved in the molten pool. The molten pool that contained the alloyed elements were solidified after the forward movement of the plasma arc. The XRD pattern revealed that the FeCoCrNiMn-alloyed PTA region contained different phases, such as FCC, BCC and intermetallic.¹⁹ Most of the alloying elements were formed in the compound phase, which shows that the high specific energy density of the plasma transferred arc results in sufficient dissolution of alloying elements in the Inconel-718 substrate. It was found that the alloyed region included CoMn, CoCr, Cr₉Mn₂₅Ni₂₁, FeNi, MnNi, FeCo, FeMn and MnCo. Miller indices of (*h*,*k*,*l*) values were identified by X'Pert high score software. In the BCC phase, the reflection is allowed only when *h* + *k* + *l* is an even value.²⁰ In the FCC phase, reflection is allowed only when *h*, *k* and *l* are all odd or all even (unmixed). Based on these rules, (011) CoMn, (110) FeCo, (011) FeNi, (013) Mn, (112) CoMn, (121) MnCo, (110) FeMn, (112) FeCo, and FeCo were identified as the BCC phase. (111) FeMn and (135) Mn were identified as the FCC phase. (006) Fe, (022) MnNi,

(006) Cr₉Mn₂₅Ni₂₁, (002) FeCo, (226) Fe, (002) FeNi, and (020) CoCr all obey both the rules. Hence, these phases are concluded as either BCC or FCC phases. (032) MnNi, (135) Mn and (012) Co are the phases that do not obey any of the above rules. Consequently, these phases are concluded as intermetallic phases.

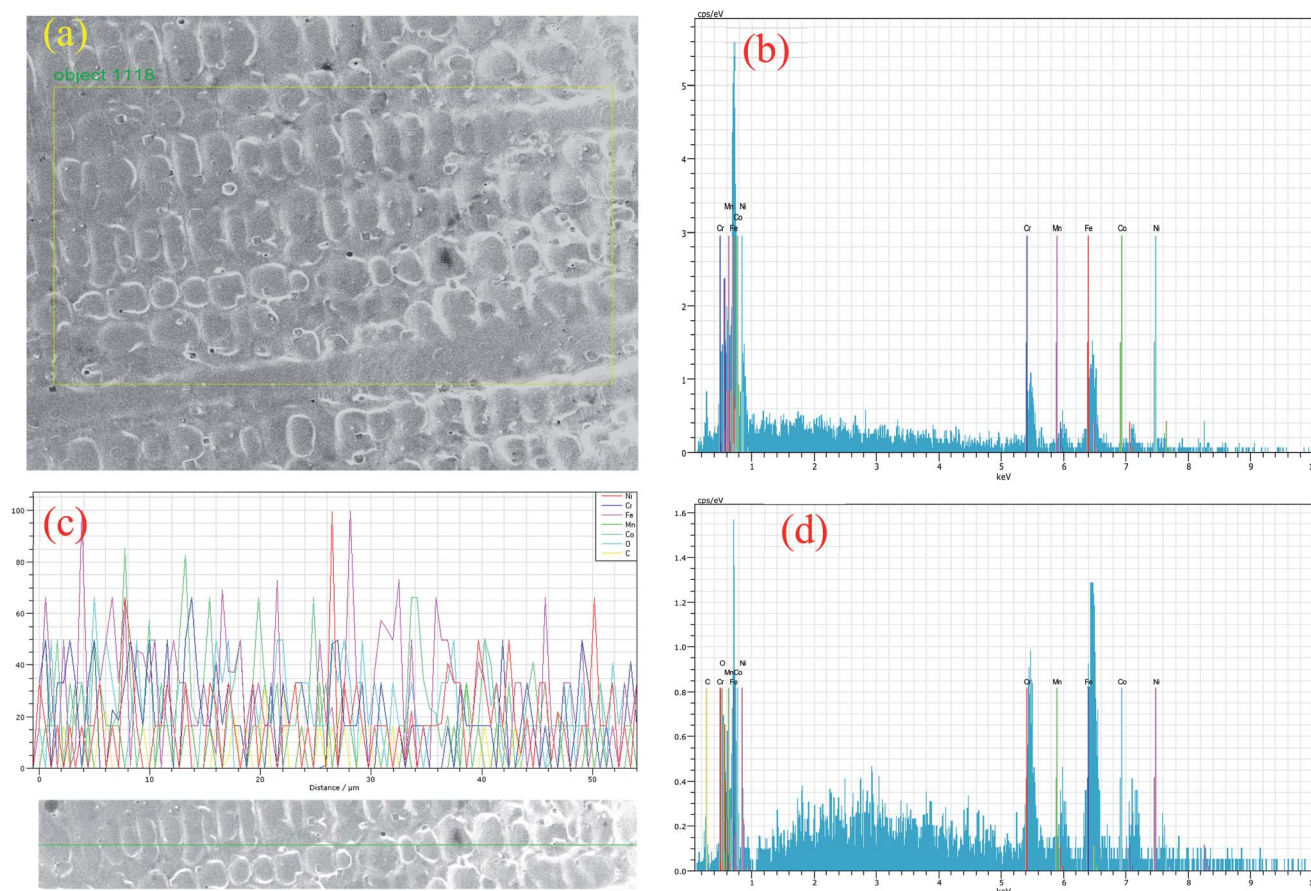
Fig. 6 (a) FESEM images of PTA alloyed region, corresponding EDS graph at: (b) area analysis, (c) line analysis and (d) point analysis.

Fig. 6(a–d) shows the EDS analysis of the PTA-alloyed region. The obtained EDS analysis indicates the presence of all alloying elements after the PTA process [Fig. 6(b)]. Table 3 lists the presence of elements obtained in the PTA-alloyed region. The elements Fe, Cr and Ni are observed as major elements with atomic wt% of 32.48, 25.59 and 16.48, respectively. The remaining positions are occupied by Mn and Co. Therefore, it is confirmed that the Fe element constitutes the matrix material for this PTA-alloyed system. The EDS analysis has proved that the diffusion of the elements of the substrate has never occurred in the central zone of the surface-alloyed region. The heat input by PTA has been majorly utilized for the melting of the alloying elements, and very meagerly utilized to melt the substrate for bonding. Therefore, the diffusion of the elements of the substrate was restricted. Fig. 6 (c and d) shows the EDS result of the interface region and substrate. This line and point scan indicate that the diffusion of major alloying elements, like Ni, Cr, Co, Fe and Mn, has occurred on either side; especially, diffusion mainly occurred on the substrate side. The EDS analysis clearly indicates that the surface treatment completely protects the Inconel-718 substrate, and no trace of the substrate chemical elements is found in the treated layer.

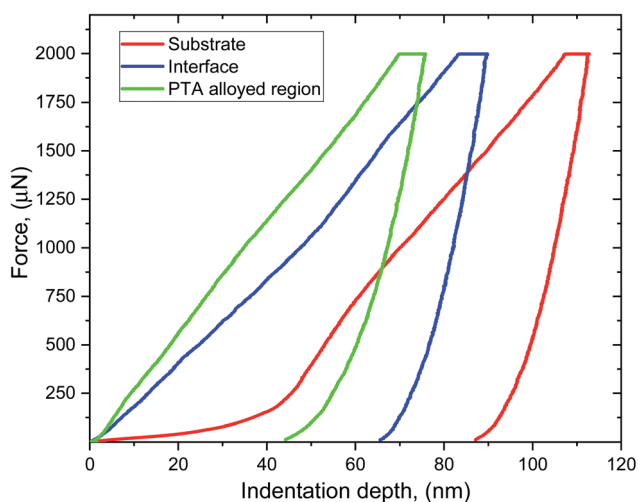
Fig. 7 Nanohardness profile of PTA alloyed, interface, substrate region.

Hardness is one of the important properties of the material performance, as it is closely associated with the wear resistance of the specimen. Fig. 7 shows the nanohardness profile of the substrate, interface and PTA-alloyed surface. The nanohardness of the substrate, interface and PTA-alloyed layer were 2.921 GPa,

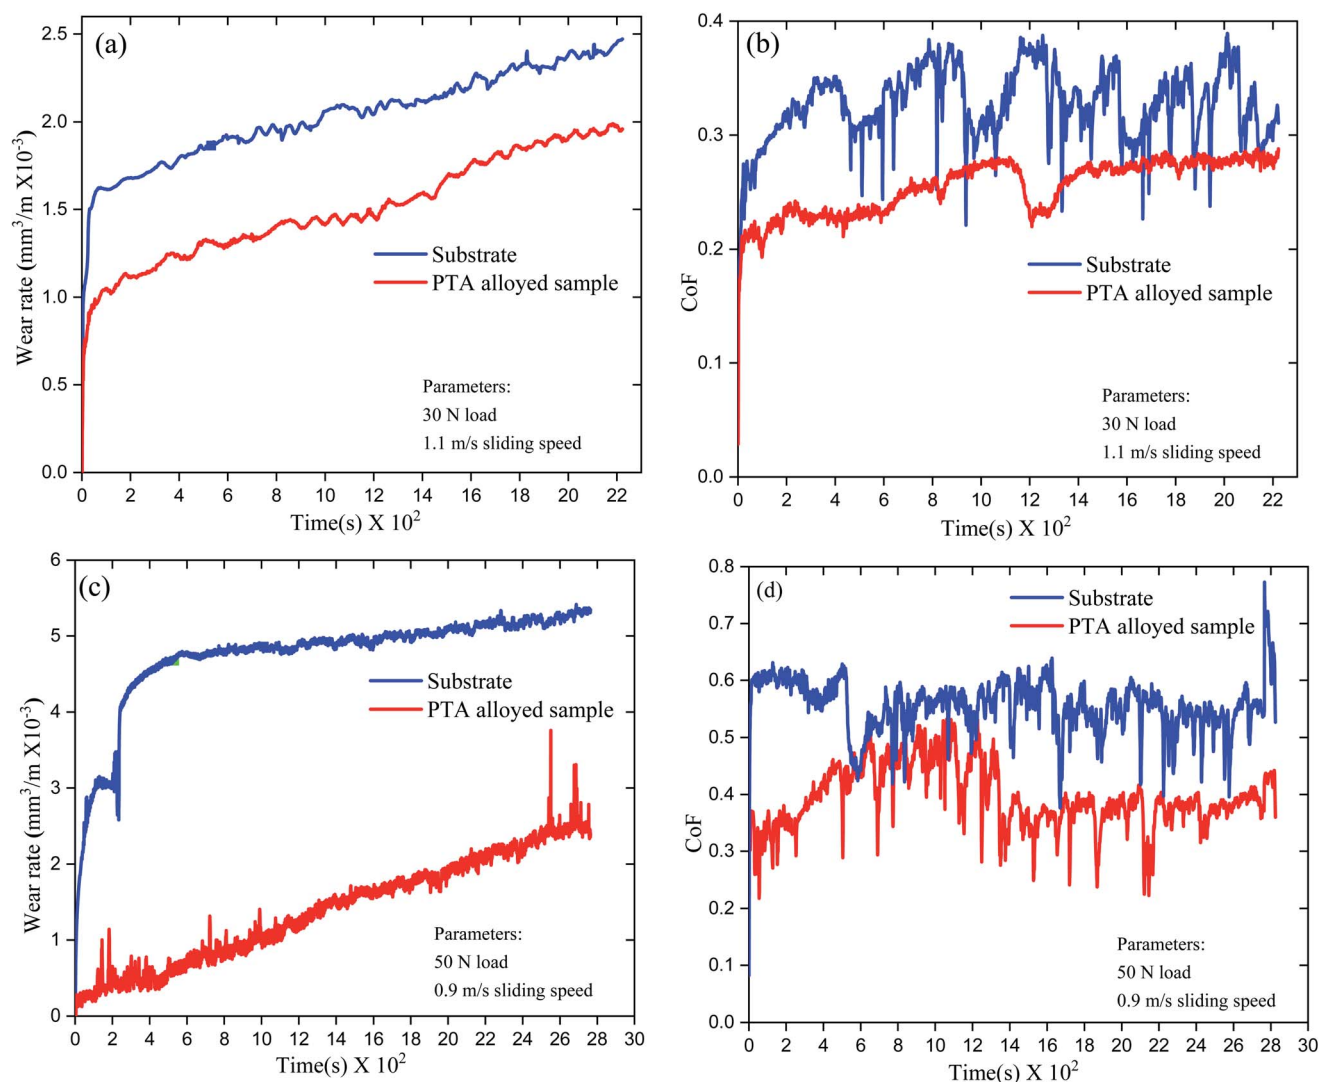
Fig. 8 (a and b) The obtained wear rate and co-efficient of friction graph at the applied load of 30 N, (c and d) wear rate and co-efficient of friction graph at the applied load of 50 N.

Fig. 8(a and c) show the wear rates of substrate and PTA alloyed samples at different input parameter conditions. The wear rate of the substrate specimen at 30 N applied load is $2.45 \times 10^{-3} \text{ mm}^3 \text{ m}^{-1}$ and for the PTA specimen, it is $1.79 \times 10^{-3} \text{ mm}^3 \text{ m}^{-1}$. Similarly, the wear rate of the substrate specimen at 50 N is $5.38 \times 10^{-3} \text{ mm}^3 \text{ m}^{-1}$ and for the PTA sample, it is $2.29 \times 10^{-3} \text{ mm}^3 \text{ m}^{-1}$. Comparison of the wear rates of the substrate and PTA specimen revealed that the PTA surfaces showed significantly improved wear resistance. Moreover, an increase in the applied load increased the wear rate in both substrate and PTA surfaces. The untreated surface tested at 50 N of applied load showed higher wear rate than the rest of the samples.

Fig. 8(b) shows the CoF of the untreated and treated samples tested at an applied load of 30 N. The CoF of the untreated sample shows an increasing trend from 0 to 0.4 at 400 s. Then, a sudden drop has occurred at 500 s, gradually increasing up to 1200 s. A similar drop in CoF is observed at 1200 s, 1400 s and 1700 s. The maximum drop of 0.25 CoF is observed at 1000 s. The initial steep increase in CoF resulted from the resistance of asperities for deformation. The frictional force minimizes when the asperities started deforming. However, the fractured asperities accumulated in the sliding path and acted as an obstacle for the forward sliding. Moreover, the fractured asperities cold-welded with the existing asperities, and formed a plasticized layer. The effect of accumulation of fractured asperities and formation of thin layer increased the frictional force to deform them. Then, the reduction of frictional force happened due to less resistance for deformation. This cycle continued until the completion of the wear test. The lower surface hardness and higher ductility are the cause for this variation of CoF in the untreated sample.

Fig. 8(b) also shows the CoF of the treated specimen tested at an applied load of 30 N. It can be observed that the CoF shows minimum fluctuations compared with the untreated sample. CoF increases up to 0.28 at 250 s. Then, a slight drop to 0.22 occurred after 250 s to 750 s. A steady increase in CoF up to 0.26 happened at 1250 s. A sharp drop in CoF occurred after 1200 s, and was retained up to 1500 s. After 1500 s, CoF has recovered and stabilized until the end of the test. Compared to the untreated sample, the fluctuations in the frictional forces are low in the treated sample. Initially, frictional forces were low during the test. However, when the test time increased, the frictional forces increased with time and attained a maximum around 1000 s to 1250 s. The PTA-alloyed surface improved the surface hardness significantly. Thus, a minimum deformation of the asperities occurred during the initial stages of the test. However, accumulation of the deformed asperities along the sliding path increased the frictional force for further deformation. The sudden decline of frictional forces was due to the bulk deformation of the accumulated thin layer of the deformed asperities. Then, the frictional forces have been regained and stabilized.

Fig. 8(d) shows the CoF of untreated samples tested at an applied load of 50 N. During the starting of the test, CoF of the untreated sample increased to 0.62 and was maintained with minor fluctuations up to 300 s. After 500 s, a sharp decline in the frictional force has been observed and major fluctuations happened over the testing. Absence of the cyclic variation in CoF was observed in 50 N loading condition compared with 30 N loading. The irregular high intensity asperities in the untreated surface have cold-welded with the counter material, and increased the frictional force at the initial stage. When the applied load exceeded the frictional resistance of the cold-welded asperities, a huge deformation occurred. Thus, it

Fig. 8(d) shows the CoF of the treated specimen at 50 N applied load. It can be observed that the treated specimen showed lower CoF than the untreated sample. In addition to that, wide fluctuations in the frictional forces are observed. The frictional forces are increasing over the testing time up to 0.45 at 500 s. A sharp decline in the frictional force occurred at 500 s. Then, it slightly increased to 0.50. This decline and recovery of CoF was observed throughout the test period. However, after 1500 s testing period, CoF reduced from its maximum range, and there were continuous fluctuations until the end. The surface-alloyed Inconel-718 improved the hardness through various particle elements. The minimum deformation of the surface asperities happened during the wear testing due to the increased hardness. The presence of intermetallic compounds and improved hardness prevented the crack propagation. The fluctuations in the CoF indicate the variations in the deformation behaviour of asperities. Decline of CoF after 1500 s of test time shows the stabilization of the surface with minimum deformation of the surface asperities. Even at increased applied load, due to increased surface hardness, the minimum deformation of asperities resulted with a reduction of the frictional forces.

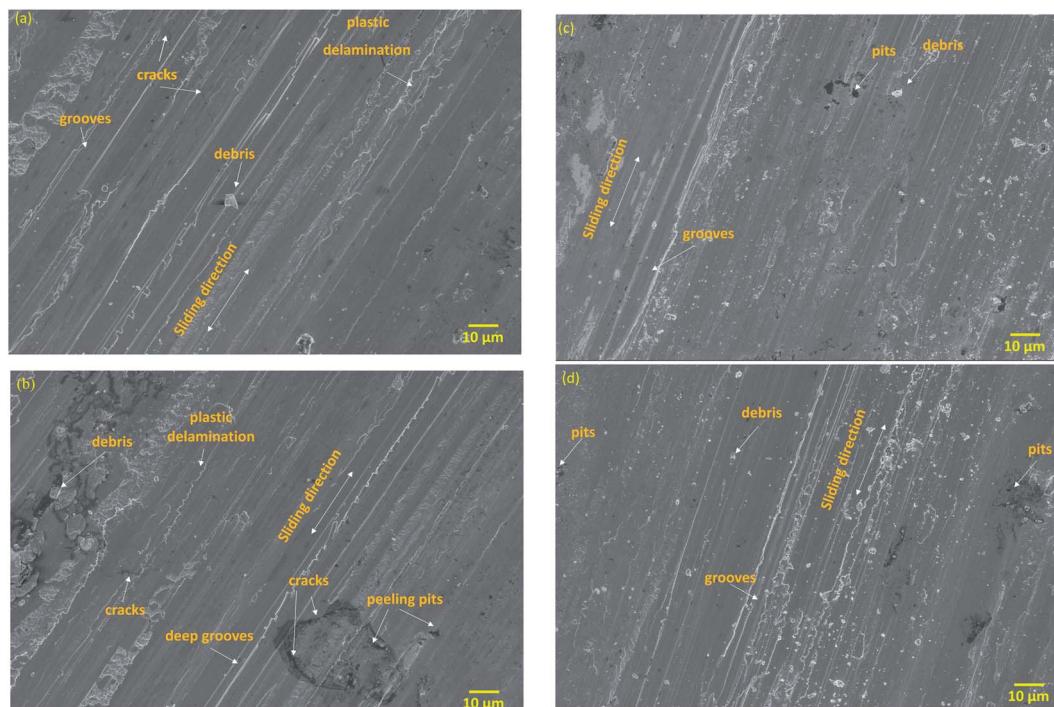
Fig. 9 Worn-out surfaces: (a and b) substrate at 30 N and 50 N load, respectively. (c and d) PTA alloyed specimen at 30 N and 50 N load, respectively.

Fig. 9(a) shows the worn-out surfaces of the substrate specimen at an applied load of 30 N. Fig. 9(a) shows the combination of adhesive and abrasive wear losses in the worn-out substrate surface. Lower hardness of the substrate accelerated the adhesive wear losses. Adhesive tendency in the substrate material varied with the nature of asperities in it. Furthermore, it is clear that a few areas in the substrate have experienced abrasive wear losses. The compressive stresses were induced in the substrate surface due to the applied load. Due to the lower surface hardness, this compressive stress initiated microcracks and plastic deformation. Fig. 9(b) shows the worn-out surface of the substrate at 50 N load condition. The worn-out surface indicates severe abrasive and adhesive wears. Along with the abrasive and adhesive wear, microcracks and plastic deformations are also observed. The adhesive wear dominated the worn-out surface of the substrate. Higher adhesive wear was attributed to the lower hardness of the substrate surface. Adhesive tendency of chemical elements like Al and Ni with the counter material during sliding increased the adhesive wear in the substrate material. Since adhesive wear was the dominant wear mechanism in the substrate, a few abrasive grooves were observed along with the adhesively worn-out areas. These abrasive losses occurred due to repetitive contact of the counter material with the adhesively bonded substrate on them.

Fig. 9(c) shows the worn-out surface of the treated surface at 30 N load condition. The worn-out surface revealed that wear losses were minimal and dominated by abrasive wear losses. A few narrow and shallow abrasive grooves were present in the worn-out surface. The absence of or a negligible amount of adhesive wear losses was observed. Improved hardness of the treated surface restricted the

adhesive wear losses and plastic deformation due to compressive stresses. Fig. 9(d) shows the worn-out surface of the PTA alloyed specimen at 50 N applied load. The worn-out surface shows the abrasive grooves. The wear type of the PTA alloyed specimen consisted of mild abrasion with oxidative wear. Different oxides were formed during the wear test and protected the PTA-alloyed surface. The results have shown that the heterogeneous oxidation film forms on the worn-out surface. The oxidation layer on the PTA-alloyed

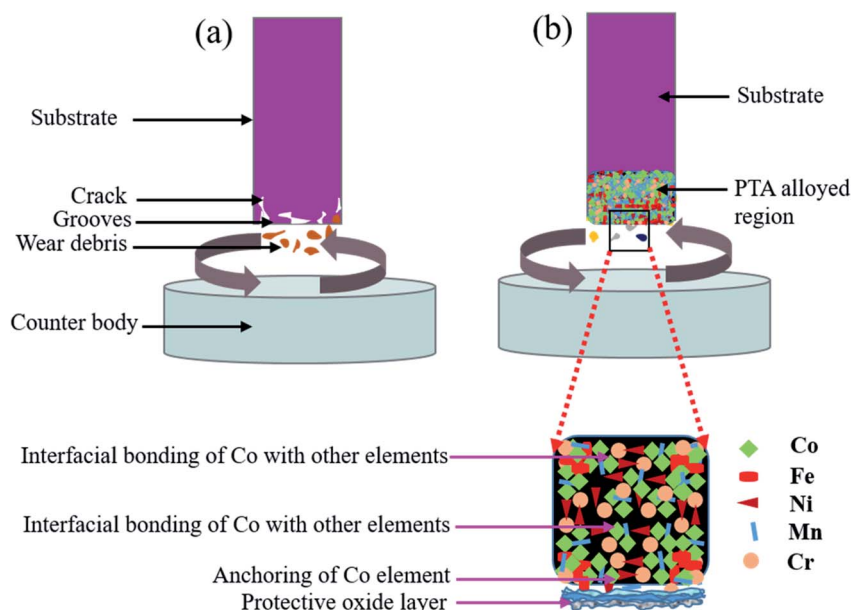
Fig. 10 Schematic representation of wear mechanism: (a) substrate showing with crack, deformation and deep grooves, (b) PTA alloyed specimen showing with mild and small grooves.

A schematic representation of the wear mechanism in the Inconel-718 substrate and the PTA alloyed specimen is shown in Fig. 10. During the wear test, the formation of thick oxide layers on the worn-out surface was followed by frictional heat generation. However, the bearing capacity of the Inconel-718

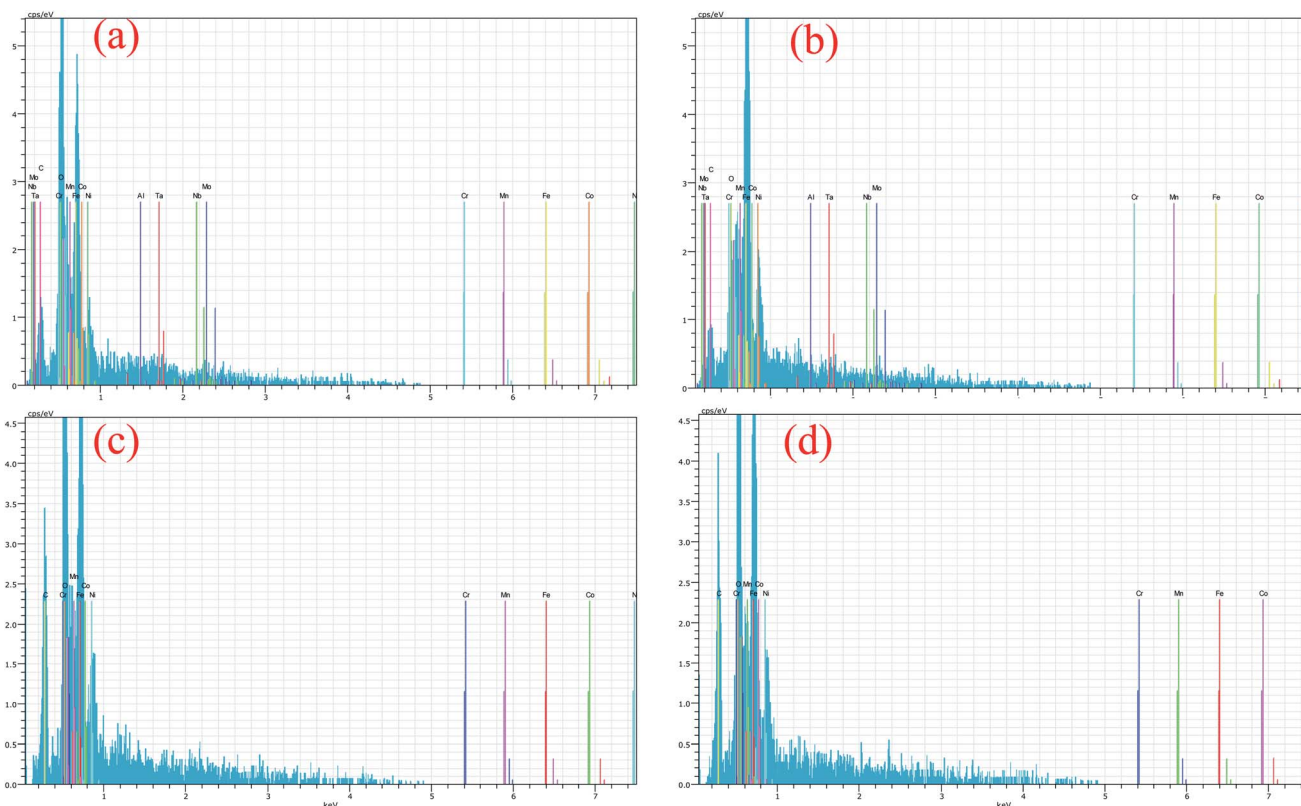
Fig. 11 EDS analysis of worn-out surfaces: (a and b) substrate at 30 N and 50 N load, respectively. (c and d) PTA alloyed specimen at 30 N and 50 N load, respectively.

The EDS results [Fig. 11(a and b)] of the worn-out surface indicate that the reduction of the Al and Ni elements in the

substrate is advocating the concept of adhesive wear loss due to those elements. Table 4 shows the detailed EDS results with their elemental percentages. While increasing the applied load, the adhesiveness of the substrate surface with the counter material increased and deformed drastically during sliding. The EDS [Fig. 11(c and d)] results proved that the worn-out surface contains the FeCoCrNiMn chemical elements with the absence of the substrate chemical elements. No traces of substrate chemical elements were found on the worn-out surfaces. Moreover, the presence of oxides in the worn-out surface acted as a barrier and protected the treated surface from an aggressive environment. This indicates that the PTA alloyed treatment significantly improved the surface protection.

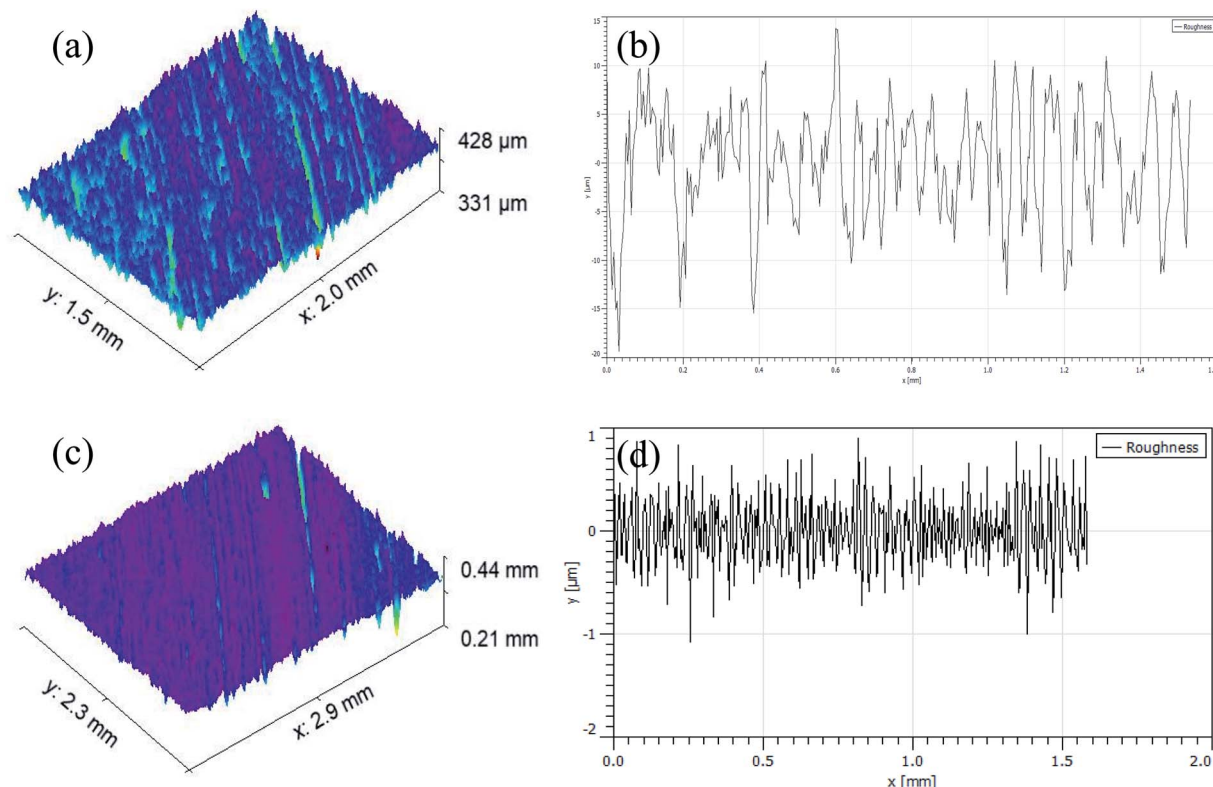
Fig. 12 3D topography of worn-out surfaces and its roughness plot at 50 N load: (a and b) substrate, (c and d) PTA alloyed sample.

Fig. 12(a and b) shows the 3D topography, and the corresponding roughness profile of the worn-out untreated surface at 50 N load. The 3D topography shows numerous wear scar marks on the untreated surface, and these wear scar marks are deeper and wider. The 2D topography indicates that the surface undulations are very rough, and that deeper wear scars are present in regular intervals. The average surface roughness (R_a) of the worn-out untreated surface is measured as $6.31 \mu\text{m}$. Fig. 12(c and d) shows the 3D topography, and the corresponding roughness profile of the worn-out PTA-alloyed surface at 50 N load. The 3D topography shows the minimum scar marks and losses. In addition to that, the absence of deep grooves is observed in the 3D topography. The 2D topography indicates that the wear scar depths are shallow and lower than the untreated surface. The PTA-alloyed surface with FeCoCrNiMn particles has significantly improved the hardness and minimized the wear losses.³² The average surface roughness of the PTA alloyed worn-out surface has been measured as $4.81 \mu\text{m}$. This reduced roughness indicates the effect of the surface alloying on the Inconel-718.
