Surface alloying of FeCoCrNiMn particles on Inconel-718 using plasma-transferred arc technique: microstructure and wear characteristics

N. Jeyaprakash,^{ID}*^{ab} Che-Hua Yang,^{ab} G. Prabu^c and K. Ganesa Balamurugan^d

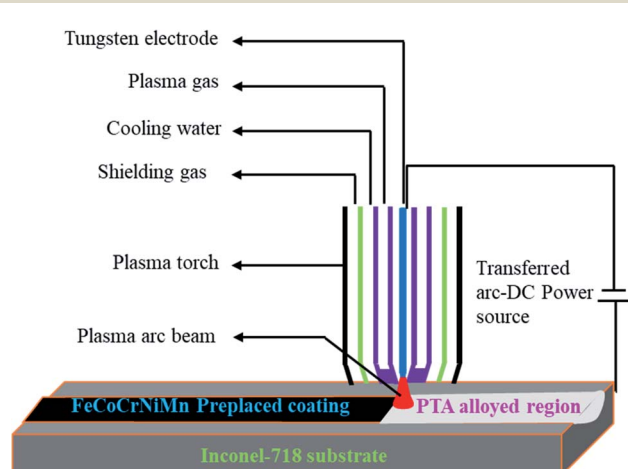
Fig. 3 Schematic representation of PTA alloying process.

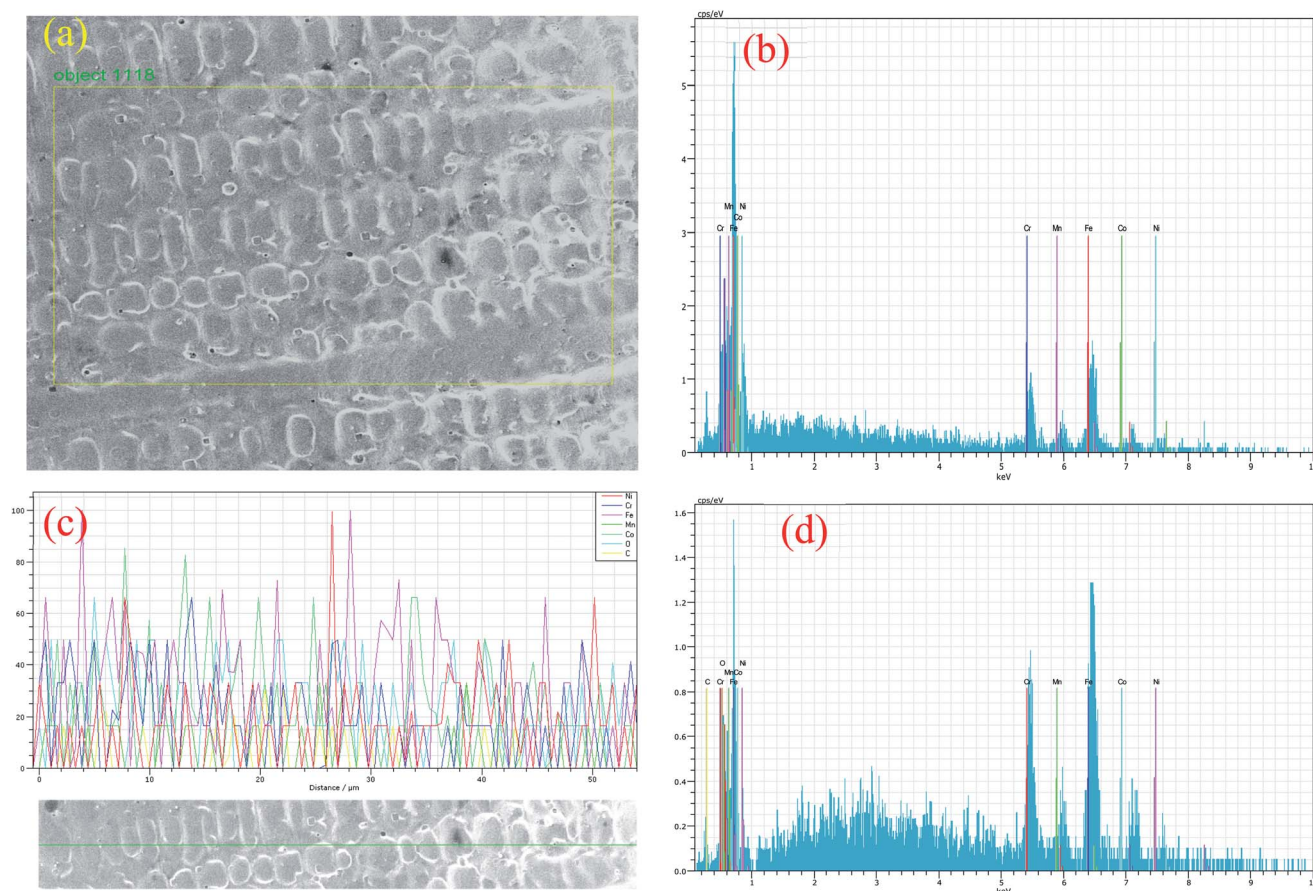
Fig. 6 (a) FESEM images of PTA alloyed region, corresponding EDS graph at: (b) area analysis, (c) line analysis and (d) point analysis.

Fig. 6(a–d) shows the EDS analysis of the PTA-alloyed region. The obtained EDS analysis indicates the presence of all alloying elements after the PTA process [Fig. 6(b)]. Table 3 lists the presence of elements obtained in the PTA-alloyed region. The elements Fe, Cr and Ni are observed as major elements with atomic wt% of 32.48, 25.59 and 16.48, respectively. The remaining positions are occupied by Mn and Co. Therefore, it is confirmed that the Fe element constitutes the matrix material for this PTA-alloyed system. The EDS analysis has proved that the diffusion of the elements of the substrate has never occurred in the central zone of the surface-alloyed region. The heat input by PTA has been majorly utilized for the melting of the alloying elements, and very meagerly utilized to melt the substrate for bonding. Therefore, the diffusion of the elements of the substrate was restricted. Fig. 6 (c and d) shows the EDS result of the interface region and substrate. This line and point scan indicate that the diffusion of major alloying elements, like Ni, Cr, Co, Fe and Mn, has occurred on either side; especially, diffusion mainly occurred on the substrate side. The EDS analysis clearly indicates that the surface treatment completely protects the Inconel-718 substrate, and no trace of the substrate chemical elements is found in the treated layer.

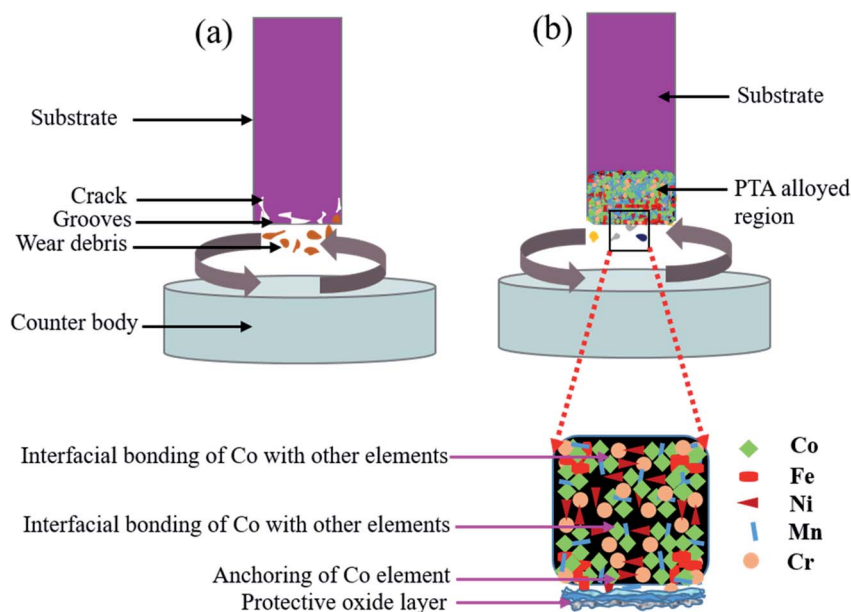
Fig. 10 Schematic representation of wear mechanism: (a) substrate showing with crack, deformation and deep grooves, (b) PTA alloyed specimen showing with mild and small grooves.

A schematic representation of the wear mechanism in the Inconel-718 substrate and the PTA alloyed specimen is shown in Fig. 10. During the wear test, the formation of thick oxide layers on the worn-out surface was followed by frictional heat generation. However, the bearing capacity of the Inconel-718
