Alba Garzón Manjón, Christina Scheu *et al.*
Evaluation of functional layers thinning of high temperature
polymer electrolyte membrane fuel cells after long term
operation

Evaluation of functional layers thinning of high temperature polymer electrolyte membrane fuel cells after long term operation†

The operation related degradation processes of high temperature polymer electrolyte membrane fuel cell operated with hydrogen-rich reformate gas are studied. CO impurities from the reformate gas are strongly adsorbed by the catalyst surface, leading to poisoning and thus, reduction of the overall performance of the cell. Most of the studies are performed in a laboratory set-up by applying accelerated stress tests. In the present work, a high temperature polymer electrolyte membrane fuel cell is operated in a realistic configuration for 12 000 h (500 days). The fuel cell contains as electrocatalyst Pt in the cathode and a Pt–Ru alloy in the anode. The study of the degradation occurring in the functional layers, *i.e.* in different regions of cathode, anode and membrane layer, is carried out by scanning electron microscopy, (scanning) transmission electron microscopy and energy dispersiv

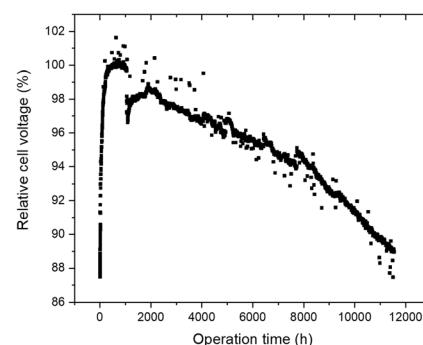
The HT-PEMFC have been subjected to long term operation. The durability is shown in Fig. 1, where the voltage change at constant current is plotted. The small slop of the curve indicates that the HT-PEMFC has some performance loss over the time span of 12 000 h, but it is not severe, and the fuel cells can be still operated. The observed changes in performance with time are due to microstructural changes as discussed below.

Fig. 1 Voltage response at constant current during HT-PEMFC operation.

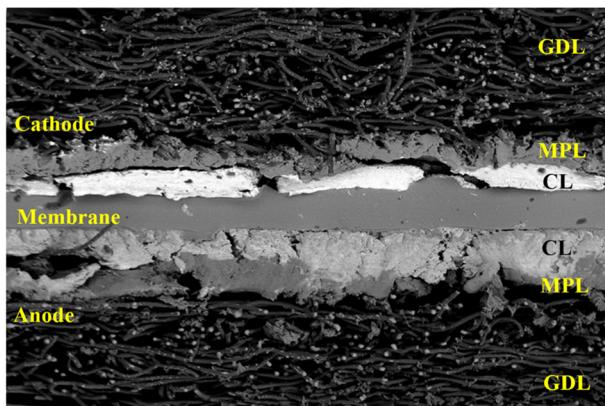
Fig. 2 SEM cross section image using BSE of the HT_non_operated cell. GDL: gas diffusion layer, MPL: microporous layer and CL: catalyst layer.

Regarding the structure of the FC, the gas diffusion layers (GDL) can be readily distinguished since it is made up of carbon fibres and constitutes the outer-most layer of the electrode. BSE images were recorded to distinguish cathode and anode. In this regard, the cathode appears brighter than the anode in BSE images which is attributed to the different composition and loading of the anode. Pt has a higher atomic number than the Pt-Ru alloy and thus appears brighter in the BSE images (Z contrast). The thickness of all three layers, *i.e.* cathode, membrane, and anode fluctuate in a range of $\pm 10\%$ along the cross-sectional surface due to the fabrication process.

The membrane has the largest layer thickness (51%) of the total FLs thickness. The anode and the cathode catalyst layer accounts for 31% and 18%, respectively of the total thickness. All differences in the average layer thickness are within the measurement uncertainty and hence, a spatially constant layer thickness is estimated.

After operation of the FC for 12 000 h the cathode suffered a pronounced degradation and is not as well defined as it was in the HT_non_operated (compare Fig. 2 and 3). In some regions the width of the cathode does not change during operation, whereas in other positions the cathode was practically completely removed. This phenomenon is especially relevant in the specimen taken from the cathode inlet region (Fig. 3c). Moreover, the thickness of the anode layer appears to have less degradation even if it is slightly thinner than before operation.

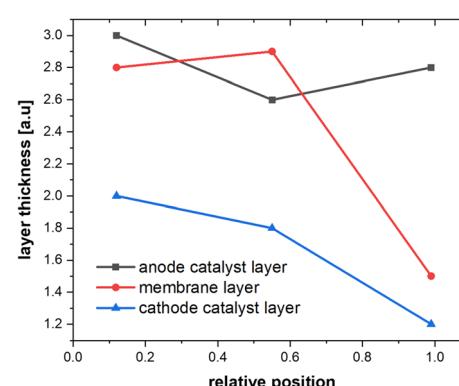
In order to achieve quantitative results on the degradation of the HT_operated cell, the thinning of the membrane was measured together with the change in width of the anode and the cathode (Fig. 4).

For the non-operated HT-PEMFC, the thickness of the FLs is constant along the fuel cell. During regular operation, the cathode thickness decreases to values between 15–65% of the initial thickness. The degree of thinning is stronger on the region closer to the cathode inlet of the HT-PEMFC. Moreover, the anode thickness decreases to values between $\sim 65\%$ and $\sim 85\%$ of the initial thickness. Moreover, on the anode, the thinning is more pronounced on the region closer to the cathode inlet of the HT-PEMFC as well.

The measurements pertaining to the cathode have the highest standard deviation: 76% in the anode inlet side, 84% in the center and 81% in the cathode inlet side. Furthermore, the cathode closer to the cathode gas inlet region is not as well defined as the rest of the components. In some sections, a

Fig. 4 Average thickness of the functional layers cathode, membrane and anode of the HT_operated cell. The thickness is given in a.u. The relative position is related to anode inlet (left) and cathode inlet (right). The lines are only to guide the eye and are no related to experimental data points.

thin layer can still be detected, while in others it is completely removed. Thus, the standard deviation from the measurements of the cathode (CL) increases considerably in this case. Fig. 3 shows the average thickness of the FLs along the FC.

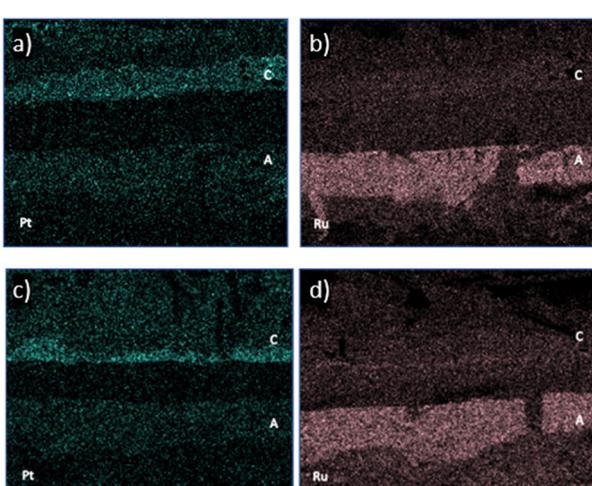
EDX maps of Pt and Ru were recorded to better understand the catalyst distribution and degradation process after 12 000 h operation. The EDX elemental maps of the non-operated cell (Fig. 5a and b) show that Pt can be found in both CL with a higher loading in the cathode side as was expected. Furthermore, the EDX analysis allows to distinguish the distribution of Ru and Pt, confirming that Ru is found exclusively in the CL of the anode of the non-operated cell. The EDX analysis allows only a qualitative analysis of Pt instead of quantitative due to the overlapping lines of P K α (2.013 keV) (membrane component) and Pt M (2.048 keV). Nevertheless, it can be used to distinguish between anode and cathode. The anode catalyst layer contains the alloy made up of PtRu. The counts for Pt and Ru detected in the membrane and MPL were attributed to noise.

The EDX maps of the HT_operated cell is depicted in Fig. 5c and d. The EDX mapping of Pt shows the thinning of

the catalyst layers after 12 000 h operation time. Especially, for the cathode catalyst layer which contains the highest amount of Pt, it can be observed that the layer thickness is significantly thinner compared to the non-operated HT-PEMFC (Fig. 5a). However, Pt can only be detected within both catalyst layers. Even after 12 000 h of operation, there is no area with a high Pt concentration outside the catalyst layers. From the Ru EDX mapping, no high level of thinning can be detected at the anode catalyst layer.

Fig. 5 EDX maps acquired across the different functional layers showing Pt (in green) and Ru (pink) distribution in HT_non_operated (a and b) and HT_operated (c and d). Close to the cathode layer, a band containing Ru and Pt is visible.

The anode catalyst layer contains both catalyst materials, Pt and Ru. Compared to the non-operated HT-PEMFC, the ratio Pt/Ru differs. Specifically, after 12 000 h of operation, the content of Pt is 7 times higher than the content of Ru. Moreover, a PtRu band can be detected in the membrane close to the cathode side, formed by the dissolution and reprecipitation of catalyst material during operation.

cate the formation of such a band in the present sample (Fig. 5 and 6). Moreover, in the anode side, the degradation of the PtRu alloy NPs is also observed. The Ru amount is decreased as well as the average NPs size. We find a bimodal average size distribution which confirm the dissolution effect.
