# Crack resistance of a noble green hydrophobic antimicrobial sealing coating film against environmental corrosion applied on the steel–cement interface for power insulators†

Due to their great load-bearing capabilities, steel–cement interface structures are commonly employed in construction projects, and power utilities including electric insulators. The service life of the steel–cement interface is always decreasing owing to fracture propagation in the cement helped by steel corrosion. In this paper, a noble crack-resistant solution for steel–cement interfaces utilized in hostile outdoor environments is proposed. A Ce-rich, homogeneous, and thick hydrophobic sealing coating (HSC) is developed on the steel–cement interface after 60 minutes of immersion in a 60 000 ppm  $\text{CeCl}_3 \cdot 7\text{H}_2\text{O}$  sealing coating solution. The specimens treated with optimized HSC film demonstrate fissure filling, lowest corrosion current ( $I_{\text{corr}}$ )  $2.3 \times 10^{-7} \text{ A cm}^{-2}$ , maximum hardness (109 Hv), oxide-jacking resistance (40 years), hydrophobic characteristics, carbonation resistance, and bacterial corrosion resistance, resulting in a crack-free steel–

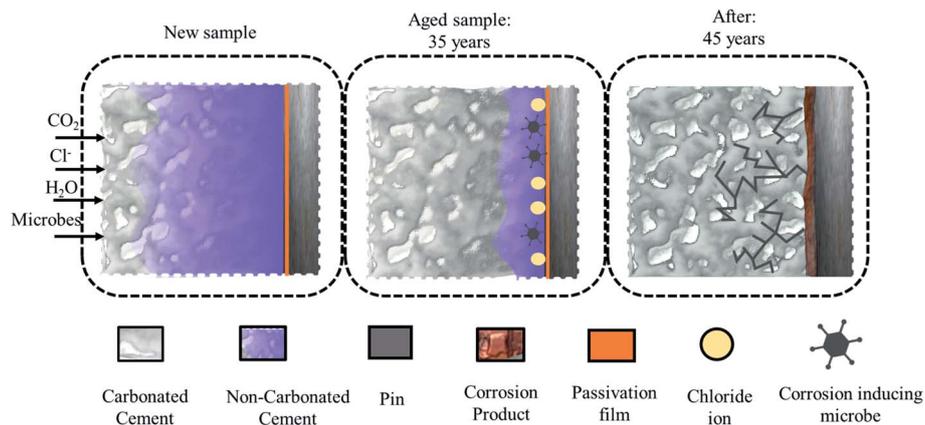
Fig. 1 The sequence of propagation of a crack in cement due to carbonation, chloride, and corrosion-inducing microbes.

The corrosion byproducts formed due to corrosion of the steel (pin) apply bursting pressure, which causes radial cracks in the cement (see Fig. 1) and finally the porcelain shell. The

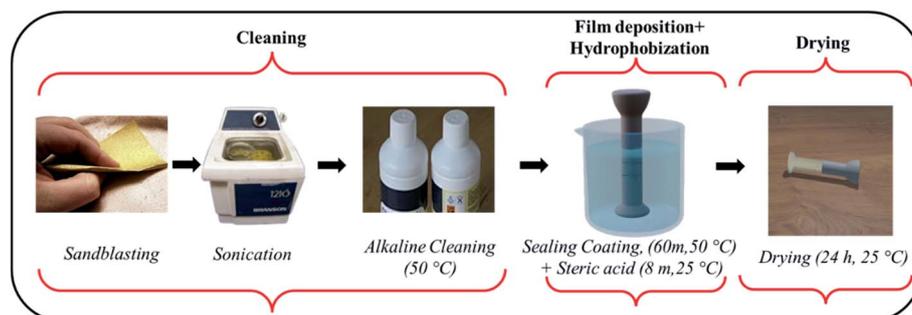
Fig. 2 Scheme for deposition of hydrophobic sealing coating film by an immersion process.

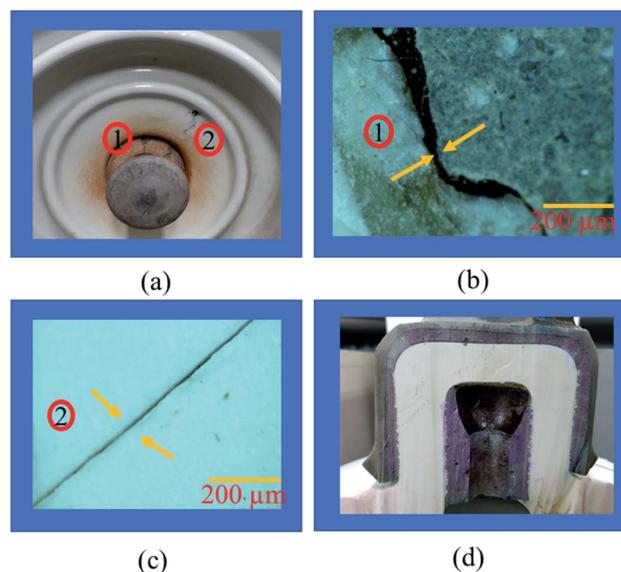
Fig. 3 Evaluation of aged insulator specimens: (a) cracks in pin–cement and cement–porcelain interfaces, (b) micrograph of cracked pin–cement interface, (c) micrograph of cracked porcelain, (d) macrograph of carbonated cement of pin–cement interface.

The micrograph represented in Fig. 3(c) depicts crack propagation from cement to shell. The reason may be the propagation of bursting pressure developed due to corrosion products. The pin–cement interface of the specimens was evaluated to examine the extent of carbonation in the cement (see Fig. 3(d)). The color is closer to the bluish-purple shown for a carbonated specimen (pH: 8). This indicates that the pin–cement interface of the specimen is highly carbonated.

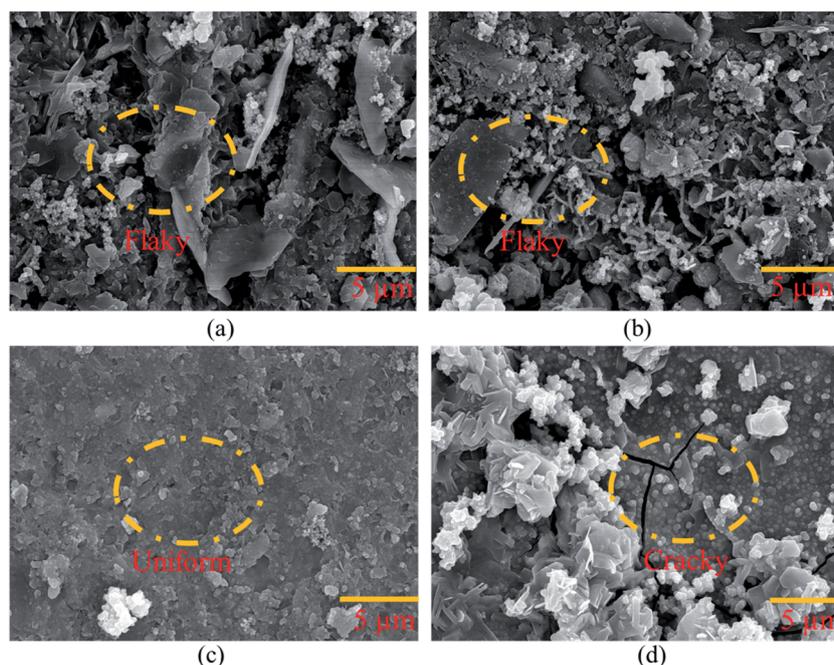
Fig. 4 Morphological analysis of the coating developed on the pin of the steel (pin)–cement interface by varying  $\text{CeCl}_3 \cdot 7\text{H}_2\text{O}$ : (a) 10 000 ppm, (b) 30 000 ppm, (c) 60 000 ppm, and (d) 100 000 ppm.

After being removed from the coating bath and dried for 24 hours, the HSC film characteristics were examined. Fig. 4 depicts the morphology of coated insulator (steel) pins obtained after immersion in 10 000 ppm to 100 000 ppm  $\text{CeCl}_3 \cdot 7\text{H}_2\text{O}$  concentration solutions. Fig. 4(a) and (b) show scanned microscopic micrographs of coated insulator pins after 60 minutes in 10 000 ppm and 30 000 ppm Ce salt baths, respectively. In both situations, a non-uniform and flaky layer developed. This film did not continuously cover the entire surface. The cause might be a low concentration of  $\text{CeCl}_3 \cdot 7\text{H}_2\text{O}$  in the sealing coating bath solution. The trials were carried out by gradually increasing the time to 180 minutes of exposure. However, even after extending the exposure period, the data did not indicate any improvement. Fig. 4(c) shows a continuous, crack-free, and homogeneous protective coating produced on the surface of the specimen. The continuous film indicates the filling effect, which may have resulted in the filling of fissures in the cement of the pin–cement contact, interfering with the diffusion of  $\text{CO}_2$  and  $\text{H}_2\text{O}$ .<sup>27</sup>

Cracks may be seen on the HSC surface in Fig. 4(d). The cause might be strain induced by the creation of a much thicker

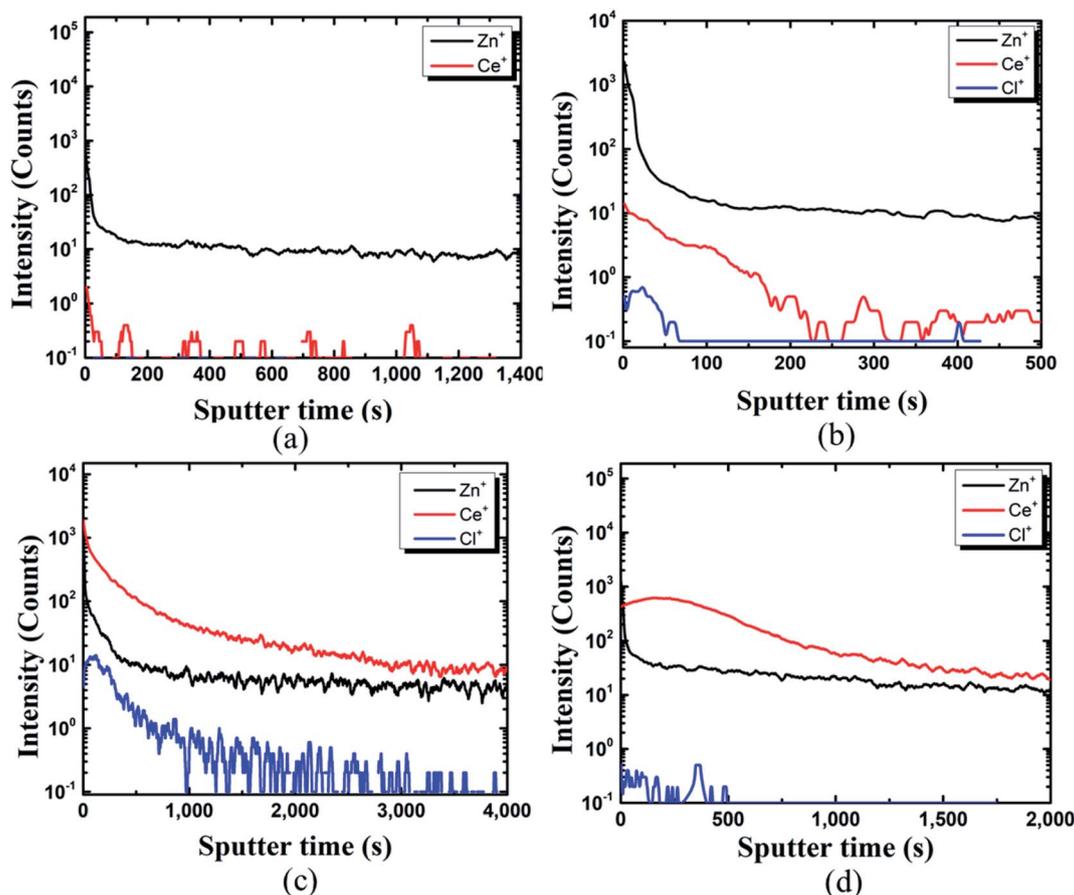
Fig. 5 TOF-SIMS analysis of coating developed on the pin of the steel (pin)-cement interface by varying  $\text{CeCl}_3 \cdot 7\text{H}_2\text{O}$ : (a) 10 000 ppm, (b) 30 000 ppm, (c) 60 000 ppm, (d) 100 000 ppm.

The TOF-SIMS depth profile of coating film on the pin was studied to gain more insights. The presence of Ce, Zn, and Cl could be identified from the coated pin surface (see Fig. 5(b–d)). In the case of Fig. 5(a), due to the deficiency in Ce ions in the coating bath (10 000 ppm), the protective film was not formed, and thus it could not be detected on the pin surface. In Fig. 5(b), Ce ions could be detected on the pin surface. However, the protective film was not formed on pin specimens, as seen in Fig. 5(b).

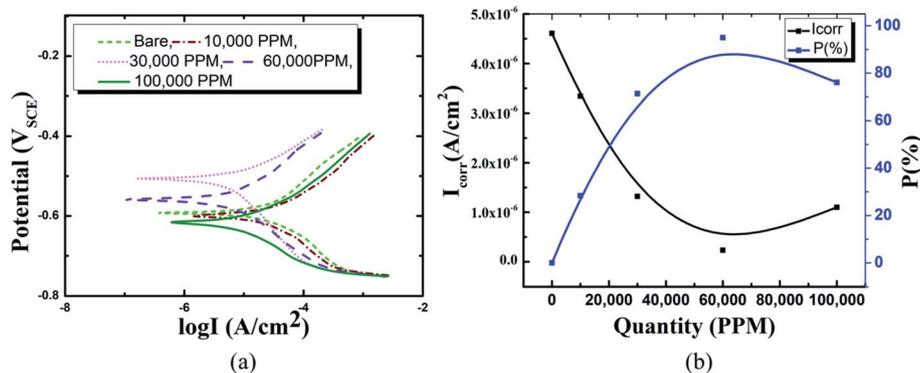
Fig. 6 Electrochemical analysis results with various concentrations of cerium ions in concrete media: (a) Tafel curves, (b) variation in  $I_{\text{corr}}$  and anticorrosion performance of HSC film with various concentrations of Ce ions.

Following the synthesis of the HSC film, the inhibitory features of the HSC film were tested using polarization curves. Fig. 6 depicts the electrochemical behavior of HSC film after 30 days of exposure in simulated concrete solution. The Tafel behavior of these specimens is predicted for the anodic and cathodic polarization branches. To determine the optimal content of cerium in the HSC film bath, corrosion kinetic characteristics in the 10 000 ppm–100,000 ppm concentration range were investigated, and inhibition performances,  $P$  (%), were computed.<sup>29</sup>

$\text{cm}^{-2}$ . This demonstrates the better corrosion resistance of coated pin specimens (see Fig. 6(a) and (b), ESI Table 1<sup>†</sup>). With increasing concentrations of Ce salts in the HSC solution, the corrosion current density ( $I_{\text{corr}}$ ) of the coated specimens falls.  $I_{\text{corr}}$  is lowest ( $2.3 \times 10^{-7} \text{ A cm}^{-2}$ ) and  $P$  (%) is highest in specimens submerged in a 60 000 ppm Ce-based HSC solution. However, when the concentration of  $\text{CeCl}_3 \cdot 7\text{H}_2\text{O}$  hits

100 000 ppm,  $I_{\text{corr}}$  rises (see Fig. 6(a) and (b)). This demonstrates that an excessive concentration of Ce salts in the HSC film may have reduced the fracture resistance and consistency of the protective HSC film. The fissures might have contributed to a rise in  $I_{\text{corr}}$ . The corrosion current density ( $I_{\text{corr}}$ ) for coated specimens is approximately three times lower than for non-

coated specimens (see Fig. 6(b)). The inhibition performances ( $P$  (%)) of HSC films can be calculated using eqn (1).

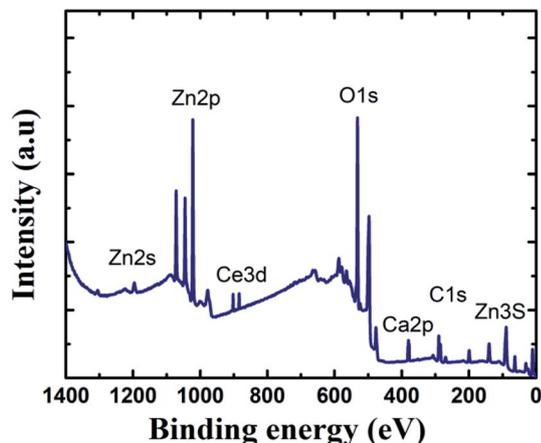
Fig. 7 XPS survey spectra of HSC film after 30 days immersion in concrete solution.

To learn more about the inhibitory capabilities of HSC film, XPS tests were performed on specimens after immersion in concrete pore solutions. Fig. 7 depicts the survey spectra for HSC-coated specimens after immersion in a concrete solution. The primary elements found in HSC-coated specimens were Zn, Ce, Na, Ca, and C.

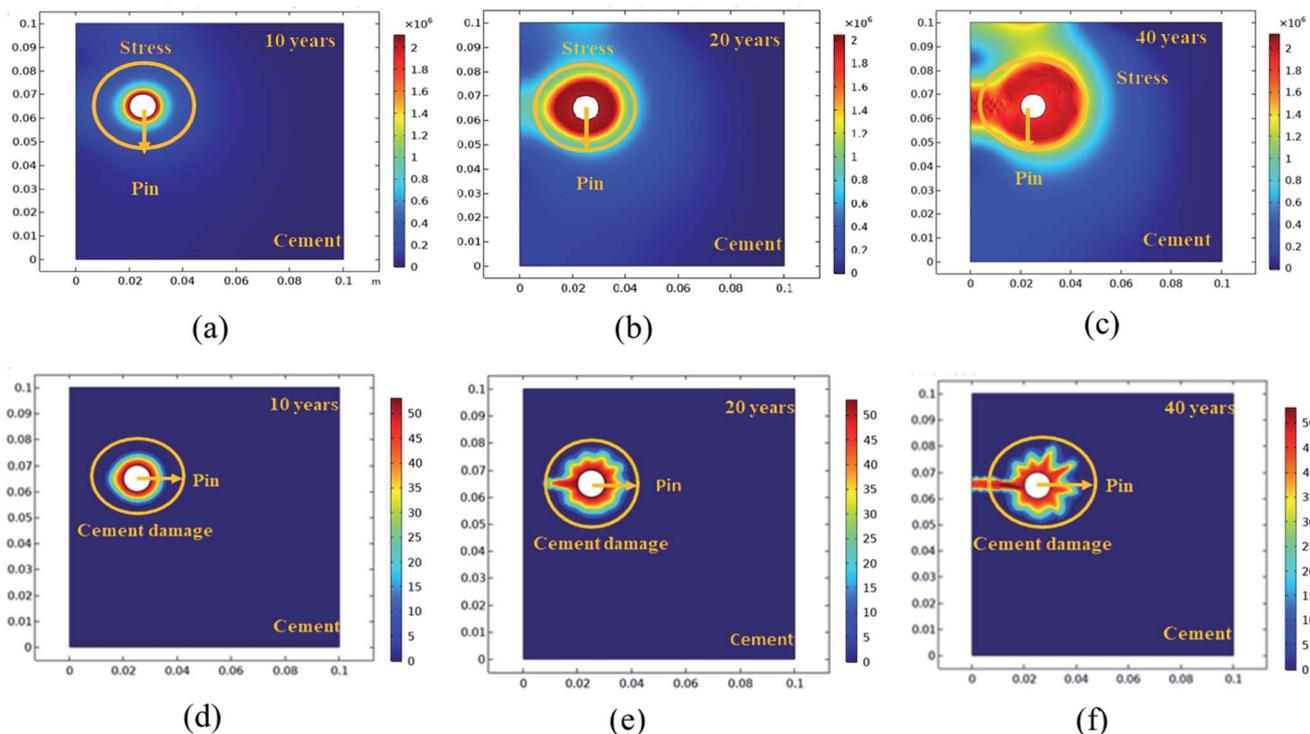
Fig. 10 The 2D modeling of: (a–c) stress propagation ( $\text{N m}^{-2}$ ) in the steel (pin)–cement interface for uncoated specimens with 10–40 years of service, (d–f) cement surface damage (%) in the steel (pin)–cement interface for uncoated specimens with 10–40 years of service.

(pin)–cement due to deposition of corrosion byproducts after 10–40 years of service is represented in Fig. 10(a–f). The material assignments were specified for the pin–cement interface. The material parameters necessary for the computation of stress fields in each component are Young's modulus and Poisson's ratio. The critical zone with the greatest stress values is seen at

the pin–cement contact (see Fig. 10). The maximum stress (red zone), calculated for untreated specimens was  $2 \times 10^6 \text{ N m}^{-2}$ . The stress fields are considerably affected by steel (pin) corrosion and enhanced with increasing (10–40 years) service age of the insulators (see Fig. 10(a–c)). After 40 years of service, the pin–cement interface model represents maximum stress ( $2 \times 10^6 \text{ N m}^{-2}$ , see Fig. 10(c)) throughout the pin–cement interface, that propagates to the cement surface. The surface damage was calculated by using the Rankine stress model. The damage model and damage evolution inputs that were considered for surface damage calculation were the scalar damage and linear strain-softening. The calculated cement surface damage (%) for insulators within the service age range 10–40 years increases with increasing service age (see Fig. 10(d–f)). The cause might be an increase in corrosion with service time. After 40 years of service the untreated specimen shows 50% surface damage (see Fig. 10(f)). The stress distribution and cement surface damage modeling of the treated specimens can be seen in Fig. 11(d–f).

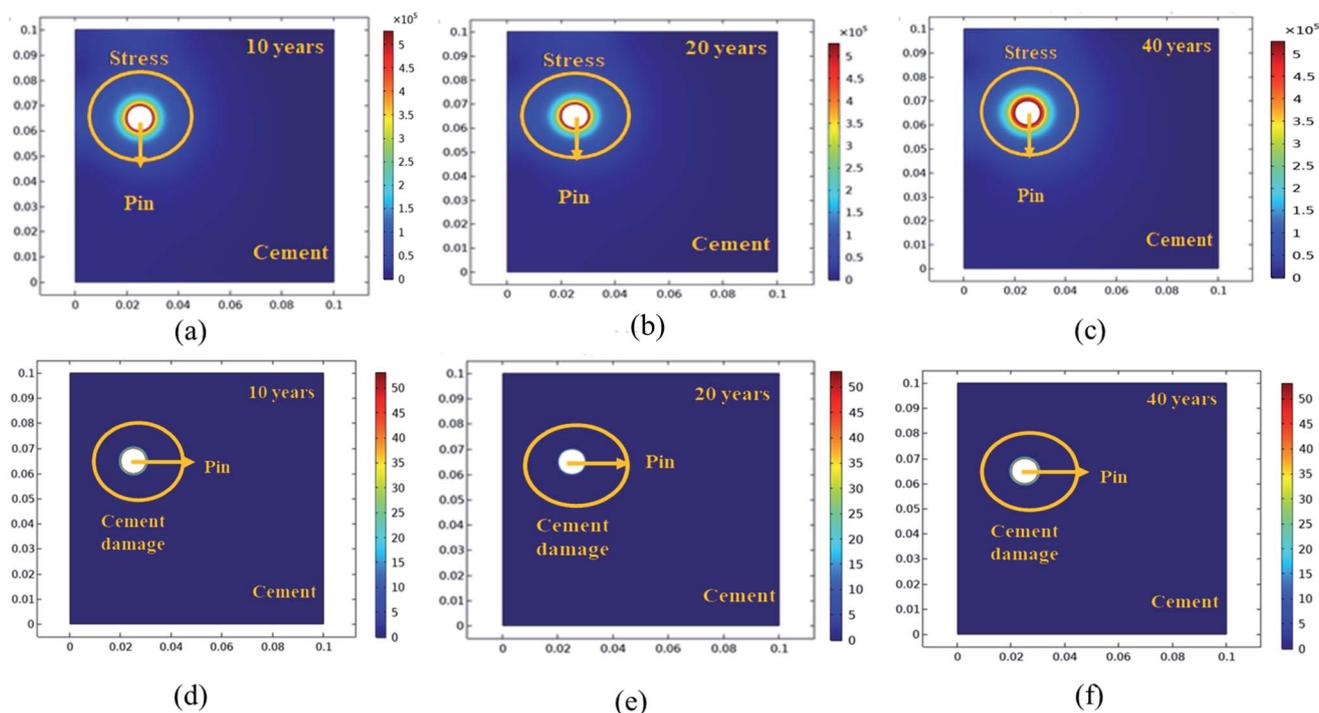
Fig. 11 The 2D modelling of: (a–c) stress propagation ( $\text{N m}^{-2}$ ) in the steel (pin)–cement interface for HSC coated specimens with 10–40 years of service, (d–f) cement surface damage (%) in the steel (pin)–cement interface for coated specimens with 10–40 years of service.

The maximum stress calculated for treated specimens (see Fig. 11(a–f)) was  $5 \times 10^5 \text{ N m}^{-2}$ . Even after 40 years of service, the specimens do not show stress propagation throughout the cement surface (see Fig. 11(c)). The surface damage models of treated specimens depict 0% cement surface damage even after 40 years of service (see Fig. 11(f)), rendering it oxide-jacking free and crack free. The material assignment specified for treated and untreated specimens for modeling stress distribution and surface damage after a certain service age is shown in Table 1.

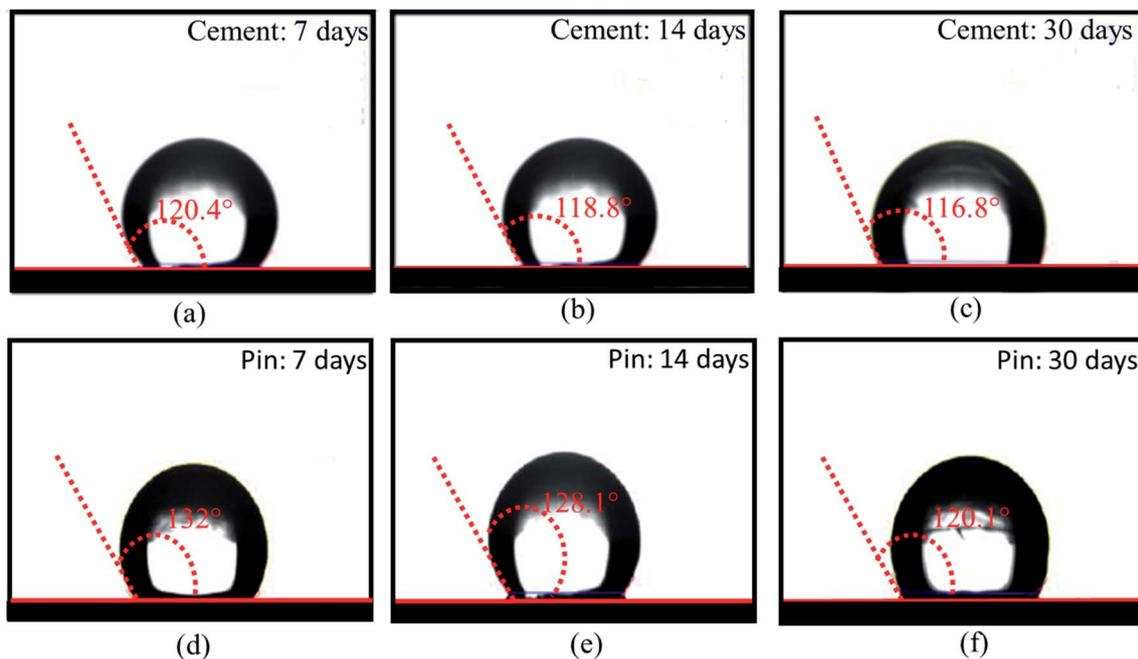
Fig. 12 Contact angle measurements of HSC film on cement (a–c) and steel (pin) specimens, (d–f) post-exposure to chloride and concrete pore solution corrosive media for 7, 14 and 30 days.

a droplet must overcome while spreading over an uneven surface of the film.<sup>37–39</sup> As a result, the interface between H<sub>2</sub>O and the pin–cement interface shifts from surface contact to point contact, rendering the HSC film waterproof. To test the waterproof behavior of the HSC film, contact angle measurements were carried after exposure to chloride medium for 30 days. The HSC treatment would slow the passage of H<sub>2</sub>O and Cl<sup>−</sup> ions inside coatings, extending the coating's protection of the underlying substrate.<sup>40</sup> After 7–30 days of exposure to chloride solution, the contact angle measurements of the treated cement were found to be 120.4°, 118.8°, and 116.8°, respectively (see Fig. 12(a–c)).

Yet after 30 days of exposure in chloride medium, the drop in contact angle measurements was 2.9% when compared to 7 days of exposure (see Fig. 12(a and c)). The hydrophobic performance of HSC-treated steel (pin) specimens is represented in Fig. 12(d–f). After 7–30 days of immersion in concrete pore solution, the contact angle measurements of treated steel (pin) were found to be 132°, 128.1° and 120.1°, respectively. After 30 days of exposure in concrete pore solution, the treated steel (pin) specimens (see Fig. 12(f)) lost just 9% of their hydrophobicity.

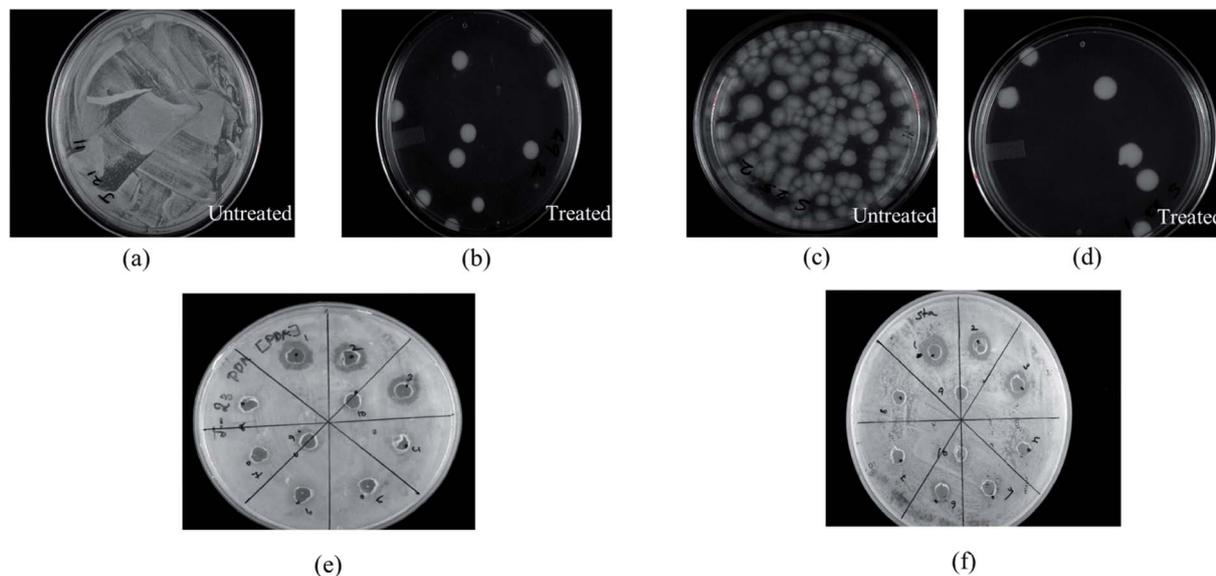
Fig. 14 Antimicrobial activity of HSC film evaluated using in-use test and disc diffusion method towards: (a) *A. ferroxidase* ATCC 23270: untreated, (b) *A. ferroxidase* ATCC 23270: treated, (c) *T. organoparus* Markosian ATCC 27977: untreated, (d) *T. organoparus* Markosian ATCC 27977: treated, (e) *A. ferroxidase* ATCC 23270: treated, (f) *T. organoparus* Markosian ATCC 27977: treated.

In this study, the antibacterial activities of HSC film were determined using the in-use test and disc diffusion method (Fig. 14(a–f)). In-use studies suggest the lethal effect of HSC film against *A. ferroxidans* and *T. organoparus* Markosian (Fig. 14(a–d)). All HSC coating extracts could hinder the growth of *A. ferroxidans* and *T. organoparus* Markosian; however, HSC film exhibited a more effective hindrance, with the highest zone of inhibition for *A. ferroxidans* ATCC 23270, and *T. organoparus* Markosian ATCC 27977, with diameters of  $18.00 \pm 0.02$  and  $21.00 \pm 0.08$  mm, respectively, as confirmed by the disc diffusion method (Fig. 14(e and f)). Overall, all tested strains were more sensitive to HSC film. The antimicrobial activity exhibited by HSC film was equivalent to that of the positive control sodium metabisulfite; however, no inhibitory activity was observed on the negative control phosphate buffer saline (PBS).

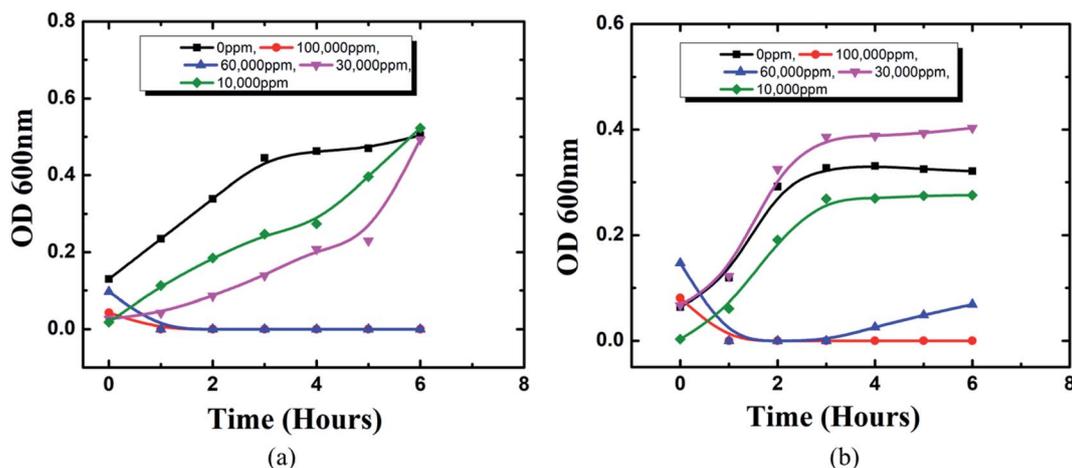
Fig. 15 MIC using microdilution assay of HSC film towards: (a) *A. ferroxidans* ATCC 23270, (b) *T. organoparus* Markosian ATCC 27977.

Further, the minimum inhibitory concentration (MIC) was determined and evaluated using a microdilution assay and the susceptibility was evaluated using 10 000–100 000 ppm per 500 mL. The antimicrobial effectiveness against *A. ferroxidans* and *T. organoparus* Markosian was highest with 60 000–100 000 ppm per 500 mL HSC coating solution (Fig. 15).

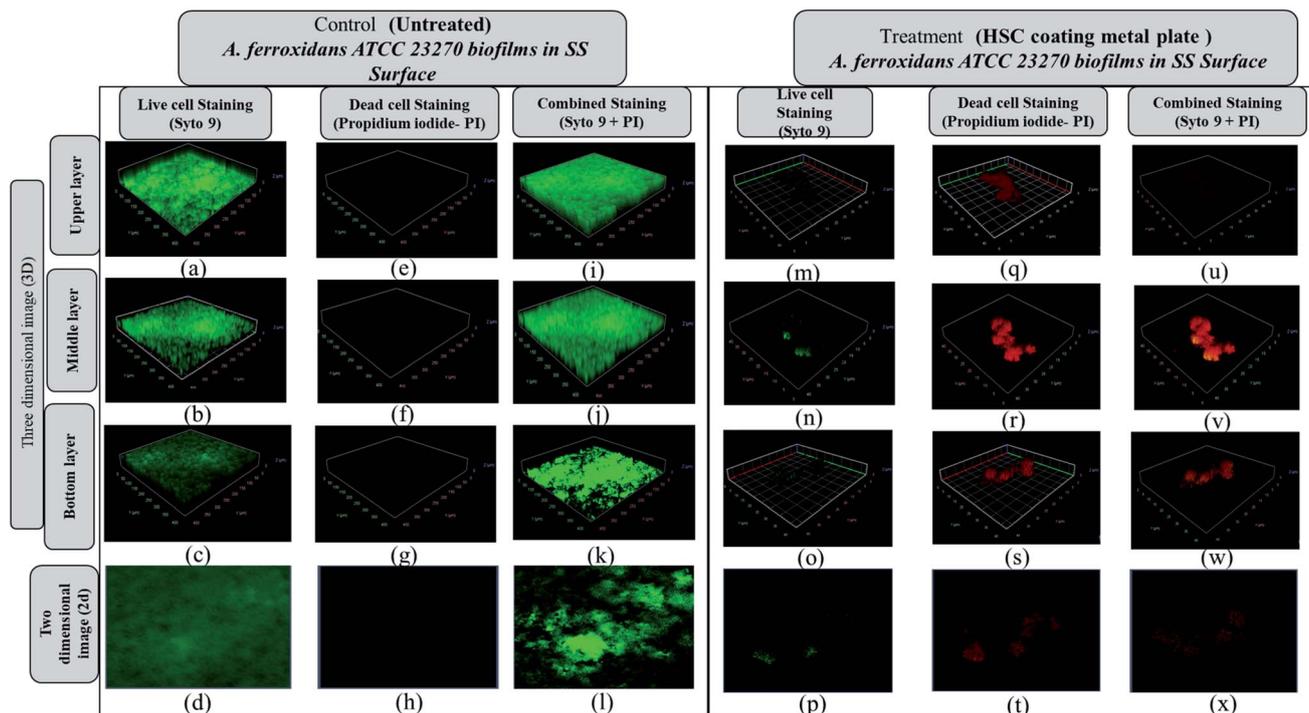
Fig. 16 Anti-adhesion analysis confocal scanning microscope 3D and Z-stack images (upper, middle, lower side of each set (3-dimensional image and 2-dimensional image, respectively)) of live (a–d), dead (e–h), and combined live and dead cells (i–l) of *Acidithiobacillus ferrooxidans* ATCC 23270 biofilms developed on stainless steel (SS) surfaces in BHI at 25 °C for 24 h. The treated metal plate after incubation showed reduced biofilm (m–x). A bacterial viability kit was used.

ability with live (green) Syto 9 (Fig. 16(a–d)) and dead (red) cells propidium iodide (Fig. 16(e–h)) stained with a LIVE/DEAD™ BacLight™ Bacterial Viability kit. The untreated specimens were compared with the treated ones (Fig. 16(m–x)). The results of the anti-adhesion analysis strongly indicate that the biofilm formation ability of *A. ferrooxidans* is greatly affected by the anti-adhesion and antimicrobial efficacy of HSC film. The treated specimens include around 0.1% viable cells (see Fig. 16(m–p)). The anti-adhesion characteristic of HSC film prevents living cells from adhering. Even if living cells attach, the HSC film destroys the maximum number of live cells (see Fig. 16(u–x)).

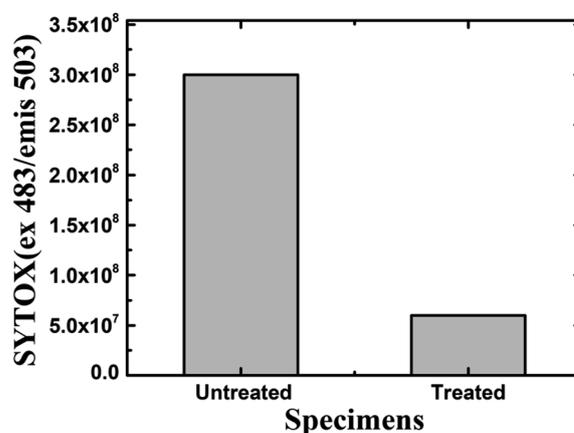
Fig. 17 Fluorescence quantification of living cells in the biofilm of *A. ferrooxidans* ATCC 23270 strain.

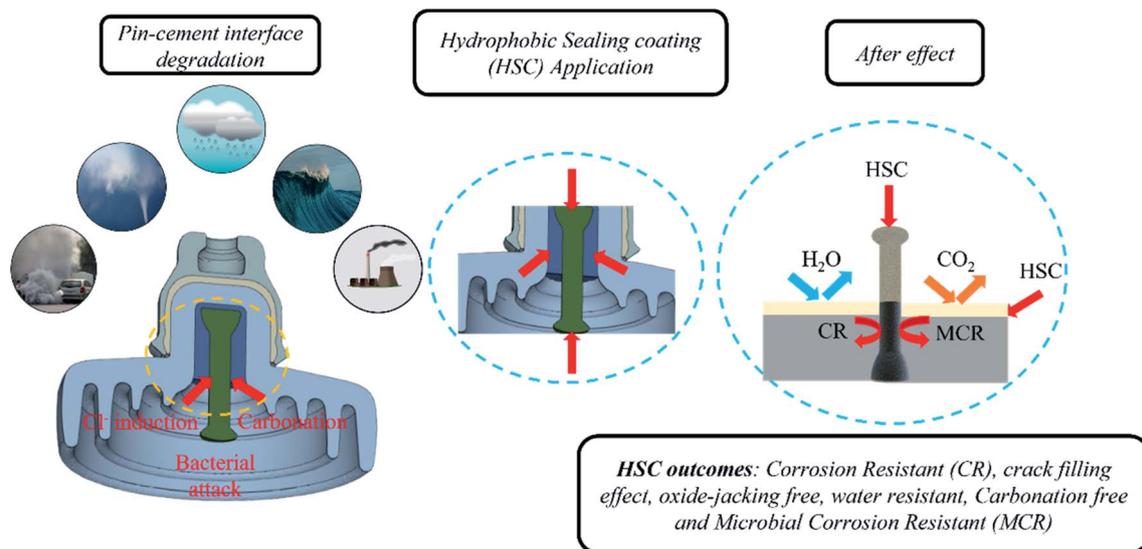
Fig. 18 The function of HSC film applied on the steel (pin)-cement interface.

(pin)–cement interface from the external environment, inhibiting the diffusion of CO<sub>2</sub> and H<sub>2</sub>O into the pores of the steel (pin)–cement interface (see Fig. 18).
