Unravelling and quantifying the aging processes of commercial  $\text{Li}(\text{Ni}_{0.5}\text{Co}_{0.2}\text{Mn}_{0.3})\text{O}_2/\text{graphite}$  lithium-ion batteries under constant current cycling

Cite this: *J. Mater. Chem. A*, 2023, **11**, 41Unravelling and quantifying the aging processes of commercial  $\text{Li}(\text{Ni}_{0.5}\text{Co}_{0.2}\text{Mn}_{0.3})\text{O}_2/\text{graphite}$  lithium-ion batteries under constant current cycling†Jia Guo,<sup>a,b</sup> Siyu Jin,<sup>a</sup> Xin Sui,<sup>a</sup> Xinrong Huang,<sup>c</sup> Yaolin Xu,<sup>\*d</sup> Yaqi Li,<sup>a,b</sup> Peter Kjær Kristensen,<sup>b</sup> Deyong Wang,<sup>b</sup> Kjeld Pedersen,<sup>b</sup> Leonid Gurevich<sup>b</sup> and Daniel-Ioan Stroe<sup>a</sup>

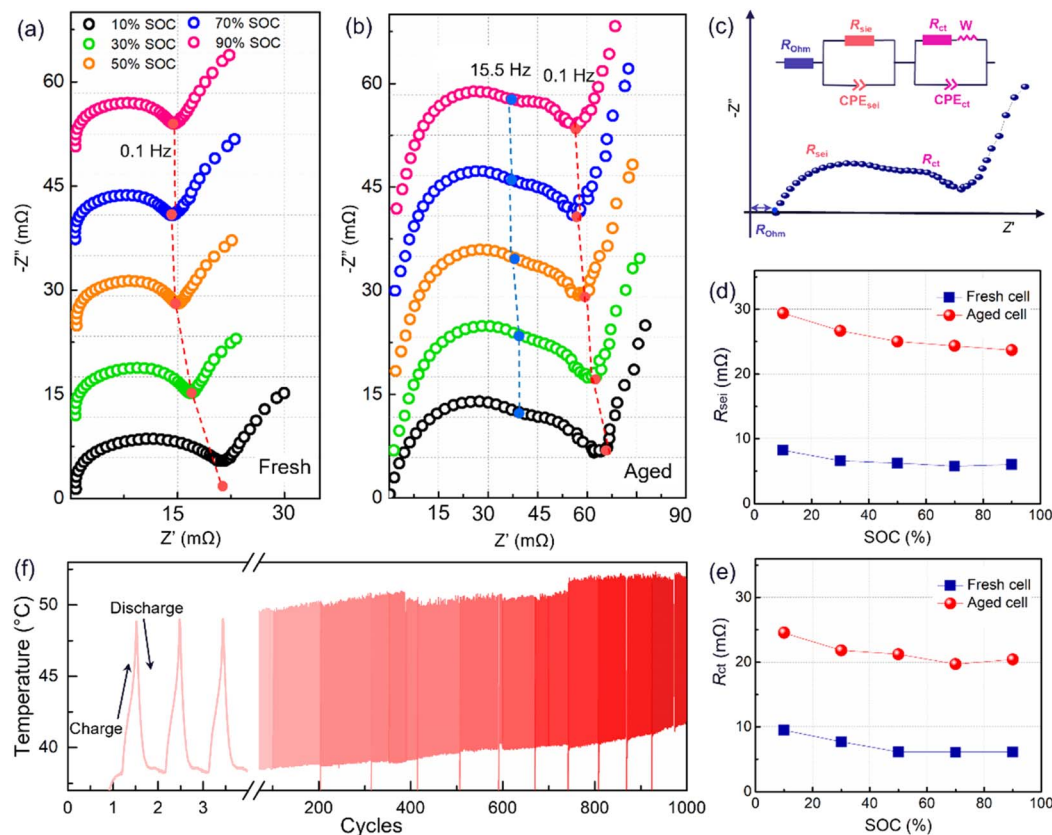
Fig. 2 EIS spectra at different SOC for (a) fresh cell and (b) an aged cell; (c) schematic illustration and an equivalent circuit used to fit the EIS Nyquist plots; the fitted results for (d)  $R_{\text{sei}}$ , and (e)  $R_{\text{ct}}$ . (f) the temperature tested using a temperature sensing probe on the outer surface of the cell.

The polarization was evaluated by performing an *operando* electrochemical impedance spectroscopy (EIS) test. As shown in Fig. 2a and b, the measured results are Nyquist plots, which are

composed of three parts with different frequency ranges, representing the bulk resistance ( $R_{\text{ohm}}$ ), the solid electrolyte interface resistance ( $R_{\text{sei}}$ ), and the charge transfer resistance ( $R_{\text{ct}}$ ), respectively.<sup>3</sup> The inserted equivalent circuit was employed to fit the Nyquist plots, as shown in Fig. 2c. The obtained results are presented in Fig. 2d and e. Here, the  $R_{\text{ohm}}$  will not be adopted due to an unstable ohmic impedance caused by the connector of the electrochemical workstation, and this always shows little change in battery aging.<sup>3,12</sup> Therefore, the Nyquist plots were translated to the origin of the coordinates. After 1000 cycles, a four-fold increase in the  $R_{\text{sei}}$  from below 8 mΩ to about 30 mΩ is observed (Fig. 2c). Besides,  $R_{\text{ct}}$  has increased to over 20 mΩ (Fig. 2d), indicating an overall degradation at the electrode interface and charge transfer. Furthermore,  $R_{\text{sei}}$  and  $R_{\text{ct}}$  decrease with the battery charging.  $R_{\text{sei}}$  is related to the diffusion of Li ions at the interface and the  $R_{\text{ct}}$  is linked to the electrochemical reaction.<sup>22</sup> As reported in ref.<sup>22</sup> the SEI film is partially ruptured at high SOC due to the increased volume of lithiation graphite, and recovers in the followed discharge process. So, the  $R_{\text{sei}}$  decreased with battery charge. Furthermore, a high SOC is linked to a high voltage as well as an active state of the electrochemical reaction, resulting in a lower  $R_{\text{ct}}$ . The temperature of the battery surface was detected in the aging process, as shown in Fig. 2f. The temperature changes periodically with the charge–discharge cycle. Besides, the temperature

range fluctuates, due to an uncontrollable change in the sticking position or tightness of the thermal probe on the battery surface. With the increase in the cycle number, the temperature of the battery surface gradually increases (varying from a low temperature of 42 °C to a high temperature close to 55 °C). The temperature increment will lead to a series of side reactions inside the battery during electrochemical cycling, for example, the rupture and reformation of the interfacial film at high temperatures, resulting in a continuous increase of the internal impedance. This is consistent with the discharge cte-OCV trend, further illustrating that the internal impedance continues to increase with battery cycling.

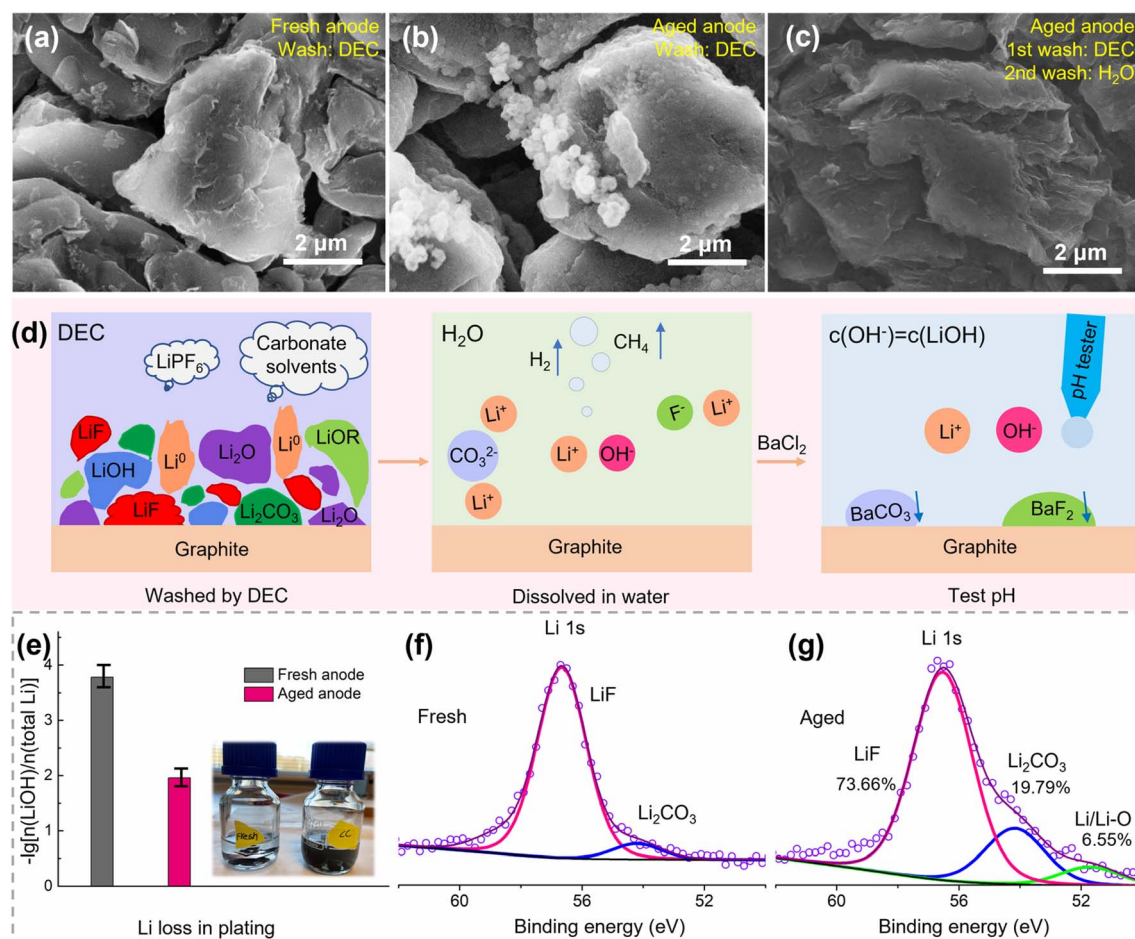
**Fig. 3** Lithium loss on the negative electrode surface. SEM images of the graphite anode from (a) the fresh cell, (b) the aged cell after washing with DEC, and (c) the aged cell after washing with DEC and then with water; (d) the mechanism diagram of the dissolution of lithium compounds in water and quantified by the pH test, and the quantified result of the LiOH content is shown in (e); Li 1s XPS spectra of the negative electrode from (f) fresh cell and (g) aged cell.

violently reacted with water producing significant bubbles, as shown in Fig. S3.† After reaction with water, the negative electrode shows a clean surface, and the SEM image is shown in Fig. 3c. Most of the particles and rough surface layer have disappeared, and then a collapsed graphitic shape and a smooth surface appear. This is due to the reactions between the water and Li or Li compounds. The possible reactions and solubility of these Li compounds are summarized in Table 1.<sup>15</sup> The reaction product is mainly alkaline soluble LiOH. pH measurement

has been widely used to quantify residual lithium in nickel-rich material production.<sup>20</sup> Here, we use the pH value to quantify the irreversible lithium that can react with water and dissolve in water as a state of  $\text{Li}^+$  and  $\text{OH}^-$ , and the process is illustrated in Fig. 3d, followed by X-ray photoelectron spectroscopy (XPS) measurement to quantify the total content of lithium loss on the graphite anode.

The pH values are 10.64 and 8.81 for the aged and fresh negative electrodes, respectively, corresponding to a lithium loss of 1.10% and 0.02% in the form of  $\text{Li}^0$ ,  $\text{Li}_2\text{O}$ ,  $\text{LiOH}$ ,  $\text{CH}_3\text{Li}$ , and  $\text{ROLi}$ , as shown in Fig. 3e. Furthermore, the XPS spectrum of Li 1s was measured for the electrodes of Fig. 3a and b, as shown in Fig. 3f and g, respectively. There are three fitted peaks for the aged negative electrode, which belong to  $\text{LiF}$ ,  $\text{Li}_2\text{CO}_3$ , and  $\text{Li/Li-O}$  compounds, corresponding to an amount of 73.66%, 19.79%, and 6.55% Li, respectively. Here, the  $\text{Li/Li-O}$  compounds correspond to the pH quantified part (1.10%). Therefore, the lithium loss in the aged negative electrode can be quantified as 16.82%. Note that some active Li inserted in graphite during the voltage recovery from a fully discharged state. So, the pH test and XPS results establish that the lithium loss is much lower compared with the capacity loss (over 50%). This further proves that there is no significant amount of

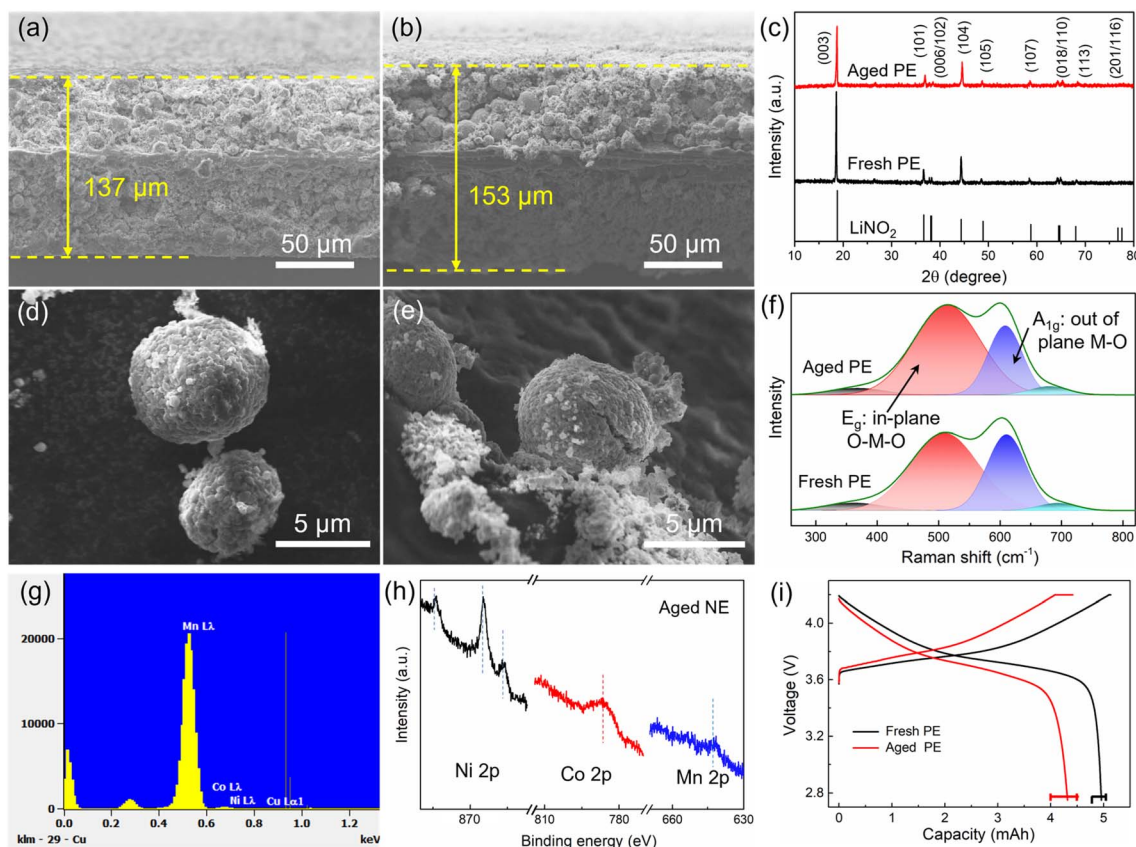
**Fig. 4** Cross-section SEM images of (a) fresh and (b) aged positive electrodes. (c) XRD patterns of the fresh and aged positive electrodes (PE). SEM images of (d) fresh and (e) aged NMC particles. (f) Raman spectra of the fresh and aged positive electrodes. Transition metals (Mn, Co, and Ni) from the positive electrode are deposited on the negative electrode surface, which can be measured by (g) EDS point scan and (h) XPS. (i) The voltage profiles of the fresh and aged positive electrodes were tested against the Li metal electrode with a coin cell in the voltage range of 2.75–4.2 V at 0.05C.

**3.2.2 Materials degradation.** Fig. 4a and b show the cross-section SEM images of the fresh and aged positive electrodes, respectively. The average thickness of the fresh positive electrode is 137  $\mu\text{m}$  (Fig. 4a). After aging, the average thickness increases to 153  $\mu\text{m}$  (*i.e.*, increases by 11.7%) (Fig. 4b). Besides, cracks appeared and extended to the inner part of the electrode, resulting in loose particles and intra-electrode voids, which is one of the reasons for the increased electrode thickness.

Another reason is the increased volume of cathode grains, which can be evaluated by the left shift of the XRD pattern as shown in Fig. 4c. This will lead to an increase in the paths of charge transfer and Li diffusion as well as an increased internal resistance. Besides, the inconspicuous splitting peaks (006/012) mean a decreased crystallinity, and the increased  $I(003)/I(104)$  means increased Li/Ni cation mixing for the aged positive electrode.<sup>28</sup> Furthermore, the deterioration of the material is also reflected in particle morphology. The surface of the fresh cathode particles (Fig. 4d) is smooth, and then, pulverization and cracking happen during aging (Fig. 4e). Besides, the presence of residue powders on the cathode particle surface seems

to be due to interface compositions, and this was tested by XPS as shown in Section 3.2.3. The cracks are also reflected in the Raman spectrum (Fig. 4f), where NMC can be thought of as a solid solution of  $\text{LiNiO}_2$ ,  $\text{LiMnO}_2$ , and  $\text{LiCoO}_2$ . Among them, layered  $\text{LiNiO}_2$  and  $\text{LiCoO}_2$  contribute only two Raman-active modes, one is the  $A_{1g}$  mode at  $609\text{ cm}^{-1}$  and the other is the  $E_g$  mode at  $503\text{ cm}^{-1}$ , corresponding to the out-of-plane M–O stretch and in-plane O–M–O band, respectively.<sup>29</sup> The additional weak bands were contributed by  $\text{LiMnO}_2$ . After aging, the increased  $E_g$  mode means an increase in the amount of the in-plane O–M–O band, which is consistent with the crack formation and inside-surface exposure as shown in Fig. 4e. As reported, the HF from electrolyte decomposition is easy to penetrate into cathode particles and induce serious side reactions, causing the transition metal to dissolve in the electrolyte and then deposit on the negative electrode surface. EDS point scans were performed to verify the presence of transition metal elements Ni, Co, and Mn, as shown in Fig. 4g. Furthermore, Ni, Co, and Mn elements can also be observed by XPS from the surface of the aged negative electrode (Fig. 4h). As reported in ref.<sup>30</sup> and <sup>31</sup>, the Co deposits on the graphite surface can also accelerate the exfoliation of graphite, leading to a severe degradation of the full cell.

electrode capacity degradation, which can be evaluated using coin cells. As shown in Fig. 4i, the aged positive electrode shows a higher charge plateau and a lower discharge plateau, which are caused by polarization. Furthermore, there is no evident constant-voltage charging segment for the aged positive electrode, which means that the positive electrode has been fully charged before the constant-voltage charging period with a  $0.05\text{C}$  current. In contrast, the battery voltage of the aged positive electrode prematurely reaches the upper cut-off voltage during charging due to a high internal resistance, resulting in a long constant-voltage charging period as well as a decreased battery capacity. However, over 86% of the initial capacity is still maintained.

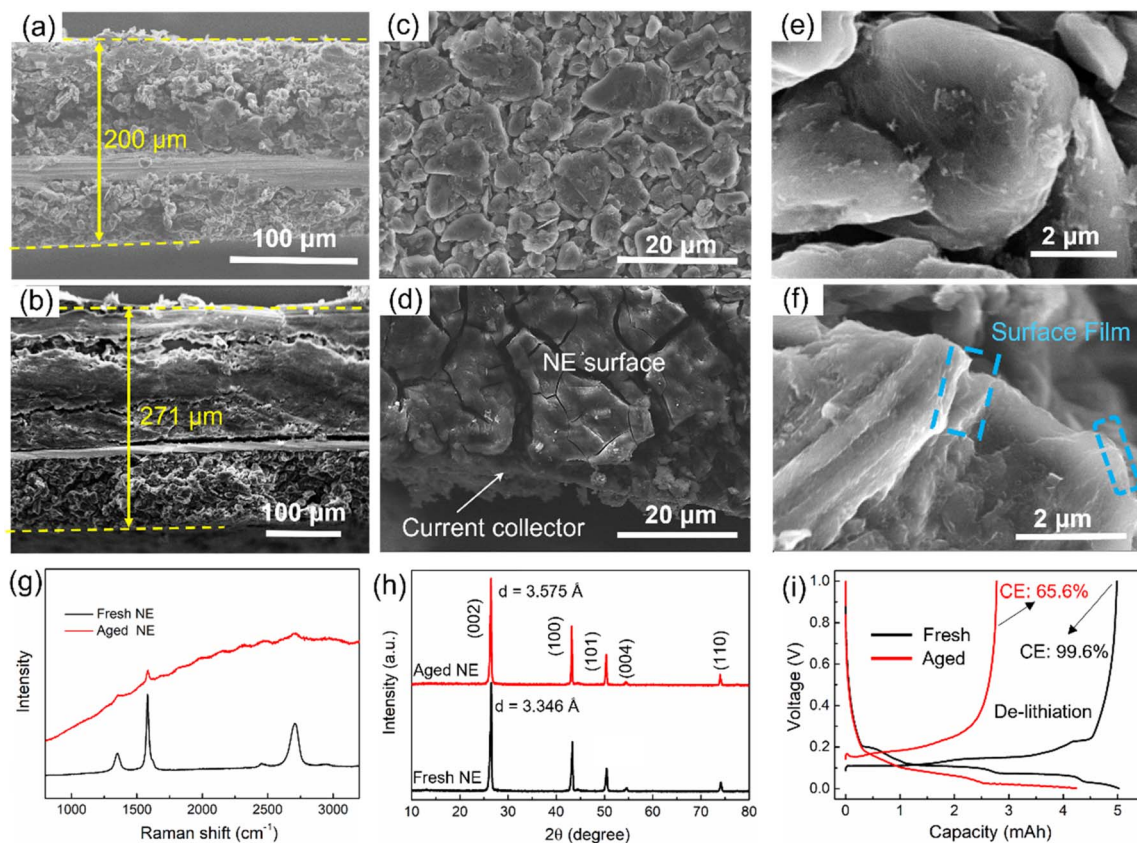
**Fig. 5** Cross-section SEM images of (a) fresh negative electrode and (b) aged negative electrode; top surface SEM images of (c) fresh negative electrode and (d) aged negative electrode; SEM images of (e) fresh graphite particles and (f) aged graphite particles; (g) Raman spectra of the fresh and aged negative electrodes; (h) XRD patterns of aged and fresh negative electrodes; (i) charge and discharge voltage curves obtained by testing against Li in coin cells in a voltage range of  $0.001\text{--}1.0\text{ V}$  at  $0.05\text{C}$ .

Similarly, the negative electrode also becomes thicker after aging. The thickness of the fresh negative electrode is  $200\text{ }\mu\text{m}$  (Fig. 5a), which increased to  $271\text{ }\mu\text{m}$  (*i.e.*, 30.5% increase) after aging (Fig. 5b). There are a lot of cracks and exfoliated pieces in the aged negative electrode, which is a key reason for the thickening of the negative electrode. Besides, the materials are stripped from the current collector, leading to an increase in  $R_{ct}$ , as illustrated in Fig. 2e. From the top view, the surface film, which has a thick and cracked surface, can be observed on the top of the aged negative electrode (Fig. 5d), and a surface film also can be observed from the edges of the graphite particles in the SEM image (Fig. 5f), which is the main reason for surface

impedance in batteries. Besides, the graphite particles collapse into irregular shapes after degradation. Furthermore, Raman measurements with laser wavelengths of 532 nm were performed to test the interface structures of both fresh and aged negative electrodes (Fig. 5g). However, Raman spectroscopy can only detect a very weak graphitic phase from the aged negative electrode interface, implying that the thickness of the interfacial precipitates is close to 500 nm. XRD patterns were recorded to evaluate the structure change, as shown in Fig. 5h. Layer spacing of graphite increased from 3.346 Å to 3.575 Å with the aging, resulting in a volume expansion of the negative electrode. This is another reason for the electrode thickening.

The influence on negative electrode capacity is shown in Fig. 5i. The lithiation process of the graphite anode can be fully carried out with a lower cut-off voltage (0.001 V). The capacity fade of the lithiation process represents the loss of lithium-intercalated graphite, which is less than 15%. However, the de-lithiation process is easily affected by the initial charging voltage caused by an internal impedance, and the coulombic

efficiency of the aged negative electrode is only 65.6%, resulting in a 44% capacity loss in the de-lithiation process compared with that of the fresh negative electrode.

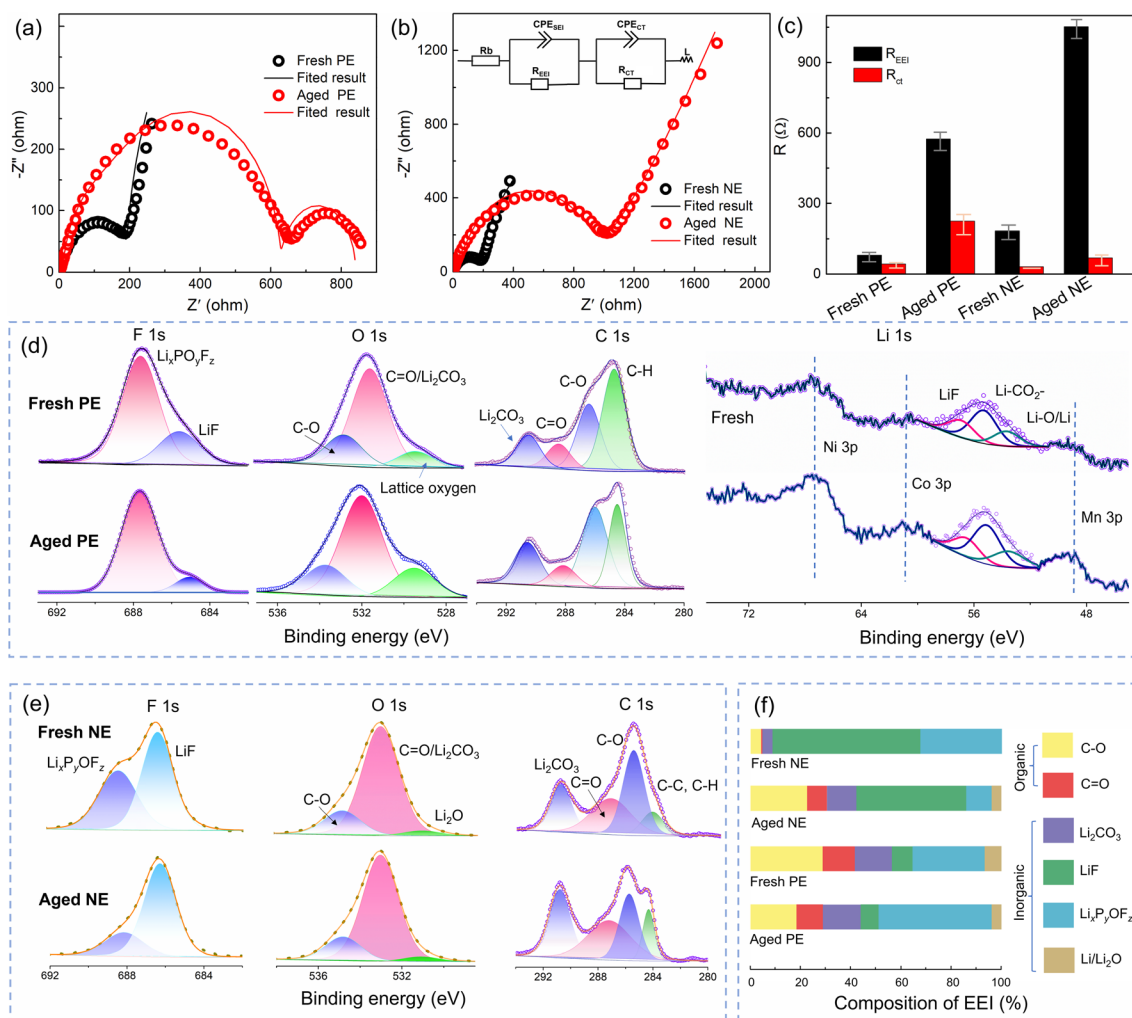
**Fig. 6** Impedance evolution tested using coin cells for the fresh and aged (a) positive electrode (PE), and (b) negative electrode (NE), and (c) fitted results,  $R_{\text{EEI}}$ ,  $R_{\text{sei}}$  or  $R_{\text{cei}}$ ; XPS spectra of (d) F 1s, O 1s, C 1s, and Li 1s for the positive electrodes and (e) F 1s, O 1s, and C 1s for the negative electrodes; (f) the chemical composition obtained by quantitative XPS characterization of the SEI film on the negative electrode surface and CEI film on the positive electrode surface.

aged positive electrode (Fig. 6a), indicating deteriorated electronic conductivity,<sup>33</sup> which is related to the cracks and pulverization on the cathode. Furthermore, the impedance spectra of the negative electrode are shown in Fig. 6b. The  $R_{\text{sei}}$  of the aged negative electrode is 1052  $\Omega$ , while the  $R_{\text{sei}}$  of the fresh one is only 183  $\Omega$ . Therefore, the impedance of the positive and negative electrodes is mainly contributed by the interface film.

XPS was performed to identify the CEI composition, and the results of F 1s, O 1s, C 1s, and Li 1s are shown in Fig. 6d. This indicates that CEI films are mainly composed of  $\text{Li}_x\text{P}_y\text{OF}_z$  (peaks at 688.5 eV in the F 1s spectrum), LiF (peaks at 56.5 eV in the Li 1s spectrum, and 686.3 eV in the F 1s spectrum), C–O (peaks at 535.3 eV in the O 1s spectrum), CO (peaks at 288.9 eV in the C 1s spectrum),  $\text{Li}_2\text{CO}_3$  (peaks at 55.6 eV in the Li 1s spectrum and 291.0 eV in the C 1s spectrum), and Li–O (peaks at 51.5 eV in the Li 1s spectrum). It is worth noting that the percentage of lattice oxygen increases obviously for the aged positive electrode in the O 1s spectrum, which is related to the crack formation and exposing a vast fresh surface inside secondary particles,<sup>34</sup> which is consistent with the SEM analysis in Fig. 4e. Furthermore, this was further confirmed by the enhanced bands of Ni–Li, Co–Li, and Mn–Li in the Li 1s spectrum.

For the SEI film (Fig. 6e), the formation of  $\text{Li}_x\text{P}_y\text{OF}_z$  originates from the reactions of trace  $\text{H}_2\text{O}$  and  $\text{LiPF}_6$  in electrolyte,<sup>35</sup> which belongs to the primary precipitated solid and can decompose to form  $\text{Li}_3\text{PO}_4$  and LiF.<sup>36,37</sup> In the Li 1s spectrum,  $\text{Li}_2\text{CO}_3$  is mainly derived from electrolyte decomposition.<sup>36</sup> Besides,  $\text{Li}_2\text{O}$  (peak at 52.4 eV) can be attributed to Li reducing  $\text{CO}_2$  that comes from the decomposition of  $\text{Li}_2\text{CO}_3$  at a high voltage (about 4.2 V).<sup>38</sup>

A quantitative analysis of the XPS data was performed for further analysis. As shown in Fig. 6f, inorganic compositions are the major EEI components, which play an essential role in achieving the electronic insulation of the EEI.<sup>32</sup> For the SEI film, the increased content of organic compositions (such as C–O and CO) on the aged NE originates from the decomposition of ethylene carbonate (EC), which is related to a degraded electrolyte.<sup>35</sup> Furthermore,  $\text{Li}_2\text{CO}_3$  and LiF are the main ionic carriers for  $\text{Li}^+$  diffusion at the interface. The decreased percentage of LiF in the aged anode will hinder the diffusion of Li-ions, as well as lead to an increased  $R_{\text{sei}}$  as shown in Fig. 2d and 6b. Unlike the SEI film, the most occupied components in the CEI film are  $\text{Li}_x\text{P}_y\text{OF}_z$  and organic components, due to  $\text{LiPF}_6$  decomposition at high voltage on the positive electrode side.<sup>35</sup> Besides, the percentage of inorganic compounds ( $\text{Li}_x\text{P}_y\text{OF}_z$ ,  $\text{Li}_2\text{CO}_3$ , LiF, and  $\text{Li}_2\text{O}$ ) changed after aging, due to the further reformation of the CEI and SEI that is more easily damaged at high operation temperature. As a result, the interface
