Cite this: *J. Mater. Chem. C*,  
2024, 12, 9401

# Infiltration issues in printed mesoporous carbon perovskite solar cells: a troubleshooting guide

C. A. Worsley,<sup>id</sup>\* T. Dunlop,<sup>id</sup> S. J. Potts,<sup>id</sup> R. Bolton, E. Jewell and  
T. M. Watson<sup>id</sup>\*

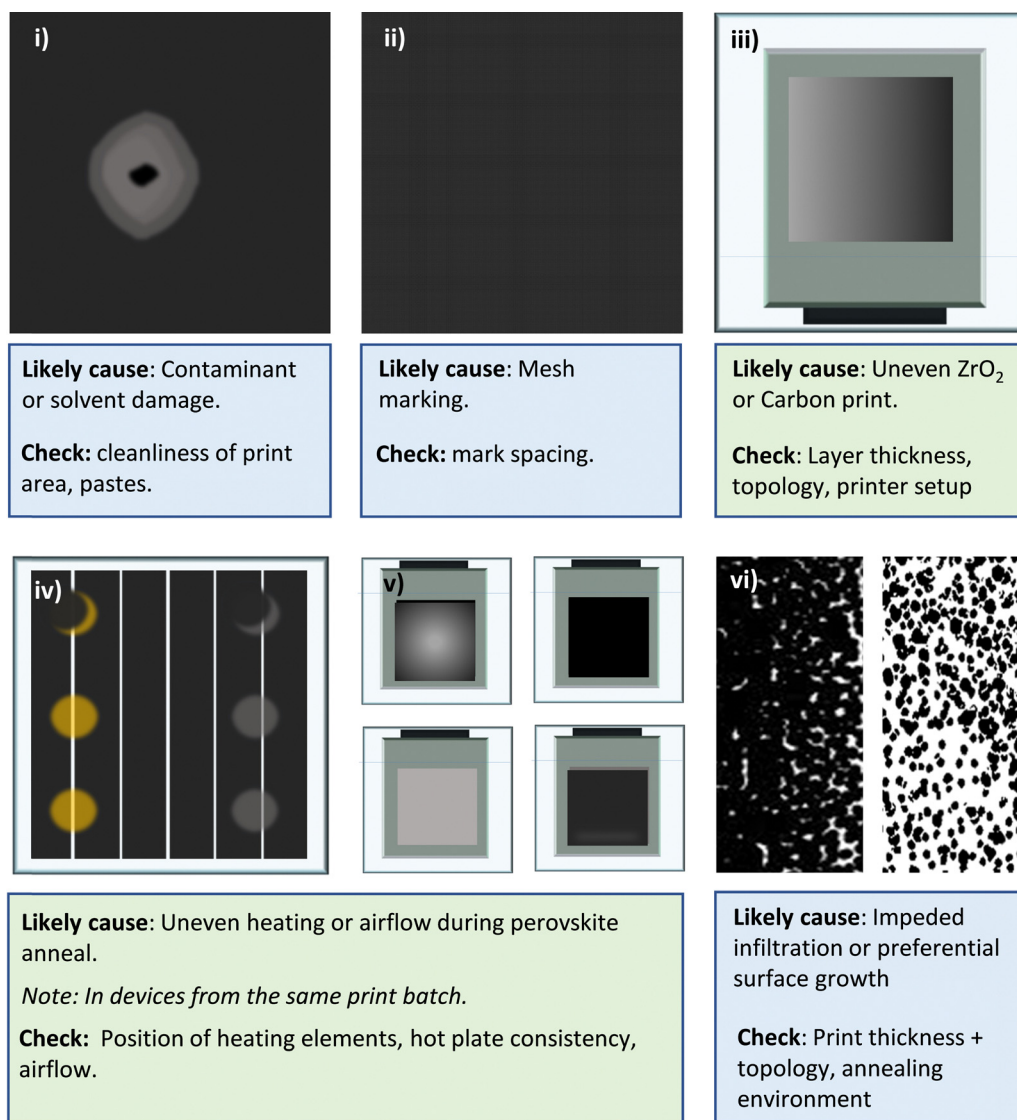
Fig. 1 Diagrams of common large (green text box, (iii)–(v)) and small-scale (blue text box, (i), (ii) and (vi)) infiltration issues in cells and modules, alongside likely causes and suggested checks. Each defect is discussed separately in the relevant numbered section below.

For quick identification of problems, Fig. 1 shows a diagrammatic representation of identified common, characteristic infiltration defects observed at the micro (blue) and macro (green) scale in CPSCs, alongside checks for potential causes. Each issue will be discussed in greater detail in a following subsection, with a final section covering causes of low performance in the absence of defects.

Note that each defect type can appear at a range of scales, and poorly infiltrated devices often exhibit many defects – sometimes with a combination of many types. The specific impact on device performance will therefore be highly dependent on defect size, spread, and prevalence. The effect on performance may also vary depending on perovskite formulation. Thus, it is not possible to provide a representative or accurate value for the performance increase attained by removing a given defect type, as its negative impact will be different in each cell. Specific performance data is not therefore presented in this work, instead focusing on the specific manufacturing issues that cause these characteristic defects and how to overcome them.

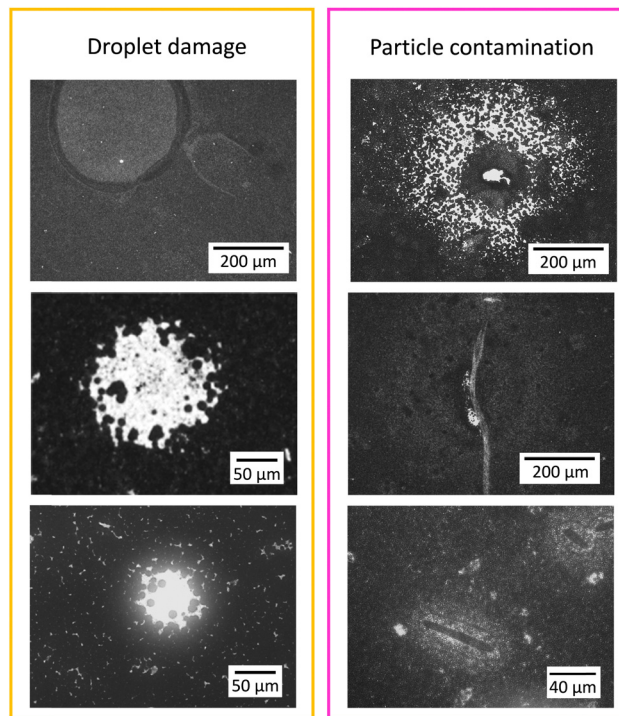
Fig. 2 Optical images of infiltration defects caused by solvent droplet damage and particle contamination.

Often (but not always) visible at the macro-scale, contaminants and solvent damage produce similar issues in completed devices, producing uneven defects of varied size, sometimes with a distinctive ‘halo’ or ringed surrounding pattern (Fig. 2). In the case of physical contaminants, a particle can be present at the defect centre, whereas solvent contamination issues are particle free. Particles will be visible through the glass substrate if the associated contamination is under, in, or on the  $\text{TiO}_2$  print. Particle contamination of the  $\text{ZrO}_2$  and carbon may also result in defects, but the given particle is unlikely to be visible through the glass substrate.

While solvent damage can be easily prevented through careful handling of liquids around printed stacks (especially when wet), physical contamination can be more persistent depending on the source. Wet and dry printed layers, screens and printing equipment should all be stored under covers to protect from dust and other airborne particulates. Placing wet films in areas of high airflow is not advised, as it can prevent film settling/slumping and increase the likelihood of particle contamination.

Upon observing these defects in cells or modules, pastes, screens, and printing equipment should be carefully inspected for particles or blockages. Blocked screens require cleaning, while contaminated pastes should be disposed of. If equipment and materials appear clean, the printing, film relaxation/slumping, annealing and storage areas should be wiped down to eliminate the source of particles, and storage procedures reviewed where necessary.

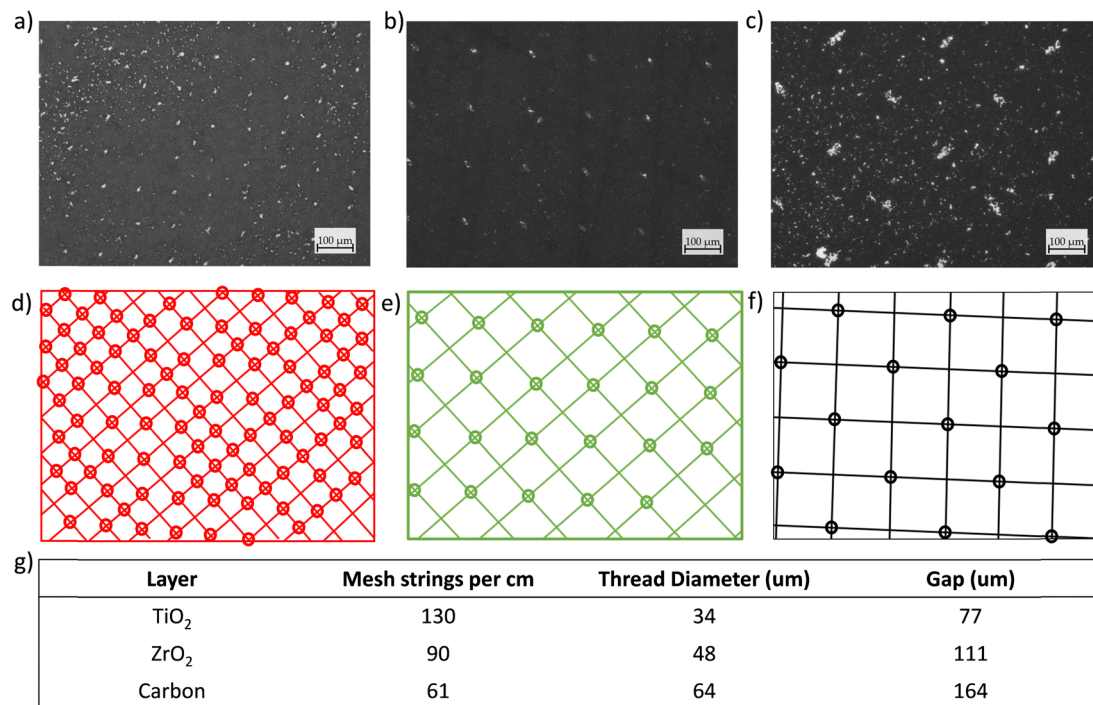
Fig. 3 Optical images of infiltrated TiO<sub>2</sub> in devices showing mesh mark defects from (a) TiO<sub>2</sub>, (b) ZrO<sub>2</sub>, and (c) carbon screens. (d)–(f) Show diagrams of mesh dimensions of TiO<sub>2</sub>, ZrO<sub>2</sub> and carbon screens respectively, with circles representing cross sections where an infiltration issue is present in the device. (g) Shows mesh types and calculated gap size for each layer.

Perhaps the most characteristic defects are those caused by mesh marks; troughs or peaks at the surface of a screen printed layer. Mesh marks occur due to ink filaments forming at mesh crossover sections as the screen separates from the substrate during printing. This produces round, evenly spaced infiltration defects in the finished device. Usually present across a large area, these features are obvious when examining the infiltrated  $\text{TiO}_2$  layer with an optical microscope (Fig. 3a–c). Critically, mesh marks in the  $\text{ZrO}_2$  or carbon print can cause infiltration defects at the base of the  $\text{TiO}_2$ . (Fig. 3a–c) shows optical microscopy images of infiltrated  $\text{TiO}_2$  layers from three devices, which respectively show evidence of  $\text{TiO}_2$ ,  $\text{ZrO}_2$  and carbon related mesh mark infiltration defects.

As presented in Fig. 3, observed infiltration defects will correspond with the mesh dimensions of the relevant screen. Therefore, if different screens have been used for  $\text{TiO}_2$ ,  $\text{ZrO}_2$  and carbon, defect spacing can be measured to conclude in which layer the problematic marks reside. For example, the small defects in Fig. 3a must correspond with those from the  $\text{TiO}_2$  layer, as this was the only deposition where a fine mesh was used (Fig. 3c). Note that defects may only appear (or be more severe) at alternate cross sections, as is the case in Fig. 3b and c. If similar mesh screens are used for different layers, the problematic layer can be identified using WLI (white light interferometry) of any remaining uninfiltrated devices single prints (Fig. 3b).

shown that slight increases in ZrO<sub>2</sub> roughness can cause severe increases in marking of the subsequent carbon print.<sup>22</sup> Therefore, the topology of all layers (in an uninfilted sample) should be examined upon observing mesh marking to ascertain the root cause of the problem.

As mesh marks are caused by ink filamentation during printing, printer setup and ink formulation are critical to their prevention. Printer setup techniques to avoid mesh marking include using the minimum printable squeegee pressure or switching to a finer mesh.<sup>22,23</sup> It should be noted that not all pastes are suitable for fine mesh screens- for example, the large graphite flakes in carbon inks are likely to cause blockages. A flow coat print regime, where paste is spread over the screen before a single squeegee pass can also reduce marking. Unless pastes are considerably viscous, a print–print (or two squeegee passes) is not likely required and unnecessarily increases the risk of severe marking.<sup>22,23</sup> Alternatively, pastes can be altered to reduce filamentation by lowering viscosity and/or elasticity.<sup>23</sup> This can be achieved with careful dilution or by changing the amount or type of binders used.<sup>22</sup>

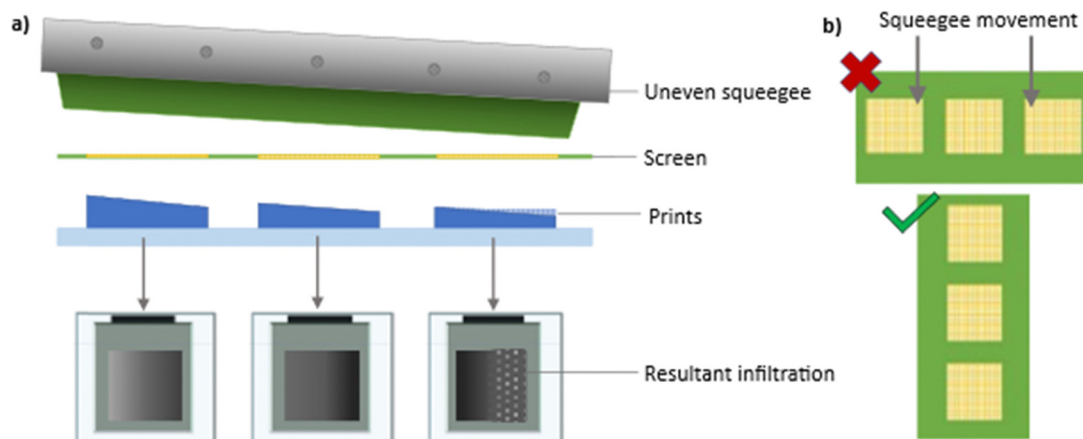
Fig. 4 (a) Diagrammatic representation of the consequences of uneven squeegee pressure and its resultant impact on device infiltration. Note that mesh marking defects in real samples will only be visible via optical microscopy. (b) Screen alignment to limit horizontal print variations.

Sub-optimal printer setup is usually the cause of these issues, although glass warping can also cause similar problems. Consequently, it may be a more prevalent issue in more manual screen-printing equipment, as advanced machines will be able to detect screen, squeegee or substrate misalignment. As shown in Fig. 4a, uneven squeegee or flow coat setup can produce thickness variation across the print. In extreme cases, one side of the print will be extremely thick (limiting infiltration), and the other thin with pronounced mesh marking (as depicted in Fig. 4a). Note that small inconsistencies in the ZrO<sub>2</sub> can cause large problems in the subsequent carbon print, so sub-optimal inhomogeneous carbon prints may not be a consequence of printer setup during carbon deposition.<sup>22</sup>

In the case of glass warping, observed infiltration gradients will align with the substrate warp, with areas further from the screen usually producing thicker prints, and areas closer to the screen producing thinner ones (sometimes accompanied by mesh marking).

It is advisable to retain an uninfilted device stack from each print batch, as print thicknesses or substrate warp can be then examined with profilometry, while white light interferometry provides quick topological data. Infiltrated devices are more difficult: although mesh marking problems can be

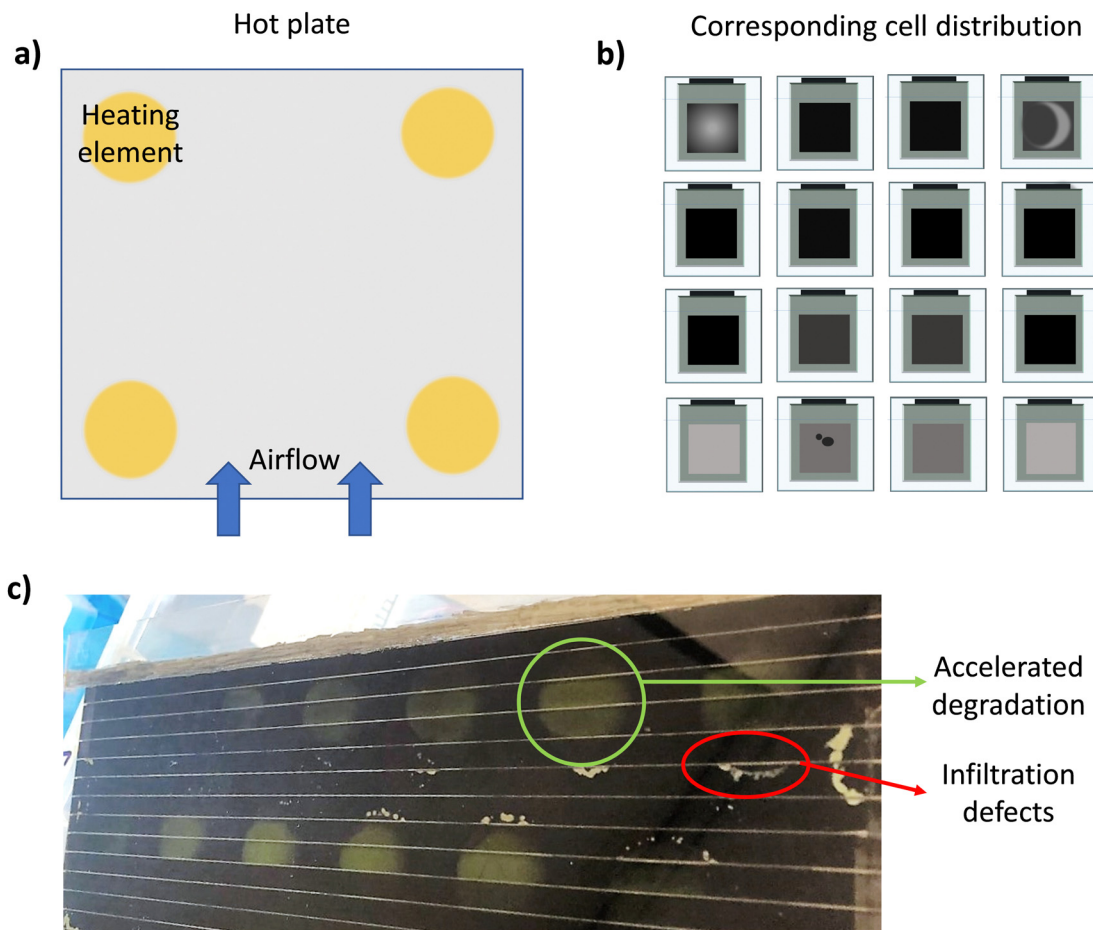
Fig. 5 Diagrammatic representation of (a) an unevenly heating hot plate and (b) resultant impact on device infiltration. Depicted in (c) is a photograph of damage on a  $30 \times 30 \text{ cm}^2$  module caused by heating elements and airflow during perovskite annealing.

Crystallisation speed is well documented to impact infiltration, with longer crystallisation times having been found to improve the infiltration of perovskite precursors based on a variety of solvents. This means that inconsistencies in temperature or airflow during infiltration or annealing can produce very different infiltration depending on the position of the device on the hot plate or oven (Fig. 5a and b). This is the case even where the print quality is consistent across the batch or module. Unless care is taken to note the hot plate position of each device during annealing, the infiltration variation across a batch may appear random. It is therefore advisable to examine each device upon removal from the hot plate or oven after annealing and note the position of any which exhibit obvious infiltration issues.

This issue can occur at multiple scales and using different equipment setup. For example, Fig. 5c shows a  $30 \times 30 \text{ cm}^2$  module annealed on a conveyor dryer. Through the glass substrate, greyish white and yellow defects can be seen, impacting multiple cells. The grey or white perovskite free voids indicate an infiltration issue caused by fast crystallisation and high airflow, whereas the yellow areas show accelerated degradation due to uneven heating. On examination of equipment, the yellow defects corresponded with overhead heating elements in the dryer and the white and grey with areas of high airflow.

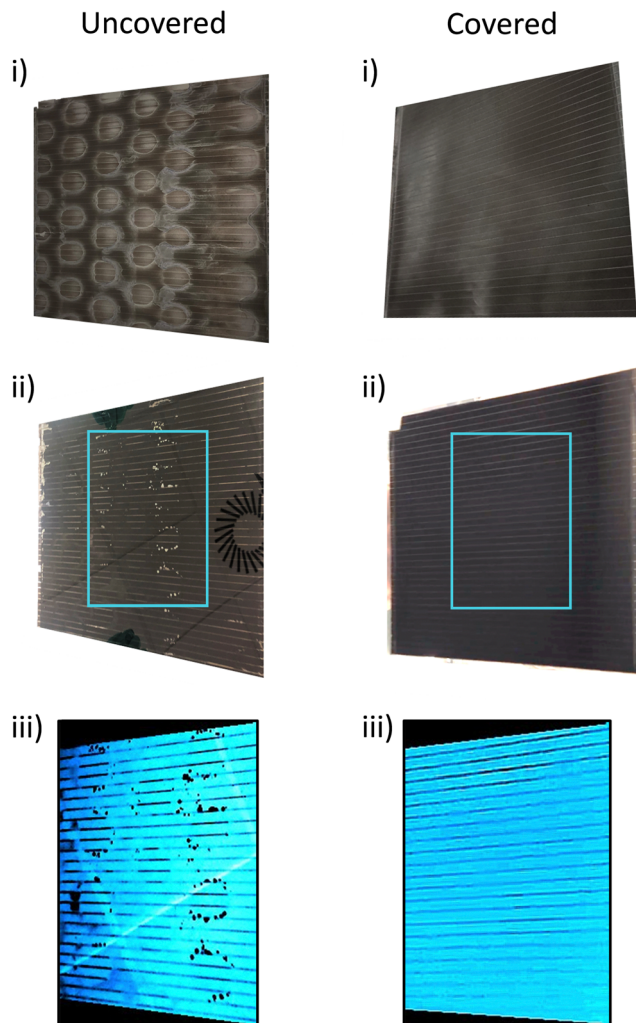
Fig. 6 Photographs of 519 cm<sup>2</sup> active area modules with (RHS) and without (LHS) a cover during perovskite annealing. (i) Back electrode, (ii) through glass substrate, (iii) magnified with applied colour filter to highlight infiltration problems.

A simple partial cover was thus applied, to protect the module surface while allowing sufficient solvent removal. This completely eliminated the defects, as shown in Fig. 6.

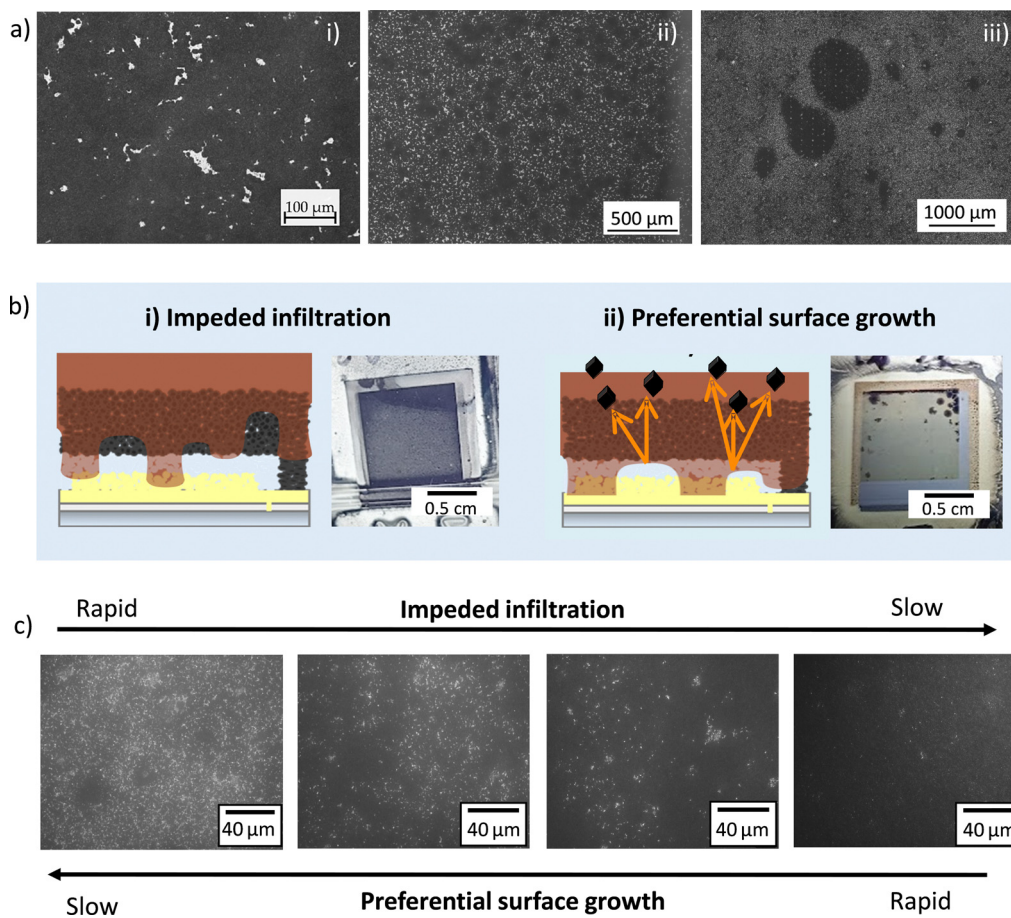
Fig. 7 (a) Optical microscopy images of randomly distributed infiltration defects at different scales. (b) Diagrammatic representation and example photograph of (i) impeded infiltration and (ii) preferential surface growth. (c) The impact of crystallisation speed with each mechanism.

Perhaps the most difficult to diagnose is when devices present with apparently random infiltration issues spread. As shown in Fig. 7a, this can appear at multiple scales with extreme variation in the shape and distribution of observed defects.

There exist two distinct mechanisms that can cause these problems, depicted in Fig. 7b. Impeded infiltration (Fig. 7b(i)) occurs when precursor cannot effectively reach the base of the stack, while preferential surface growth (Fig. 7b(ii)) is seen when nucleation and crystal growth occurs more favourably atop or within the carbon layer, reducing crystal formation in the small pores of the  $\text{TiO}_2$  electrode. Both mechanisms can also occur concurrently: *e.g.* upon applying a new precursor formulation that favours surface crystal growth to a batch of cells with thick, rough carbon prints.

Example photographs of devices with particularly severe infiltration issues caused by each mechanism are shown in Fig. 7b. It should be noted that although the devices in the example look very different, they are not characteristic of the associated infiltration issue: without further examination or specific knowledge of the given sample, is not possible to tell visually which mechanism is present.

The causative mechanism can sometimes be identified through monitoring perovskite crystallisation speed across a batch and subsequently examining infiltration. To induce different crystallisation speeds, samples can be deliberately annealed at different temperatures. In the case of impeded infiltration, the best infiltration will be attained in devices that crystallised slowly, as the precursor had more time to percolate the stack. Conversely, with preferential surface growth the best infiltration will present in rapidly crystallised devices, as the infiltrated precursor rapidly forms small grains within the  $\text{TiO}_2$  pores instead of slowly growing larger grains at the carbon

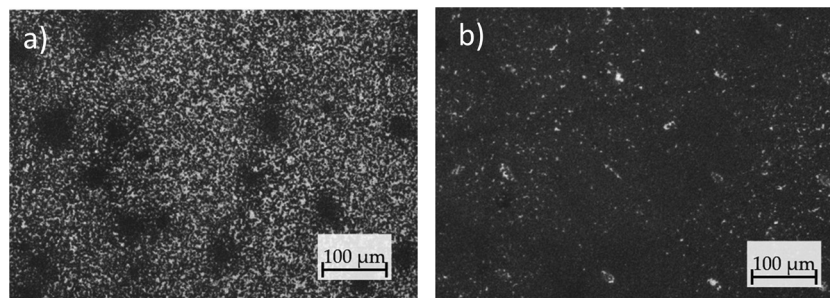
Fig. 8 Optical microscopy images of two devices with impeded infiltration, (a) annealed on an open hot plate and (b) under a partial cover. (b) Reveals mesh marks not observed.

Severe issues are usually caused by multiple concurrent problems acting in tandem. Fig. 8 shows images of  $\text{TiO}_2$  infiltration from two devices from the same print batch, (a) annealed on the hot plate and (b) under a partial cover to limit surface airflow. Reducing surface airflow has produced better infiltration in sample b, revealing mesh marking defects that were not observable in the more sparsely filled sample a. Both issues (high surface airflow and mesh marking) therefore require resolving to ensure high-quality infiltration.
