Journal of Materials Chemistry C

DOI: 10.1039/d4tc01157k

Infiltration issues in printed mesoporous carbon perovskite solar cells: a troubleshooting guide

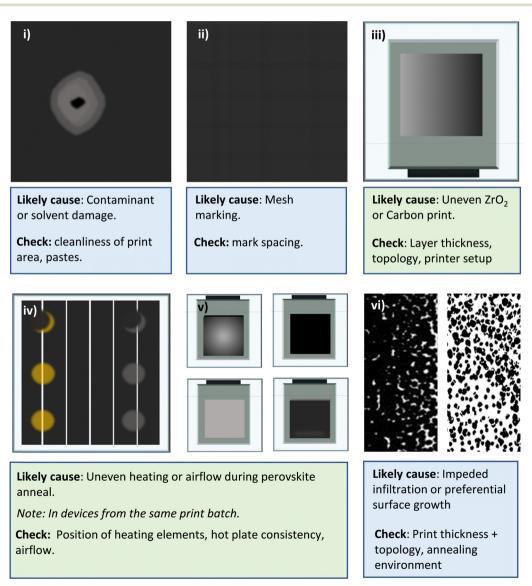
Fig. 1 Diagrams of common large (green text box, (iii) – (v)) and small-scale (blue text box, (i), (ii) and (vi)) infiltration issues in cells and modules, alongside likely causes and suggested checks. Each defect is discussed seperately in the relevant numbered section below.

For quick identification of problems, Fig. 1 shows a diagrammatic representation of identified common, characteristic infiltration defects observed at the micro (blue) and macro (green) scale in CPSCs, alongside checks for potential causes. Each issue will be discussed in greater detail in a following subsection, with a final section covering causes of low performance in the absence of defects.

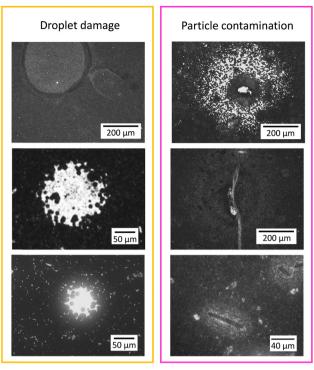
Fig. 2 Optical images of infiltration defects caused by solvent droplet damage and particle contamination.

Often (but not always) visible at the macro-scale, contaminants and solvent damage produce similar issues in completed devices, producing uneven defects of varied size, sometimes with a distinctive 'halo' or ringed surrounding pattern (Fig. 2). In the case of physical contaminants, a particle can be present at the defect centre, whereas solvent contamination issues are particle free. Particles will be visible through the glass substrate if the associated contamination is under, in, or on the TiO2 print. Particle contamination of the ZrO2 and carbon may also result in defects, but the given particle is unlikely to be visible through the glass substrate.

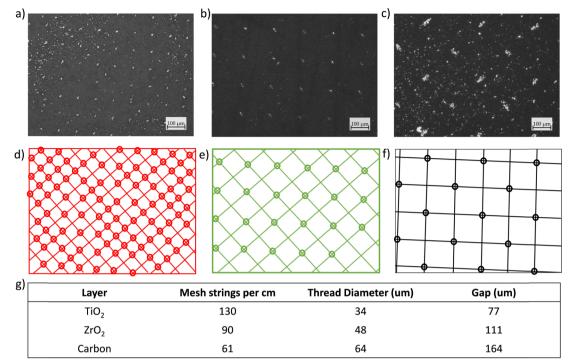
Fig. 3 Optical images of infiltrated TiO2 in devices showing mesh mark defects from (a) TiO2, (b) ZrO2, and (c) carbon screens. (d) – (f) Show diagrams of mesh dimensions of TiO2, ZrO2 and carbon screens respectively, with circles representing cross sections where an infiltration issue is present in the device. (g) Shows mesh types and calculated gap size for each layer.

As presented in Fig. 3, observed infiltration defects will correspond with the mesh dimensions of the relevant screen. Therefore, if different screens have been used for TiO2, ZrO2 and carbon, defect spacing can be measured to conclude in which layer the problematic marks reside. For example, the small defects in Fig. 3a must correspond with those from the TiO₂ layer, as this was the only deposition where a fine mesh was used (Fig. 3c). Note that defects may only appear (or be more severe) at alternate cross sections, as is the case in Fig. 3b and c. If similar mesh screens are used for different layers, the problematic layer can be identified using WLI (white light interferometry) of any remaining uninfiltrated devices single prints (Fig. 3b).

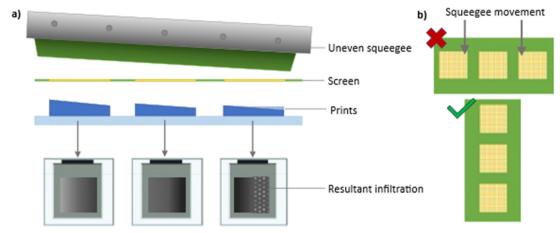
Fig. 4 (a) Diagrammatic representation of the consequences of uneven squeegee pressure and its resultant impact on device infiltration. Note that mesh marking defects in real samples will only be visible via optical microscopy. (b) Screen alignment to limit horizontal print variations

Careful setup and pressure monitoring can help prevent squeegee related issues. Changing screen designs to limit the horizontal print width (depicted in Fig. 4b) can also improve uniformity and batch variation. In the case of glass warping, ramped heating and cooling steps for blocking layer spraying and each high temperature anneal can help minimise these issues.

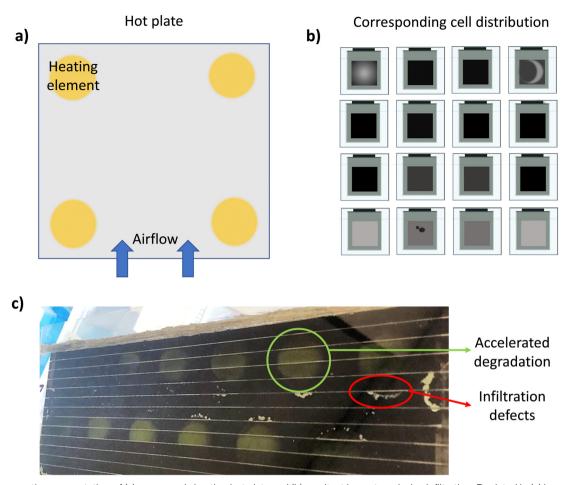
Fig. 5 Diagrammatic representation of (a) an unevenly heating hot plate and (b) resultant impact on device infiltration. Depicted in (c) is a photograph of damage on a $30 \times 30 \text{ cm}^2$ module caused by heating elements and airflow during perovskite annealing.

This issue can occur at multiple scales and using different equipment setup. For example, Fig. 5c shows a 30 × 30 cm² module annealed on a conveyor dryer. Through the glass substrate, greyish white and yellow defects can be seen, impacting multiple cells. The grey or white perovskite free voids indicate an infiltration issue caused by fast crystallisation and high airflow, whereas the yellow areas show accelerated degradation due to uneven heating. On examination of equipment, the yellow defects corresponded with overhead heating elements in the dryer and the white and grey with areas of high airflow.

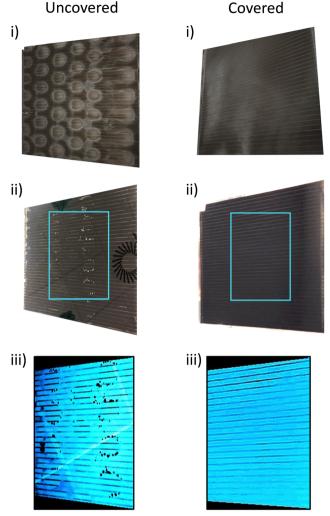
Fig. 6 Photographs of 519 cm² active area modules with (RHS) and without (LHS) a cover during perovskite annealing. (i) Back electrode, (ii) through glass substrate, (iii) magnified with applied colour filter to highlight infiltration problems.

A simple partial cover was thus applied, to protect the module surface while allowing sufficient solvent removal. This completely eliminated the defects, as shown in Fig. 6.

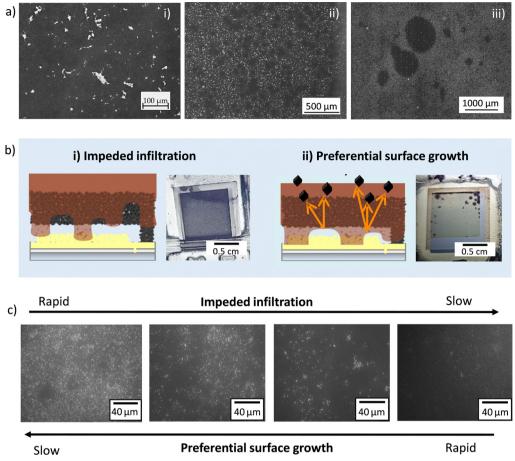
Fig. 7 (a) Optical microscopy images of randomly distributed infiltration defects at different scales. (b) Diagrammatic representation and example photograph of (i) impeded infiltration and (ii) preferential surface growth. (c) The impact of crystallisation speed with each mechanism.

Perhaps the most difficult to diagnose is when devices present with apparently random infiltration issues spread. As shown in Fig. 7a, this can appear at multiple scales with extreme variation in the shape and distribution of observed defects.

There exist two distinct mechanisms that can cause these problems, depicted in Fig. 7b. Impeded infiltration (Fig. 7b(i)) occurs when precursor cannot effectively reach the base of the stack, while preferential surface growth (Fig. 7b(ii)) is seen when nucleation and crystal growth occurs more favourably atop or within the carbon layer, reducing crystal formation in the small pores of the TiO₂ electrode. Both mechanisms can also occur concurrently: e.g. upon applying a new precursor formulation that favours surface crystal growth to a batch of cells with thick, rough carbon prints.

Example photographs of devices with particularly severe infiltration issues caused by each mechanism are shown in Fig. 7b. It should be noted that although the devices in the example look very different, they are not characteristic of the associated infiltration issue: without further examination or specific knowledge of the given sample, is not possible to tell visually which mechanism is present.
