Cite this: *Energy Environ. Sci.*, 2025, 18, 264

Removal of residual contaminants by minute-level washing facilitates the direct regeneration of spent cathodes from retired EV Li-ion batteries†

DOI: 10.1039/d4ee03021d

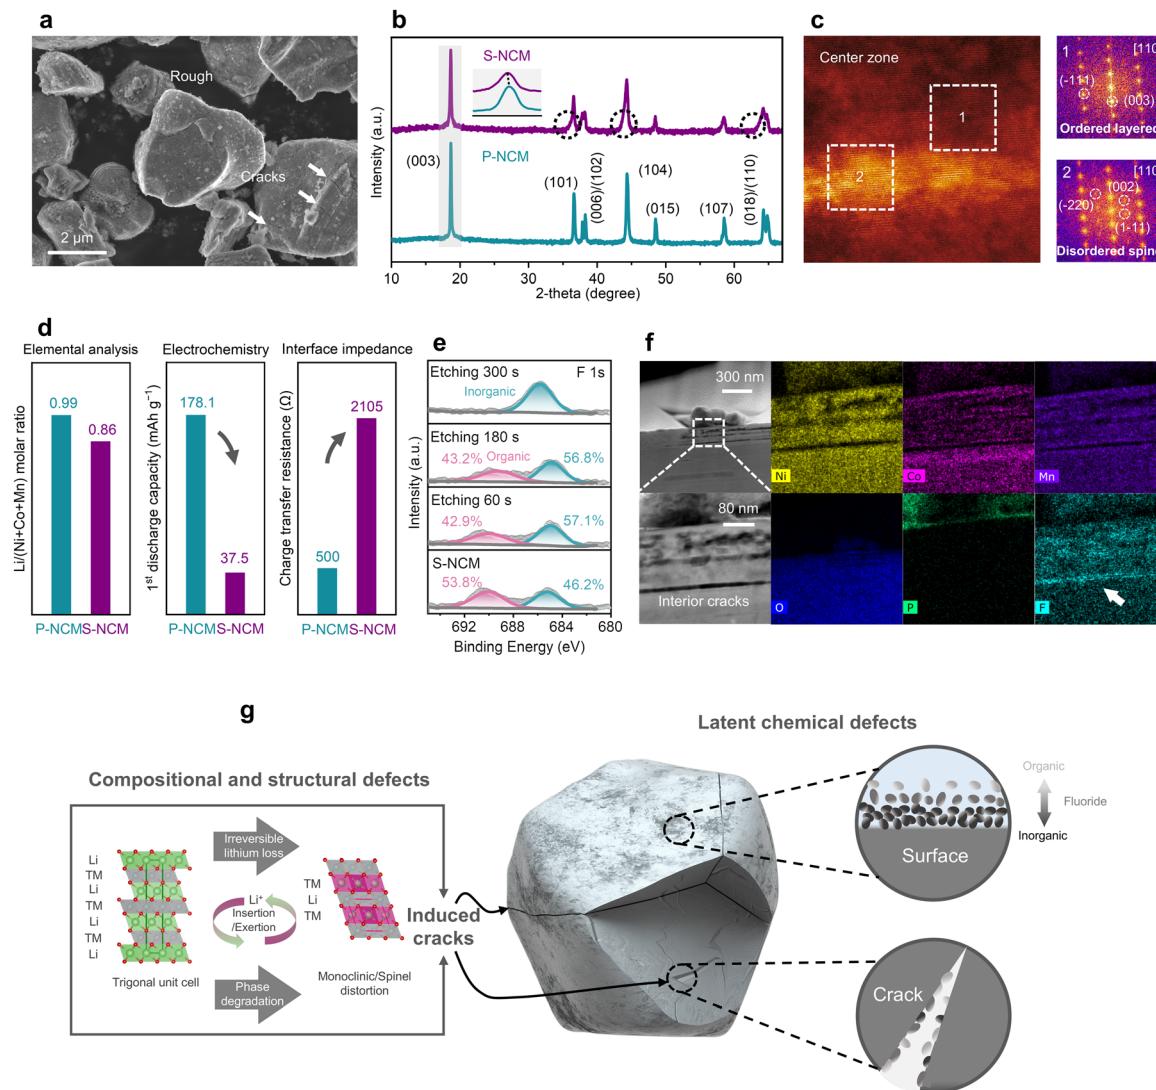
Fig. 1 Neglected chemical residuals on the 250k-miles-serviced cathode. (a) SEM image and (b) XRD pattern of the degraded S-NCM. The black dotted circle accentuates the subtle peaks that do not belong to the layered structure; (c) high-resolution HAADF-STEM images on the central area of the S-NCM particle and the FFT patterns of the selected dark and bright regions; (d) comprehensive comparison of lithium loss in degraded powders measured by ICP-OES, electrochemical capacity, and charge-transfer resistance analyses in the half-cell using S-NCM and P-NCM powders as cathode active materials; (e) F 1s XPS patterns of S-NCM powders for different sputtering times using an ion-beam. Based on the calculated integral area, the proportional values of the organics and inorganics in fluoride are presented in the patterns; (f) HAADF-STEM images based on focused ion beam cutting and an enlarged view displaying the interior microcracks. Corresponding EDS mapping analysis indicates the presence of F elements along these microcracks pointed out by a white arrow. (g) Deficiencies of S-NCM addressed before direct regeneration, including the compositional and structural aspects (e.g., irreversible lithium-ionic loss, phase degradation, internal and external cracks) and latent chemical defects (e.g., surface and crack-edge impurities enriching the F element).

To understand the surface state of the spent cathode, energy-dispersive spectroscopy (EDS) element mapping and X-ray photoelectron spectroscopy (XPS) were conducted. As shown in Fig. S7–S9, and Tables S5, S6 (ESI[†]), the S-NCM cathode surface residuals consisted of C, O, F, and P elements, and displayed a surface-rich gradient distribution, as revealed

by XPS with etching. The F 1s XPS peaks with etching for S-NCM are shown in Fig. 1e, where two F 1s peaks could be observed before sputtering, with the major peak centered at 685.5 eV, which was attributed to inorganic fluorides and the minor F 1s peak centered at 690.4 eV, which could be assigned to organic fluorides, with the ratio of 53.8% for organic fluorides.²⁹ However, the organic-related F peak declined significantly after sputtering, and completely disappeared after 300 s Ar^+ sputtering. The surface-rich distribution of organic fluoride was consistent with the cathode electrolyte interphase (CEI) composition previously reported.^{29,30}

To further reveal the microscopic distribution of those F-rich residuals, SEM combined with time-of-flight secondary ion mass spectrometry (SEM-ToF-SIMS) characterization was conducted for the cycled cathode. The results are shown in Fig. S10 and Videos S1, S2 (ESI[†]). Based on the spatial distribution of F[−] secondary ion fragments, it was confirmed that fluoride impurities were primarily deposited on the particle surface. Moreover, during the long-time battery service, it could be observed from the HAADF-STEM image and corresponding element mapping (see Fig. 1f) that, in the S-NCM cathode, the fluorides could spread into the interior of the cathode along the intragranular cracks. Coincidentally, from the selected FFT figure shown in Fig. S4 (ESI[†]), the existence of an amorphous ring was observed along the intragranular cracking, which may be related to the fluorides also observed in the bulk. To sum up, the collected S-NCM exhibited limited structural and compositional degradation, while preserving the fluoride-containing impurities aggregated on the surface and along the intragranular cracks, as illustrated in Fig. 1g.

Furthermore, it was previously widely accepted that the source of F-rich impurities in the spent cathode was due to decomposition of the PVDF binder during the heat delamination process at around 350 °C,^{11,23–25,31} however, during the thermal decomposition of PVDF, most the fluoride-containing products were gas species (*i.e.*, HF) and fragments (−CF[−] and −CH−CF[−]),^{32–34} which are subject to ejection instead of propagating along the cathode intragranular cracks. To confirm the source of those observed residual impurities, four kinds of cathodes with varying cycling conditions were collected and examined, namely cathode laminates with/without electrolyte filling, and laminates from 125k and 250k miles-serviced batteries, as listed in Table S7 (ESI[†]). The SEM images and electrochemical performance are shown in Fig. S11 and S12 (ESI[†]). Compared with the pristine one (sample A), the other spent cathodes from battery formation and cycling exhibited a rough surface and limited discharge capacity. Notably, the laminate from formation only but with no cycling (sample B), which it was believed would retain the full lithium inventory and show negligible structural degradation since it had not undergone charge/discharge cycling, showed a poor discharge capacity, which was the same as the other long-cycled ones. Moreover, the heat exfoliation used to pyrolyze the adhesive binders deteriorated the original CEI layer on the spent cathodes and generated more harmful byproducts (*e.g.*, Li₂CO₃, Li₃PO₄, LiF). This, combined with electrolyte decomposition during electrochemical cycling, exacerbates chemical degradation, resulting in a significant capacity decline. Therefore, the above comparison revealed that the cathode residual impurities should originate from the electrolyte components (such as LiPF₆, DMC, ethylene carbonate (EC)) decomposition during battery formation, cycling, and common heat exfoliation, leading to severe capacity loss in spent cathodes (Fig. 1d).

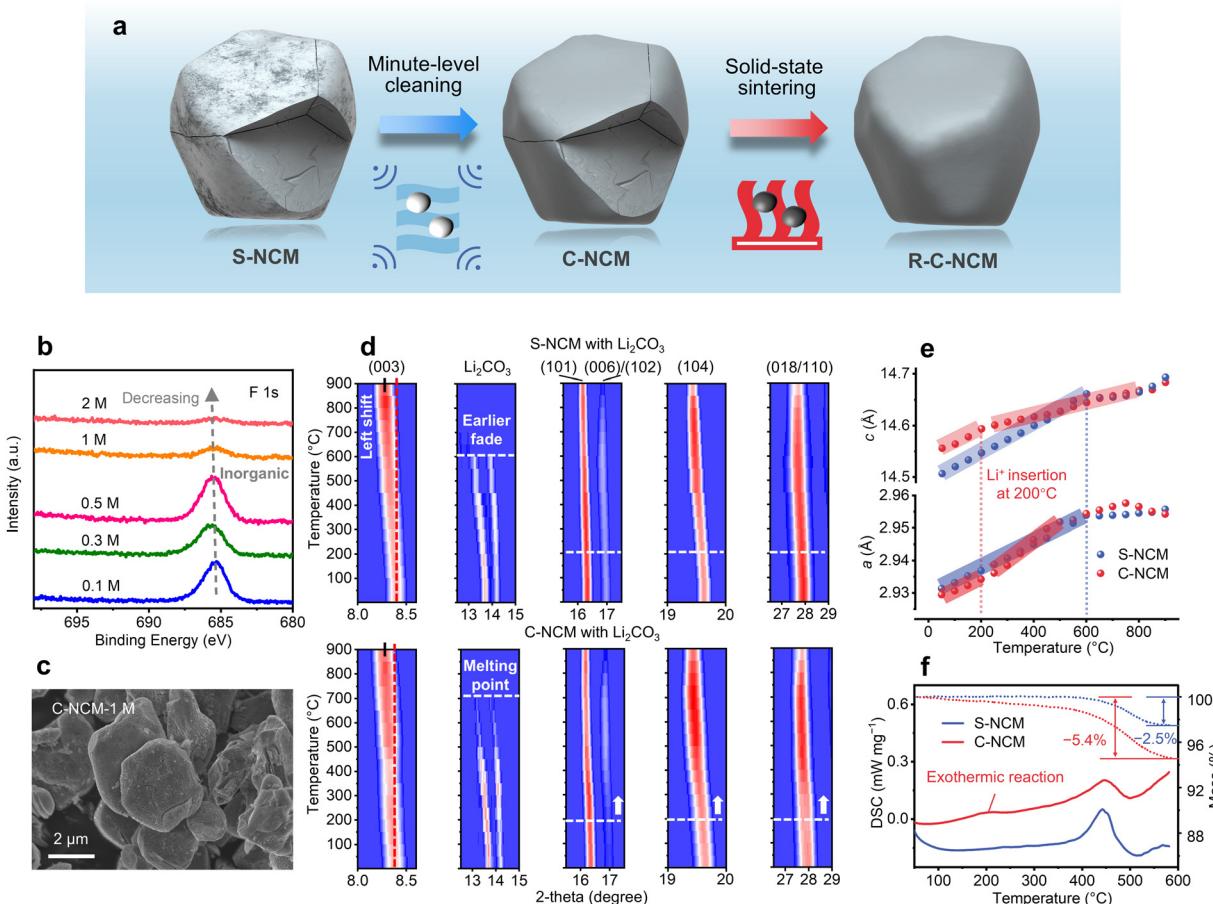
Fig. 2 Removal of the impurities and change in the crystal structure during the direct regeneration process combined with pretreatment. (a) Traditional direct regeneration path using solid-state sintering and the minute-level pretreatment introduced in an advanced path targeted to the critical obstacles within degraded cathode materials; (b) F 1s XPS fine patterns of C-NCM undergoing ultrasonic stirring in solutions with different concentrations; (c) SEM image of C-NCM obtained by soaking S-NCM in 1 M HNO_3 solution; (d) partial *in situ* XRD patterns of S-NCM and C-NCM mixed with a Li resource, keeping a constant heating rate ($20\text{ }^\circ\text{C min}^{-1}$) and holding the temperature for diffraction at $50\text{ }^\circ\text{C}$ intervals; (e) evolution of the unit cell parameters a and c for S-NCM (blue symbols) and C-NCM (red symbols) mixed with Li slate through Rietveld refinement. The earlier Li^+ insertion at $200\text{ }^\circ\text{C}$ changed the variation tendency of the unit parameters for the sample after cleaning. (f) Heat generation measured by DSC from mixtures.

To reveal the effect of the residuals during the direct regeneration of the recycled cathode, *in situ* XRD characterizations were compared following the regeneration of S-NCM and C-NCM. During the heating, the unit cell lattice first nearly linearly expanded until there was a differentiation of the expansion ratio caused by the lithium insertion. As shown in Fig. 2d, the shift of the (003) peak of C-NCM was less pronounced than that of S-NCM when heating to $900\text{ }^\circ\text{C}$, indicating its unit cell lattice c was not expanded as much as for the S-NCM due to its more efficient lithium insertion. Therefore, more lithium insertion was observed for the C-NCM cathode. Correspondingly, the Li_2CO_3 in the mixture of S-NCM and C-NCM also performed differently, whereby the Li_2CO_3 in the

C-NCM cathode was consumed gradually until it disappeared at its melting point around $730\text{ }^\circ\text{C}$, while the Li_2CO_3 in the S-NCM cathode completely vanished at around only $600\text{ }^\circ\text{C}$, and this earlier consumption of the lithium source may be attributed to the reaction between Li_2CO_3 and the residual impurities (such as LiF , LiOH , and Li_3PO_4) by co-melting, vaporizing, and replenishing in S-NCM.⁴² Equivalently, the high angle reflection peak intensity spanning from (006) to (110), representing the layered structure, significantly increased starting from around $200\text{ }^\circ\text{C}$ for the C-NCM cathode after the purifying treatment compared to there being no obvious enhancement for S-NCM, indicating the better repair of the layered structure during heating. To further unveil the underlying mechanism, Rietveld refinement of each XRD pattern was conducted, which can depict the continuous change of the unit cell parameters during regeneration. Generally, the unit cell parameter c decreases and a increases with the insertion of Li ions into a layered structure, similar to in the discharge process.²⁸ As shown in Fig. 2e, the lattice evolution of the S- and C-NCM

cathodes were compared. For C-NCM, the lattice *c* expansion slope became obviously flatter at 200 °C, denoting a lattice *c* shrinkage at this temperature induced by the Li-ion insertion and repairing. However, for the S-NCM without undergoing purifying treatment for the residuals, the lattice expanded still nearly linearly with no obvious lithium insertion until 600 °C. Concurrently, the lattice *a* expansion slope became steeper at 200 °C for C-NCM. Last but not least, Differential scanning calorimetry (DSC) characterization was also conducted during the regeneration process to confirm the lithium insertion pattern for the S- and C-NCM cathodes, which can trace the lithium replenishment associated with the exothermic reaction as reported by others.⁴³ As shown in Fig. 2f, the characteristic exothermic reaction at around 200 °C was only observed for C-NCM, confirmed the earlier lithium insertion after the purifying treatment. The earlier lithium insertion was also supported by the CO₂ gas release observed during Li₂CO₃ decomposition to supply the lithium source for the C-NCM cathode, as shown Fig. S23 (ESI†). Moreover, from the thermogravimetric results

shown in Fig. 2f, the weight loss of C-NCM was 5.4%, which was significantly larger than that of S-NCM of 2.5%, indicating that more Li₂CO₃ was activated and decomposed to provide the lithium source for C-NCM.^{43,44} To sum up, through multiple *in situ* and *ex situ* characterizations, we proved that, with a purifying pretreatment, the direct regeneration could be facilitated to start at a lower temperature of 200 °C from the spent cathode.

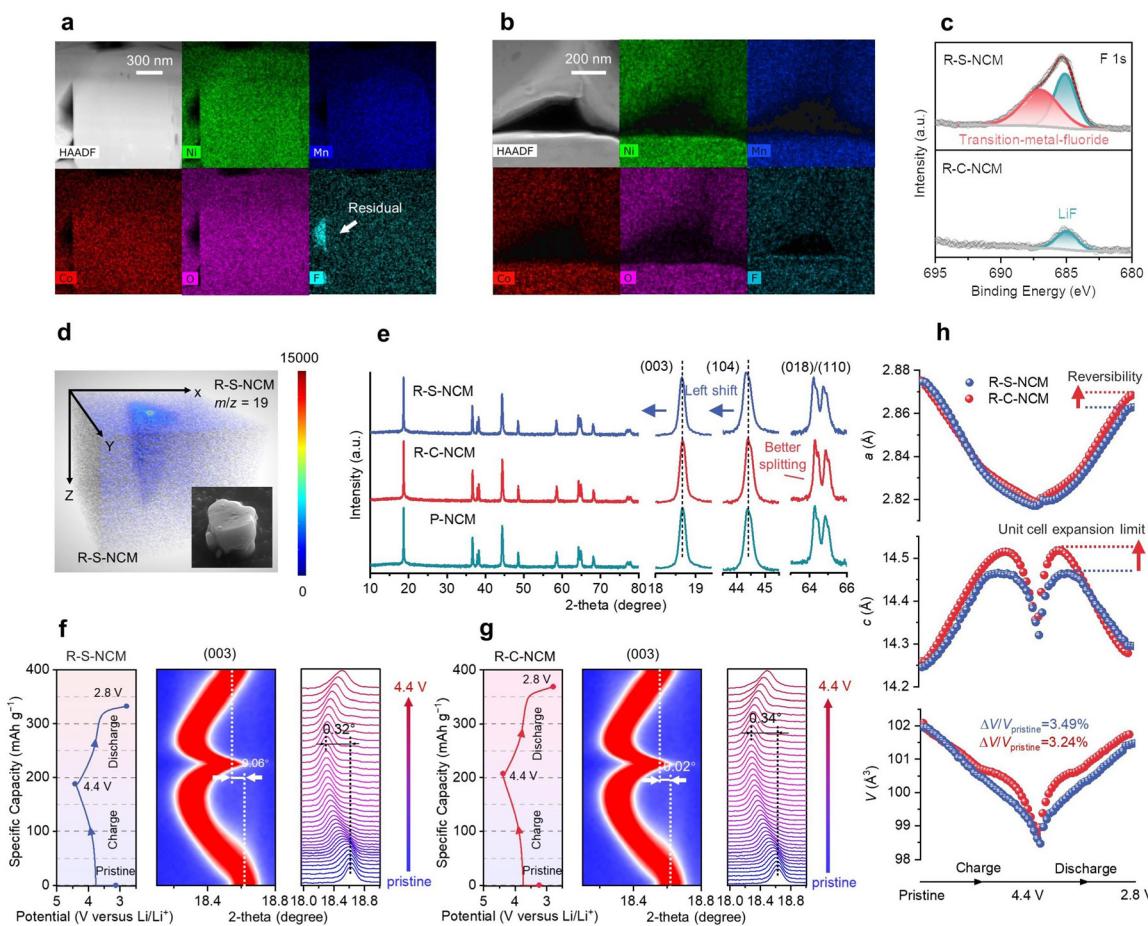
Fig. 3 Chemical and structural details of the regenerated cathode materials under the influence of impurities. (a) HAADF-STEM images and (b) corresponding EDS element mappings of R-S-NCM and R-C-NCM particles, focusing on the pores of the packing particles. (c) F 1s XPS high-resolution patterns of R-S-NCM and R-C-NCM powders. (d) Pseudo-three-dimensional distribution of F element and SEM image of the corresponding R-S-NCM particle. (e) Full patterns and characteristic peak comparison of the regenerated and pristine NCM cathodes with Cu K α radiation at a scan rate of 8° min $^{-1}$. (f) 1st charge–discharge curves, corresponding XRD patterns of R-S-NCM, and (g) (003) peak position variation when the cell charge from pristine to 4.4 V and comparison with R-C-NCM. (h) Lattice parameters *a*, *c*, and the unit cell volume *V* of R-S-NCM and R-C-NCM in the 1st charge–discharge test according to the refinement.

Furthermore, the crystal structure of the regenerated cathode could also be affected by the residual impurities. As shown in Fig. 3e and Fig. S28 (ESI†), the XRD pattern indicated a layered structure with no impurities phase for both the R-S-NCM and R-C-NCM cathodes. However, the R-C-NCM cathode had a higher (003)/(104) intensity ratio and larger splitting degree for the (018)/(110) peaks compared to R-S-NCM, suggesting its more ideal layered structure similar to P-NCM cathodes. After regeneration accompanied by impurities, the diffraction peaks of R-S-NCM were shifted toward a low-angle direction, indicating the lattice expansion, as supported by the refined parameters (Table S11, ESI†) and *in situ* experiments (Fig. 2d). Furthermore, *in situ* XRD was performed during the 1st charge/discharge process for both regenerated cathodes (see Fig. 3f and g). The R-C-NCM cathode showed a higher capacity with a smaller offset (0.02°) of the (003) peak position than the

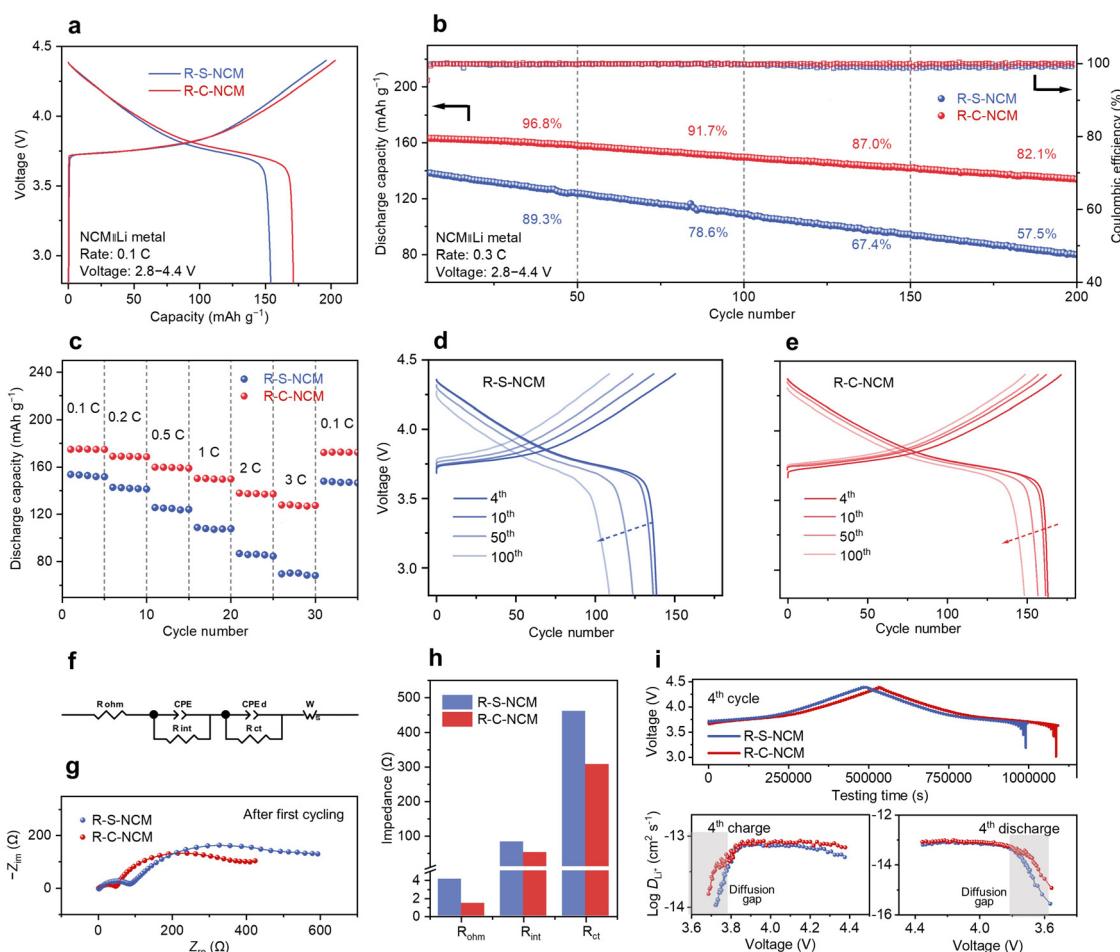
Fig. 4 Electrochemical deterioration for the regenerated NCM cathodes with impurity residue. (a) Initial galvanostatic charge–discharge curves of R-S-NCM and R-C-NCM at 0.1C (1C = 150 mA h g⁻¹) and (b) long cycling test and capacity retention in a half-cell. (c) Rate capabilities of R-S-NCM and R-C-NCM. Charge–discharge curves of (d) R-S-NCM, (e) R-C-NCM in the voltage range of 2.8–4.4 V (vs. Li/Li⁺) at different cycles. (f) Equivalent circuit applied in the EIS measurements. Nyquist plots of (g) R-S-NCM and R-C-NCM and (h) fitting results showing the Ohmic resistance (R_{ohm}), interface resistance (R_{int}), and charge-transfer resistance (R_{ct}). (i) GITT curves and the calculated Li⁺-diffusion rate of R-S-NCM and R-C-NCM for the 4th cycle number after activation in the same charge–discharge period. The shadow area indicates low Li⁺ diffusion in a certain voltage range.

As shown in Fig. 4a and Fig. S30 (ESI†), the initial discharge capacity increased from 154.1 mA h g⁻¹ for R-S-NCM to 171.4 mA h g⁻¹ for R-C-NCM after the purifying treatment, although this was slightly lower than for P-NCM. In Fig. 4b and Fig. S31 (ESI†), the R-C-NCM cathode exhibit 91.7% and 82.1% capacity retention after 100 cycles and 200 cycles, respectively, compared with 91.6% and 78.3% for P-NCM, and 78.6% and

According to the above results (Fig. 1d, Fig. S6, S16 (ESI[†]), and Fig. 4h, i), the migration rate of lithium ions was significantly influenced by the residual impurities; therefore it was crucial to theoretically investigate their influence on capacity delivery in the reuse case and during direct regeneration. Considering the impurities were mostly concentrated at the surface before and after regeneration, and that F-rich residuals could be observed, as shown in Fig. S9 and S10 (ESI[†]) and Fig. 3c, we chose three representative inorganic components (LiF, Li₂CO₃, and LiOH) in the CEI layer⁴⁸ or residual alkali⁴⁹ to calculate the Li⁺ diffusion from a thermodynamic perspective, and their structures are shown in Fig. 5a. By maintaining a similar distance and concentration of mobile Li-ions, the diffusion energy barrier of lithium ions (ΔE_{Li^+}) during the cycling of spent cathodes within the different crystal structures (Fig. 5b) allowed valid comparisons. We found that the ΔE_{Li^+} of the LiF phase, as a common inorganic component from CEI, was about 2 and 3 times higher than that of the LiOH and Li₂CO₃ phases from

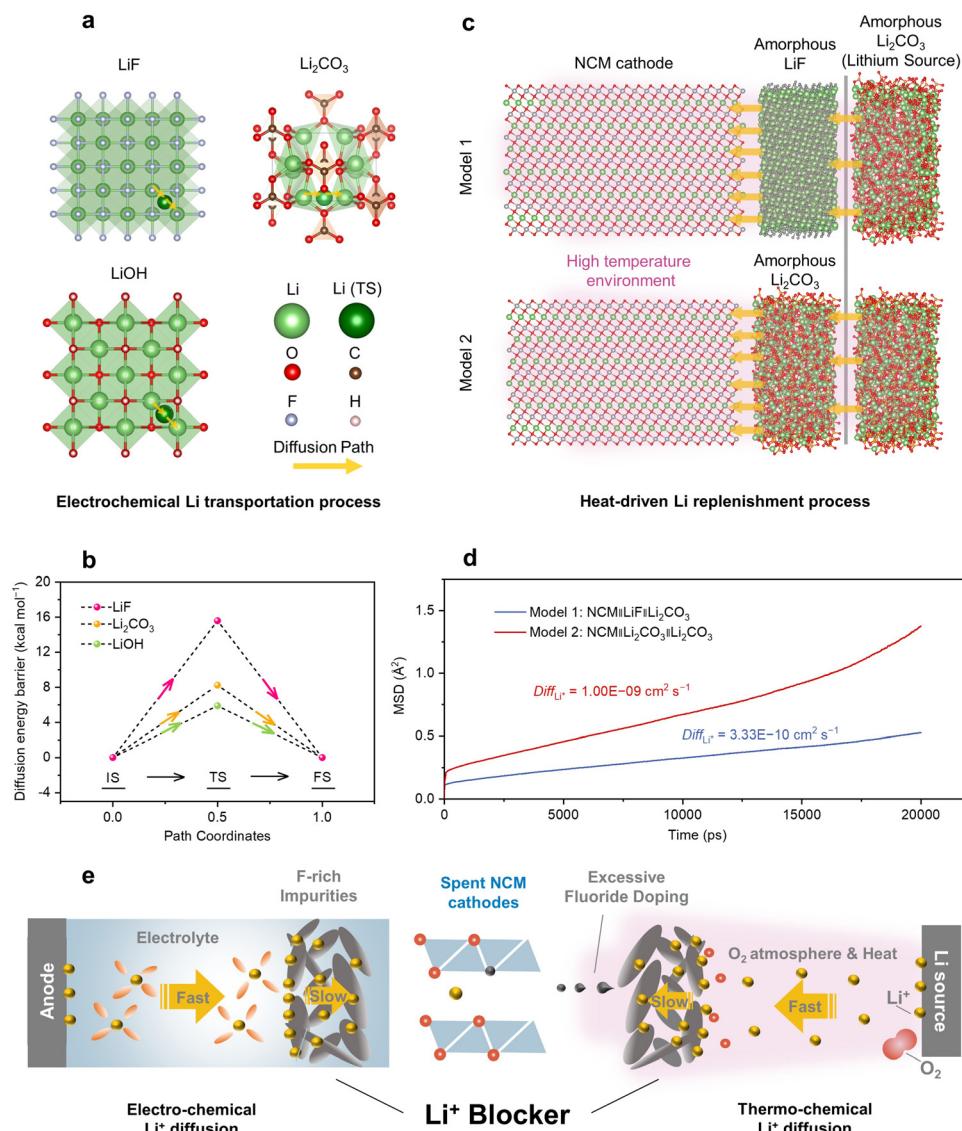
Fig. 5 Role of the F-rich impurities as a blocker in electrochemical and thermochemical Li^+ diffusion as ascertained from thermodynamic and kinetic simulations. (a) Illustrations of the selected migration pathways with a similar distance for Li^+ inside the crystal lattice of three common components. The initial state, transition state, and final state of Li^+ transportation are denoted as IS, TS, and FS, respectively. (b) Calculated energy diffusion barrier for Li^+ ions in selected phases. (c) Two models for stimulating the kinetics of Li^+ transportation in direct regeneration. Model 1 consists of the NCM cathode substrate, the amorphous LiF layer, and Li₂CO₃ as a lithium source in direct regeneration, which is denoted as NCM||LiF||Li₂CO₃. In Model 2 (NCM||Li₂CO₃||Li₂CO₃ in short), the middle LiF layer is replaced by a common residual alkali (Li₂CO₃), which is used to simulate the regeneration of NCM cathodes after cleaning pretreatment. Each shape symbol is the same as for Fig. 5a. (d) MSD of the Li atoms in 20 ns and calculated Li^+ diffusivity based on the above model. "E - 9" means 10^{-9} . (e) Mechanism diagram for preventing the NCM cathodes from reusing and directly regenerating under the influence of impurities.

Fig. 5b. Therefore, this result confirmed that the presence of fluoride-rich impurity residuals on the cathode surface significantly increased the diffusion resistance of Li ions when cycling, ultimately exacerbating the cell impedance and interfacial parasitic reactions (Fig. 1d). To comprehend the larger-scale kinetic characteristics and understand the effect of impurity coatings during heating for regeneration of the spent cathodes, two molecular dynamics models were established for simulating Li⁺ transportation at 1000 K over 20 ns. Specifically, Model 1 was devised to include an impurity barrier consisting of a LiF layer (Fig. 5c and Fig. S33, ESI[†]). Through computing the mean square displacement (MSD) of Li atoms and fitting curves (Fig. 5d), we determined that the Li diffusivity (Diff_{Li⁺}) of Model 1 was 3.33×10^{-10} , which was an order of magnitude lower than that of Model 2 (1.00×10^{-9}). The differences in molecular dynamics models under practical conditions suggest that fluoride-rich impurity coatings increase the resistance to Li-ion diffusion into spent cathodes with Li deficiencies during thermo-driven regeneration, leading to inadequate compositional and structural recovery.

As illustrated in Fig. 5e, the impurity phase containing the F element served as an electro- and thermo-diffusion blocker of Li ions hindering the reuse and direct regeneration of the spent cathode. In the spent cathodes collected by physical pretreatment and collection from used lithium-ion batteries, the ubiquitous electrolyte was decomposed to form an ion barrier with slow ion diffusivity. However, these impurities have long been overlooked in most studies (Table S2, ESI[†]), mainly due to the use of lab-scale degraded cathodes and fine manual separation pretreatment. In previous studies,^{12–16,42} the latent impact of the residual impurities on direct regeneration remains untouched because impurities are easily converted into other inconspicuous matter in extreme physical or chemical regeneration environments. Looking ahead, the direct regeneration of next-generation sensitive cathode materials, such as Li-rich Mn-based, Co-free, and ultra-high-Ni cathode materials, faces serious challenges from these latent impurities if they enter the recycling circle. From another perspective, establishing the controlling law for the inherent impurities doping within the closed-loop material flow could instructively enhance the performance of such recycled materials in the future. Moreover, only by revealing the effect of the overlooked impurities or by getting rid of impurities, can evolving technologies and mechanisms for direct regeneration and upcycling be reasonably evaluated.⁵⁰
