## Impact of wildfires on the drinking water catchment for the capital area of Iceland – a case study†

Climate change is leading to an increase in extreme weather events in the Arctic, which can significantly affect both the quality and availability of drinking water. Prolonged droughts lower groundwater levels and reduce soil moisture that elevates the risk of wildfires, which can contaminate water resources and damage water supply infrastructure. This case study examines the impact of wildfires on water quality in porous volcanic strata in the Arctic. The primary water extraction area for the capital region of Iceland supplies drinking water to six municipalities, representing approximately 64% of the country's population. The water source is mainly located in a postglacial porous lava field with thin volcanic strata and limited surface water. On May 4th, 2021, a large wildfire occurred in the watershed following a prolonged drought, burning 56.5 hectares of land. Three of the water intake zones for the capital region are situated 300 meters to a few kilometres from the fire-affected area. Water quality monitoring data from these zones, covering the period 2011–2023 and comprisi

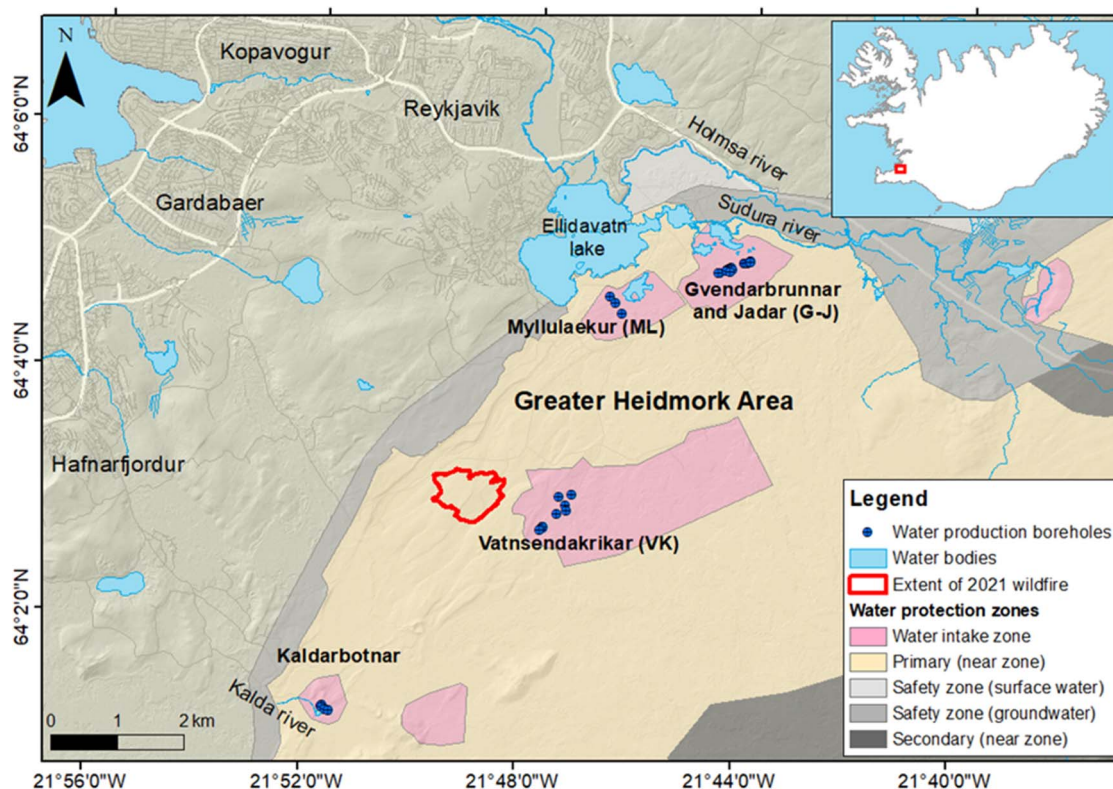
Fig. 1 The greater Heidmork area – the water protection area for the capital region. Drinking water production boreholes are shown. The wildfire area is marked as red (based on data from the Icelandic Institute of Natural History).

The groundwater resources for drinking water for the capital region of Iceland are in the greater Heidmork area (see Fig. 1). The area supplies water to six municipalities—Reykjavik, Kopavogur, Gardabaer, Hafnarfjörður, Mosfellsbaer, and Seltjarnarnes—serving 64% of the population of Iceland (about 230 thousand residents) and is harnessed by six publicly owned water utilities with a yearly average of about 1100 l s<sup>-1</sup>.<sup>44</sup> Furthermore, the area is designated as a nature reserve and serves as the largest outdoor recreational area in the vicinity of the city, covering approximately 32 square kilometers. Almost 90% of the area is vegetated land, of which about 20% is cultivated woodland and 20% is wild birch forest and scrub.<sup>45</sup> According to the NDVI (Normalized Difference Vegetation Index), measured since 1982, there has been a great increase in vegetation in the northern latitudes, including Iceland, since the 1980s.<sup>40,46</sup>

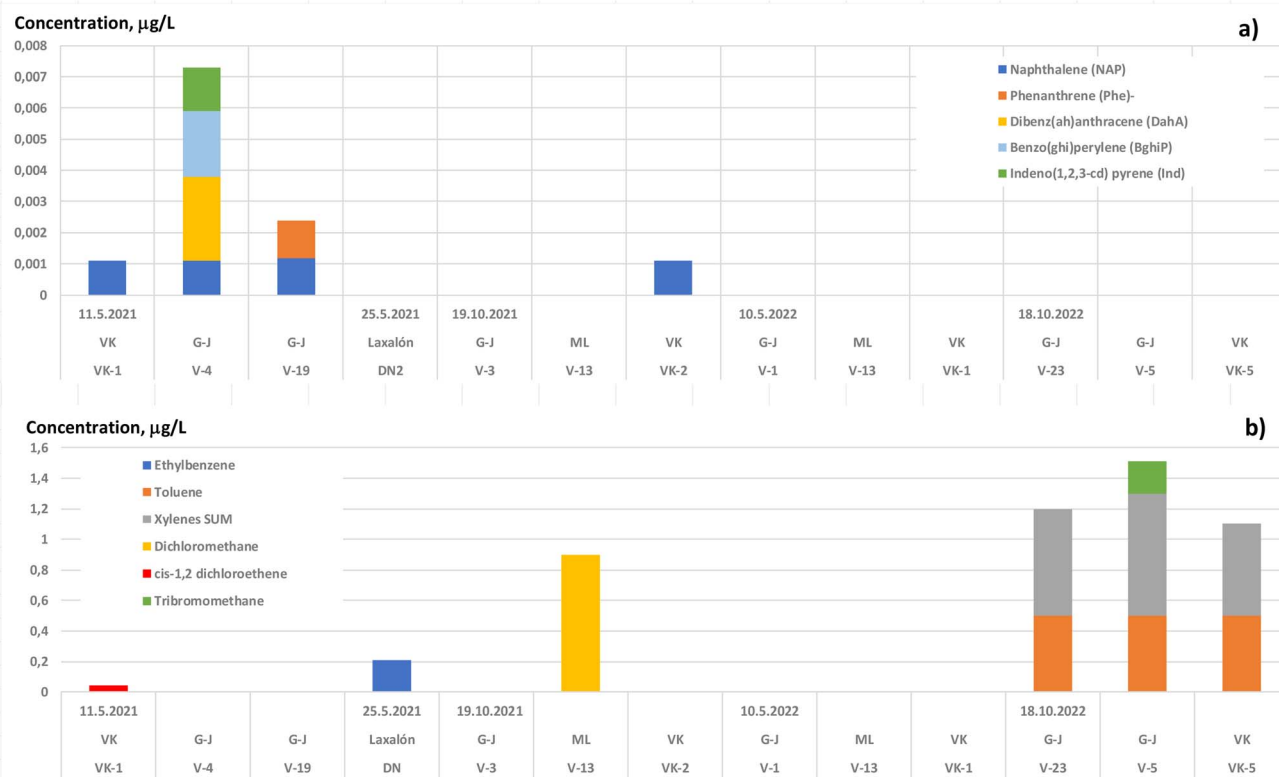
Fig. 2 PAHs (a) and VOCs (b) detected in samples from 11.5.2021 until 18.10.2022 (VK = Vatnsendakrikkar, G–J = Gvendarbrunnar–Jadar, DN = distribution network, and ML = Myllulaekur).

Results from sampling taken a week after the fire (May 11) from boreholes in the two water intake zones VK and G–J showed various PAHs and some VOCs following the fire (Fig. 2 and Table 4). Although the analysis of organic compounds is part of the routine monitoring program at the Heidmork production site, the detection limits of the employed methods were, most often, up to an order of magnitude higher prior to the wildfire compared to post-wildfire. The detection limit for all organic chemicals is shown in the ESI† to this article. None of the pre-fire samples exceeded the detection limits for PAHs.

Five of the 16 priority PAHs were above the detection limit in zones G–J and VK within weeks of the wildfire (ML was not measured then). These include naphthalene (NAP) and phenanthrene (Phe) with two or three benzene rings; these are

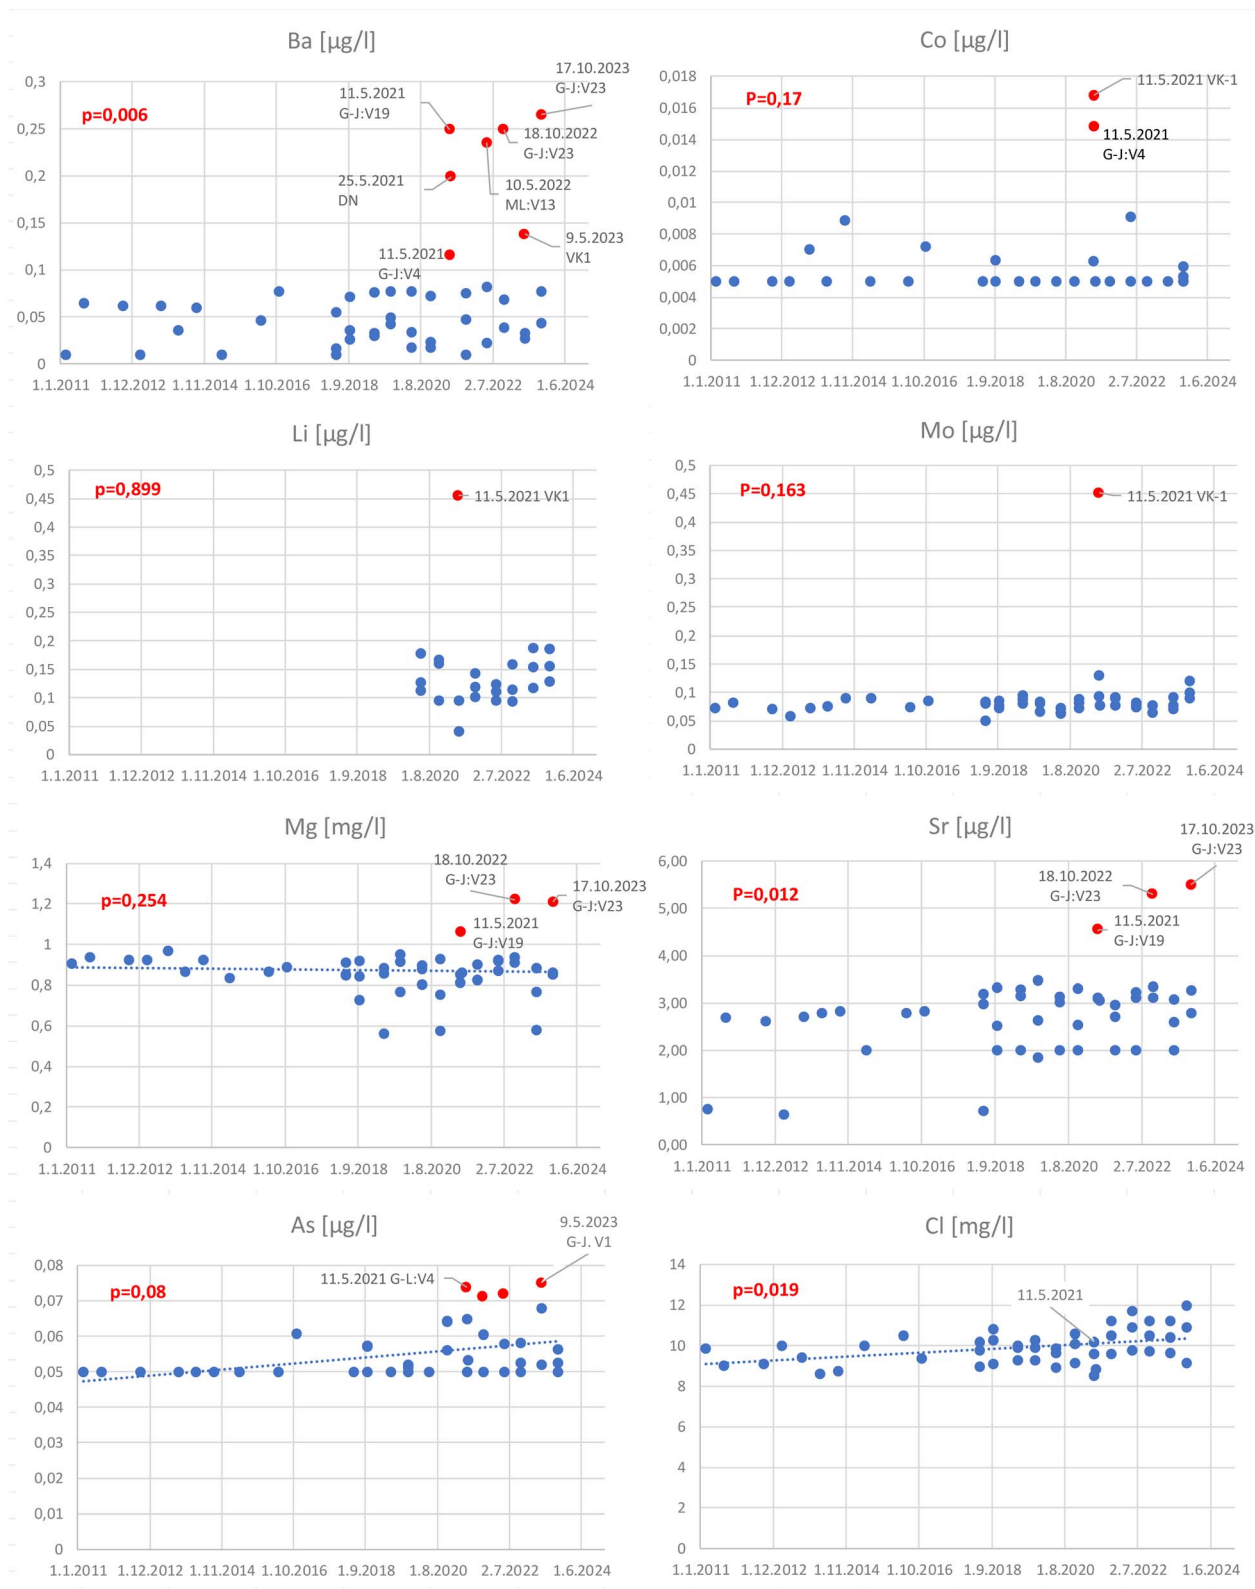
Fig. 3 Eight elements measured in samples taken between 2011 and 2023 showing either a temporary increase after the fire or a significant post-fire increase.

Six metals, barium (Ba), cobalt (Co), lithium (Li), molybdenum (Mo), magnesium (Mg) and strontium (Sr), were measured in two to nearly six-fold higher concentrations after the fire compared to the median value (Fig. 3 and Table 3). Some increases were short-lived, namely Co, Li, Mg and Mo, while Ba and Sr showed a tendency for longer-lasting impacts and there was a significant post-fire increase in concentration in both ( $p < 0.05$ ). Arsenic (As) and chloride (Cl) also have significantly higher post-fire concentrations. However, this does not seem to be related to the wildfire as shown in Fig. 3. It is noted that the elevated concentration of

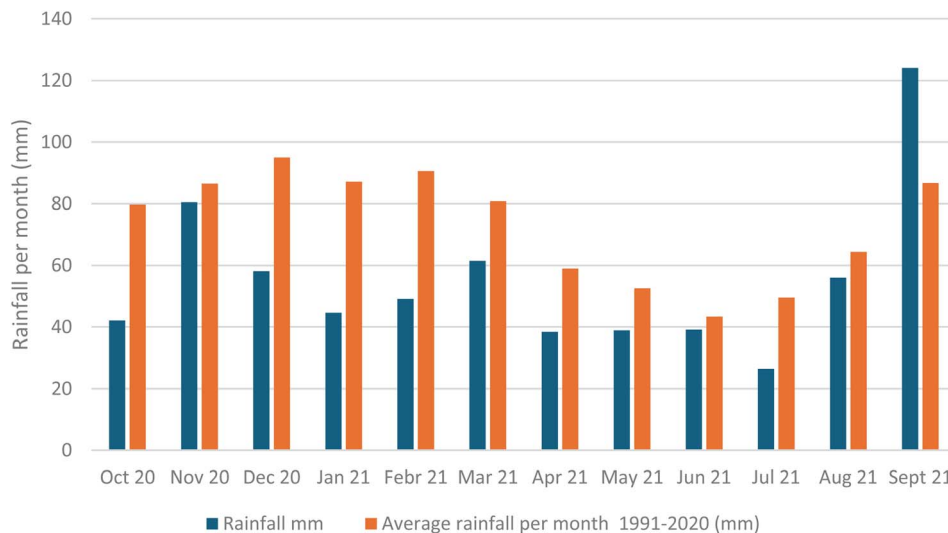
Fig. 4 Monthly rainfall in Reykjavik from 1.10.2020 to 1.10.2021 compared to the average monthly rainfall for the period 1991–2020.

Meteorological measurements clearly show the impact of the drought on the hydrology (Fig. 4). The average precipitation in December, January and February preceding the fire was approximately half the monthly average (90 mm). This resulted in a low volumetric water content in the soil in the open field of the water intake zone at ML and an exceptionally low groundwater level in boreholes at VK. The volumetric water content in soil was low for the late winter period leading up to the fire, fell significantly at the beginning of January and did not recover to the normal stage until after the heavy rain incident on May 29th (Fig. 5). The groundwater level in borehole VK-1 was low in the first months of 2021 compared to the daily average (2008–2020) and exceptionally low in the weeks leading up to the fire (Fig. 6). These measurements demonstrate the importance of systematically monitoring the hydrometeorological parameters to provide early warning for potential wildfires.

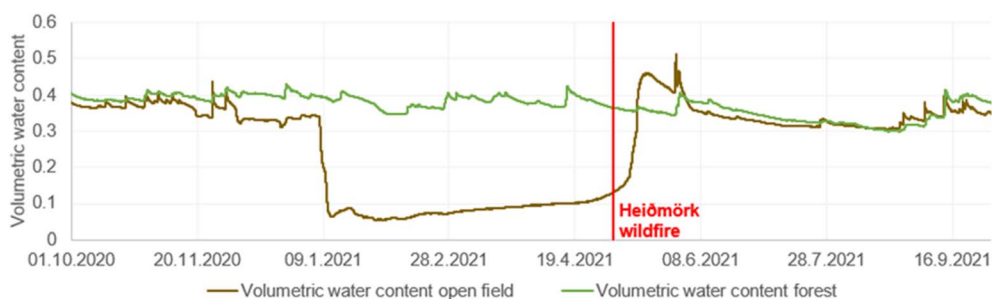
Fig. 5 Volumetric water content in soil in pine forest (green) and open field (brown) from 1.10.2020 to 1.10.2021 measured in the water protection area ML. The vertical line shows the timing of the wildfire.

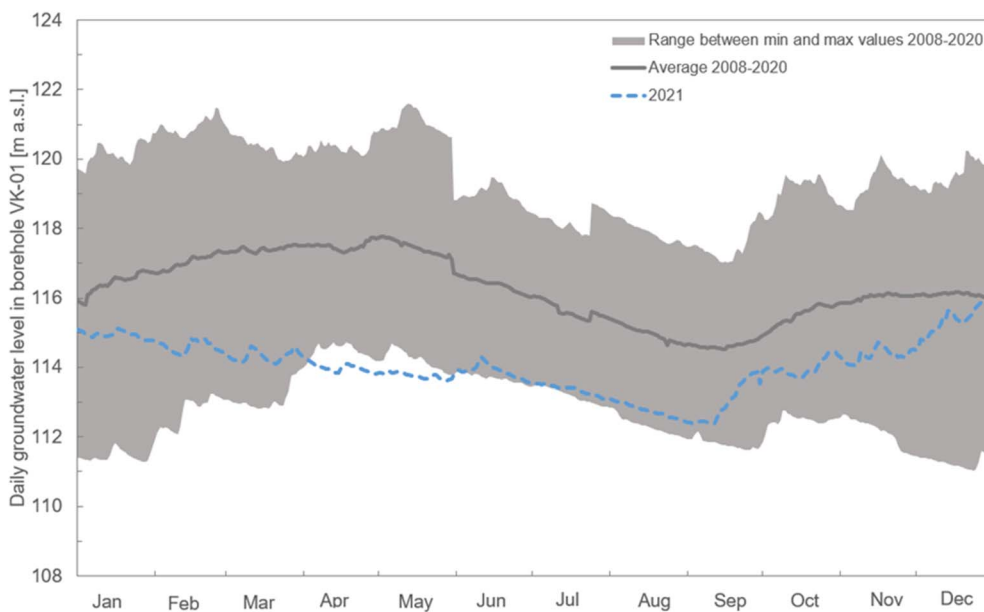
Fig. 6 Average groundwater level for VK-1 for the period 2008–2020, where the shaded area shows the range of the max mean values. The blue line shows the level for 2021.

values were used. Records of the historical groundwater level in the VK production zone east of the wildfire were available from 2008. Daily averages from borehole VK-1 were used.
