Cite this: *Environ. Sci.: Adv.*, 2025, 4, 606

Impact of wildfires on the drinking water catchment for the capital area of Iceland – a case study†

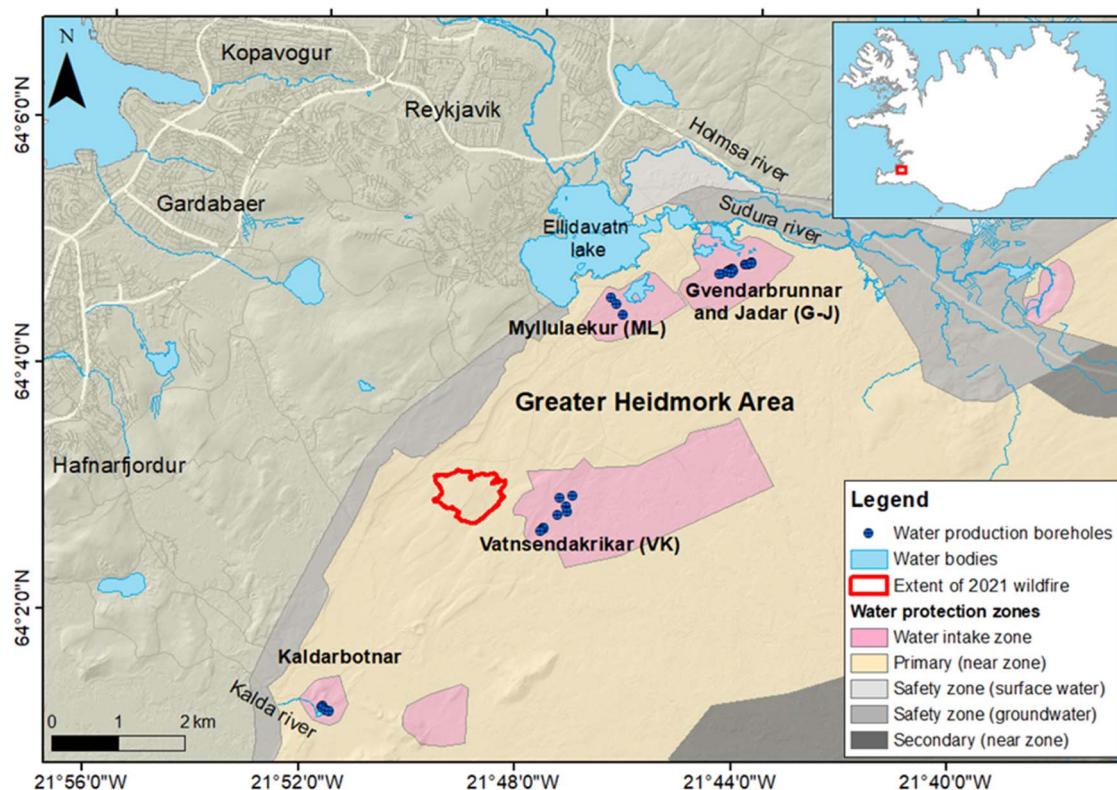
Fig. 1 The greater Heidmork area – the water protection area for the capital region. Drinking water production boreholes are shown. The wildfire area is marked as red (based on data from the Icelandic Institute of Natural History).

The groundwater resources for drinking water for the capital region of Iceland are in the greater Heidmork area (see Fig. 1). The area supplies water to six municipalities—Reykjavik, Kopavogur, Gardabaer, Hafnarfjordur, Mosfellsbaer, and Seltjarnarnes—serving 64% of the population of Iceland (about 230 thousand residents) and is harnessed by six publicly owned water utilities with a yearly average of about 1100 l s⁻¹.⁴⁴ Furthermore, the area is designated as a nature reserve and serves as the largest outdoor recreational area in the vicinity of the city, covering approximately 32 square kilometers. Almost 90% of the area is vegetated land, of which about 20% is cultivated woodland and 20% is wild birch forest and scrub.⁴⁵ According to the NDVI (Normalized Difference Vegetation Index), measured since 1982, there has been a great increase in vegetation in the northern latitudes, including Iceland, since the 1980s.^{40,46}

A protected catchment zone is defined in Heidmork according to Icelandic regulation (796/1999) and the EU Water Framework Directive (Directive, 2000/60/EC). It is divided into four zones: water intake, primary (near zone), secondary (distance zone), and safety zones. Regulation no. 796 from 1999, together with later additional regulations related to drinking water protection (555/2015), restricts land use and the use of chemicals in Heidmork protection zones. The water source is in a postglacial porous lava field (VK and G-J) and in older

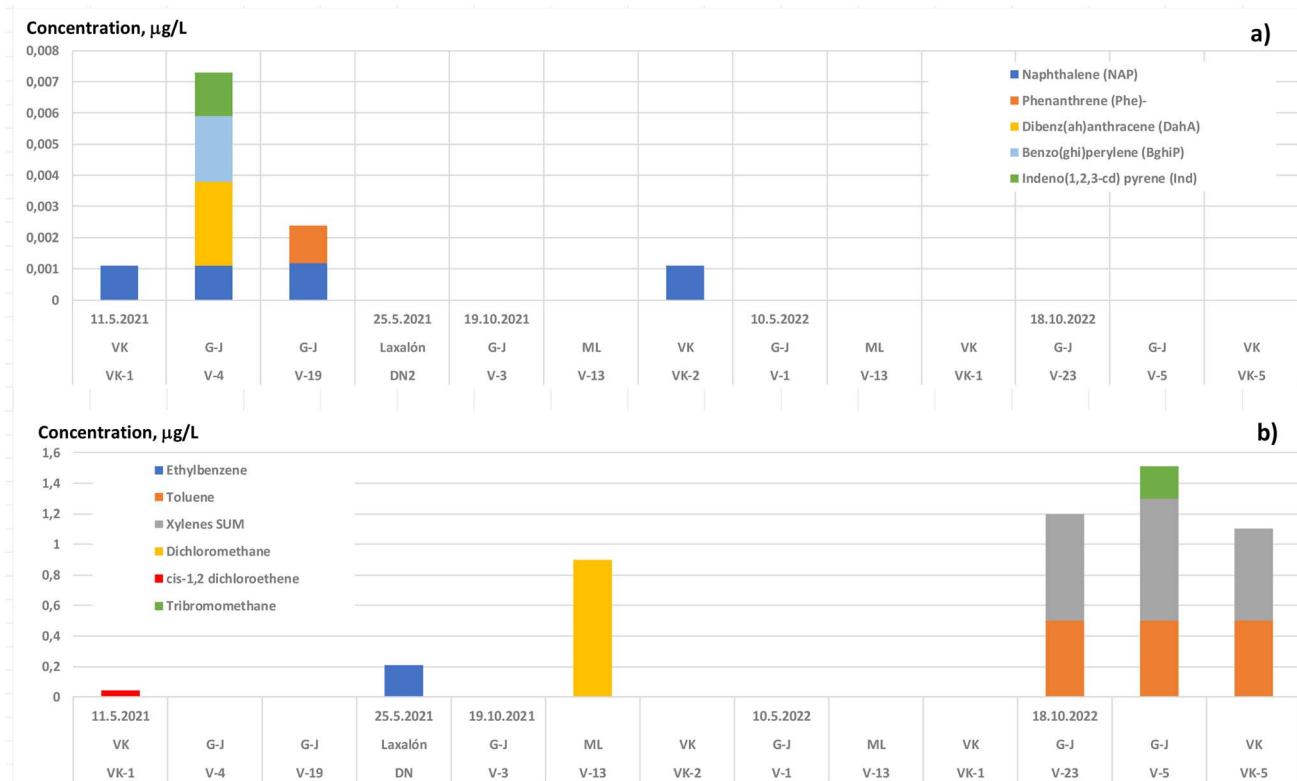
Fig. 2 PAHs (a) and VOCs (b) detected in samples from 11.5.2021 until 18.10.2022 (VK = Vatnsendakrikar, G-J = Gvendarbrunnar–Jadar, DN = distribution network, and ML = Myllulaekur).

Results from sampling taken a week after the fire (May 11) from boreholes in the two water intake zones VK and G-J showed various PAHs and some VOCs following the fire (Fig. 2 and Table 4). Although the analysis of organic compounds is part of the routine monitoring program at the Heidmork production site, the detection limits of the employed methods were, most often, up to an order of magnitude higher prior to the wildfire compared to post-wildfire. The detection limit for all organic chemicals is shown in the ESI† to this article. None of the pre-fire samples exceeded the detection limits for PAHs.

Five of the 16 priority PAHs were above the detection limit in zones G-J and VK within weeks of the wildfire (ML was not measured then). These include naphthalene (NAP) and phenanthrene (Phe) with two or three benzene rings; these are

classified as non-carcinogenic. Dibenz(ah)anthracene (DahA), benzo(ghi)perylene (BghiP) and indeno(1,2,3-cd) pyrene (Ind), in turn, are carcinogens with 5 to 6 benzene rings.⁴⁹ While some of the concentrations were close to the detection limit, they were always well below health limits. The highest concentrations were two to three times the detection limit. The fact that the concentrations mostly exceeded detection limits one week after the fire, coinciding with an increase in some metal concentrations (Fig. 3), supports that the pollution is linked to the wildfire. The total sum of the five PAHs detected a week after the wildfire ranged from 1.1 to 7.3 ng L⁻¹. The three carcinogenic PAHs were only detected in borehole V4 in the lower intake area (G-J), where the groundwater level is only 1–10 m (Table 1). Because of the lack of sampling after the precipitation at the end of May (29th, 2021), it is difficult to know the influence of infiltration into groundwater aquifers and thus the phase-out of the PAH contamination.

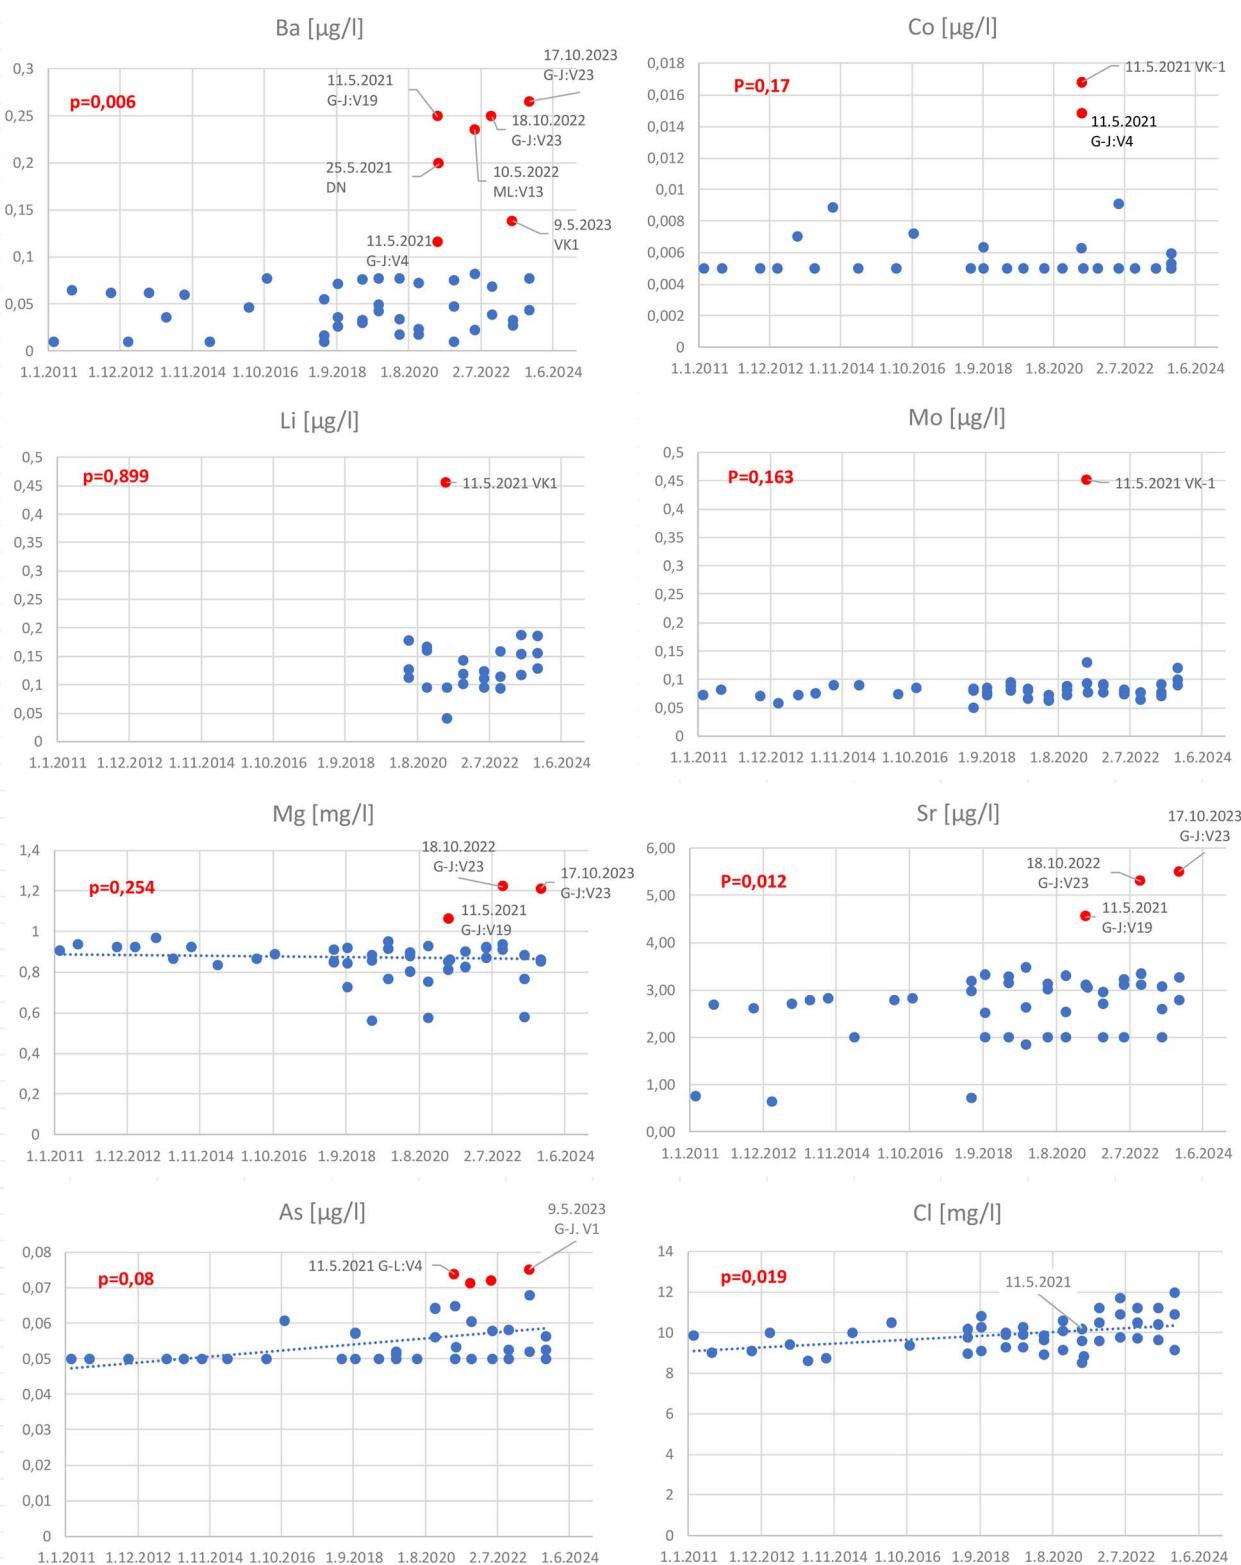
Fig. 3 Eight elements measured in samples taken between 2011 and 2023 showing either a temporary increase after the fire or a significant post-fire increase.

Six metals, barium (Ba), cobalt (Co), lithium (Li), molybdenum (Mo), magnesium (Mg) and strontium (Sr), were measured in two to nearly six-fold higher concentrations after the fire compared to the median value (Fig. 3 and Table 3). Some increases were short-lived, namely Co, Li, Mg and Mo, while Ba and Sr showed a tendency for longer-lasting impacts and there was a significant post-fire increase in concentration in both ($p < 0.05$). Arsenic (As) and chloride (Cl) also have significantly higher post-fire concentrations. However, this does not seem to be related to the wildfire as shown in Fig. 3. It is noted that the elevated concentration of

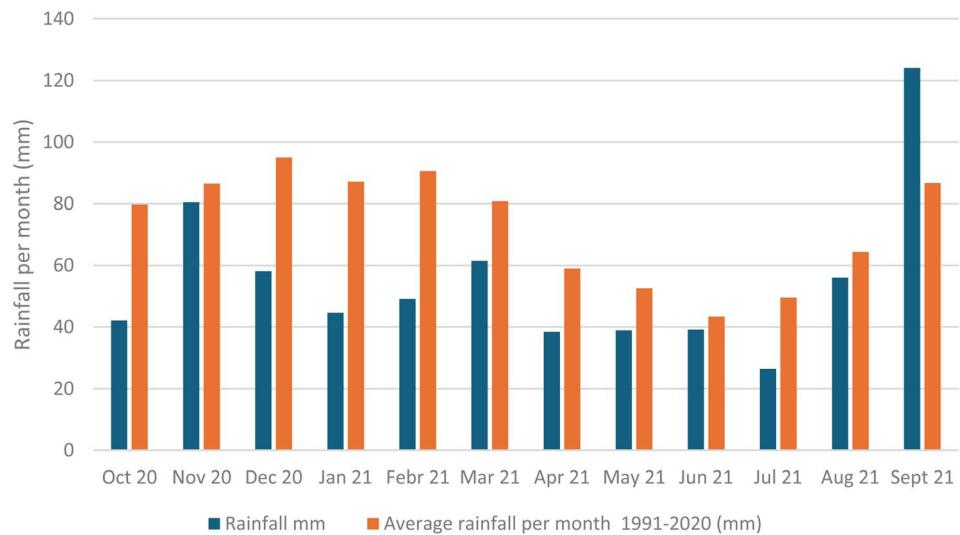
Fig. 4 Monthly rainfall in Reykjavik from 1.10.2020 to 1.10.2021 compared to the average monthly rainfall for the period 1991–2020.

Meteorological measurements clearly show the impact of the drought on the hydrology (Fig. 4). The average precipitation in December, January and February preceding the fire was approximately half the monthly average (90 mm). This resulted in a low volumetric water content in the soil in the open field of the water intake zone at ML and an exceptionally low groundwater level in boreholes at VK. The volumetric water content in soil was low for the late winter period leading up to the fire, fell significantly at the beginning of January and did not recover to the normal stage until after the heavy rain incident on May 29th (Fig. 5). The groundwater level in borehole VK-1 was low in the first months of 2021 compared to the daily average (2008–2020) and exceptionally low in the weeks leading up to the fire (Fig. 6). These measurements demonstrate the importance of systematically monitoring the hydrometeorological parameters to provide early warning for potential wildfires.

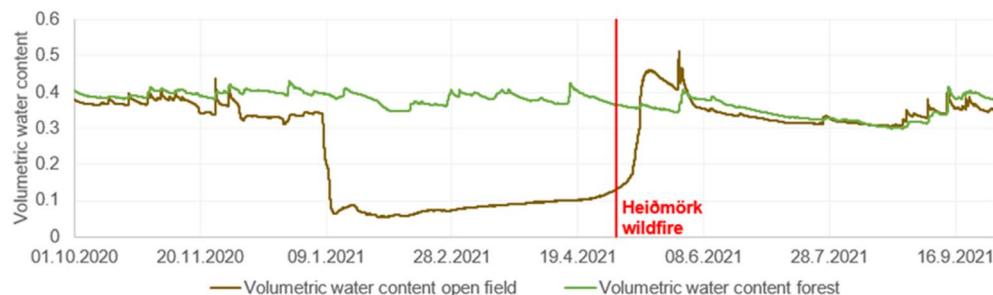
Fig. 5 Volumetric water content in soil in pine forest (green) and open field (brown) from 1.10.2020 to 1.10.2021 measured in the water protection area ML. The vertical line shows the timing of the wildfire.

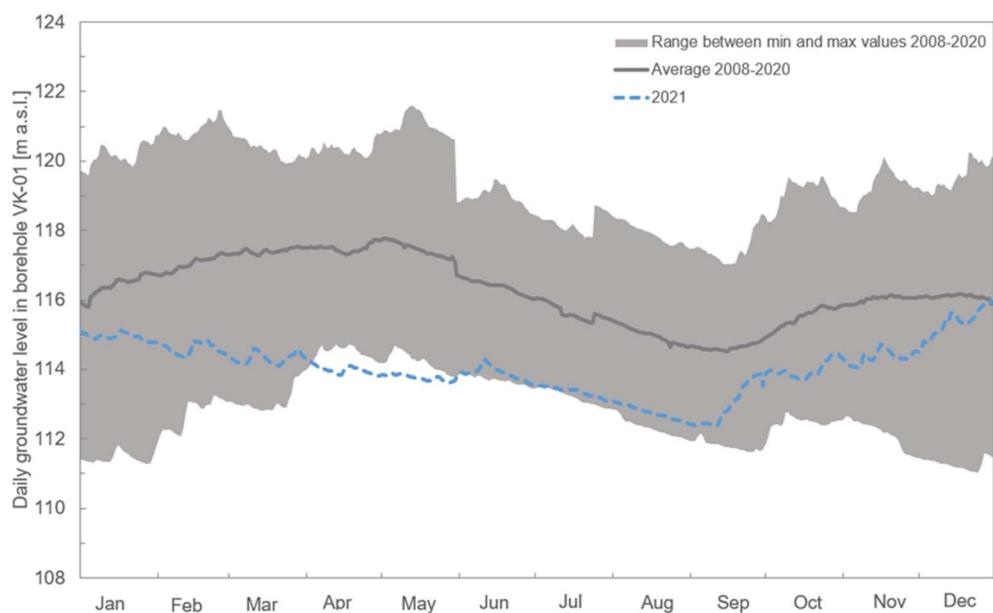
Fig. 6 Average groundwater level for VK-1 for the period 2008–2020, where the shaded area shows the range of the max mean values. The blue line shows the level for 2021.

values were used. Records of the historical groundwater level in the VK production zone east of the wildfire were available from 2008. Daily averages from borehole VK-1 were used.
