Cite this: *Environ. Sci.: Adv.*, 2025, 4, 606

Impact of wildfires on the drinking water catchment for the capital area of Iceland – a case study†

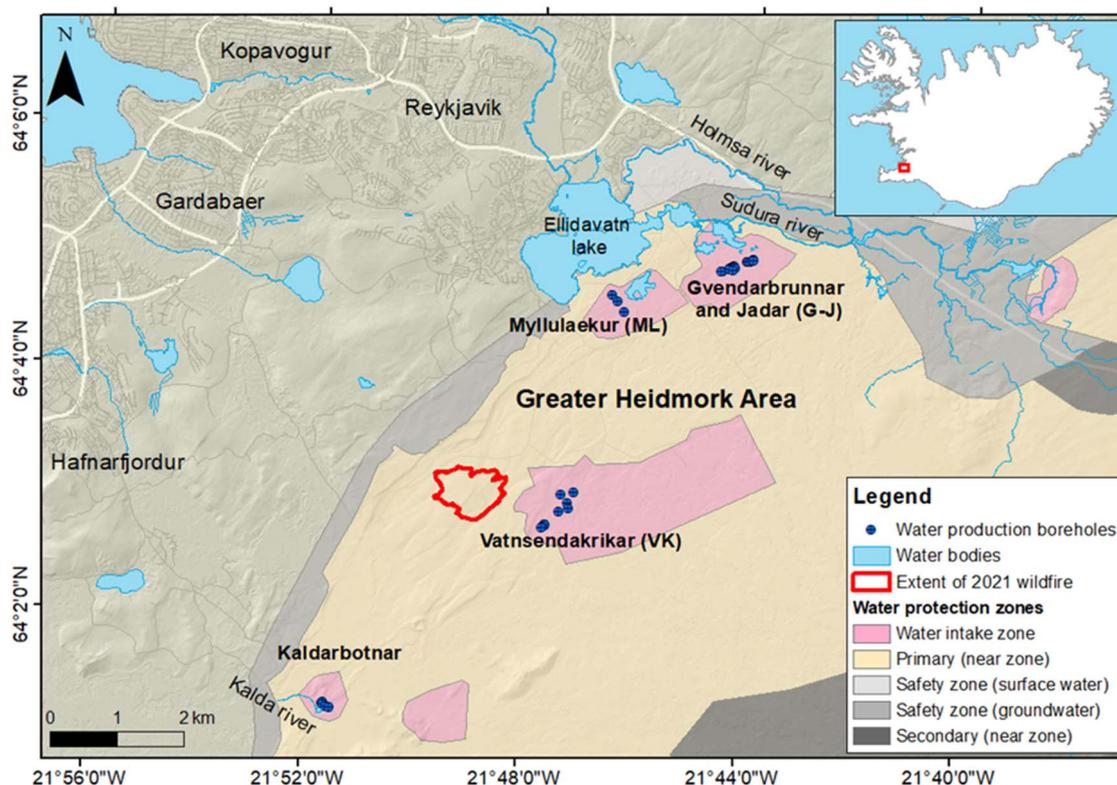
Fig. 1 The greater Heidmork area – the water protection area for the capital region. Drinking water production boreholes are shown. The wildfire area is marked as red (based on data from the Icelandic Institute of Natural History).

The groundwater resources for drinking water for the capital region of Iceland are in the greater Heidmork area (see Fig. 1). The area supplies water to six municipalities—Reykjavik, Kopavogur, Gardabaer, Hafnarfjörður, Mosfellsbaer, and Seltjarnarnes—serving 64% of the population of Iceland (about 230 thousand residents) and is harnessed by six publicly owned water utilities with a yearly average of about 1100 l s⁻¹.⁴⁴ Furthermore, the area is designated as a nature reserve and serves as the largest outdoor recreational area in the vicinity of the city, covering approximately 32 square kilometers. Almost 90% of the area is vegetated land, of which about 20% is cultivated woodland and 20% is wild birch forest and scrub.⁴⁵ According to the NDVI (Normalized Difference Vegetation Index), measured since 1982, there has been a great increase in vegetation in the northern latitudes, including Iceland, since the 1980s.^{40,46}

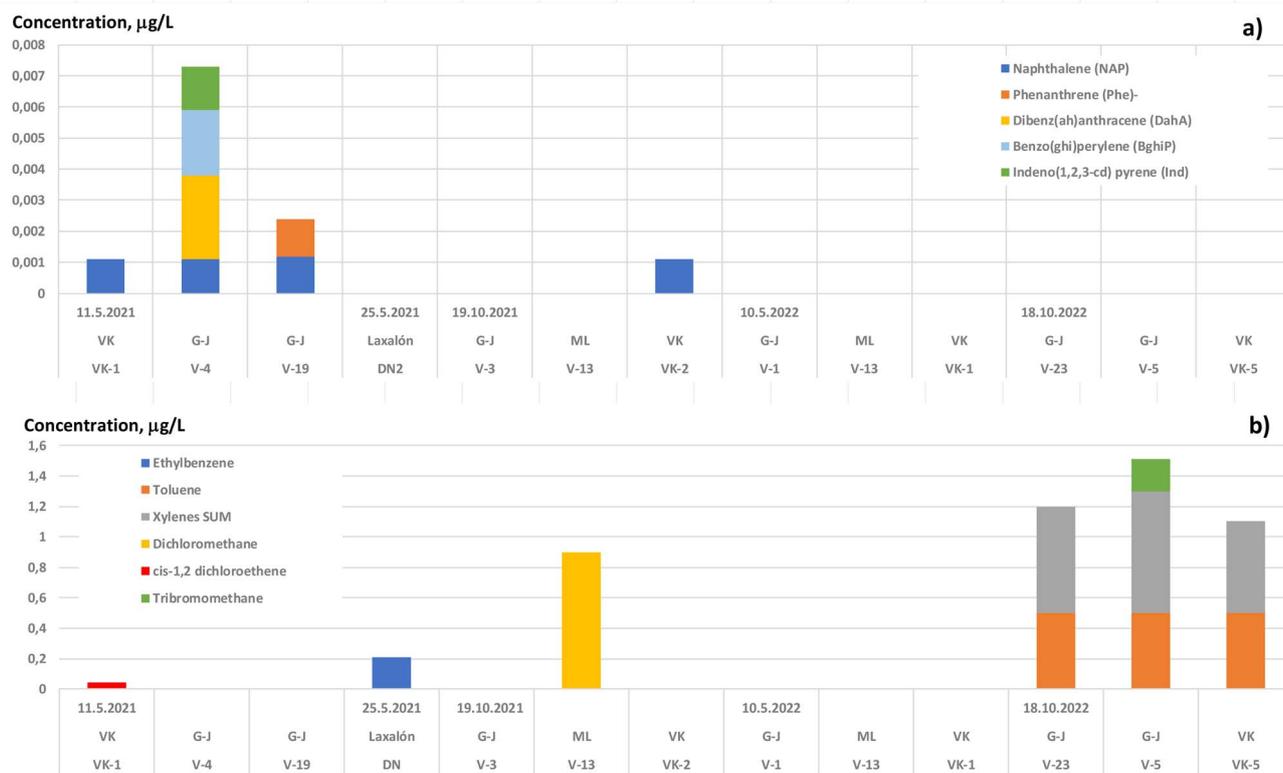
Fig. 2 PAHs (a) and VOCs (b) detected in samples from 11.5.2021 until 18.10.2022 (VK = Vatnsendakrikkar, G–J = Gvendarbrunnar–Jadar, DN = distribution network, and ML = Myllulækur).

Results from sampling taken a week after the fire (May 11) from boreholes in the two water intake zones VK and G–J showed various PAHs and some VOCs following the fire (Fig. 2 and Table 4). Although the analysis of organic compounds is part of the routine monitoring program at the Heidmork production site, the detection limits of the employed methods were, most often, up to an order of magnitude higher prior to the wildfire compared to post-wildfire. The detection limit for all organic chemicals is shown in the ESI† to this article. None of the pre-fire samples exceeded the detection limits for PAHs.

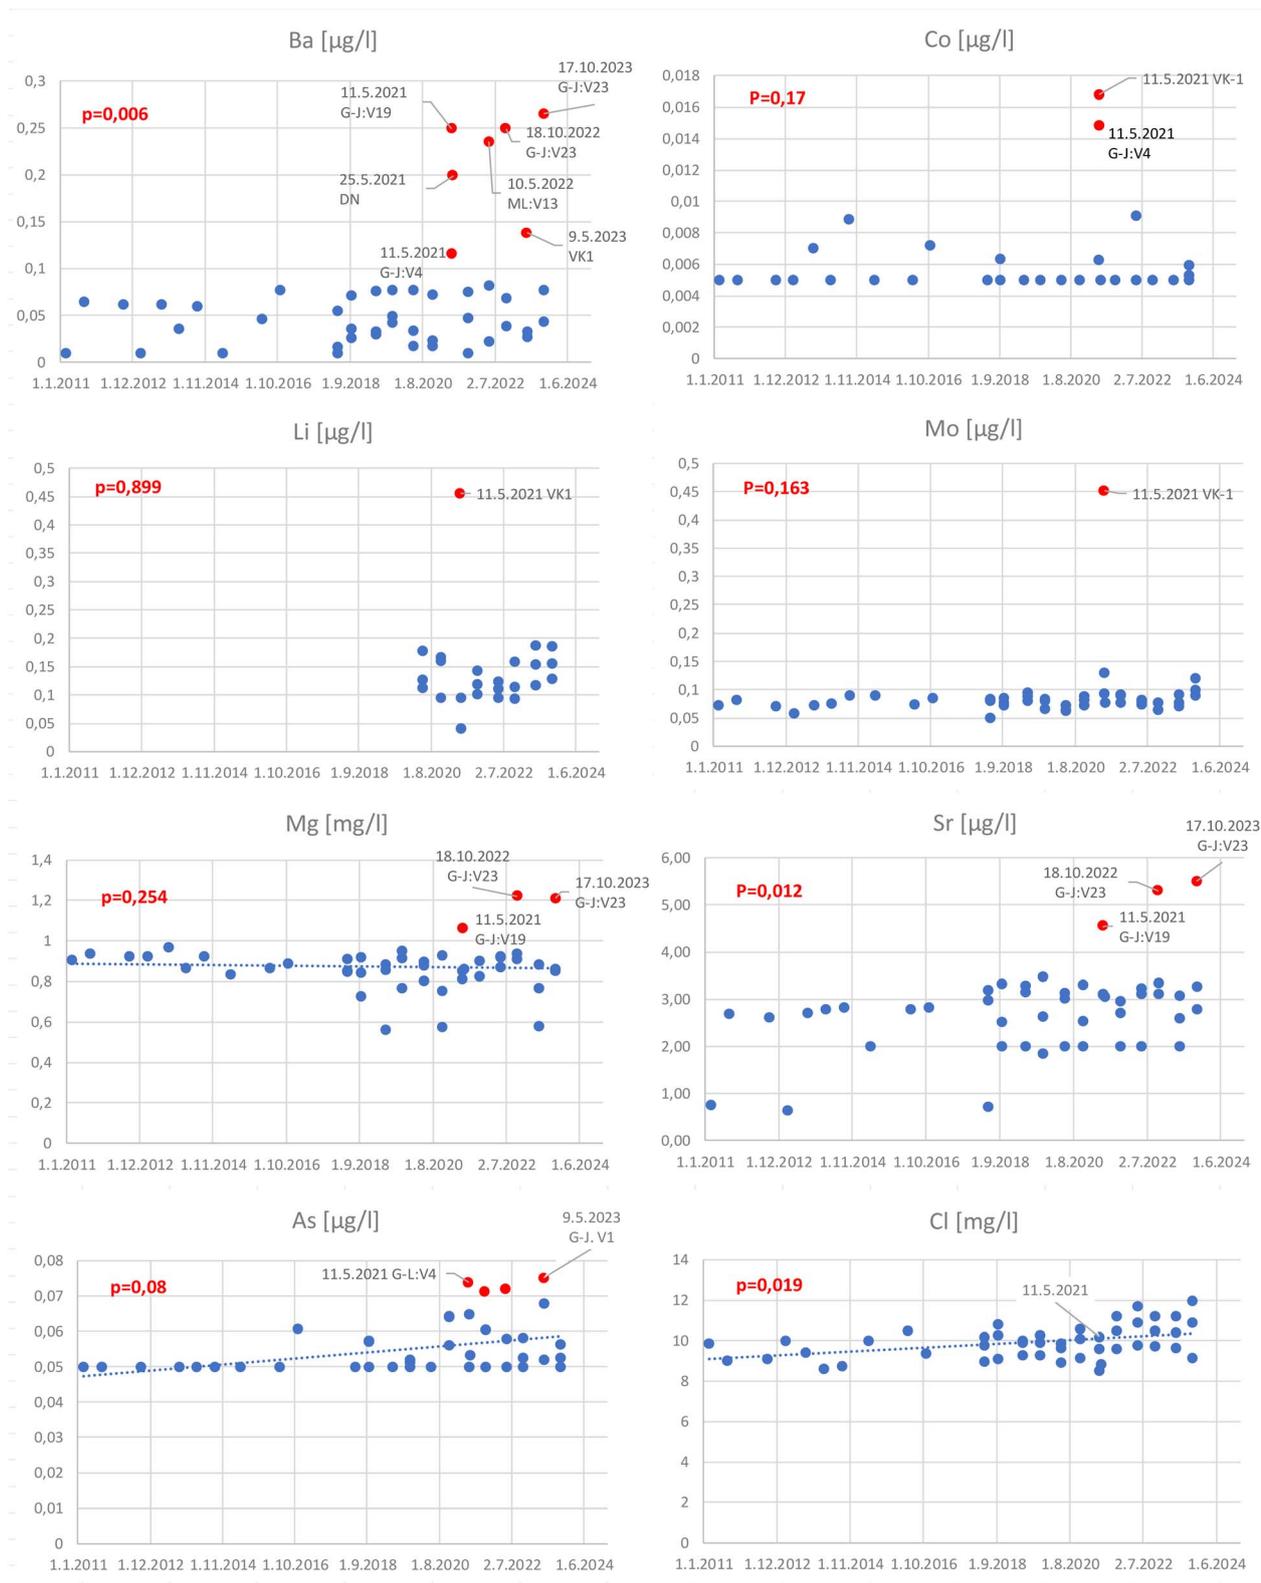
Fig. 3 Eight elements measured in samples taken between 2011 and 2023 showing either a temporary increase after the fire or a significant post-fire increase.

Six metals, barium (Ba), cobalt (Co), lithium (Li), molybdenum (Mo), magnesium (Mg) and strontium (Sr), were measured in two to nearly six-fold higher concentrations after the fire compared to the median value (Fig. 3 and Table 3). Some increases were short-lived, namely Co, Li, Mg and Mo, while Ba and Sr showed a tendency for longer-lasting impacts and there was a significant post-fire increase in concentration in both ($p < 0.05$). Arsenic (As) and chloride (Cl) also have significantly higher post-fire concentrations. However, this does not seem to be related to the wildfire as shown in Fig. 3. It is noted that the elevated concentration of

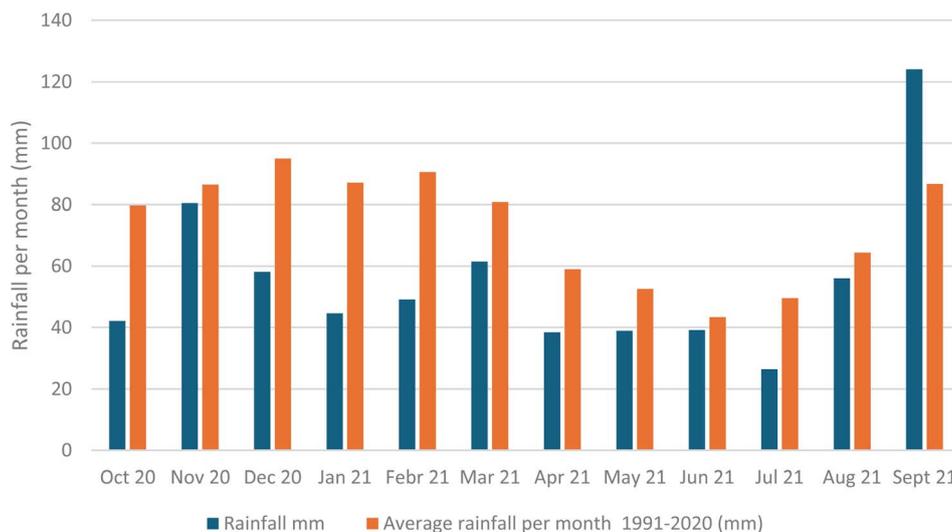
Fig. 4 Monthly rainfall in Reykjavik from 1.10.2020 to 1.10.2021 compared to the average monthly rainfall for the period 1991–2020.

Meteorological measurements clearly show the impact of the drought on the hydrology (Fig. 4). The average precipitation in December, January and February preceding the fire was approximately half the monthly average (90 mm). This resulted in a low volumetric water content in the soil in the open field of the water intake zone at ML and an exceptionally low groundwater level in boreholes at VK. The volumetric water content in soil was low for the late winter period leading up to the fire, fell significantly at the beginning of January and did not recover to the normal stage until after the heavy rain incident on May 29th (Fig. 5). The groundwater level in borehole VK-1 was low in the first months of 2021 compared to the daily average (2008–2020) and exceptionally low in the weeks leading up to the fire (Fig. 6). These measurements demonstrate the importance of systematically monitoring the hydrometeorological parameters to provide early warning for potential wildfires.

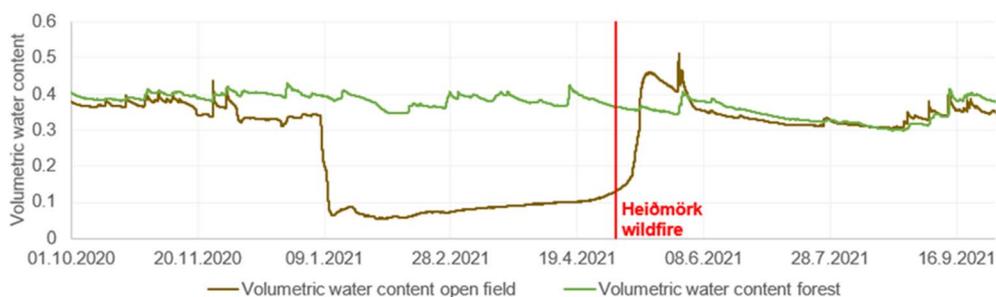
Fig. 5 Volumetric water content in soil in pine forest (green) and open field (brown) from 1.10.2020 to 1.10.2021 measured in the water protection area ML. The vertical line shows the timing of the wildfire.

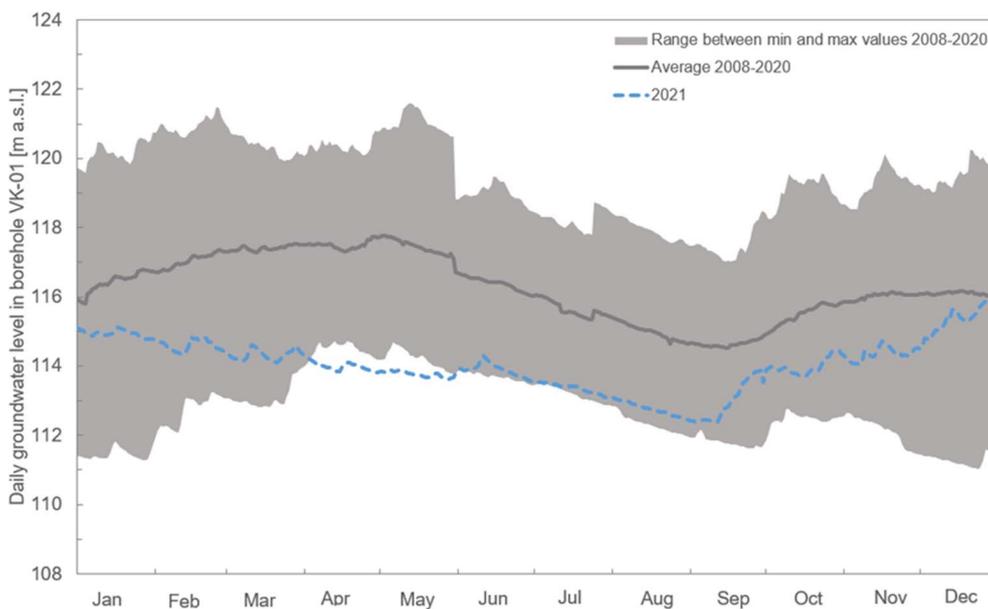
Fig. 6 Average groundwater level for VK-1 for the period 2008–2020, where the shaded area shows the range of the max mean values. The blue line shows the level for 2021.
