# **Physical Chemistry Chemical Physics**

# Investigating lithium-ion battery materials during overcharge-induced thermal runaway: An *operando* and multi-scale X-ray CT study

Catastrophic failure of lithium-ion batteries occurs across multiple length scales and over very short time periods. A combination of high-speed *operando* tomography, thermal imaging and electrochemical measurements is used to probe the degradation mechanisms leading up to overcharge-induced thermal runaway of a LiCoO<sub>2</sub> pouch cell, through its interrelated dynamic structural, thermal and electrical responses. Failure mechanisms across multiple length scales are explored using a *post-mortem* multi-scale tomography approach, revealing significant morphological and phase changes in the LiCoO<sub>2</sub> electrode microstructure and location dependent degradation. This combined *operando* and multi-scale X-ray computed tomography (CT) technique is demonstrated as a comprehensive approach to understanding battery degradation and failure.

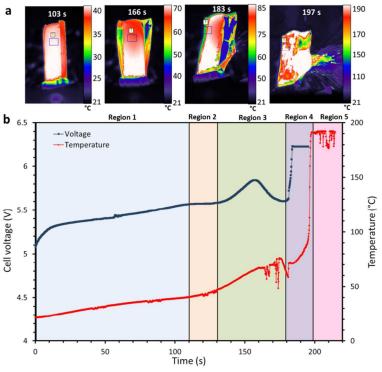
Figure 1. a) Sequence of time-stamped thermal images showing the increasing surface temperature of the LiCoO $_2$  pouch cell leading up to thermal runaway. The average temperature within the labelled square is plotted. b) Plot of the cell voltage and surface temperature, leading up to and during thermal runaway. The battery was charged at a constant current of 3 A (18.75 C), from 100% SOC (4.2 V) until failure. Real time thermal images are presented in Supplementary Movie 1.

During overcharge of lithium-ion batteries, a sequence of events related to the evolution of voltage, temperature and chemistry of the cell occurs leading up to thermal runaway and failure. In Figure 1b, distinctive features can be identified in the temperature and voltage curves. For the initial 110 s (Region 1), the external temperature of the cell increases from 20 °C to ca. 40 °C. This initial heating is expected to derive primarily from irreversible heat generation mechanisms, such as Ohmic losses, which are most prevalent at high C rates<sup>32</sup>. A plateau in cell voltage is observed after 110 s (Region 2 in Figure 1b), followed by a significant increase in the rate of temperature rise after 120 s. The simultaneous voltage plateau and temperature rise indicates

Finally, within Region 4 in Figure 1b, the cell voltage rises sharply to the maximum voltage of the potentiostat, the most likely cause of which is the shutdown of the separator and damage to the internal circuit caused by the rupture of

Fluctuations in the surface temperature of the cell occur after around 160 s as the cell ruptures (Supplementary Movie 1), at which point the unstable electrodes are exposed to air and the process of thermal runaway is accelerated. The heat generated from the reaction between the  $LiCoO_2$  and electrolyte, along with the decomposition of the SEI layer provide heat for the occurrence of thermal runaway which soon ensues, following which the surface temperature of the cell exceeds the limit of the thermal camera's calibrated range (Region 5 in Figure 1b).

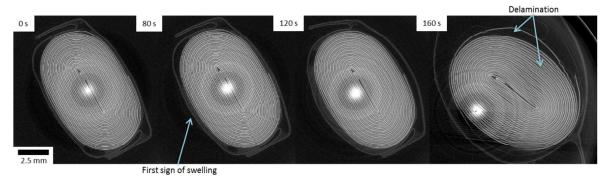
Figure 2. Time-stamped horizontal slices taken from sequential tomograms during electrical overcharge of the  $LiCoO_2$  cell. Pouch swell begins after 80 s (blue arrow), and the electrode layers begin to deform and delaminate after 160 s. The  $LiCoO_2$  electrode also delaminates from the Al current collector after 160 s (blue arrow pointing to inner region)

After ca. 80 s, corresponding to an external temperature of 40 °C, the pouch of the cell has begun to swell (Figure 2) as gas is generated from reduction of the electrolyte and decomposition of the SEI<sup>36-38</sup>. After 120 s, severe delamination is observed around the separator regions in the outer layers. Within Region 3 in Figure 1b, a distinctive peak in cell voltage occurs over the space of ca. 40 s, consistent with the behaviour observed by Belov and Yang<sup>39</sup>. In Supplementary Movie 1, the pouch structure is seen to diverge from its original packaged structure, which corresponds with this voltage peak, as observed in Figure 1b. It is expected that the rise in voltage is caused by the resistance increase associated with the gas pockets forming between the active layers, and the subsequent fall in voltage by the decrease in resistance when the pouch bursts and the gases are channelled away. The tightly wound active layers channel gases out into the exterior pouch when the pouch begins to lose its original package structure and starts to swell.

the cell at that time. The tomogram taken at  $160 \, \mathrm{s}$  in Figure 2 shows delamination of the  $\mathrm{LiCoO_2}$  layers from the aluminium current collector in various places, which may be evidence of the electrolyte vaporising or initial stages of decomposition of the  $\mathrm{LiCoO_2}$  resulting in gas pockets forming between the aluminium current collector and the  $\mathrm{LiCoO_2}$  layer. This may also be due to the current collector being oxidised by the electrolyte, or the products of electrolyte decomposition  $^{40}$ ,

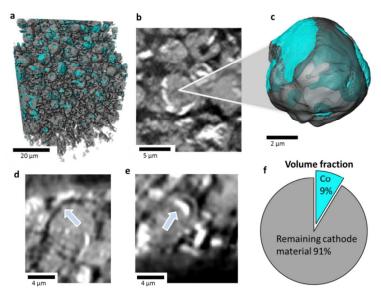
Figure 5. (a) 3D rendering of a portion of  $LiCoO_2$  electrode showing isolated Co phase (teal); (b) greyscale slice view of  $LiCoO_2$  particle showing evidence of phase separation based on attenuation and (c) semi-transparent 3D visualisation of  $LiCoO_2$  particle (grey) showing surface and sub-surface presence of Co (teal); (d, e) greyscale slice views showing delamination of Co metal surface layer; (f) 2D representation of the volume fraction of Co within the remaining  $LiCoO_2$  electrode material. This sample was extracted from an inner region labelled as A in Figure 3.

be greater. Post-mortem micro-CT of the LiCoO<sub>2</sub> particles shows severe microstructural degradation (Figure 5). Evidence of a surface layer of Co metal on the electrode particles is seen in Figure 5a. Figure 5b shows a greyscale 2D slice with the highly attenuating Co layer (white) at the surface of the particle. A semi-transparent 3D rendering of the particle (Figure 5c) shows the presence of Co (teal) on the surface and Co channels within the particle. As a result of changes in density of materials during decomposition, a reduction in particle volume and delamination of phases is expected to occur. The density of Co metal is almost twice that of LiCoO<sub>2</sub> and accordingly, there is evidence of delamination of the Co layer from the bulk of the particle, shown in Figure 5(d-e). During thermal runaway, this delamination would have exposed further surface material to exothermic reduction.

From attenuation coefficients of expected decomposition products (see Supplementary Information) the composition of the particle surface layer and interior can be inferred; the difference in greyscale between the Co surface layer and the particle interior suggests that most of the particle consists of CoO, which is consistent with previous XRD experiments<sup>10</sup>. The volume fraction of Co metal in the remaining cathode material is calculated to be 9 % (Figure 5f). SEM images and EDS (Figure 6a,b) show that the surface of the particle consists of Co globules rather than the smooth surface presented in Figure 5; this is due to the limited resolution of

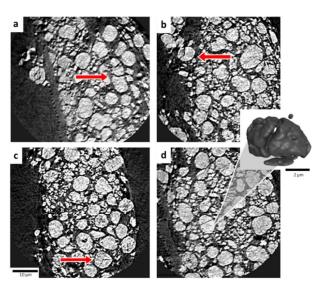
Figure 7. (a-d) Orthoslices highlighting cracked  $LiCoO_2$  particles. Sample was extracted from the outer region labelled as B in Figure 3. Inset: an isolated 3D volume of the cracked particle in (d).

In contrast to the subsurface samples, the surface sample presented in Figure 7 contains numerous fractured particles. As Geder *et al.*<sup>17</sup> demonstrated, a reduced particle size (and increased specific surface area) results in unfavourable consequences, such as a higher rate of heat generation and lower onset temperatures for thermal runaway.

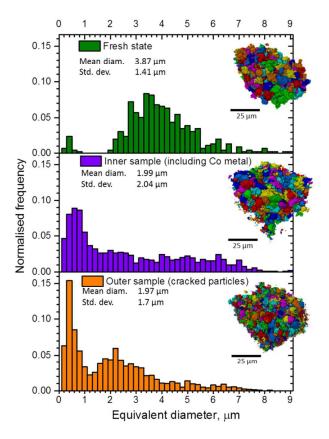
Figure 8. Particle size distributions for LiCoO<sub>2</sub> particles from a fresh sample (top), a sample taken from the inner regions of the failed overcharged cell showing evidence of complete reduction to Co metal (middle), and a sample taken from the outer region of the failed overcharged cell showing evidence of particle cracking with no formation of Co (bottom).

Mass loss occurs at each reduction step according to equations (2) - (4), and the electrode particles are expected to reduce in mass and volume, and increase in density. The particle size distribution (PSD) of a fresh sample is compared with that of both *post-mortem* samples; the inner sample (showing presence of a Co surface layer) and the outer sample (showing significant cracking and the absence of Co). The particle volumes used for the PSD of the three samples were 24,897  $\mu$ m<sup>3</sup> (fresh), 34,907  $\mu$ m<sup>3</sup> (inner), and 33,785  $\mu$ m<sup>3</sup> (outer). The PSD for each sample is presented in Figure 8. In its fresh state the PSD centres around a mean diameter 3.87 µm with a relatively low standard deviation. There is a significant decrease in the mean diameter of the remaining particles for both post-mortem samples to approximately half their original size (to 1.99  $\mu m$  and 1.97  $\mu m$  for the inner and outer samples respectively), but the spread of data in the PSD greatly differs (Figure 8). The PSD for the inner sample shows a single peak which has shifted below 2 µm, which is due to a combination of particle shrinkage during phase transitions and the presence of significant debris consisting of fractured particles and delaminated Co. In contrast, a bimodal PSD is observed for the outer sample (cracked particles). When compared to the PSD of the fresh sample, the twin peaks correspond to the occurrence of particle cracking, where the majority of the distribution is shifted to a smaller equivalent particle diameter. However, a second peak which consists of particles < 1 µm in diameter contains the highest frequency of particles. This second peak may reflect smaller particle fragments from the fractured larger particles. Due to the limited resolution of the X-ray CT technique, the specific surface area of the particles could not be accurately determined; however, the dramatic reduction in particle size observed between the fresh and outer samples is expected to significantly affect the rate of decompositon of the electrode at elevated temperatures. Additional surface area would be exposed to reaction with the electrolyte and the smaller fragmented particles would exhibit a lower onset temperature 16, 17. For example, as demonstrated by Jiang and Dahn<sup>16</sup>, a reduction in particle size of  $LiCoO_2$  from 5  $\mu m$  to 0.8  $\mu m$  results in decreased thermal stability, with lower onset temperatures.
