Cite this: *Energy Environ. Sci.*,  
2025, 18, 264

## Removal of residual contaminants by minute-level washing facilitates the direct regeneration of spent cathodes from retired EV Li-ion batteries†

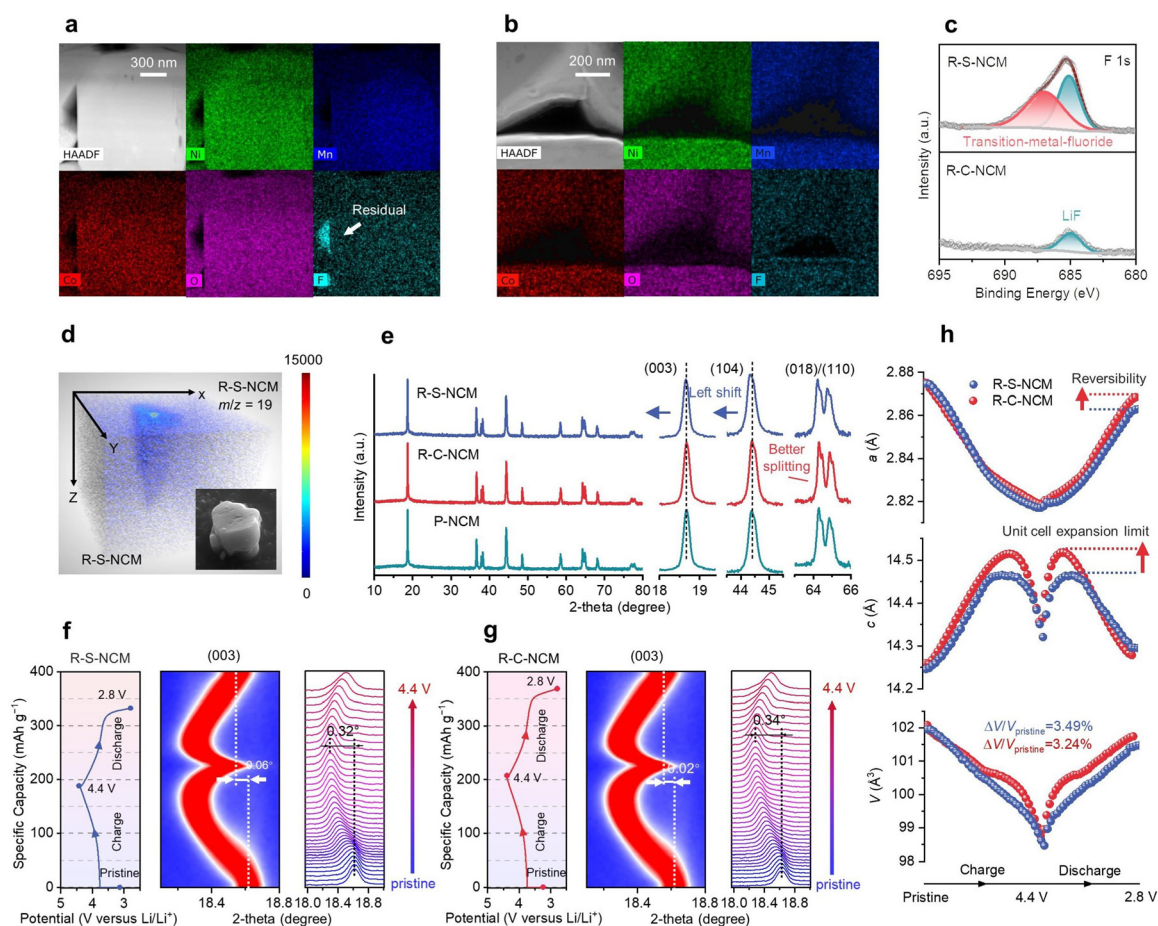
**Fig. 3** Chemical and structural details of the regenerated cathode materials under the influence of impurities. (a) HAADF-STEM images and (b) corresponding EDS element mappings of R-S-NCM and R-C-NCM particles, focusing on the pores of the packing particles. (c) F 1s XPS high-resolution patterns of R-S-NCM and R-C-NCM powders. (d) Pseudo-three-dimensional distribution of F element and SEM image of the corresponding R-S-NCM particle. (e) Full patterns and characteristic peak comparison of the regenerated and pristine NCM cathodes with Cu K $\alpha$  radiation at a scan rate of 8° min<sup>-1</sup>. (f) 1st charge-discharge curves, corresponding XRD patterns of R-S-NCM, and (g) (003) peak position variation when the cell charge from pristine to 4.4 V and comparison with R-C-NCM. (h) Lattice parameters  $a$ ,  $c$ , and the unit cell volume  $V$  of R-S-NCM and R-C-NCM in the 1st charge-discharge test according to the refinement.

the spent cathode could completely decompose in air with an  $O_2$  atmosphere at 550 °C and 750 °C, which suggested these additives led to only minor residuals for the regenerated cathode after the high-temperature regeneration. Comparing the morphology (Fig. S25, ESI†) and element composition (Table S4, ESI†) showed that both the regenerated cathodes exhibited a smooth surface without cracks and possessed a similar composition as pristine P-NCM. However, the element distribution was distinct, as indicated by the corresponding EDS mapping shown in Fig. 3a and b, where it could be clearly seen that there were fluorine residuals aggregated in the nanopores inside the R-S-NCM cathode, while the R-C-NCM cathode did not show a F-rich area. Meanwhile, the XPS (Fig. 3c and Fig. S26, ESI†) results showed that the R-C-NCM cathode exhibited a much less intense F 1s characteristic peak and more similar C 1s and O 2p peaks with the P-NCM one compared with R-S-NCM without the purifying treatment. The SEM-ToF-SIMS results (Fig. 3d and Fig. S27 and Videos S5, S6, ESI†) also demonstrated that even though long-time calcination was

applied, the F-rich residual impurities in R-S-NCM had hardly vaporized and were still concentrated on the surface and in the bulk due to their strong electronegativity.<sup>45</sup>

Furthermore, the crystal structure of the regenerated cathode could also be affected by the residual impurities. As shown in Fig. 3e and Fig. S28 (ESI†), the XRD pattern indicated a layered structure with no impurities phase for both the R-S-NCM and R-C-NCM cathodes. However, the R-C-NCM cathode had a higher (003)/(104) intensity ratio and larger splitting degree for the (018)/(110) peaks compared to R-S-NCM, suggesting its more ideal layered structure similar to P-NCM cathodes. After regeneration accompanied by impurities, the diffraction peaks of R-S-NCM were shifted toward a low-angle direction, indicating the lattice expansion, as supported by the refined parameters (Table S11, ESI†) and *in situ* experiments (Fig. 2d). Furthermore, *in situ* XRD was performed during the 1st charge/discharge process for both regenerated cathodes (see Fig. 3f and g). The R-C-NCM cathode showed a higher capacity with a smaller offset (0.02°) of the (003) peak position than the

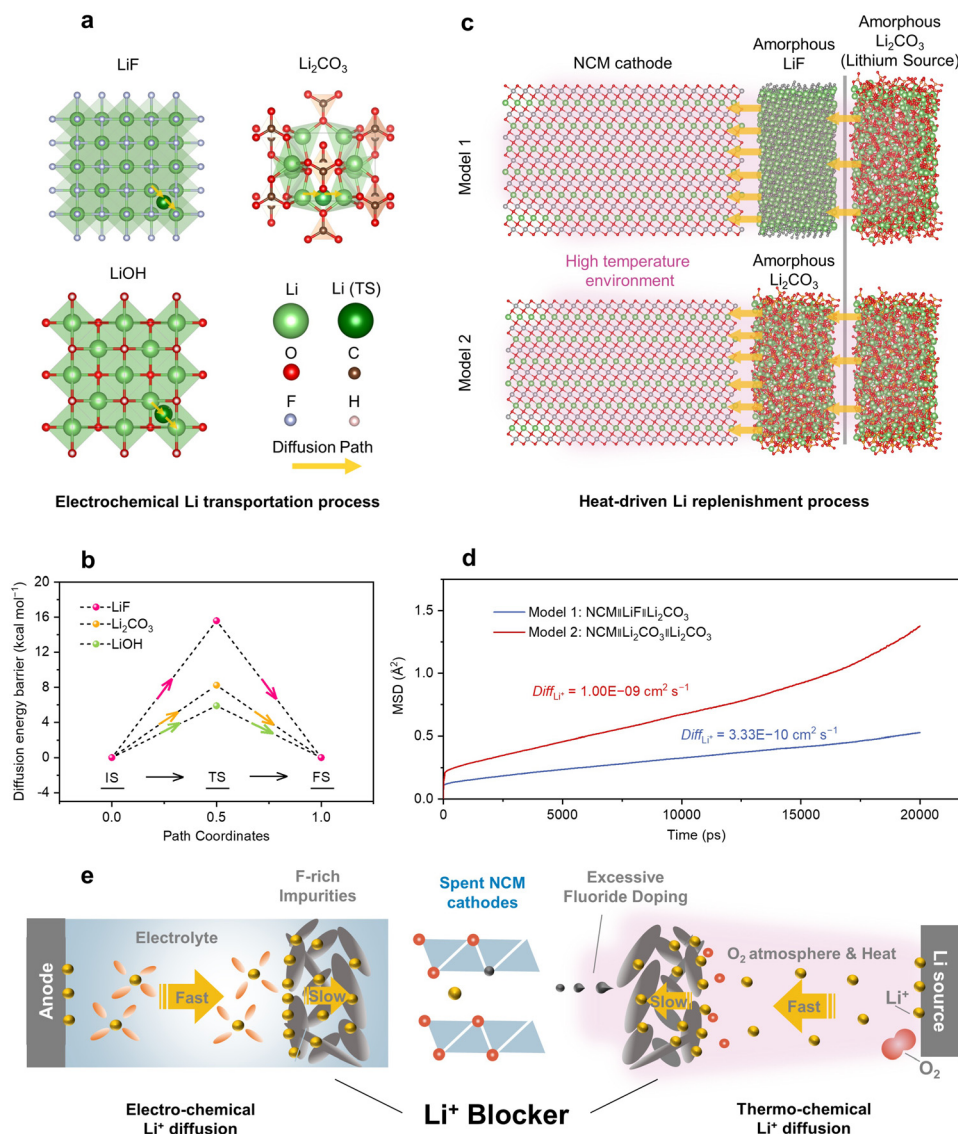
**Fig. 5** Role of the F-rich impurities as a blocker in electrochemical and thermochemical  $\text{Li}^+$  diffusion as ascertained from thermodynamic and kinetic simulations. (a) Illustrations of the selected migration pathways with a similar distance for  $\text{Li}^+$  inside the crystal lattice of three common components. The initial state, transition state, and final state of  $\text{Li}^+$  transportation are denoted as IS, TS, and FS, respectively. (b) Calculated energy diffusion barrier for Li ions in selected phases. (c) Two models for stimulating the kinetics of Li transportation in direct regeneration. Model 1 consists of the NCM cathode substrate, the amorphous LiF layer, and  $\text{Li}_2\text{CO}_3$  as a lithium source in direct regeneration, which is denoted as NCM||LiF|| $\text{Li}_2\text{CO}_3$ . In Model 2 (NCM|| $\text{Li}_2\text{CO}_3$ || $\text{Li}_2\text{CO}_3$  in short), the middle LiF layer is replaced by a common residual alkali ( $\text{Li}_2\text{CO}_3$ ), which is used to simulate the regeneration of NCM cathodes after cleaning pretreatment. Each shape symbol is the same as for Fig. 5a. (d) MSD of the Li atoms in 20 ns and calculated  $\text{Li}^+$  diffusivity based on the above model. "E – 9" means  $10^{-9}$ . (e) Mechanism diagram for preventing the NCM cathodes from reusing and directly regenerating under the influence of impurities.

According to the above results (Fig. 1d, Fig. S6, S16 (ESI†), and Fig. 4h, i), the migration rate of lithium ions was significantly influenced by the residual impurities; therefore it was crucial to theoretically investigate their influence on capacity delivery in the reuse case and during direct regeneration. Considering the impurities were mostly concentrated at the surface before and after regeneration, and that F-rich residuals could be observed, as shown in Fig. S9 and S10 (ESI†) and Fig. 3c, we chose three representative inorganic components ( $\text{LiF}$ ,  $\text{Li}_2\text{CO}_3$ , and  $\text{LiOH}$ ) in the CEI layer<sup>48</sup> or residual alkali<sup>49</sup> to calculate the  $\text{Li}^+$  diffusion from a thermodynamic perspective, and their structures are shown in Fig. 5a. By maintaining a similar distance and concentration of mobile Li-ions, the diffusion energy barrier of lithium ions ( $\Delta E_{\text{Li}^+}$ ) during the cycling of spent cathodes within the different crystal structures (Fig. 5b) allowed valid comparisons. We found that the  $\Delta E_{\text{Li}^+}$  of the  $\text{LiF}$  phase, as a common inorganic component from CEI, was about 2 and 3 times higher than that of the  $\text{LiOH}$  and  $\text{Li}_2\text{CO}_3$  phases from

Fig. 5b. Therefore, this result confirmed that the presence of fluoride-rich impurity residuals on the cathode surface significantly increased the diffusion resistance of Li ions when cycling, ultimately exacerbating the cell impedance and interfacial parasitic reactions (Fig. 1d). To comprehend the larger-scale kinetic characteristics and understand the effect of impurity coatings during heating for regeneration of the spent cathodes, two molecular dynamics models were established for simulating  $\text{Li}^+$  transportation at 1000 K over 20 ns. Specifically, Model 1 was devised to include an impurity barrier consisting of a  $\text{LiF}$  layer (Fig. 5c and Fig. S33, ESI†). Through computing the mean square displacement (MSD) of Li atoms and fitting curves (Fig. 5d), we determined that the Li diffusivity ( $\text{Diff}_{\text{Li}^+}$ ) of Model 1 was  $3.33 \times 10^{-10}$ , which was an order of magnitude lower than that of Model 2 ( $1.00 \times 10^{-9}$ ). The differences in molecular dynamics models under practical conditions suggest that fluoride-rich impurity coatings increase the resistance to Li-ion diffusion into spent cathodes with Li deficiencies during thermo-driven regeneration, leading to inadequate compositional and structural recovery.

As illustrated in Fig. 5e, the impurity phase containing the F element served as an electro- and thermo-diffusion blocker of Li ions hindering the reuse and direct regeneration of the spent cathode. In the spent cathodes collected by physical pretreatment and collection from used lithium-ion batteries, the ubiquitous electrolyte was decomposed to form an ion barrier with slow ion diffusivity. However, these impurities have long been overlooked in most studies (Table S2, ESI†), mainly due to the use of lab-scale degraded cathodes and fine manual separation pretreatment. In previous studies,<sup>12–16,42</sup> the latent impact of the residual impurities on direct regeneration remains untouched because impurities are easily converted into other inconspicuous matter in extreme physical or chemical regeneration environments. Looking ahead, the direct regeneration of next-generation sensitive cathode materials, such as Li-rich Mn-based, Co-free, and ultra-high-Ni cathode materials, faces serious challenges from these latent impurities if they enter the recycling circle. From another perspective, establishing the controlling law for the inherent impurities doping within the closed-loop material flow could instructively enhance the performance of such recycled materials in the future. Moreover, only by revealing the effect of the overlooked impurities or by getting rid of impurities, can evolving technologies and mechanisms for direct regeneration and upcycling be reasonably evaluated.<sup>50</sup>
