# Environmental Science Advances

# **PAPER**

# Impact of wildfires on the drinking water catchment for the capital area of Iceland — a case study†

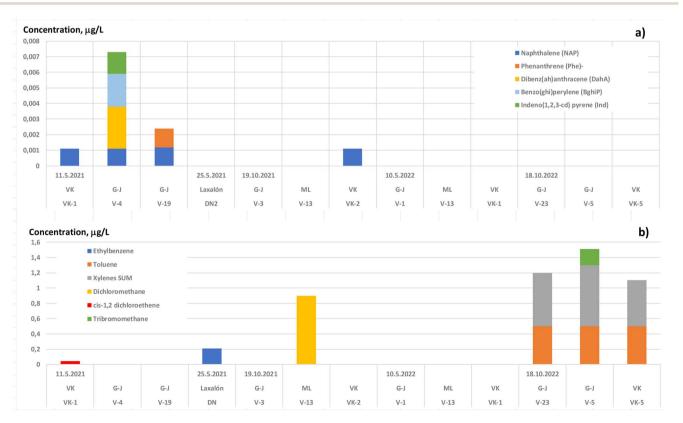
Fig. 2 PAHs (a) and VOCs (b) detected in samples from 11.5.2021 until 18.10.2022 (VK = Vatnsendakrikar, G-J = Gvendarbrunnar-Jadar, DN = distribution network, and ML = Myllulaekur).

Results from sampling taken a week after the fire (May 11) from boreholes in the two water intake zones VK and G–J showed various PAHs and some VOCs following the fire (Fig. 2 and Table 4). Although the analysis of organic compounds is part of the routine monitoring program at the Heidmork production site, the detection limits of the employed methods were, most often, up to an order of magnitude higher prior to the wildfire compared to post-wildfire. The detection limit for all organic chemicals is shown in the ESI† to this article. None of the prefire samples exceeded the detection limits for PAHs.

Five of the 16 priority PAHs were above the detection limit in zones G–J and VK within weeks of the wildfire (ML was not measured then). These include naphthalene (NAP) and phenanthrene (Phe) with two or three benzene rings; these are

classified as non-carcinogenic. Dibenz(ah)anthracene (DahA), benzo(ghi)pervlene (BghiP) and indeno(1,2,3-cd) pyrene (Ind), in turn, are carcinogens with 5 to 6 benzene rings.49 While some of the concentrations were close to the detection limit, they were always well below health limits. The highest concentrations were two to three times the detection limit. The fact that the concentrations mostly exceeded detection limits one week after the fire, coinciding with an increase in some metal concentrations (Fig. 3), supports that the pollution is linked to the wildfire. The total sum of the five PAHs detected a week after the wildfire ranged from 1.1 to 7.3 ng  $l^{-1}$ . The three carcinogenic PAHs were only detected in borehole V4 in the lower intake area (G-J), where the groundwater level is only 1-10 m (Table 1). Because of the lack of sampling after the precipitation at the end of May (29th, 2021), it is difficult to know the influence of infiltration into groundwater aquifers and thus the phase-out of the PAH contamination.

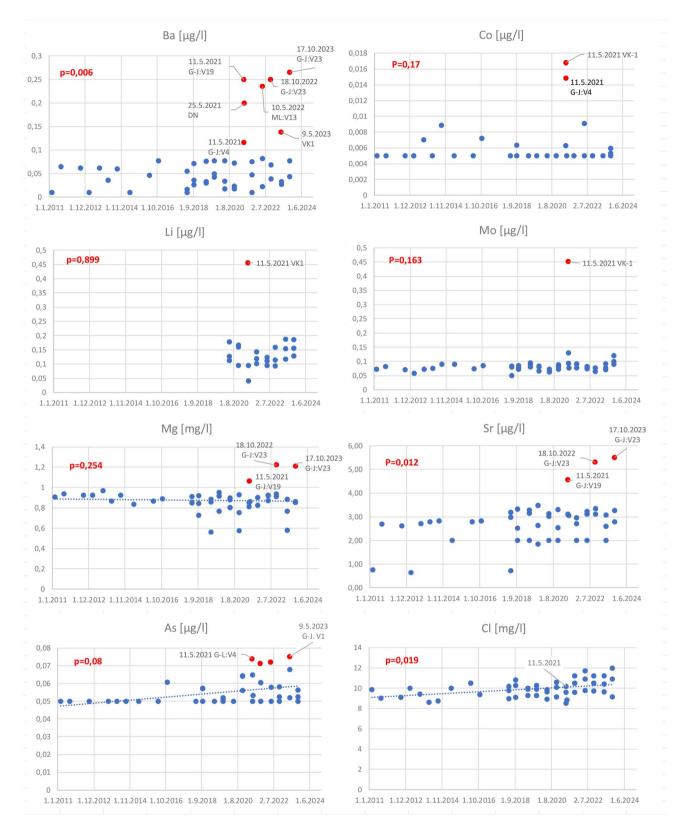
Fig. 3 Eight elements measured in samples taken between 2011 and 2023 showing either a temporary increase after the fire or a significant postfire increase.

Six metals, barium (Ba), cobalt (Co), lithium (Li), molybdenum (Mo), magnesium (Mg) and strontium (Sr), were measured in two to nearly six-fold higher concentrations after the fire compared to the median value (Fig. 3 and Table 3). Some increases were short-lived, namely Co, Li, Mg and Mo, while Ba and Sr showed a tendency for longer-lasting impacts and there was a significant post-fire increase in concentration in both (p < 0.05). Arsenic (As) and chloride (Cl) also have significantly higher post-fire concentrations. However, this does not seem to be related to the wildfire as shown in Fig. 3. It is noted that the elevated concentration of

As might be due to volcanic activity in the Reykjanes peninsula or steam from a geothermal power plant less than 20 km away. Steam from the geothermal power plant has been

Most often, the increases in metals occurred in zone G-J, which again can be explained by the shallow groundwater table. Other elements did not show any clear changes that could be attributed to the wildfire and appeared to be unaffected by the fire. The behaviour of nutrients and other elements was analysed, revealing no changes for most major elements, although an increase is often cited in other research.<sup>33,34</sup> Fluoride and sulphate showed a statistically significant increase after the fire in the Braga Region in Portugal.<sup>33</sup> The detection limit (DL) used at the laboratory ALS Scandinavia AB for fluoride, sulphate, selenium, and boron in Heidmork was sometimes above the natural background level, so limited measurements are available for registering any change for those parameters, as shown in the ESI file.†

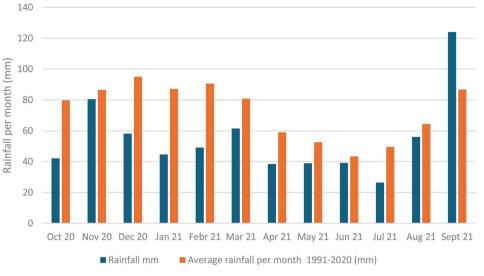
Fig. 4 Monthly rainfall in Reykjavik from 1.10.2020 to 1.10.2021 compared to the average monthly rainfall for the period 1991–2020.

Meteorological measurements clearly show the impact of the drought on the hydrology (Fig. 4). The average precipitation in December, January and February preceding the fire was approximately half the monthly average (90 mm). This resulted in a low volumetric water content in the soil in the open field of the water intake zone at ML and an exceptionally low groundwater level in boreholes at VK. The volumetric water content in soil was low for the late winter period leading up to the fire, fell significantly at the beginning of January and did not recover to the normal stage until after the heavy rain incident on May 29th (Fig. 5). The groundwater level in borehole VK-1 was low in the first months of 2021 compared to the daily average (2008–2020) and exceptionally low in the weeks leading up to the fire (Fig. 6). These measurements demonstrate the importance of systematically monitoring the hydrometeorological parameters to provide early warning for potential wildfires.

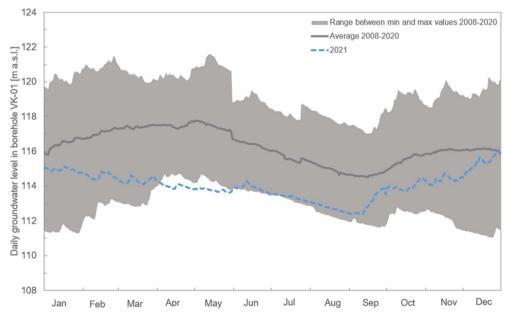
Fig. 6 Average groundwater level for VK-1 for the period 2008–2020, where the shaded area shows the range of the max mean values. The blue line shows the level for 2021.
