Three decades, three climates: environmental and material impacts on the long-term reliability of photovoltaic modules†

As the world has entered the terawatt age of photovoltaic (PV) deployment, ensuring long-term reliability is more critical than ever for the global energy transition. This study analyses the long-term performance of six PV systems in Switzerland over three decades, with more than 20 years of high-quality monitoring data. The plants feature modules from the same family (AM55 and SM55) installed across varying altitudes and climates, providing a unique dataset to compare performance trends under different operating conditions. Using the multi-annual year-on-year (multi-YoY) approach, system-level performance loss rates (PLR) were assessed, averaging just $-0.24 \pm 0.16\%$ per year, well below the commonly reported range of -0.75% to -1% per year in the literature. Laboratory analyses further revealed that higher thermal stress in low-altitude systems (up to 20 °C warmer) accelerated encapsulant degradation and acetic acid formation, contributing to localised corrosion and higher performance losses. Importantly, the bill of materials (BOM) is identified as the most

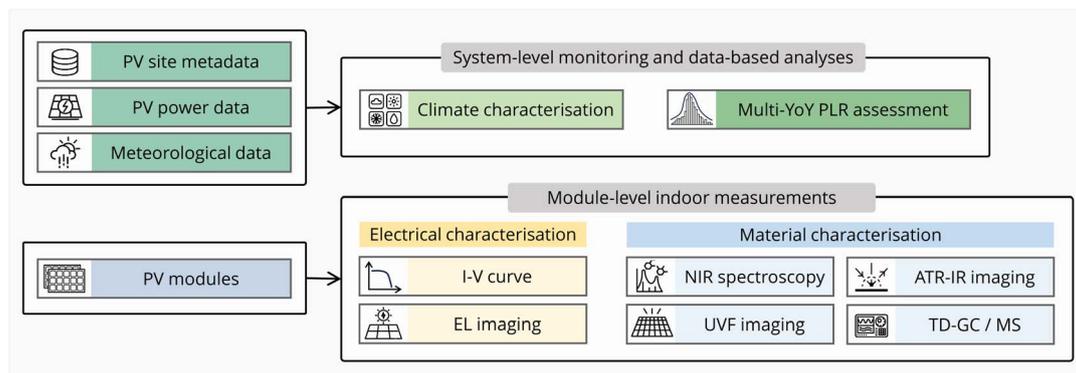
Fig. 1 Flowchart illustrating the analysis methods in this study, combining system-level monitoring for climate characterisation and long-term performance assessment, and module-level indoor measurements for electrical and material characterisation. Abbreviations: PV (photovoltaics), multi-YoY (multi-annual year-on-year), PLR (performance loss rate), I - V curve (current-voltage characteristic), EL (electroluminescence), NIR (near-infrared), UVF (ultraviolet fluorescence), ATR-IR (attenuated total reflection infrared), TD-GC/MS (thermo-desorption gas chromatography/mass spectrometry).

The datasets in this study provide a unique opportunity to analyse and characterise system- and module-level performance changes over more than 30 years of operation. The analysis follows two complementary approaches. First, a data-driven approach leverages long-term system monitoring and meteorological data to quantify the impact of different operating conditions on performance. Second, laboratory measurements of selected modules enable a detailed assessment of electrical and material degradation. A flowchart summarises the analysis methodologies employed in this study (Fig. 1). The methods are organised as follows: Section 2.1 describes the sites and systems, Section 2.2 details the module types used in these systems, Section 2.3 outlines the system-level outdoor data analysis, and Section 2.4 delves into the module-level indoor measurements.

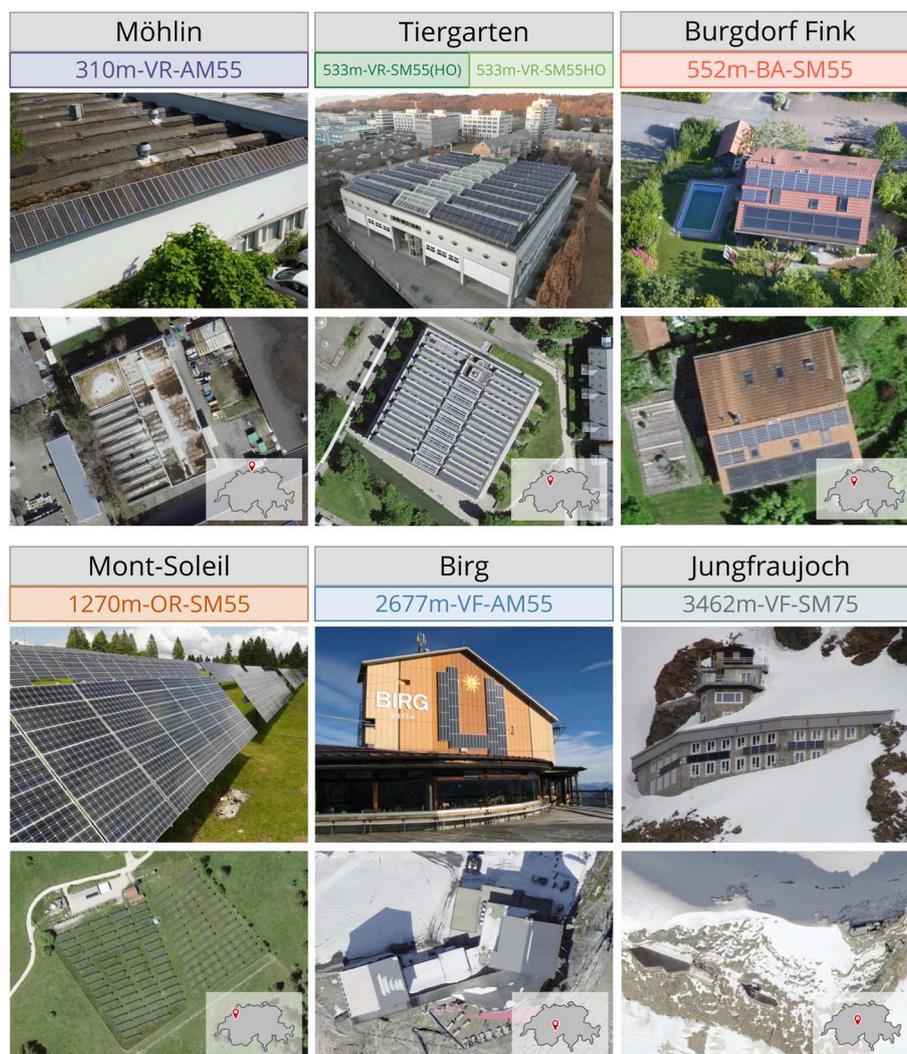
Fig. 2 System photos, showing the profile view (top) and aerial view (bottom). Approximate location in Switzerland is indicated in the bottom right corner. The Tiergarten system is separated in the East and West parts of the rooftop in the data and results. Site IDs are indicated below the system name, following the defined format: [Altitude]-[Mounting Config.]-[Module Type], see Table 1.

The plant layouts, module types, and locations are illustrated in Fig. 2, while a summary of PV system metadata is provided in Table 1.^{14,15} Each system is assigned a unique Site ID, constructed using the format [Altitude]–[Mounting Config.]–[Module Type], which will be used throughout the paper. The studied PV systems are classified into three altitude zones: low-altitude (<600 m), mid-altitude (1000–1500 m), and high-altitude (>2500 m), each corresponding to distinct Köppen-Geiger (KG) climate classifications: Cfb (temperate, no dry season, warm summer), Dfb (Cold, no dry season, warm summer), and ET (Polar, tundra).¹⁶ The low-altitude sites include Switzerland's first private grid-connected PV system in Möhlin (310m-VR-AM55), Tiergarten East and West in Burgdorf

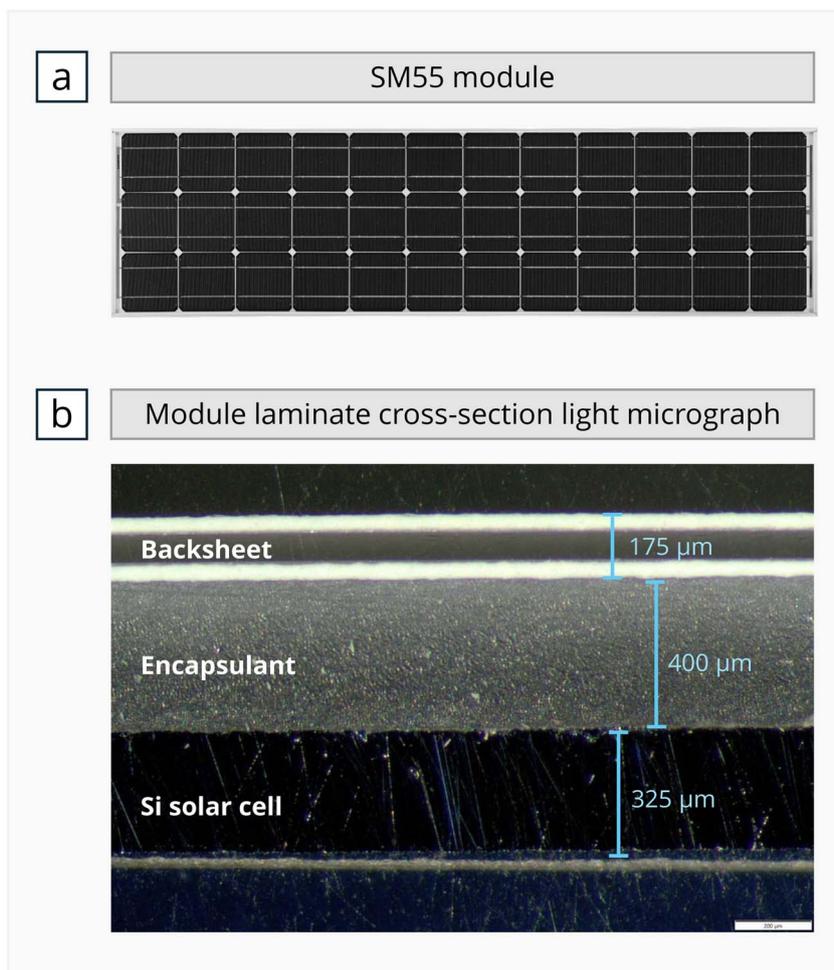
Fig. 3 (a) Photograph of a Siemens SM55 module. (b) Light micrograph of the cross section of part of the module laminate: 3-layer backsheet, back encapsulant and Si-solar cell.

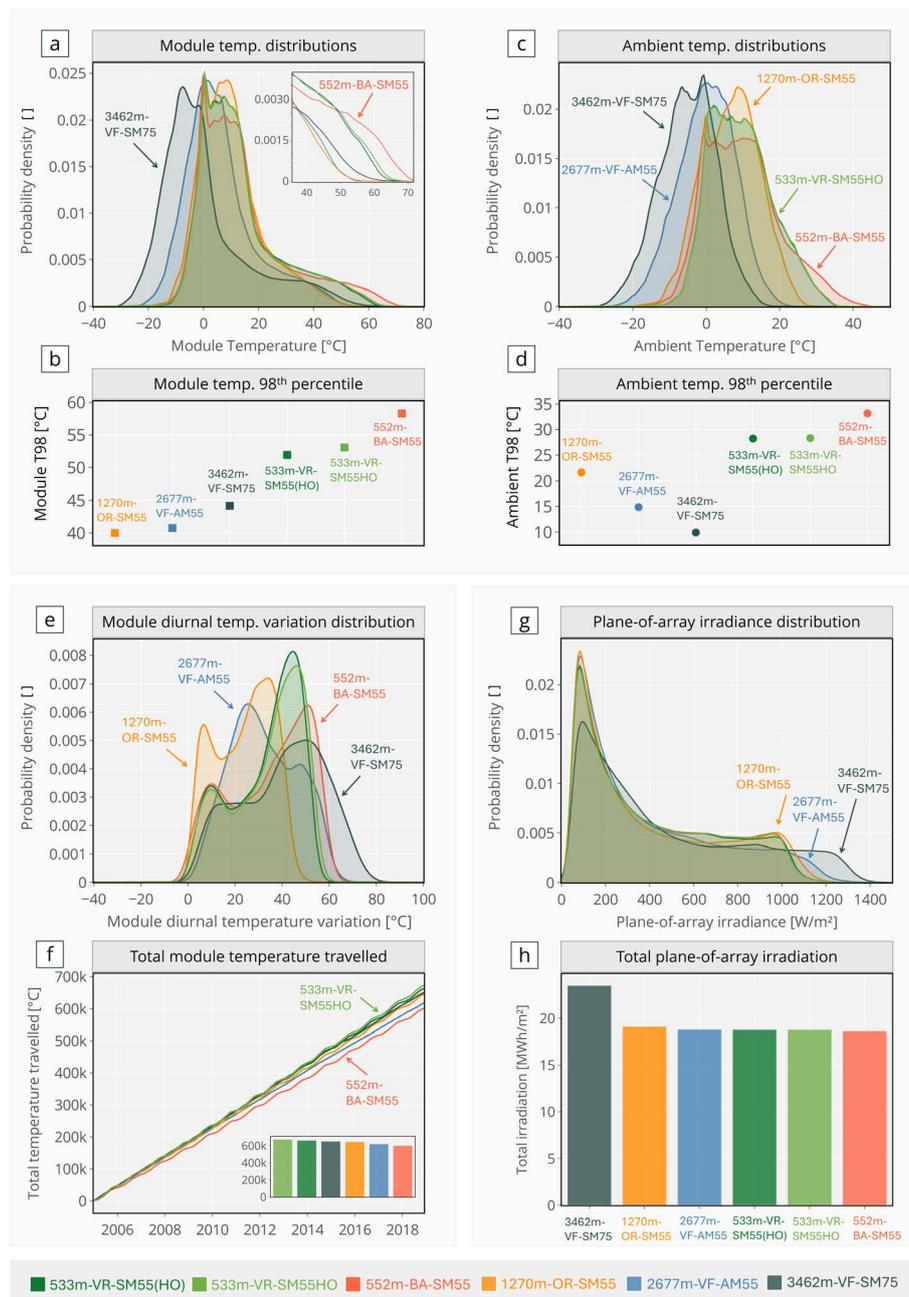
Fig. 4 Statistical analysis of the meteorological data. (a)–(d) Thermal stress: module and ambient temperature distributions and 98th percentile temperatures. (e) and (f) Thermo-mechanical stress: diurnal temperature variation distributions and total temperature travelled. (g) and (h) Irradiance stress: plane-of-array irradiance distribution (values 50 W m^{-2} filtered out to avoid nighttime and low irradiance) and total irradiation. All datasets are filtered between 2005–2018 to compare the same time periods and number of years.

The probability density of diurnal temperature variation at the module level and the total temperature travelled are used to evaluate thermo-mechanical stress (Fig. 4e and f). Diurnal temperature variations reflect intra-day thermo-mechanical stress in module components due to differences in thermal expansion coefficients. Results indicate that the highest-altitude site (3462m-VF-SM75) experiences the greatest day-night temperature variations, likely due to freezing nighttime temperatures. In the mid- and low-altitude range, the BAPV system (552m-BA-SM55) exhibits the largest diurnal temperature variations, which may be attributed to reduced ventilation compared to open-rack or ventilated roof configurations. On top of day-night temperature fluctuations, total accumulated thermo-mechanical stress is estimated by the total temperature travelled. Interestingly, low-altitude ventilated roofs show the highest temperature travelled, likely due to faster cooling rates and thus lower thermal inertia. In contrast, the BAPV system has the lowest total temperature traversed, reflecting higher thermal inertia. Overall, frequent temperature ramping events

induce material stress, with thermo-mechanical stress appearing more pronounced in low- to mid-altitude systems with partial ventilation.

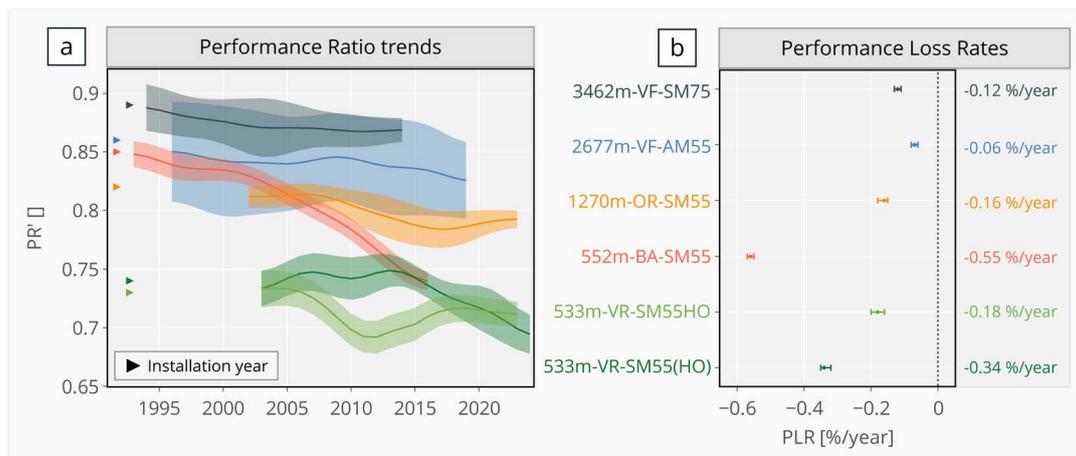
Fig. 5 (a) Temperature-corrected performance ratio (PR') trends, using yearly data aggregation and smoothed with a Gaussian filter ($\sigma = 2$). The CI is computed using one standard deviation of the yearly averaged data. (b) PLR results with 95% CI from the daily aggregation results of the multi-YoY method. All systems with long-term performance data are included.

using yearly aggregation show the relative system performances over time (Fig. 5a). The PV system installation dates are indicated with arrows (the initial PR' value is not based on a measurement but simply placed as a visual reference), to show the extent of outdoor module exposure relative to the monitoring data available for the PLR assessment. The final PLR value and 95% CI are based on the daily aggregation results which feature the lowest uncertainty (Fig. 5b). The detailed multi-YoY results per system are shown in the Appendix (Fig. A.1, ESI),[†] with the PLR results for daily, weekly, monthly and yearly aggregation strategies.

The PR' trend results highlight clear differences in PR' for the various locations, module types and mounting configurations (Fig. 5): (i) higher altitude systems tend to have higher average PR' , with values ranging from 0.7 to 0.89 for the alpine facade 3462m-VF-SM75; (ii) facades seem to experience higher seasonal variations in performance, visible with the wider standard deviation; (iii) non-linearities can be observed in the low-altitude systems, which is mostly due to soiling and cleaning events, as identified and studied in previous work on the same installation,¹³ and may also be linked to non-linear degradation;^{45,46} (iv) the highest PR' trend decline is observed for the low-altitude building-applied system, although no indication of soiling was detected. Unfortunately no indoor measurements are available to further correlate this to actual degradation or reversible loss effects. In terms of PLR values, all systems exhibit remarkable stability considering more than 30 years of operation, with values ranging from -0.55% per year for the low-altitude BAPV system, to -0.12% per year for the high-altitude ventilated facade. These system-level PLRs are significantly lower than the commonly reported values of -0.75% per year for older PV systems^{47–49} and -1% per year for more recent installations,⁵⁰ with an average PLR of only $-0.24 \pm 0.16\%$ per year.

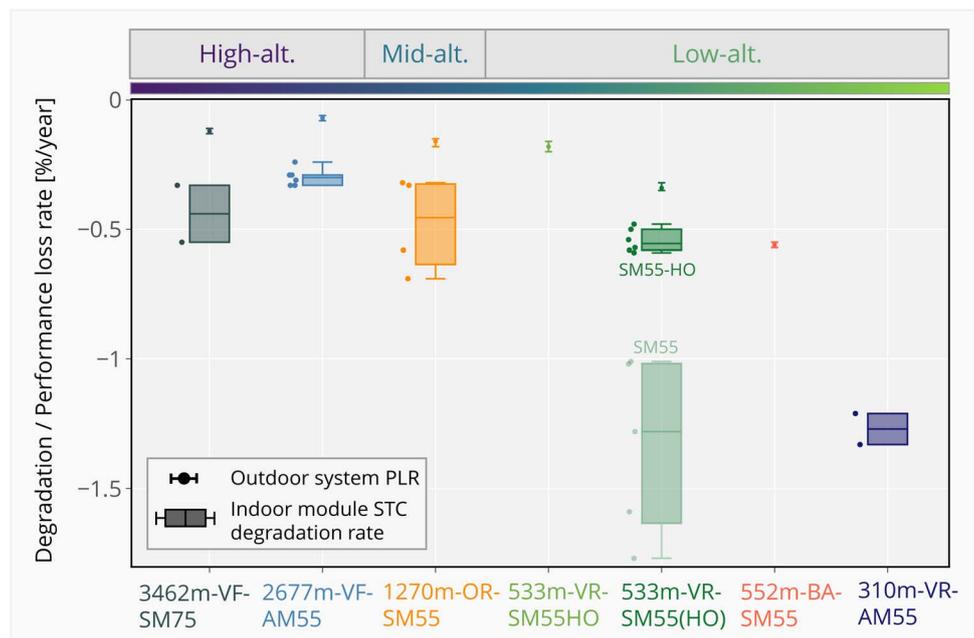
Fig. 6 Overview of indoor and outdoor measurement results for all analysed systems. The figure shows: (i) the module degradation rates of P_{mp} based on indoor $I-V$ measurements (box plots with underlying data points), and (ii) the system PLR calculated from outdoor monitoring data using the multi-YoY method, with 95% CI. Systems are ordered by altitude zones indicated at the top. For the site 533m-VR-SM55(HO), which is composed of 94% SM55-HO modules and 6% SM55 modules, both types are shown for the indoor $I-V$ results. The minority type is displayed in a faded colour for clarity as it is less representative of the system behaviour.

3.2.1.2 Möhlin and Tiergarten West (310m-VR-AM55 and 533m-VR-SM55(HO)): modules SM55 and AM55. Recurring solder bond failures, initially identified in EL images of SM55 modules from the 533m-VR-SM55(HO) system, were also observed in the AM55 modules of the 310m-VR-AM55 system, as shown in Fig. 9. These failures similarly contributed to performance degradation of the AM55 modules, confirmed with I - V measurement results in the form of increased series resistance and decreased FF. This results in a median module degradation rate of -1.27% per year (Fig. 6).

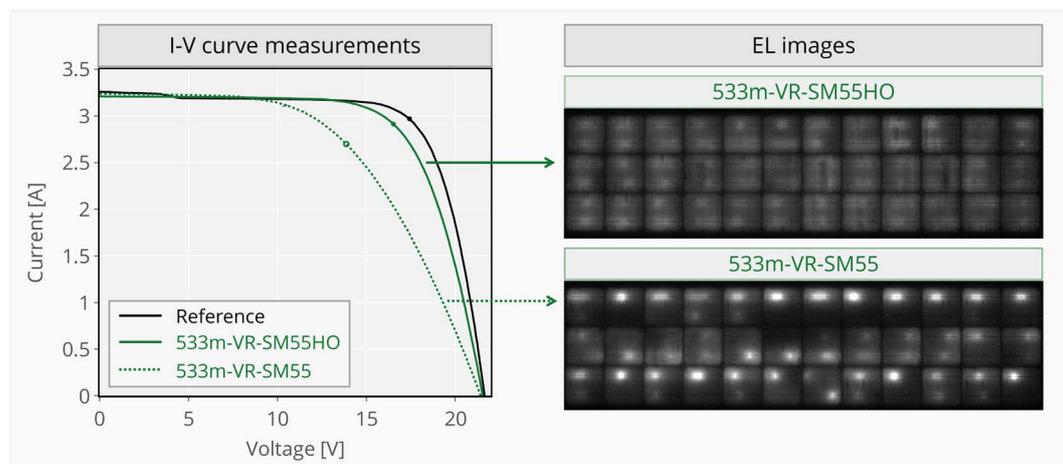
Fig. 7 $I-V$ curves of the reference, SM55, and SM55-HO modules from the 533m-VR-SM55(HO) site, along with EL images taken after approximately 30 years of outdoor operation. The SM55 module exhibits increased series resistance and reduced fill factor due to recurring solder bond failures, visible as dark areas near cell edges and bright spots along the ribbons in the EL images.

observed in all five modules of this type, resulting in increased series resistance and a decrease in fill factor (FF), visible in the I - V curve and EL image of the SM55 module (Fig. 7). The solder interconnections between the ribbons and the busbars seem to have developed cracks starting at the cell edges and progressing towards the centre of the busbars. This results in darker areas near the cell edges and bright spots at the centre of the ribbons. In some severe cases, solder interconnections between ribbons and busbars appear to have completely cracked, leading to entirely dark areas without bright spots along the ribbons. Similar patterns of recurring solder bond failure in this type of module have been documented in previous studies.^{51,52} The consistent occurrence of solder bond failures suggests potential inadequacies in production processes and quality control measures. Based on energy dispersive X-ray spectroscopy (EDX) element analysis of the solder interconnection area (Sn-Pb), Han *et al.*⁵¹ suggest that solder interconnection fatigue is caused by repeating temperature cycles,⁵³ coupled with possible chemical corrosion and the formation of intermetallics.

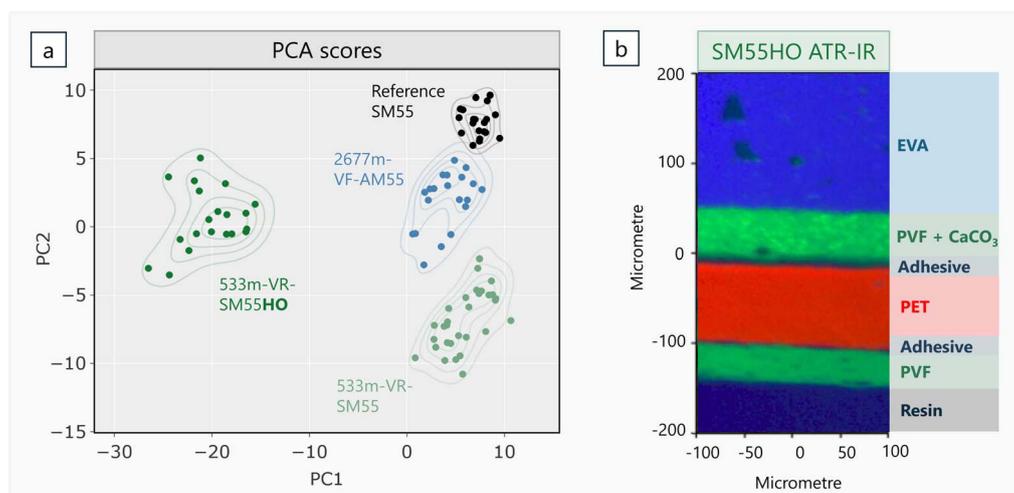
Fig. 8 (a) PCA scores obtained from PCA clustering analysis of the whole NIR spectra, highlighting a clear distinction of the SM55-HO module type. (b) ATR-IR image of the cross-section of the backsheet of a SM55-HO module showing the CaCO_3 filler.

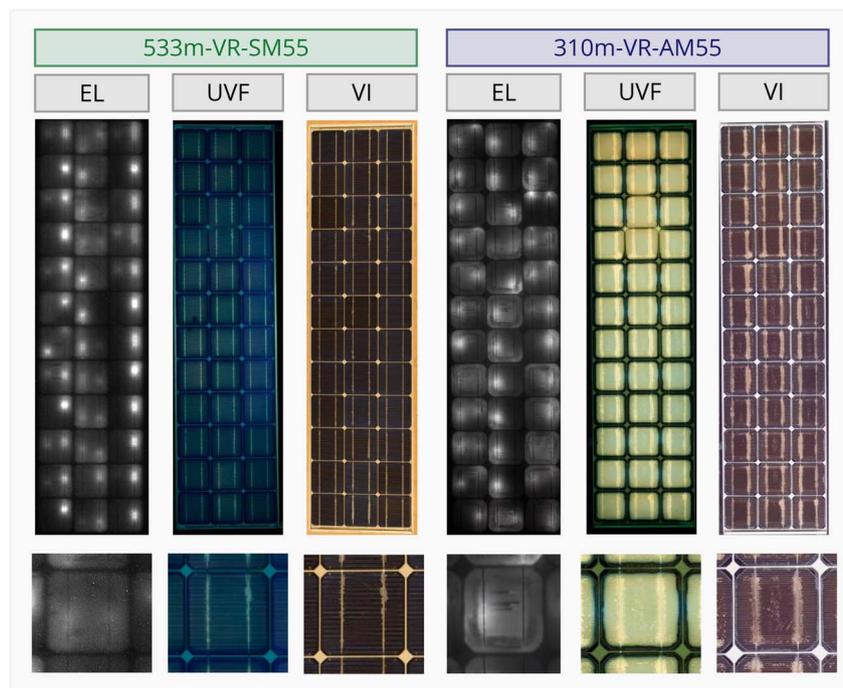
Fig. 9 Electroluminescence (EL), ultraviolet-fluorescence (UVF) and visual inspection (VI) images of the modules from the 533m-VR-SM55 and 310m-VR-AM55 systems.

Two major differences between the SM55 and AM55 modules from the 533m-VR-SM55(HO) and 310m-VR-AM55 systems, respectively, were identified through UVF and visual inspection (VI) imaging. In the UVF images, the encapsulant in the AM55 module exhibits a different emission colour and intensity, suggesting potential variations in additives or encapsulant composition (Fig. 9). In the VI images, both module types show delamination of the encapsulant along the ribbons, with the AM55 module displaying more severe delamination compared to the SM55 module. In addition, the AM55 module shows discolouration of the encapsulation material. These modules are the oldest of those examined (manufactured in 1987) and were manufactured before the introduction of UV-stabilisation of EVA for PV applications. The discolouration can be explained by photo-oxidative degradation. Encapsulant quality improved after 1987 by stepwise stabilisation of the polymer

with UV-stabilisers and anti-oxidants, thus effectively reducing discolouration. A noticeable lack of discolouration and fluorescence is observed at the cell edges, likely caused by photo-bleaching, a competing process to the discolouration and fluorescence of EVA in the presence of oxygen permeating through the backsheet.⁵⁵

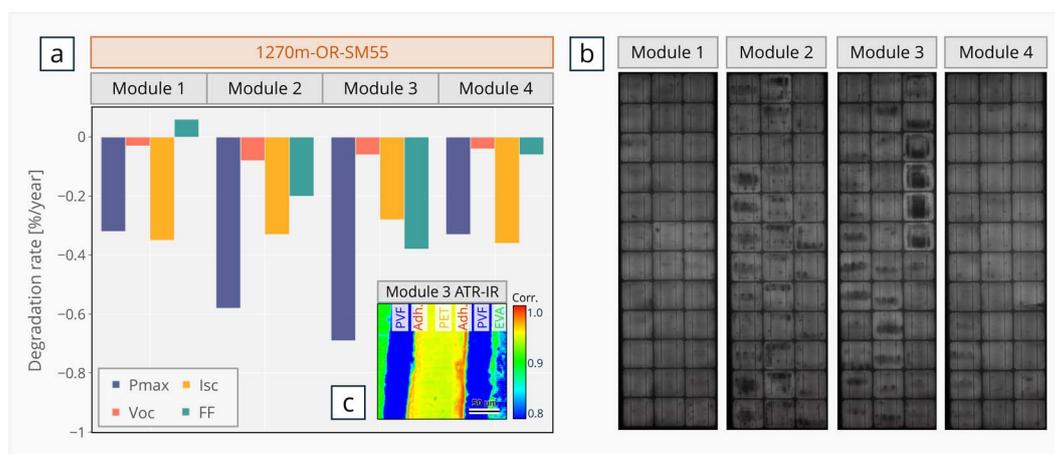
Fig. 10 (a) Degradation rates of the module I - V parameters (indoor) and (b) EL images of four modules from the 1270m-OR-SM55 system. (c) ATR-IR image, shown as an inset in the figure, highlights the dark area of Module 3 with compare-correlation analysis with the IR spectrum of the unaged adhesive.

shown in Fig. 10a, all modules exhibited a reasonable decrease in I_{sc} , yet they have different FF trends: two modules experienced a reduction in FF, while the remaining two showed no significant change.

EL imaging revealed that modules with higher FF loss exhibited dark areas in some cells, whereas no dark areas were observed in the other modules (Fig. 10b). Encapsulation materials, extracted destructively from Module 1 and from both the dark and non-dark areas of Module 3, were analysed for their degradation product content by thermo-desorption GC-MS. The

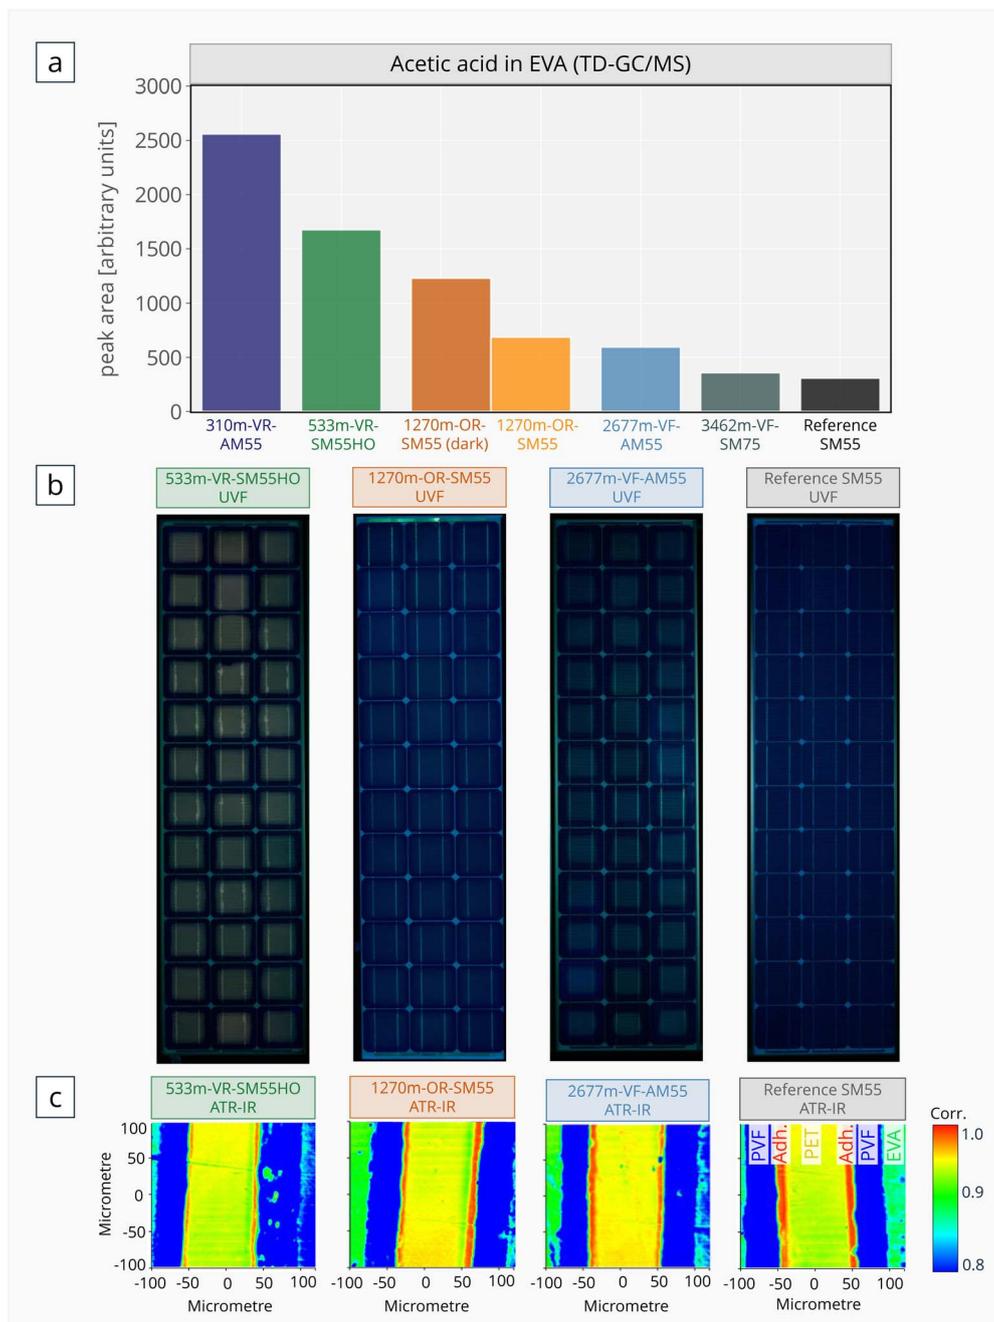
Fig. 11 (a) Amount of acetic acid detected in the EVA with TD-GC/MS. (b) UVF images of the modules after 30 years of outdoor exposure, alongside a UVF image of a non-weathered reference SM55 module. (c) ATR-IR images of the cross-sections of backsheets after compare-correlation with the IR spectrum of the unaged adhesive (high correlation = red).

acetic acid detected in EVA from the dark areas of Module 3 was approximately twice the amount found in the non-dark areas of the same module (Fig. 11a). In fact, the acetic acid concentration in the non-dark areas of Module 3 was similar to that of the less degraded Module 1 (not shown). This suggests a locally higher rate of degradation and acetic acid formation in the dark areas likely due to locally higher temperatures. Acetic acid is known to cause corrosion of the silver (Ag) fingers and reduce the conductivity of the Ag finger,^{56–58} thereby increasing the

the laminate.⁴³ In the unaged reference module, the adhesive layer is well-defined, with a thickness of approximately 5–7 μm , and exhibits a high correlation with the original adhesive spectrum (Fig. 11c, where red areas indicate high spectral accordance). However, in the dark regions observed in the EL image of Module 3, the adhesive layers appear indistinct, with the outer layer degrading almost completely (Fig. 10c). In addition to the corrosion of the Ag fingers leading to dark areas in the EL images, this additional degradation route also suggests significantly higher thermal stress in these areas.

acid content in the low-altitude modules than in the high-altitude modules (Fig. 11a). As discussed in Section 3.2.1, the acetic acid produced can react with the Ag and lead (Pb) in the cell fingers and solder of the connectors, causing corrosion and poor electrical conductivity, resulting in cell degradation performance losses.
