## CRITICAL REVIEW

## Decentralized UV disinfection systems in rural areas or low-resource contexts: a case study compilation

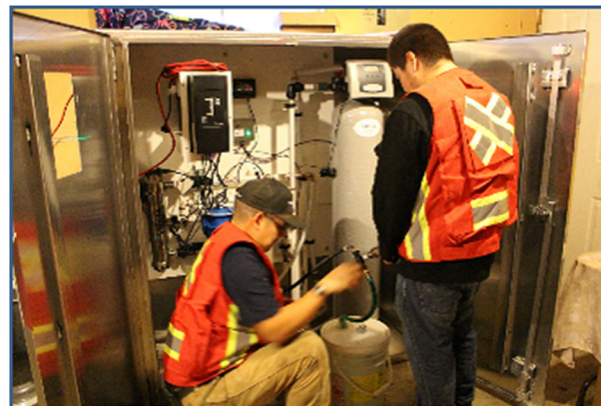
Fig. 3 The Lytton POE systems, with the low-pressure UV system, were installed in a secured enclosure, placed inside residents' homes.

An emergency solenoid shut-off valve was located downstream of the UV lamp and was normally closed when the water was not in use, preventing water from reaching the consumer. It also closed if the UV dose was less than 40 mJ cm<sup>-2</sup> and if the system lost power, was unplugged or if the UV lamp failed to turn on. In

response to a power failure, the solenoid valve would close, as it would no longer be powered open. The UV unit had a sensor to detect lamp intensity. If a safe UV dose was not achieved during the warmup cycle (if the intensity went below a set value calculated for the required dose), an alarm occurred, and the solenoid remained closed. A backup battery was available for temporary power (approximately providing up to one hour power for continuous operation) in the case of a power failure.

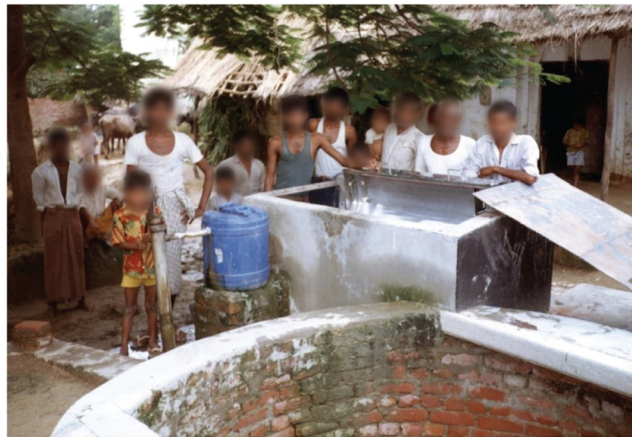
**Fig. 12** View of the Bhupalpur field test. The open well in the foreground is in disuse. The hand pump to the left of the well supplies water to the blue surge tank, which feeds into a large early-design UV Waterworks unit, partly seen within the low-height concrete walls. The villager noted that the flow of this first design (60 LPM) was far larger than any hand pump flow the villager had ever encountered. This led to the more compact revised design that disinfected a water flow of 15 LPM, better matched to the UNICEF India mark-II hand pumps widely installed in the developing world.
