Cite this: *Energy Environ. Sci.*,  
2025, 18, 264

## Removal of residual contaminants by minute-level washing facilitates the direct regeneration of spent cathodes from retired EV Li-ion batteries†

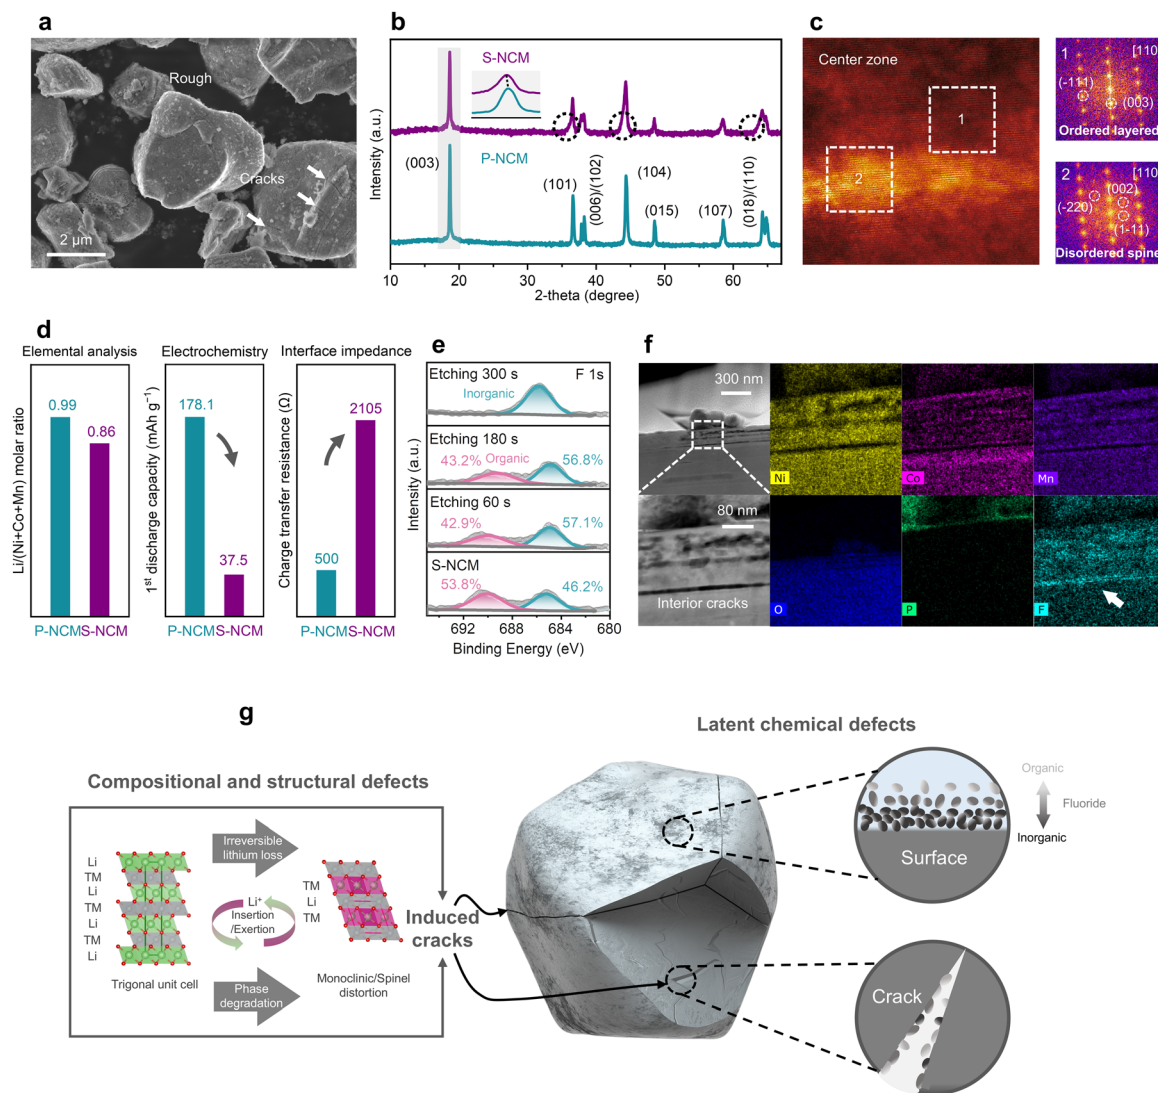
**Fig. 1** Neglected chemical residuals on the 250k-miles-serviced cathode. (a) SEM image and (b) XRD pattern of the degraded S-NCM. The black dotted circle accentuates the subtle peaks that do not belong to the layered structure; (c) high-resolution HAADF-STEM images on the central area of the S-NCM particle and the FFT patterns of the selected dark and bright regions; (d) comprehensive comparison of lithium loss in degraded powders measured by ICP-OES, electrochemical capacity, and charge-transfer resistance analyses in the half-cell using S-NCM and P-NCM powders as cathode active materials; (e) F 1s XPS patterns of S-NCM powders for different sputtering times using an ion-beam. Based on the calculated integral area, the proportional values of the organics and inorganics in fluoride are presented in the patterns; (f) HAADF-STEM images based on focused ion beam cutting and an enlarged view displaying the interior microcracks. Corresponding EDS mapping analysis indicates the presence of F elements along these microcracks pointed out by a white arrow. (g) Deficiencies of S-NCM addressed before direct regeneration, including the compositional and structural aspects (e.g., irreversible lithium-ionic loss, phase degradation, internal and external cracks) and latent chemical defects (e.g., surface and crack-edge impurities enriching the F element).

To understand the surface state of the spent cathode, energy-dispersive spectroscopy (EDS) element mapping and X-ray photoelectron spectroscopy (XPS) were conducted. As shown in Fig. S7–S9, and Tables S5, S6 (ESI<sup>†</sup>), the S-NCM cathode surface residuals consisted of C, O, F, and P elements, and displayed a surface-rich gradient distribution, as revealed

by XPS with etching. The F 1s XPS peaks with etching for S-NCM are shown in Fig. 1e, where two F 1s peaks could be observed before sputtering, with the major peak centered at 685.5 eV, which was attributed to inorganic fluorides and the minor F 1s peak centered at 690.4 eV, which could be assigned to organic fluorides, with the ratio of 53.8% for organic fluorides.<sup>29</sup> However, the organic-related F peak declined significantly after sputtering, and completely disappeared after 300 s Ar<sup>+</sup> sputtering. The surface-rich distribution of organic fluoride was consistent with the cathode electrolyte interphase (CEI) composition previously reported.<sup>29,30</sup>

To further reveal the microscopic distribution of those F-rich residuals, SEM combined with time-of-flight secondary ion mass spectrometry (SEM-ToF-SIMS) characterization was conducted for the cycled cathode. The results are shown in Fig. S10 and Videos S1, S2 (ESI†). Based on the spatial distribution of F<sup>−</sup> secondary ion fragments, it was confirmed that fluoride impurities were primarily deposited on the particle surface. Moreover, during the long-time battery service, it could be observed from the HAADF-STEM image and corresponding element mapping (see Fig. 1f) that, in the S-NCM cathode, the fluorides could spread into the interior of the cathode along the intragranular cracks. Coincidentally, from the selected FFT figure shown in Fig. S4 (ESI†), the existence of an amorphous ring was observed along the intragranular cracking, which may be related to the fluorides also observed in the bulk. To sum up, the collected S-NCM exhibited limited structural and compositional degradation, while preserving the fluoride-containing impurities aggregated on the surface and along the intragranular cracks, as illustrated in Fig. 1g.

Furthermore, it was previously widely accepted that the source of F-rich impurities in the spent cathode was due to decomposition of the PVDF binder during the heat delamination process at around 350 °C;<sup>11,23–25,31</sup> however, during the thermal decomposition of PVDF, most the fluoride-containing products were gas species (*i.e.*, HF) and fragments (−CF− and −CH−CF−),<sup>32–34</sup> which are subject to ejection instead of propagating along the cathode intragranular cracks. To confirm the source of those observed residual impurities, four kinds of cathodes with varying cycling conditions were collected and examined, namely cathode laminates with/without electrolyte filling, and laminates from 125k and 250k miles-serviced batteries, as listed in Table S7 (ESI†). The SEM images and electrochemical performance are shown in Fig. S11 and S12 (ESI†). Compared with the pristine one (sample A), the other spent cathodes from battery formation and cycling exhibited a rough surface and limited discharge capacity. Notably, the laminate from formation only but with no cycling (sample B), which it was believed would retain the full lithium inventory and show negligible structural degradation since it had not undergone charge/discharge cycling, showed a poor discharge capacity, which was the same as the other long-cycled ones. Moreover, the heat exfoliation used to pyrolyze the adhesive binders deteriorated the original CEI layer on the spent cathodes and generated more harmful byproducts (*e.g.*, Li<sub>2</sub>CO<sub>3</sub>, Li<sub>3</sub>PO<sub>4</sub>, LiF). This, combined with electrolyte decomposition during electrochemical cycling, exacerbates chemical degradation, resulting in a significant capacity decline. Therefore, the above comparison revealed that the cathode residual impurities should originate from the electrolyte components (such as LiPF<sub>6</sub>, DMC, ethylene carbonate (EC)) decomposition during battery formation, cycling, and common heat exfoliation, leading to severe capacity loss in spent cathodes (Fig. 1d).

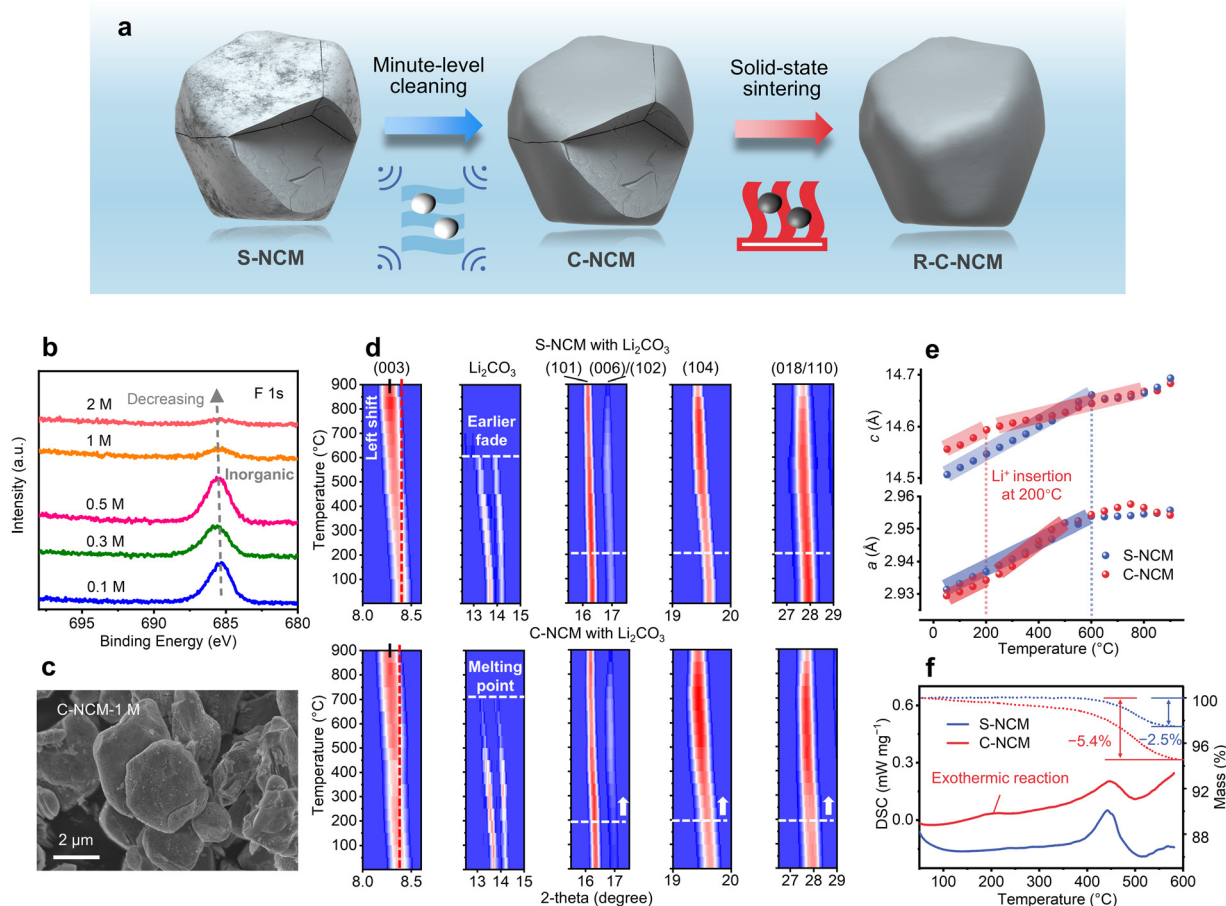
**Fig. 2** Removal of the impurities and change in the crystal structure during the direct regeneration process combined with pretreatment. (a) Traditional direct regeneration path using solid-state sintering and the minute-level pretreatment introduced in an advanced path targeted to the critical obstacles within degraded cathode materials; (b) F 1s XPS fine patterns of C-NCM undergoing ultrasonic stirring in solutions with different concentrations; (c) SEM image of C-NCM obtained by soaking S-NCM in 1 M  $\text{HNO}_3$  solution; (d) partial *in situ* XRD patterns of S-NCM and C-NCM mixed with a Li resource, keeping a constant heating rate ( $20\text{ }^\circ\text{C min}^{-1}$ ) and holding the temperature for diffraction at  $50\text{ }^\circ\text{C}$  intervals; (e) evolution of the unit cell parameters  $a$  and  $c$  for S-NCM (blue symbols) and C-NCM (red symbols) mixed with Li slate through Rietveld refinement. The earlier  $\text{Li}^+$  insertion at  $200\text{ }^\circ\text{C}$  changed the variation tendency of the unit parameters for the sample after cleaning. (f) Heat generation measured by DSC from mixtures.

To reveal the effect of the residuals during the direct regeneration of the recycled cathode, *in situ* XRD characterizations were compared following the regeneration of S-NCM and C-NCM. During the heating, the unit cell lattice first nearly linearly expanded until there was a differentiation of the expansion ratio caused by the lithium insertion. As shown in Fig. 2d, the shift of the (003) peak of C-NCM was less pronounced than that of S-NCM when heating to  $900\text{ }^\circ\text{C}$ , indicating its unit cell lattice  $c$  was not expanded as much as for the S-NCM due to its more efficient lithium insertion. Therefore, more lithium insertion was observed for the C-NCM cathode. Correspondingly, the  $\text{Li}_2\text{CO}_3$  in the mixture of S-NCM and C-NCM also performed differently, whereby the  $\text{Li}_2\text{CO}_3$  in the

C-NCM cathode was consumed gradually until it disappeared at its melting point around  $730\text{ }^\circ\text{C}$ , while the  $\text{Li}_2\text{CO}_3$  in the S-NCM cathode completely vanished at around only  $600\text{ }^\circ\text{C}$ , and this earlier consumption of the lithium source may be attributed to the reaction between  $\text{Li}_2\text{CO}_3$  and the residual impurities (such as  $\text{LiF}$ ,  $\text{LiOH}$ , and  $\text{Li}_3\text{PO}_4$ ) by co-melting, vaporizing, and replenishing in S-NCM.<sup>42</sup> Equivalently, the high angle reflection peak intensity spanning from (006) to (110), representing the layered structure, significantly increased starting from around  $200\text{ }^\circ\text{C}$  for the C-NCM cathode after the purifying treatment compared to there being no obvious enhancement for S-NCM, indicating the better repair of the layered structure during heating. To further unveil the underlying mechanism, Rietveld refinement of each XRD pattern was conducted, which can depict the continuous change of the unit cell parameters during regeneration. Generally, the unit cell parameter  $c$  decreases and  $a$  increases with the insertion of Li ions into a layered structure, similar to in the discharge process.<sup>28</sup> As shown in Fig. 2e, the lattice evolution of the S- and C-NCM

cathodes were compared. For C-NCM, the lattice  $c$  expansion slope became obviously flatter at 200 °C, denoting a lattice  $c$  shrinkage at this temperature induced by the Li-ion insertion and repairing. However, for the S-NCM without undergoing purifying treatment for the residuals, the lattice expanded still nearly linearly with no obvious lithium insertion until 600 °C. Concurrently, the lattice  $a$  expansion slope became steeper at 200 °C for C-NCM. Last but not least, Differential scanning calorimetry (DSC) characterization was also conducted during the regeneration process to confirm the lithium insertion pattern for the S- and C-NCM cathodes, which can trace the lithium replenishment associated with the exothermic reaction as reported by others.<sup>43</sup> As shown in Fig. 2f, the characteristic exothermic reaction at around 200 °C was only observed for C-NCM, confirmed the earlier lithium insertion after the purifying treatment. The earlier lithium insertion was also supported by the CO<sub>2</sub> gas release observed during Li<sub>2</sub>CO<sub>3</sub> decomposition to supply the lithium source for the C-NCM cathode, as shown Fig. S23 (ESI<sup>†</sup>). Moreover, from the thermogravimetric results

shown in Fig. 2f, the weight loss of C-NCM was 5.4%, which was significantly larger than that of S-NCM of 2.5%, indicating that more Li<sub>2</sub>CO<sub>3</sub> was activated and decomposed to provide the lithium source for C-NCM.<sup>43,44</sup> To sum up, through multiple *in situ* and *ex situ* characterizations, we proved that, with a purifying pretreatment, the direct regeneration could be facilitated to start at a lower temperature of 200 °C from the spent cathode.

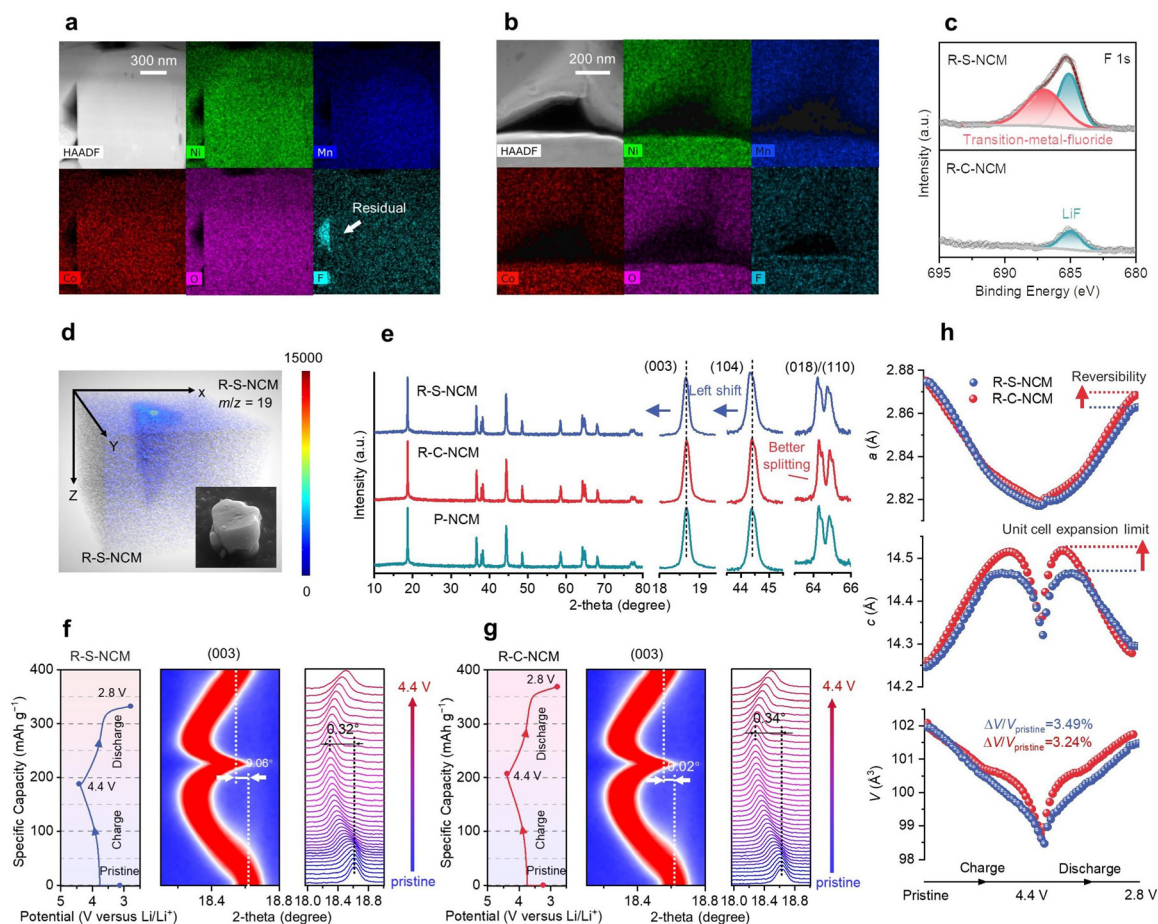
**Fig. 3** Chemical and structural details of the regenerated cathode materials under the influence of impurities. (a) HAADF-STEM images and (b) corresponding EDS element mappings of R-S-NCM and R-C-NCM particles, focusing on the pores of the packing particles. (c) F 1s XPS high-resolution patterns of R-S-NCM and R-C-NCM powders. (d) Pseudo-three-dimensional distribution of F element and SEM image of the corresponding R-S-NCM particle. (e) Full patterns and characteristic peak comparison of the regenerated and pristine NCM cathodes with Cu K $\alpha$  radiation at a scan rate of 8° min<sup>-1</sup>. (f) 1st charge-discharge curves, corresponding XRD patterns of R-S-NCM, and (g) (003) peak position variation when the cell charge from pristine to 4.4 V and comparison with R-C-NCM. (h) Lattice parameters  $a$ ,  $c$ , and the unit cell volume  $V$  of R-S-NCM and R-C-NCM in the 1st charge-discharge test according to the refinement.

applied, the F-rich residual impurities in R-S-NCM had hardly vaporized and were still concentrated on the surface and in the bulk due to their strong electronegativity.<sup>45</sup>

Furthermore, the crystal structure of the regenerated cathode could also be affected by the residual impurities. As shown in Fig. 3e and Fig. S28 (ESI†), the XRD pattern indicated a layered structure with no impurities phase for both the R-S-NCM and R-C-NCM cathodes. However, the R-C-NCM cathode had a higher (003)/(104) intensity ratio and larger splitting degree for the (018)/(110) peaks compared to R-S-NCM, suggesting its more ideal layered structure similar to P-NCM cathodes. After regeneration accompanied by impurities, the diffraction peaks of R-S-NCM were shifted toward a low-angle direction, indicating the lattice expansion, as supported by the refined parameters (Table S11, ESI†) and *in situ* experiments (Fig. 2d). Furthermore, *in situ* XRD was performed during the 1st charge/discharge process for both regenerated cathodes (see Fig. 3f and g). The R-C-NCM cathode showed a higher capacity with a smaller offset (0.02°) of the (003) peak position than the

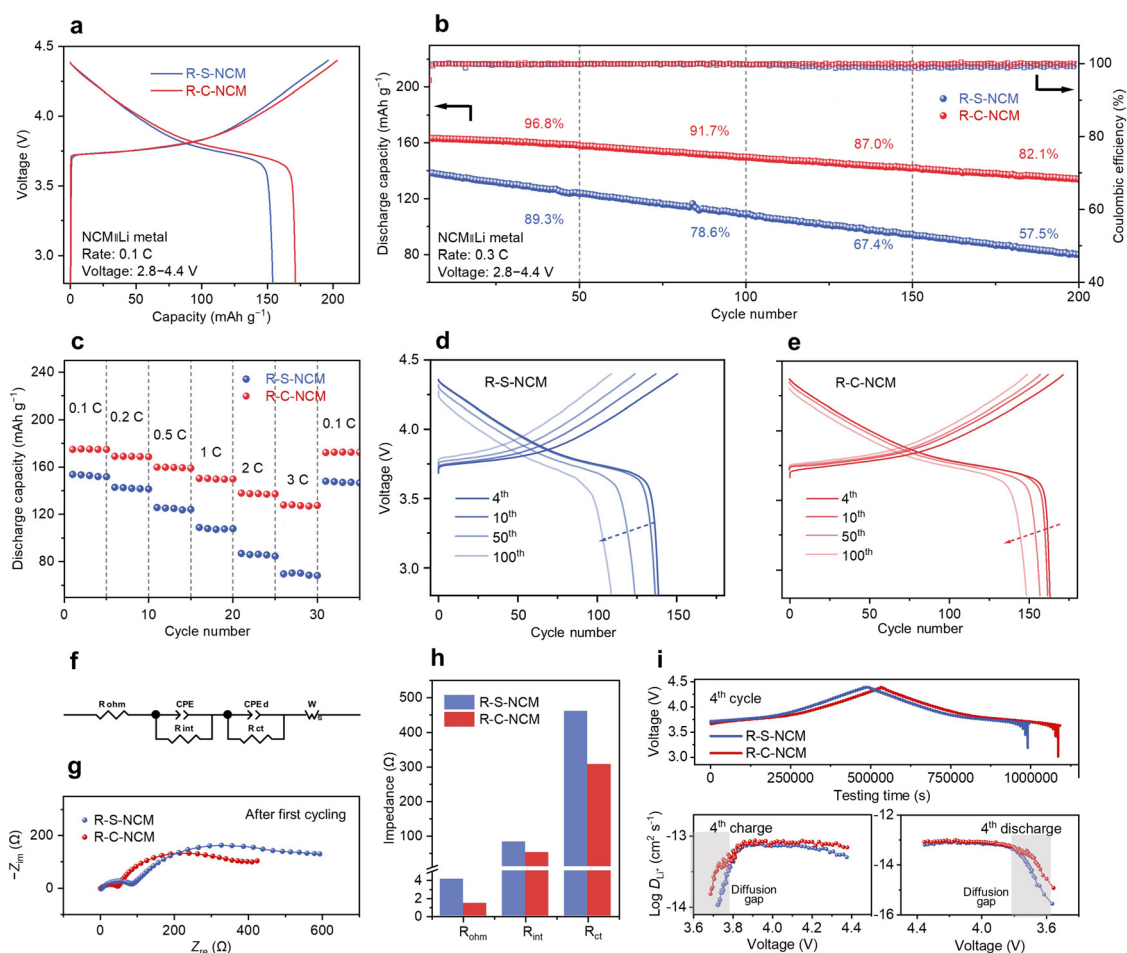
**Fig. 4** Electrochemical deterioration for the regenerated NCM cathodes with impurity residue. (a) Initial galvanostatic charge–discharge curves of R-S-NCM and R-C-NCM at 0.1C (1C = 150 mA h g<sup>−1</sup>) and (b) long cycling test and capacity retention in a half-cell. (c) Rate capabilities of R-S-NCM and R-C-NCM. Charge–discharge curves of (d) R-S-NCM, (e) R-C-NCM in the voltage range of 2.8–4.4 V (vs. Li/Li<sup>+</sup>) at different cycles. (f) Equivalent circuit applied in the EIS measurements. Nyquist plots of (g) R-S-NCM and R-C-NCM and (h) fitting results showing the Ohmic resistance ( $R_{ohm}$ ), interface resistance ( $R_{int}$ ), and charge-transfer resistance ( $R_{ct}$ ). (i) GITT curves and the calculated Li<sup>+</sup>-diffusion rate of R-S-NCM and R-C-NCM for the 4th cycle number after activation in the same charge–discharge period. The shadow area indicates low Li<sup>+</sup> diffusion in a certain voltage range.

As shown in Fig. 4a and Fig. S30 (ESI<sup>†</sup>), the initial discharge capacity increased from  $154.1 \text{ mA h g}^{-1}$  for R-S-NCM to  $171.4 \text{ mA h g}^{-1}$  for R-C-NCM after the purifying treatment, although this was slightly lower than for P-NCM. In Fig. 4b and Fig. S31 (ESI<sup>†</sup>), the R-C-NCM cathode exhibit 91.7% and 82.1% capacity retention after 100 cycles and 200 cycles, respectively, compared with 91.6% and 78.3% for P-NCM, and 78.6% and

57.5% for R-S-NCM, indicating the R-C-NCM cathode had better cycling stability, even compared to the pristine one. As for the rate performance, the R-C-NCM cathode demonstrated a better high-rate capability (Fig. 4c and Fig. S30, ESI†) at 3C ( $127.8 \text{ mA h g}^{-1}$ ) compared to R-S-NCM ( $69.8 \text{ mA h g}^{-1}$ ) and P-NCM ( $108.9 \text{ mA h g}^{-1}$ ), which was commonly observed on the regenerated NCM cathodes and may be attributed to appropriate F element doping.<sup>12,47</sup> The plateau at  $\sim 3.6 \text{ V}$  in the voltage profiles (Fig. 4d and e and Fig. S30, ESI†) for R-S-NCM nearly disappears after 100 cycles, suggesting that R-S-NCM had a rising polarization after long-term cycling. Based on the cyclic voltammetry curves at different scan rates and calculations (Fig. S31 and Table S12, ESI†), the fitting line slope for R-S-NCM was found to be the lowest among all the samples. According to the equivalent circuit (Fig. 4f), the calculated impedance values ( $R_{\text{ohm}}$ ,  $R_{\text{int}}$ , and  $R_{\text{ct}}$ ) of R-C-NCM (Fig. 4g and h) were 1.4, 51.1, and  $307.1 \Omega$ , respectively, and were smaller than that of R-S-NCM. These results indicate the deteriorated kinetics of  $\text{Li}^+$  transportation due to the residual impurities, especially on the surfaces of the regenerated cathodes. According to the chemical state of the electrode surface (Fig. S32, ESI†), R-C-NCM exposed less inorganic fluoride and more lattice oxide, leading to the suppressed interfacial resistance growing during the long-term cycling. Furthermore, the galvanostatic intermittent titration technique (GITT) test also revealed the kinetic characteristics of the solid phase. The current pulse profile and calculated Li-ion diffusion coefficient ( $D_{\text{Li}^+}$ ) after activation are shown in Fig. 4i. The average  $D_{\text{Li}^+}$  values of R-C-NCM and R-S-NCM were calculated to be  $5.78 \times 10^{-14}$  and  $2.99 \times 10^{-14}$  for the charge process (and  $4.56 \times 10^{-14}$  and  $4.29 \times 10^{-14}$  for the discharge process), suggesting that residual impurities penetrating the interior bulk after regeneration hamper  $\text{Li}^+$  hopping within the lattice of the NCM cathode, as supported by the observed F element (Fig. 3c and Fig. S27, ESI†).

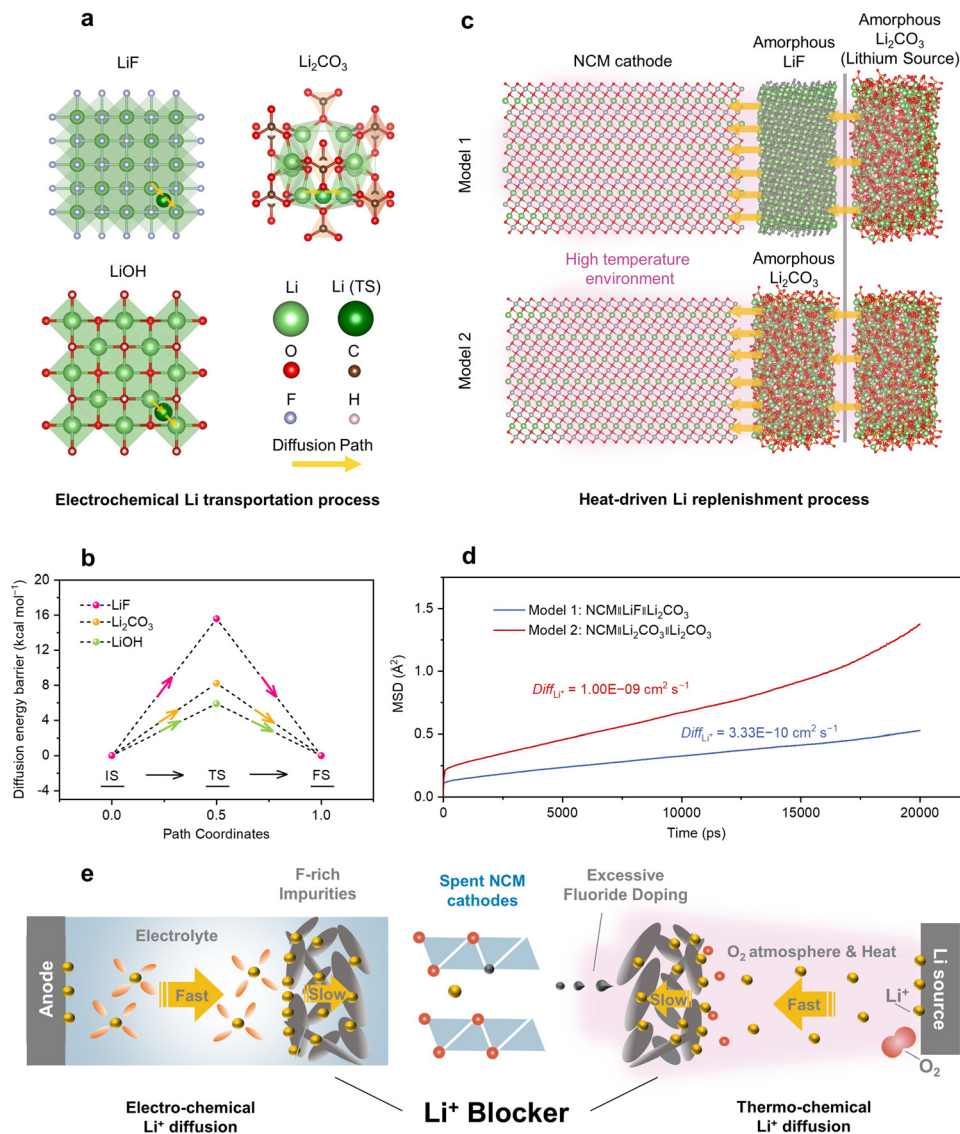
**Fig. 5** Role of the F-rich impurities as a blocker in electrochemical and thermochemical  $\text{Li}^+$  diffusion as ascertained from thermodynamic and kinetic simulations. (a) Illustrations of the selected migration pathways with a similar distance for  $\text{Li}^+$  inside the crystal lattice of three common components. The initial state, transition state, and final state of  $\text{Li}^+$  transportation are denoted as IS, TS, and FS, respectively. (b) Calculated energy diffusion barrier for Li ions in selected phases. (c) Two models for stimulating the kinetics of Li transportation in direct regeneration. Model 1 consists of the NCM cathode substrate, the amorphous LiF layer, and  $\text{Li}_2\text{CO}_3$  as a lithium source in direct regeneration, which is denoted as NCM||LiF|| $\text{Li}_2\text{CO}_3$ . In Model 2 (NCM|| $\text{Li}_2\text{CO}_3$ || $\text{Li}_2\text{CO}_3$  in short), the middle LiF layer is replaced by a common residual alkali ( $\text{Li}_2\text{CO}_3$ ), which is used to simulate the regeneration of NCM cathodes after cleaning pretreatment. Each shape symbol is the same as for Fig. 5a. (d) MSD of the Li atoms in 20 ns and calculated  $\text{Li}^+$  diffusivity based on the above model. "E – 9" means  $10^{-9}$ . (e) Mechanism diagram for preventing the NCM cathodes from reusing and directly regenerating under the influence of impurities.

Fig. 5b. Therefore, this result confirmed that the presence of fluoride-rich impurity residuals on the cathode surface significantly increased the diffusion resistance of Li ions when cycling, ultimately exacerbating the cell impedance and interfacial parasitic reactions (Fig. 1d). To comprehend the larger-scale kinetic characteristics and understand the effect of impurity coatings during heating for regeneration of the spent cathodes, two molecular dynamics models were established for simulating  $\text{Li}^+$  transportation at 1000 K over 20 ns. Specifically, Model 1 was devised to include an impurity barrier consisting of a  $\text{LiF}$  layer (Fig. 5c and Fig. S33, ESI†). Through computing the mean square displacement (MSD) of Li atoms and fitting curves (Fig. 5d), we determined that the Li diffusivity ( $\text{Diff}_{\text{Li}^+}$ ) of Model 1 was  $3.33 \times 10^{-10}$ , which was an order of magnitude lower than that of Model 2 ( $1.00 \times 10^{-9}$ ). The differences in molecular dynamics models under practical conditions suggest that fluoride-rich impurity coatings increase the resistance to Li-ion diffusion into spent cathodes with Li deficiencies during thermo-driven regeneration, leading to inadequate compositional and structural recovery.

As illustrated in Fig. 5e, the impurity phase containing the F element served as an electro- and thermo-diffusion blocker of Li ions hindering the reuse and direct regeneration of the spent cathode. In the spent cathodes collected by physical pretreatment and collection from used lithium-ion batteries, the ubiquitous electrolyte was decomposed to form an ion barrier with slow ion diffusivity. However, these impurities have long been overlooked in most studies (Table S2, ESI†), mainly due to the use of lab-scale degraded cathodes and fine manual separation pretreatment. In previous studies,<sup>12–16,42</sup> the latent impact of the residual impurities on direct regeneration remains untouched because impurities are easily converted into other inconspicuous matter in extreme physical or chemical regeneration environments. Looking ahead, the direct regeneration of next-generation sensitive cathode materials, such as Li-rich Mn-based, Co-free, and ultra-high-Ni cathode materials, faces serious challenges from these latent impurities if they enter the recycling circle. From another perspective, establishing the controlling law for the inherent impurities doping within the closed-loop material flow could instructively enhance the performance of such recycled materials in the future. Moreover, only by revealing the effect of the overlooked impurities or by getting rid of impurities, can evolving technologies and mechanisms for direct regeneration and upcycling be reasonably evaluated.<sup>50</sup>
