Cite this: *Energy Environ. Sci.*,  
2025, 18, 9254

# Investigating the effect of lithiation on polycrystalline NMC811 Li-ion battery cathode cracking using *in situ* SEM micromechanical testing

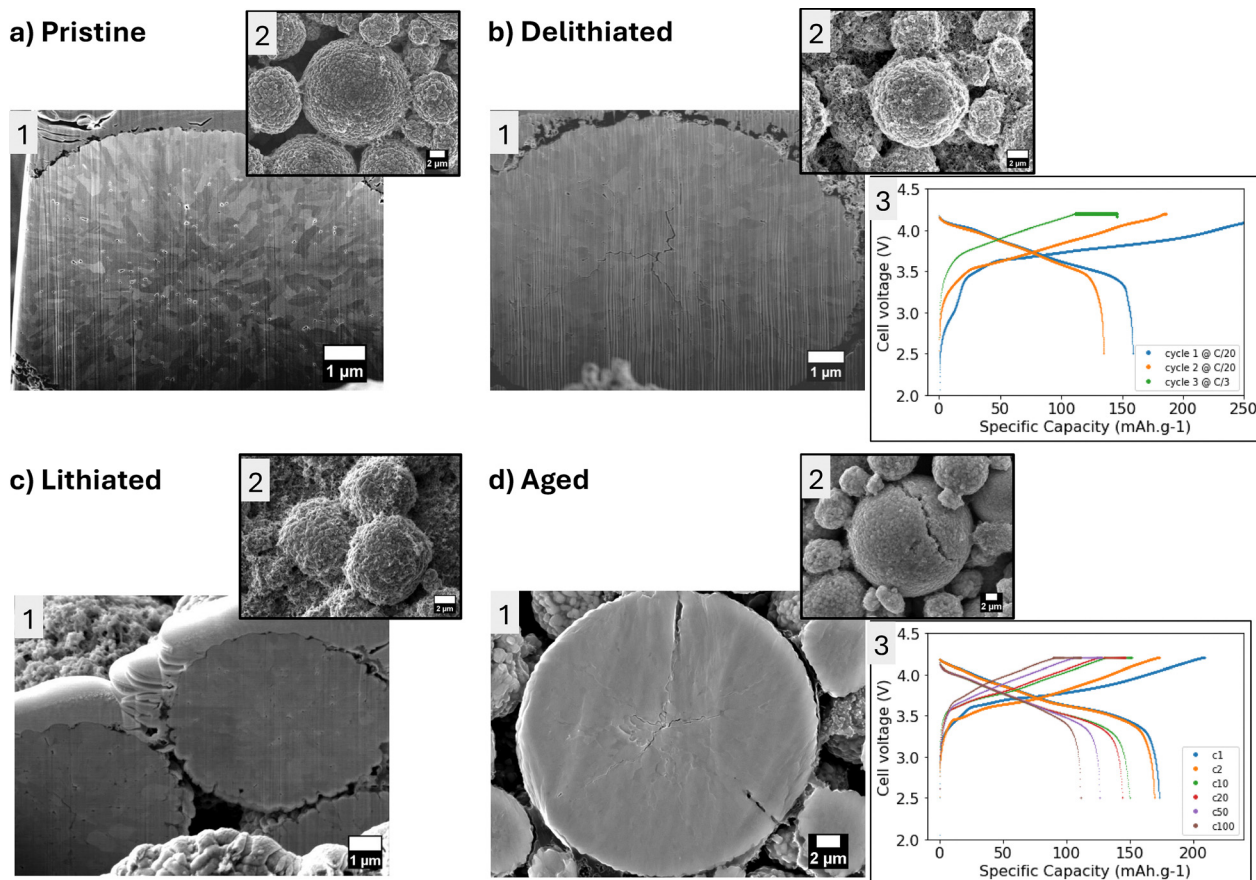
**Fig. 1** SEM characterisation and electrochemical cycling of NMC811 cathodes. (a) Cross section of pristine polycrystalline uncalendered NMC811 cathode showing absence of crack at the centre (1). No cracks are visible on the surface of the secondary particles (2); (b) cross section of NMC811 cathode particle in delithiated state showing the presence of the crack at the centre of the particle (1). The cracks were not visible on the surface SEM images (2). The sample was extracted from the full cell configuration cycled with 2 formation cycles at C/20 rate and 1 charging cycle at C/3 rate (3); (c) the cross section of the (re)lithiated samples showing two particles: with (left) and without (crack) in the center (1). No cracks were visible on top SEM images (2); (d) the cross section of aged NMC811 cathode particle (1) in (re)lithiated state showing the cracks at the centre of the particle. Cracks can also be observed on outer surfaces of secondary particles (2). The sample was cycled in a full cell configuration with 2 formation cycles at C/20 rate and 98 cycles at C/3 rate (3).

Polycrystalline NMC811 particles were characterised under different electrochemical states. Fig. 1 shows the SEM micrographs of pristine, delithiated, lithiated and aged polycrystalline NMC811 particles following prolonged cycling. The morphology of the secondary particles in the as-received state is shown in Fig. 1a-2 and in SI1: Fig S2a and b, where the 100–300 nm range primary particles are assembled into spherical secondary particles of 5–15  $\mu\text{m}$  diameter. No cracks were observed in the cross sections of pristine, as-received NMC811 cathode particles (Fig. 1a-1). Following 2 formation cycles at C/20 rate and 1 charge to 4.2 V at C/3 rate, there are no apparent cracks on the top view SEM

image (Fig. 1b-2). However, once the cross-section was exposed using broad-beam argon milling, small cracks were observed at the centre of the delithiated particle (Fig. 1b-1). Note that similar result is observed when the cross-sectioning was carried out using either a Ga<sup>+</sup> ion beam or Xe plasma, confirming that the preparation method did not induce cracking of the material (SI1: Fig. S3a and b). There was also a noticeable increase in porosity between the primary particles of NMC811 in the delithiated state, compared to the homogeneity observed in the pristine particles. This can be related to the primary particle inhomogeneity and lattice mismatch at high SOC.<sup>12,28</sup> The origin of this lattice mismatch lies in the formation of rigid rock-salt or spinel layers on the surface of the layered NMC811. During delithiation, the layered structure undergoes *a/b* lattice parameter contraction and initial *c*-axis expansion, followed by rapid contraction. On the other hand, the rock-salt structure remains unchanged owing to the absence of Li activity, resulting in a considerable lattice mismatch during delithiation at high SOC. Indeed, TEM characterisation of the NMC811 sample delithiated to 4.2 V *vs.* Li/Li<sup>+</sup> confirms the presence of rock-salt layer, alongside cation-mixed and layered structures (SI1: Fig. S4).

Fig. 1c-1 shows the cross sections of two (re)lithiated NMC811 particles: one with a visible crack at the centre and one without. Study of intragranular cracking in polycrystalline NMC811 showed reversible formation of nanoscale cracks at delithiated state in early cycling.<sup>29</sup> If no contact with electrolyte has occurred, these closed yet resulted in increased lattice spacing. Over time, the surface was irreversibly reduced as evident by evolution of rock-salt layer that was found inside the primary particle. Similarly, initial intergranular cracks (and pores) in secondary particles were shown to close up upon (re)lithiation during discharge as evidenced by operando X-ray computed tomography (XCT).<sup>26</sup> Authors tracked the particles during 10 cycles and showed that cumulative effect of volume expansion and contraction over repeated cycles lead to more damaged particles. It must be noticed that the small cracks similar to one depicted in Fig. 1c-1 can be challenging to track *via* XCT as its size is much smaller than the resolution of the synchrotron technique (<325 nm).

Upon ageing the sample through continuous cycling between 2.5 V and 4.2 V, cracks become visible on the external faces of the particle, suggesting that the internal cracks are now more established on the surface of the particle (Fig. 1d-2). This agrees with the significant cycle-on-cycle capacity reduction seen during electrochemical cycling of the cell in Fig. 1d-3. When cracks are sufficiently wide for the electrolyte ingress, fresh cathode areas are exposed to electrolyte infiltration. The reaction takes place at these sites, resulting in CEI formation, which reduces the amount of active material and increases the cathode impedance. It also creates more surface for cation mixing, rock-salt reconstruction and gas evolution.<sup>23,30</sup> This increases the fatigued phase concentration, which is defined as areas with large mismatch between the layered and epitaxially grown rock-salt layers.<sup>28</sup> Quantifying the strength of NMC811 particles as a function of state of charge and cycling history is an important step in understanding the link between

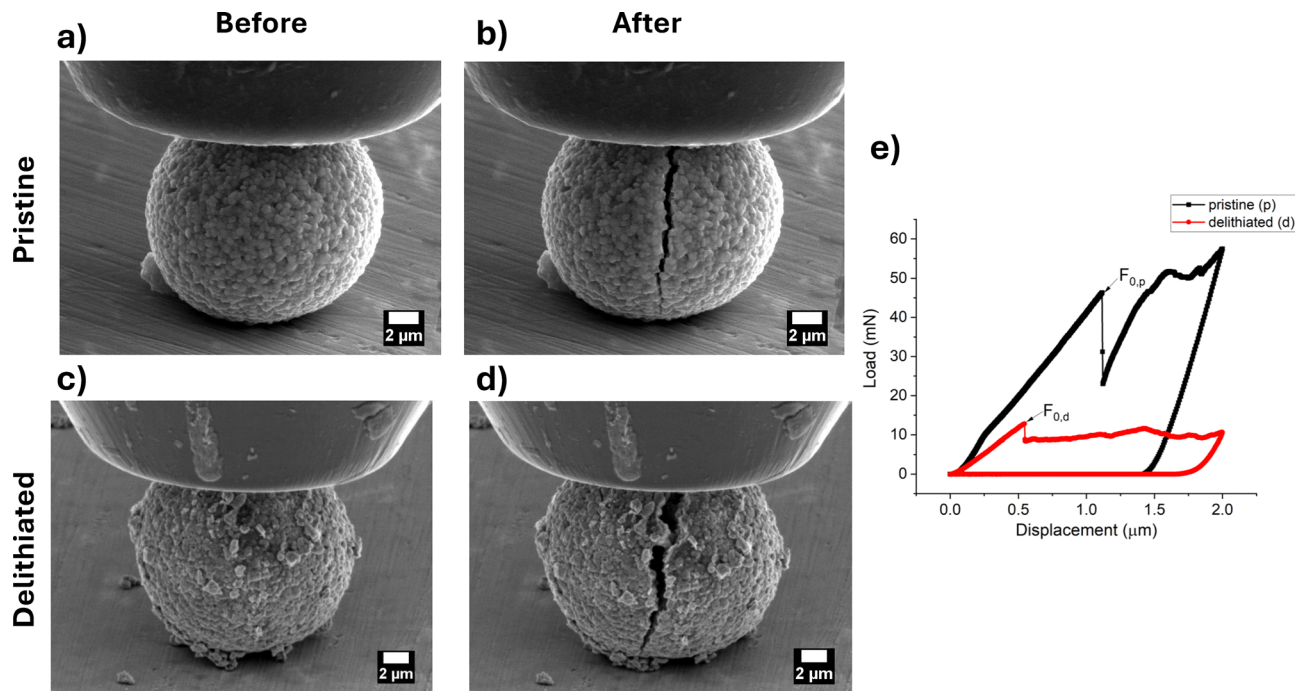
Fig. 2 The SEM images of NMC811 secondary particles before and after intragranular crack appearance in the pristine (a) and (b) and delithiated (c) and (d) states. The corresponding load–displacement curves (e) are presented with the critical loads denoted as  $F_{0,p}$  and  $F_{0,d}$  for pristine and delithiated particles respectively.

*In situ* micromechanical testing was used to measure the evolution of mechanical properties as a function of the electrochemical cycling history. In particular, we demonstrate the use of powder compression as a robust method to quantify particle strength, following the methodology originally developed by Hiramatsu and Oka to determine the tensile strength of irregular rock pieces.<sup>25</sup> In this methodology the tensile strength of

the particle can be approximated to 0.9 times the critical load divided by the square of the particle diameter, *i.e.* the distance between loading points. This assumes that the fracture takes place due to tensile stress over the centre of the particle. Fig. 2a and b present the SEM images just before and immediately after crack appearance on the pristine, which exists in the lithiated state, NMC811 particle (full videos of particle loading tests can be found in SI2). Similar SEM images are presented in Fig. 2c and d for the delithiated NMC811 particle extracted from a full coin cell charged to 4.2 V at C/20 rate. The fracture of the particles occurred at loads denoted in Fig. 2e as the critical load,  $F_0$ . For both pristine (lithiated) and delithiated particles, the crack propagates from the centre of the particle along the grain boundaries between the primary particles. For similar particle sizes, the critical load for delithiated particles  $F_{0,d}$  is considerably lower than that of the pristine, lithiated cathode particles  $F_{0,p}$ . This indicates a reduction in the strength of the particles upon delithiation during the battery charging, even on the first cycle.

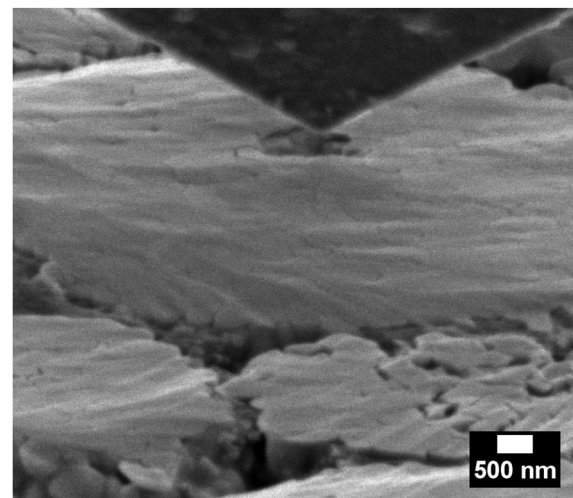
**Fig. 4** Snapshots extracted from a real time video recorded during *in situ* nanoindentation testing showing the cross-section of NMC811 sample and the cube corner nanoindenter tip (a) prior to and (b) following the application of a 3 mN load. The sample was charged to 4.2 V vs. Li/Li<sup>+</sup> and disassembled in the delithiated state.

*In situ* nanoindentation was used to corroborate single particle powder compression test results. Fig. 4 presents the snapshots taken during nanoindentation test, where the delithiated polycrystalline NMC811 particle cross-section was subject to 3 mN load. The hardness and elastic modulus of the pristine (lithiated) NMC811 particle cross-sections were compared to that of charged (delithiated) NMC811 particles in Table 1. The mechanical properties obtained from nanoindentation are in good agreement with those derived from powder compression, where significant reduction is seen at high SOC. Lithium ions shuttle out of the NMC811 structure during charging, resulting in a significantly weaker structure. As mentioned previously, TEM characterisation of delithiated NMC811 revealed the presence of rock-salt layer alongside layered and cation-mixed phases. This can result in significant anisotropic strain in the material. Fig. 4a and b reveal the presence of intergranular gaps at the boundaries between primary particles in the delithiated NMC811 sample at high SOC, observable as distinct separations along the grain boundaries. This apparent reduction in boundary strength, exacerbated by strain due to phase change, is one of the reasons for the decreased hardness observed in the nanoindentation tests. Voids between the primary particles of NMC811 at delithiated state are commonly occurring phenomena and were observed in TEM analysis (see SI1: Fig. S4a and b) as well as during Atom Probe Tomography (APT) sample preparation (SI1: Fig. S5).
