Cite this: *Environ. Sci.: Water Res. Technol.*, 2026, 12, 14

## Decentralized UV disinfection systems in rural areas or low-resource contexts: a case study compilation

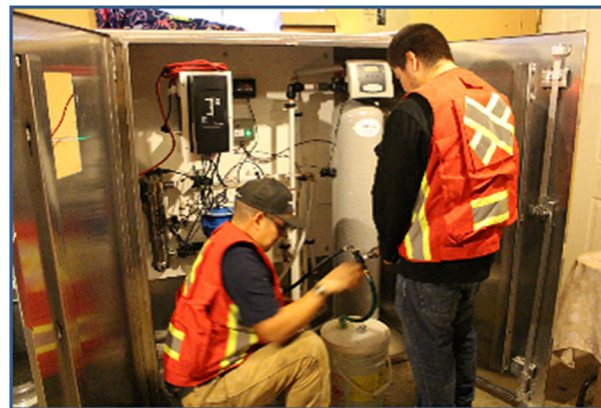
Fig. 3 The Lytton POE systems, with the low-pressure UV system, were installed in a secured enclosure, placed inside residents' homes.

An emergency solenoid shut-off valve was located downstream of the UV lamp and was normally closed when the water was not in use, preventing water from reaching the consumer. It also closed if the UV dose was less than 40 mJ cm<sup>-2</sup> and if the system lost power, was unplugged or if the UV lamp failed to turn on. In

response to a power failure, the solenoid valve would close, as it would no longer be powered open. The UV unit had a sensor to detect lamp intensity. If a safe UV dose was not achieved during the warmup cycle (if the intensity went below a set value calculated for the required dose), an alarm occurred, and the solenoid remained closed. A backup battery was available for temporary power (approximately providing up to one hour power for continuous operation) in the case of a power failure.

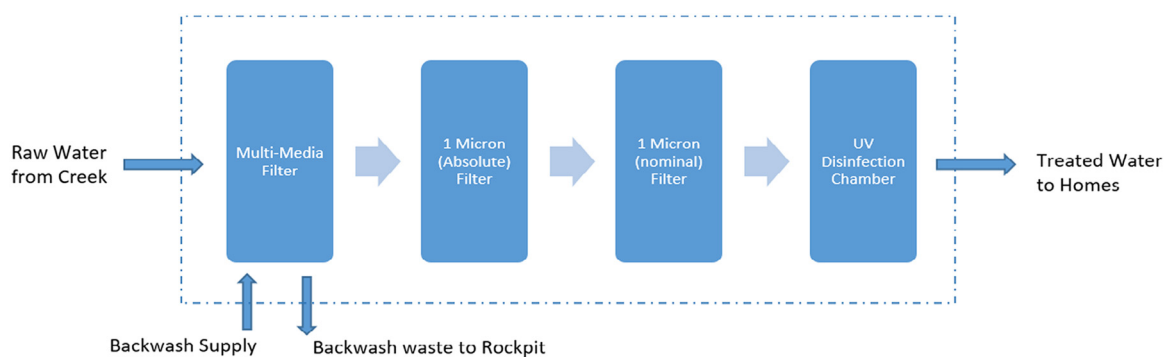
Fig. 2 The Lytton POE systems process flow diagram.

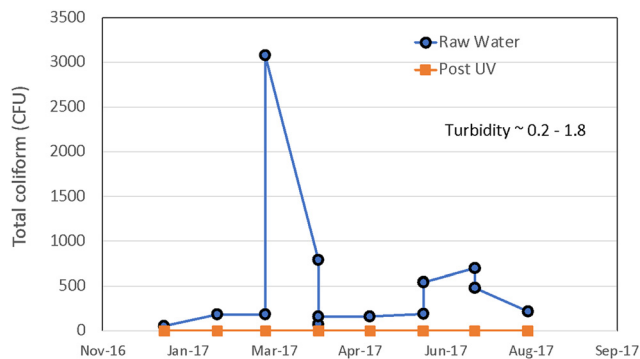
Fig. 4 Total coliform counts, before and after the UV POE systems.

careful oversight. The regulations set by FNHA required three consecutive weeks of clean results (*i.e.*, non-detectable microbial counts) in order to lift the boil water advisories. This target was achieved between mid-December and mid-January 2016, based on a staggered sampling schedule and testing that included weekly bacteriological results. As of January 2017, both Reserve communities and all five participant residences, were off the boil water advisory.

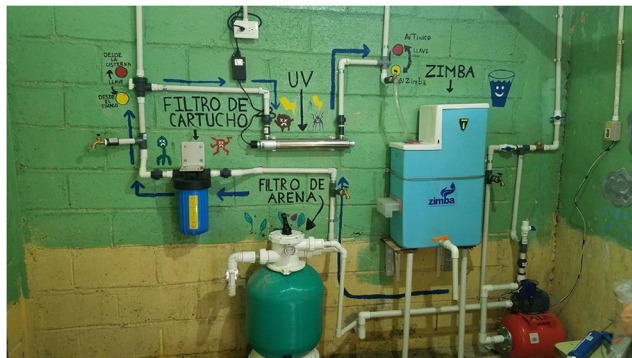
Fig. 5 Potable water treatment system installed in Escuela Primaria Aureliano El Mamey.

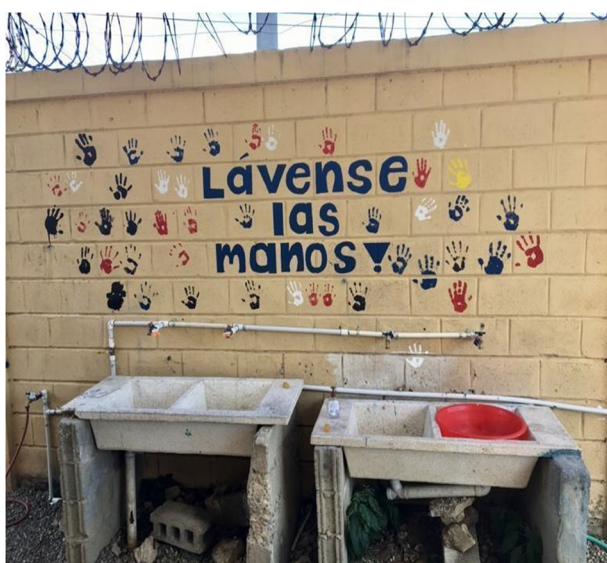
Fig. 6 Handwashing station at Escuela Primaria La Torre with handprints from the school's students.

filtration and disinfection to produce finished water that is safe for drinking, cleaning and cooking at the schools. Treated water also can be routed to the handwashing station (Fig. 6). A sand filter is used to remove debris and large particles followed by a 1-micron cartridge filter for removal of microscopic particles, including bacteria and other microbial pathogens.

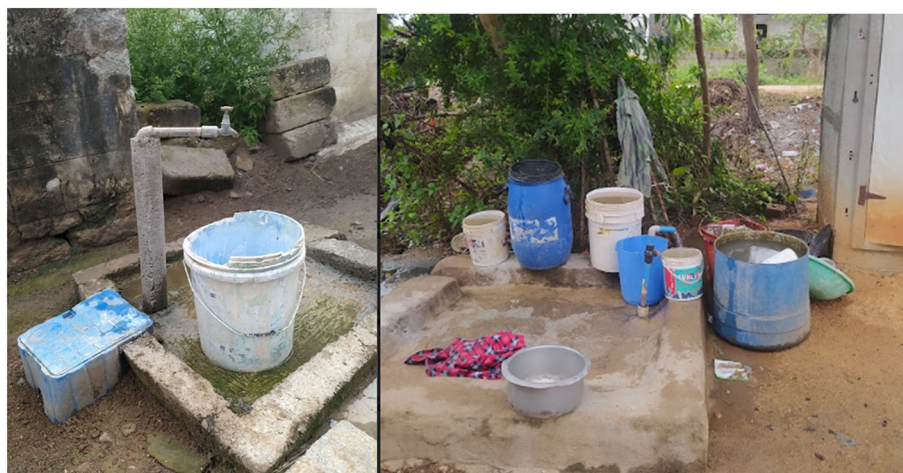
Fig. 7 Community water taps.

Community taps are scattered throughout the village within the living area, with a group of four households living around a tap in the village. The water is not streamed regularly; instead, it is streamed without notice between 4:00 a.m. and 7:00 am (Fig. 7). The water quality is poor and the source of the water is the river or wells. Table 4 details the water quality with high total dissolved solids, TDS, and part of the sources with high turbidity. The water quality at the current taps is also poor. Structurally, the taps are shaky, fragile and unstable; thus, the community must exercise care to avoid damaging them. The water pressure when the tap is open ranges from 0.3 to 0.8 bar, and when the taps are closed the pressure ranges from 1.0 to 1.5 bar. The inner tap diameter is between 1.6 cm and 2.2 cm, and the outer tap diameter is between 1.8 cm and 2.6 cm. For hand pumps, the inner diameter is 4.6 cm and the outer diameter is 5.0 cm (Table 4).

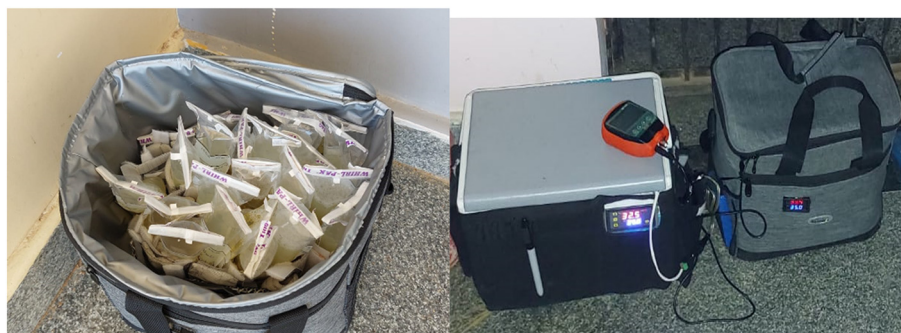
Fig. 8 Field incubator and test kits.

rural areas with intermittent electricity supply. The parts of the incubator were purchased in India and built in the field. Fig. 8 shows the field incubator and the Aquagenx field test

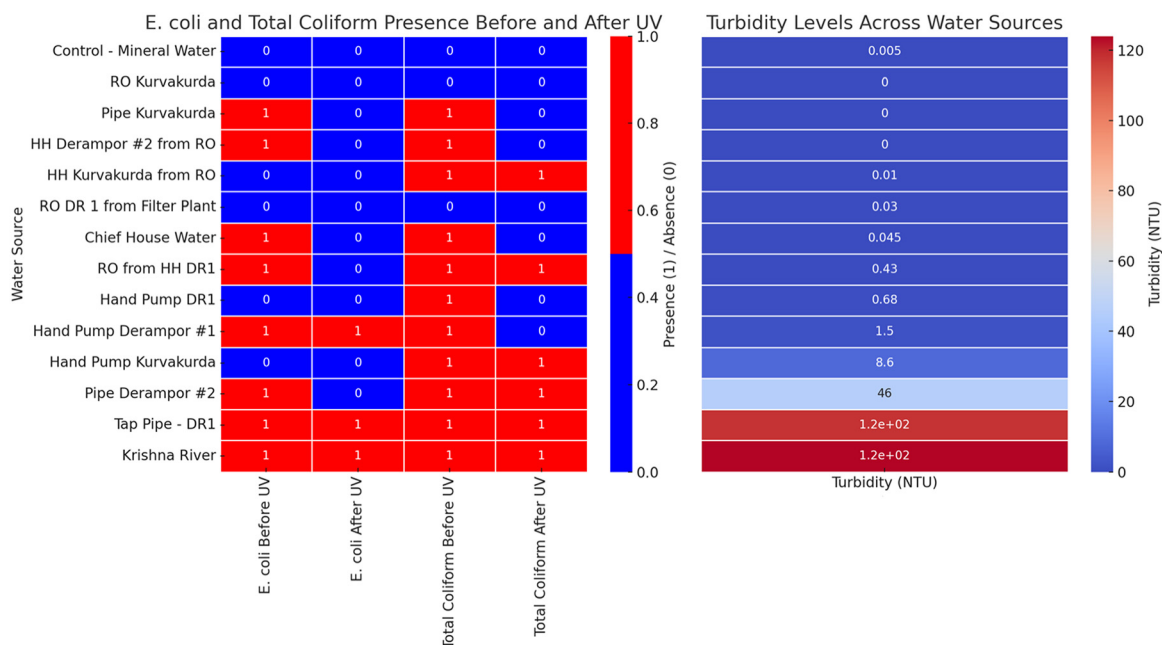
Fig. 9 E. coli and total coliform results before and after UV disinfection, and turbidity levels across water sources.

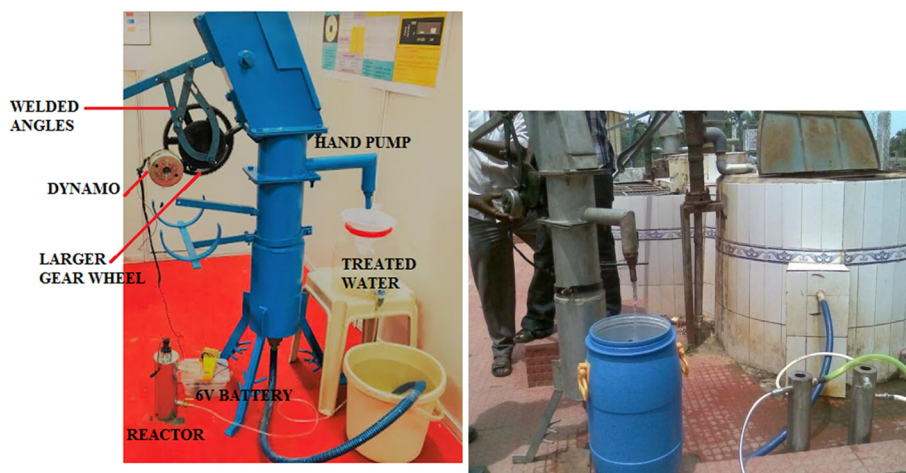
Fig. 11 Fitting of experimental setup on Pattikadu Oorani. The hand pump with gear wheel, shown on the left, was modified to drive a gear system linked to a dynamo, converting mechanical energy into electricity and charging a 6 V DC battery. The UV LED reactor is the silver cylinder in the bottom right of the right photo.

For the improvement of the quality of drinking water, zero-energy technology for the removal of pathogenic organisms was developed (Fig. 11) as described further in Sundar and Kanmani.<sup>39</sup> An annular UV LED photoreactor (1.0 L capacity) designed as a batch reactor that contained 24 UV LEDs connected in parallel and placed inside a quartz tube of diameter 30 mm and length 300 mm. The quartz tube was fitted inside an enclosure made of stainless steel of diameter 87 mm and length 240 mm and thickness 2.0 mm. The distance between the light source and the nearer/farther side of the water medium was 1.5 cm and 2.75 cm, respectively.

With the exposure to UV LED irradiance, the colony counts reduced significantly with time, resulting in  $<1$  CFU mL<sup>-1</sup>. The system was observed to achieve a maximum inactivating fluence of  $\sim 5$  mJ cm<sup>-2</sup> for *E. coli*, which corresponds with 2 log inactivation. The cost of UV LEDs is the major barrier to scalability, followed by the design and large-scale manufacturing of UV LEDs through collaboration with manufacturing companies with a target of zero-energy disinfection technology at the point of use in remote rural villages.

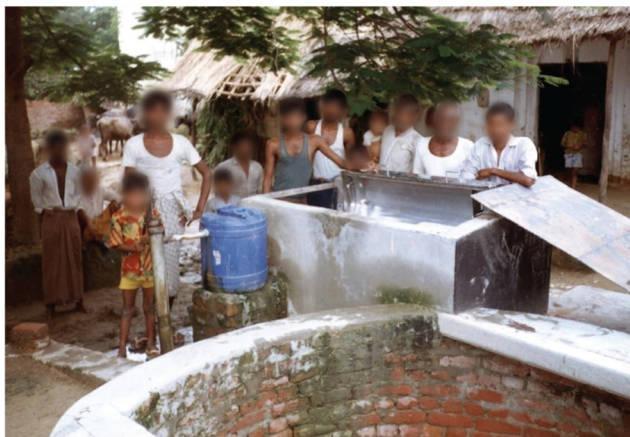
**Fig. 12** View of the Bhupalpur field test. The open well in the foreground is in disuse. The hand pump to the left of the well supplies water to the blue surge tank, which feeds into a large early-design UV Waterworks unit, partly seen within the low-height concrete walls. The villager noted that the flow of this first design (60 LPM) was far larger than any hand pump flow the villager had ever encountered. This led to the more compact revised design that disinfected a water flow of 15 LPM, better matched to the UNICEF India mark-II hand pumps widely installed in the developing world.

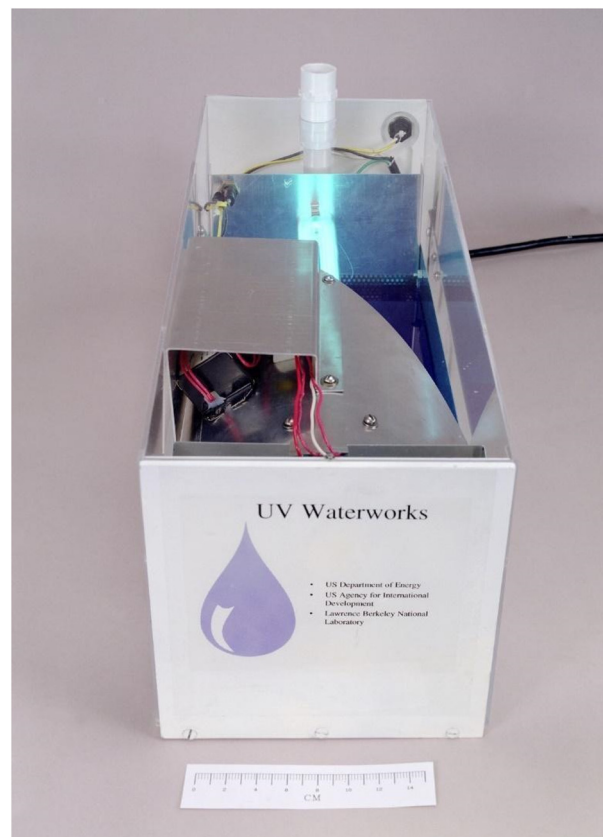
**Fig. 13** UV waterworks, built with a glass cover for exhibits and displays to explain how the technology works.

influent, a system was created with no solid surfaces between the UV source and the water, ensuring that the UV disinfection remained unaffected by chemical or biological fouling. Positioning the UV lamp above the water flow also improves lamp life, output, and UV fluence. Operating in the air keeps the temperature stable, improving performance and longevity while preventing fluctuations that reduce UV output.<sup>40</sup> Avoiding contact with water minimizes fouling, corrosion and moisture damage, reducing maintenance needs.<sup>41</sup>

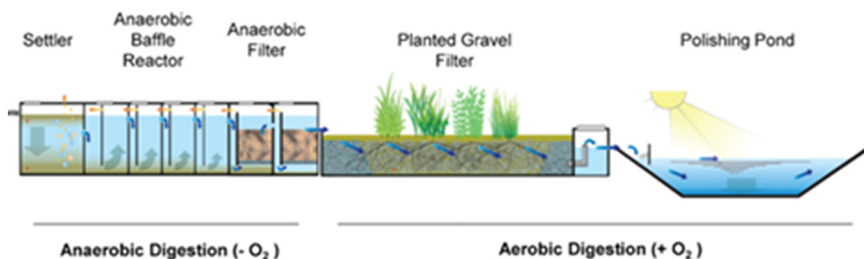
Fig. 14 Pretreatment of wastewater prior to UV disinfection.

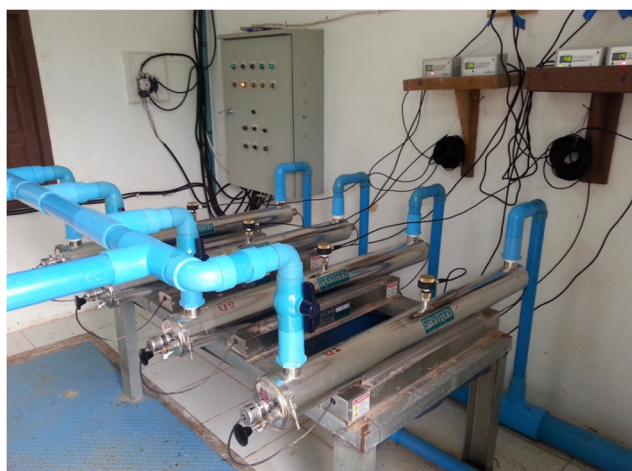
Fig. 15 UV disinfection system.

Atlantic Ultraviolet Corporation, which used STER-L-RAY low-pressure germicidal lamps, emitting at 254 nm, encased in a stainless-steel chamber. The lamps are horizontal, operated in parallel, in two groups of two (Fig. 15). This particular system also included a Guardian digital UV light monitor, which was installed in the visualization port to detect decreases in UV irradiance from, for example, a) fouling of the quartz sleeves; b) poor water quality, which would block the UV transmission through the water; or c) depreciation of the lamp output.

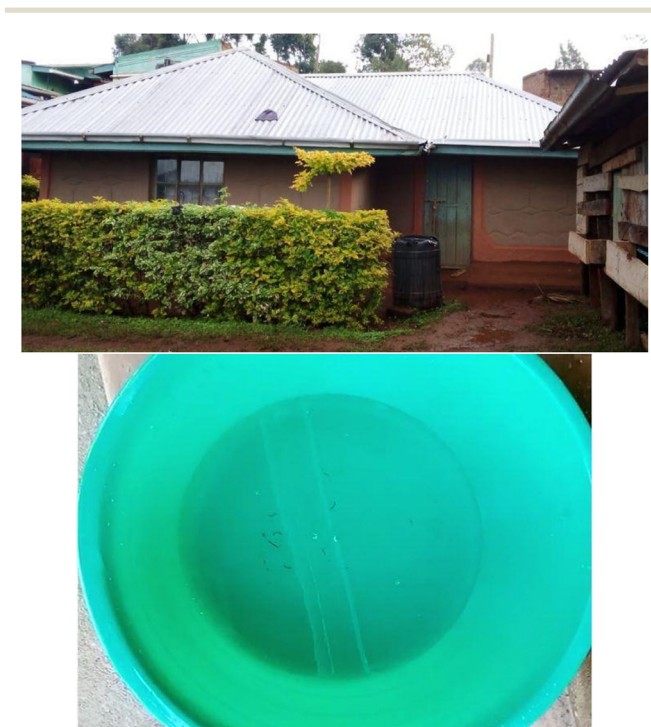
Fig. 16 Worms in water collected from water storage tank.

The collected rainwater is commonly stored in polystyrene tanks, metal jerry cans, clay pots and other water storage containers. Galvanized corrugated iron sheets are the commonly-used housing roofing material for most communities in Kenya, including the rural communities at Nyamesocho village (Fig. 16). Therefore, the rainwater is often collected from such roofs. Notably, if not filtered, the collected and stored rainwater is contaminated by dirt found in the rooftops originating from bird and some animal droppings, tree leaves, *etc.* In the past, visible worms frequently have been seen in the stored rainwater (Fig. 16), which is a confirmation of the reports on the growth of microbial contaminants within water storage containers.<sup>46,47</sup> Also, if the water is stored for long periods of time, it can produce an unpleasant smell, which can prevent people from drinking it. Therefore, this project was designed to collect,

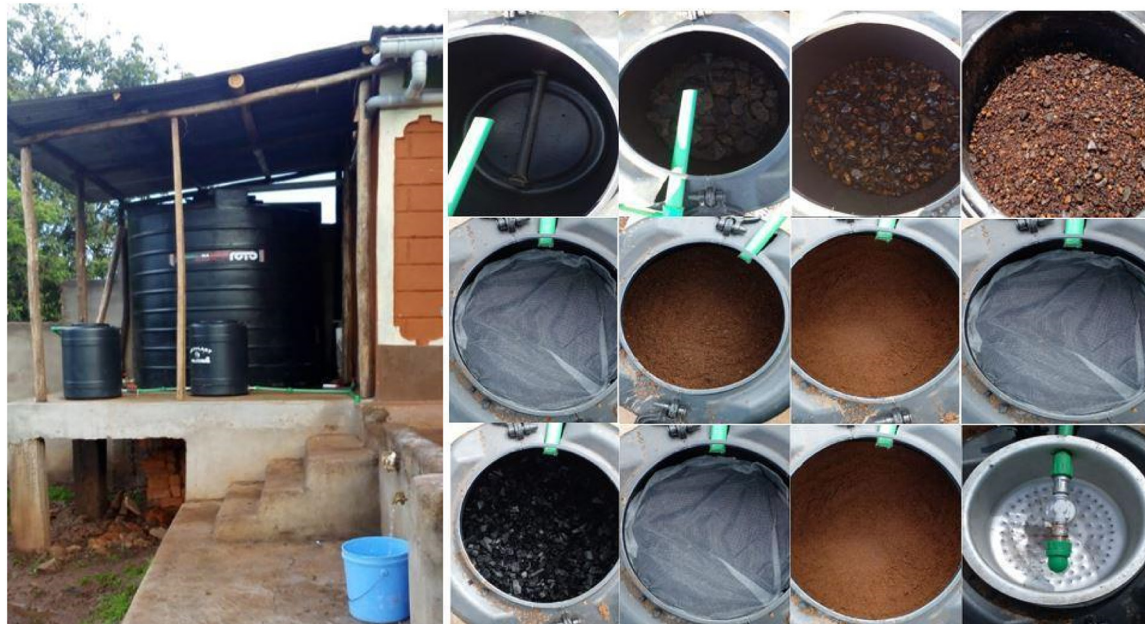
Fig. 17 (Left) Rainwater collection, filtration and disinfection system. (Right) Biosand and biochar layers within the filtration system.

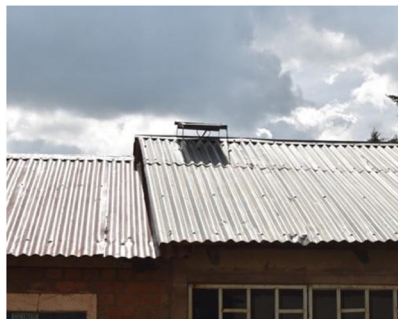
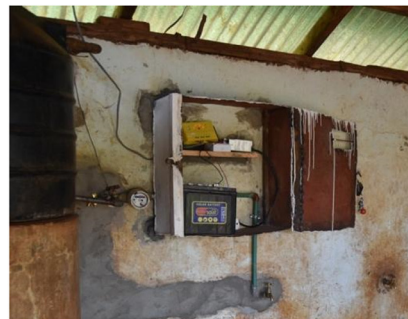
**Fig. 18** System components that were designed and constructed by the welder; (left) a solar panel bracket holds the panel in place on the roof and locks so the panel cannot be stolen, and (right) a box to protect the system from tampering.

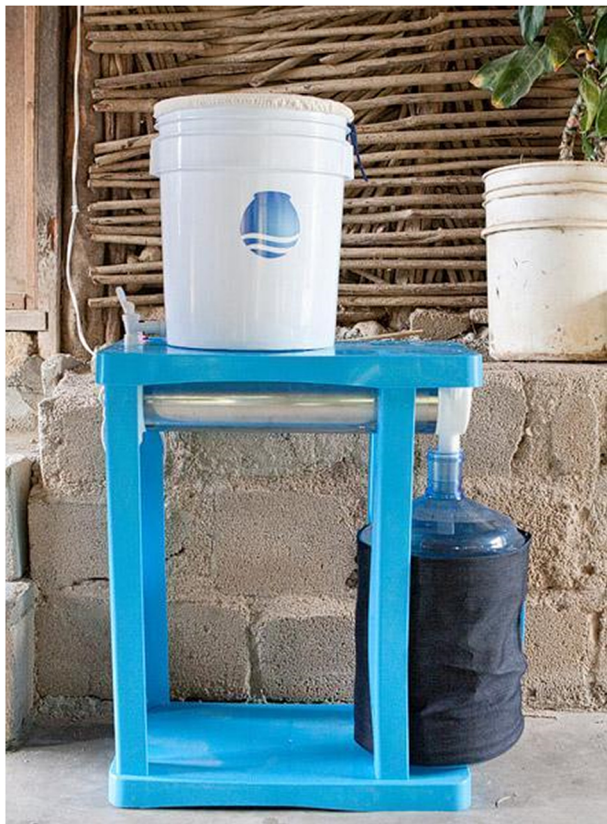
Fig. 19 Mesita Azul household water treatment system with an open-channel UV reactor (silver cylinder) fed by gravity.

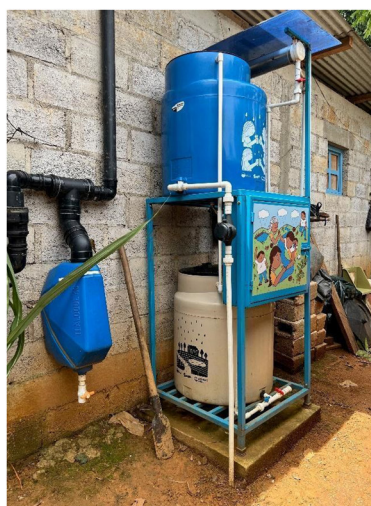
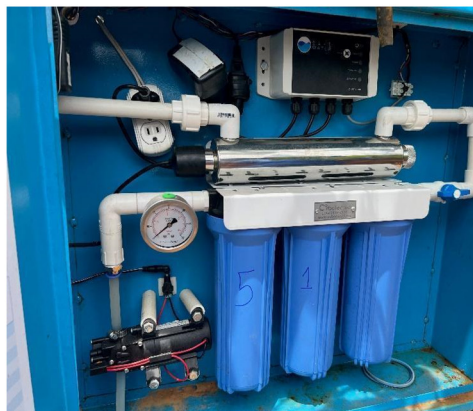
Fig. 20 The 250 L SAFEWATER system (left) with the encased LP UV lamp and activated carbon filters (right).

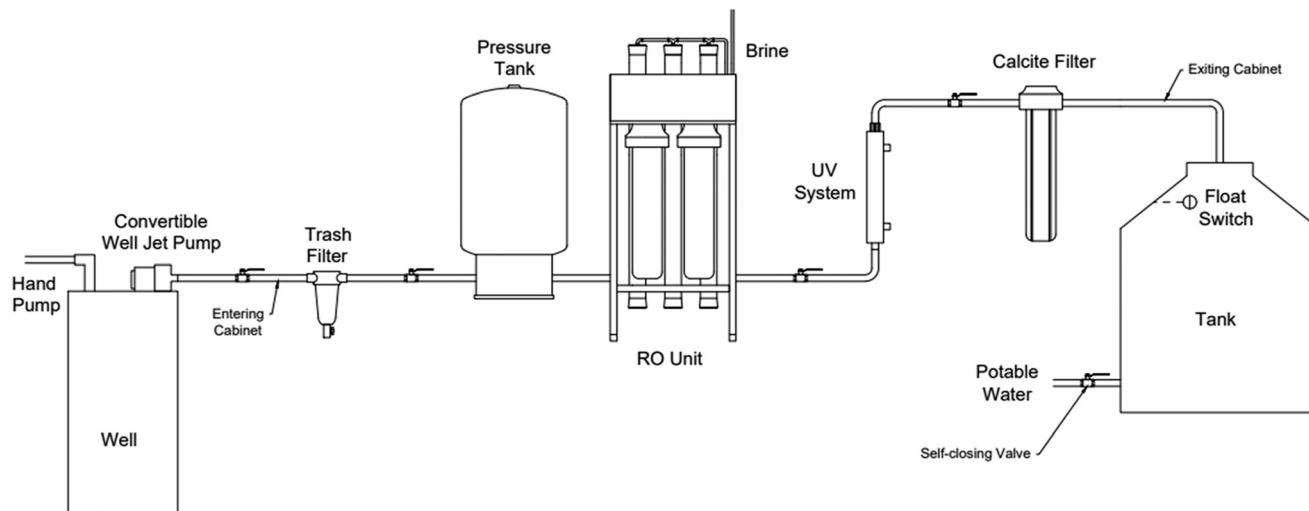
Fig. 21 The multi-barrier treatment train includes prefiltration, reverse osmosis (RO), UV disinfection and calcite filters.

The capital cost of each individual water system was approximately \$9400 USD, including RO (\$4500 USD), UV disinfection (\$325 USD), calcite contactors (\$375 USD), tanks and plumbing (\$3000 USD) and electrical components (\$1150 USD). For each system, the replacement costs are \$345 USD every two years for RO pre-filters and membranes, \$84 USD per year for UV lamps and \$90 USD per year for calcite filter media. This is planned to be funded by the Friends in Action Organization. The final system will be housed in a concrete building and community members will be able to collect potable water from tanks.

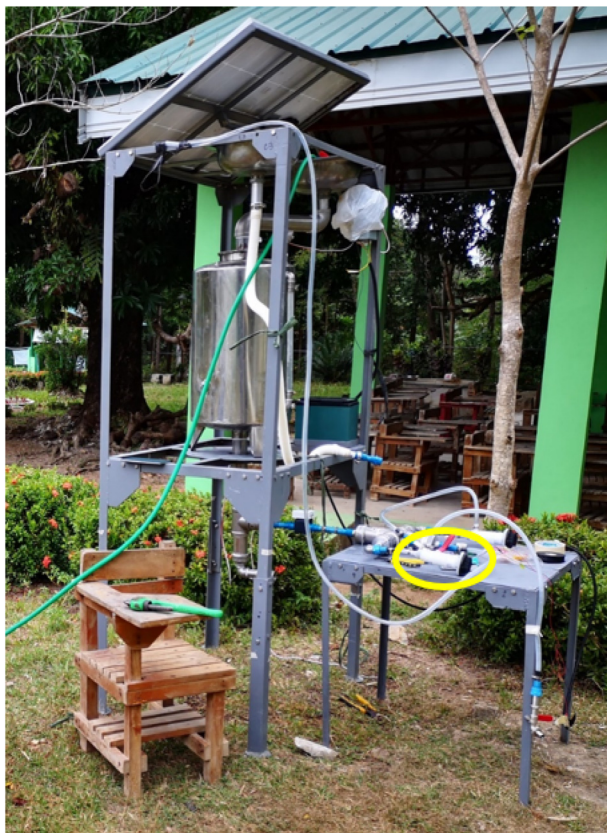
Fig. 22 Pilot setup of solar-powered UV LED water disinfection system in Panobolon Island, Guimaras, Philippines. The UV LED module is enclosed in the yellow circle.

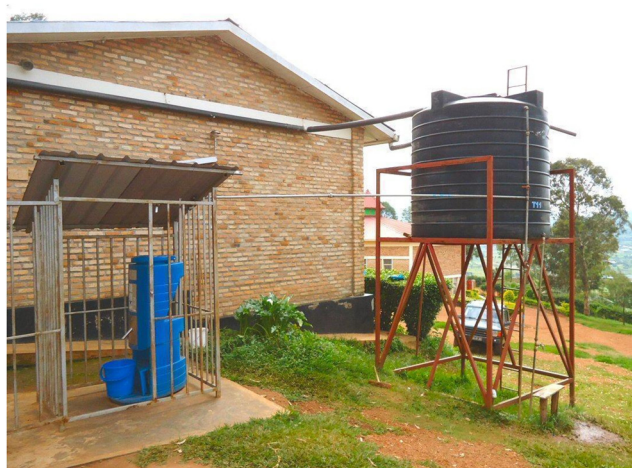
Fig. 25 A Naiade (on the left) and rainwater harvesting tank on a primary school in Kigali, serving 240 children and 20 staff members.

Twenty-three Naïade units have been installed at schools (Fig. 25) and small hospitals in Rwanda and maintained by the Impala Foundation, and some of these units have been operational for over 12 years now. Units were financed by the Dutch Soroptimists organization.

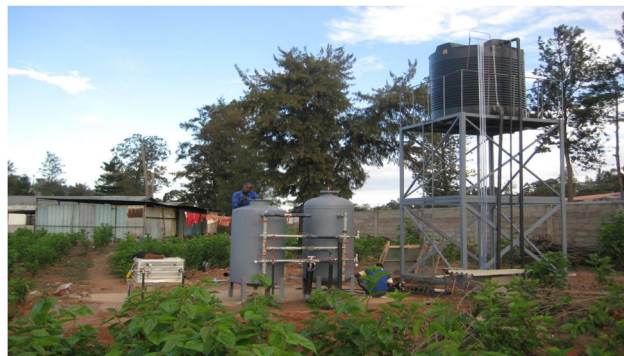
Fig. 27 An example of the Manna Energy Limited water treatment system. The system is installed in-line with existing water pipes. On the right is an elevated backwash tank. In the center is a gravel filter and a pressurized sand filter. On the left is the solar photovoltaic-powered UV system.

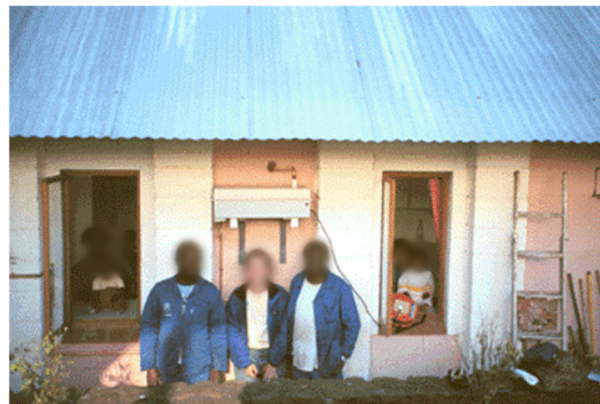
Fig. 29 UV Waterworks 2.0 unit installed on the exterior wall of the kitchen at the Lily of the Valley HIV-Hospice near Durban, South Africa.

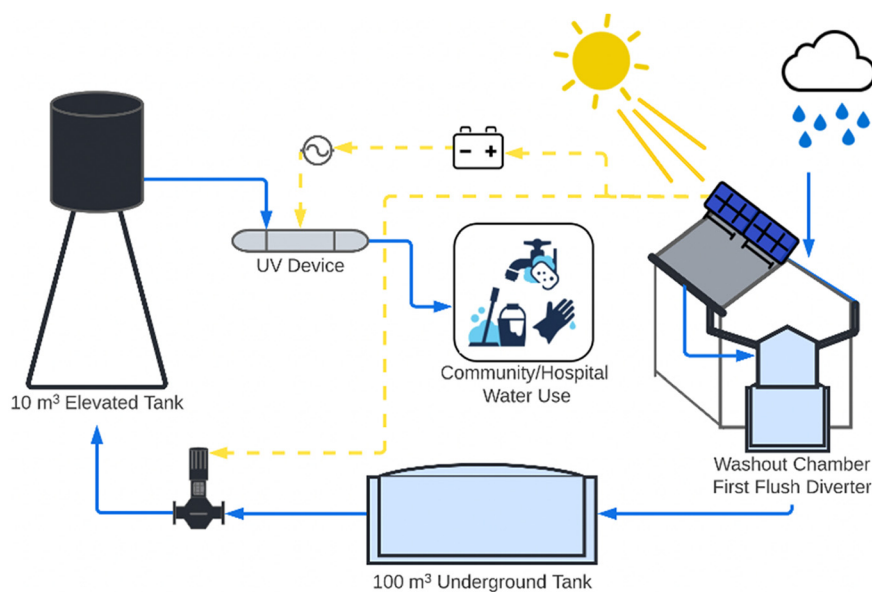
**Fig. 31** UV rainwater harvesting (UV RWH) system.

In this instance, rainwater harvesting (RWH) was used as a water source due to the lack of available groundwater and surface water in the area. Rainwater is known to be subject to contamination from collection surfaces and storage – bird and animal feces, tree waste and air pollution. At each hospital, rainwater was collected from a large rooftop catchment area. Through a series of gutters, the rainwater passed through a first flush diverter and wash-out chamber, which removed dirt, debris and leaves. The water was then stored in a 100 m<sup>3</sup> underground storage tank. A solar-powered pump brought the rainwater into a 10 m<sup>3</sup> raised storage tank. Water then flowed through a 25 W low-pressure UV lamp into the hospital facility for multiple uses for staff and patients in operation rooms, doctors' offices, bathrooms, *etc.* (Fig. 31). The UV lamp was powered by a 125 W, 12 V solar panel, which charged a 12 V lead-acid battery.

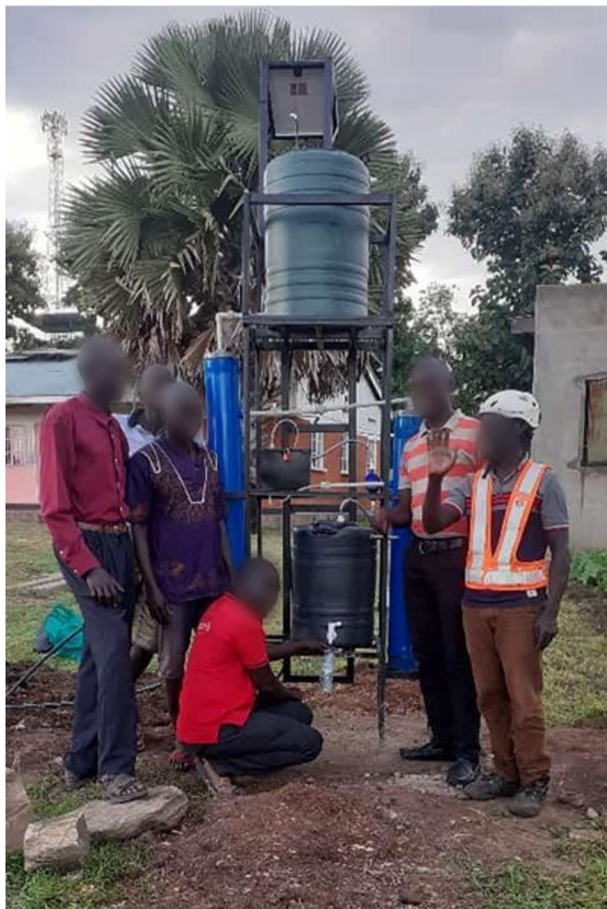
Fig. 32 ASEI and AQUISENSE Technologies water treatment and delivery system.

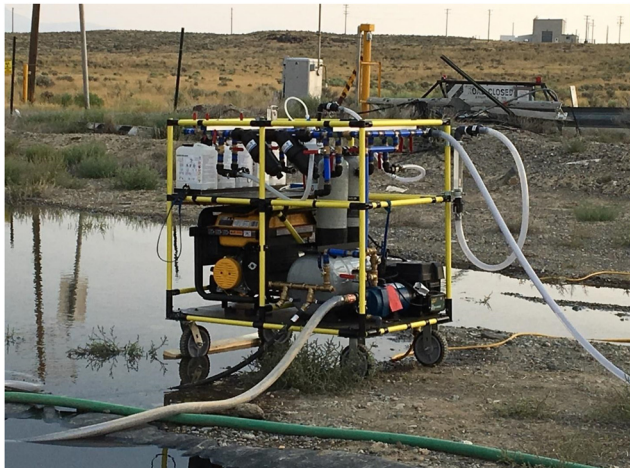
Fig. 33 WOW cart.

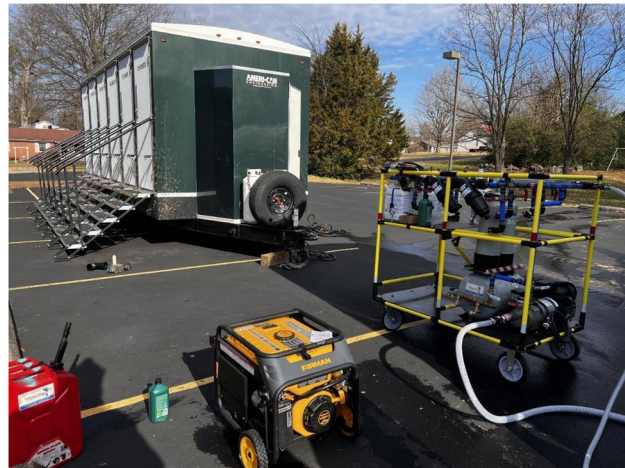
Fig. 34 WOW cart providing water for mobile showers in Western Kentucky.

The WOW cart's design minimizes the footprint and weight, which can enable transportation in the back of a pickup truck and movement on-site by two people. The UV LED system also adds to the robustness of the system, minimizing any risk of damaging the device during transportation and operation. The on-site treatment of water also reduces the dependence on bottled water, which creates a solid waste disposal problem. Additionally, the WOW cart fills a niche that bottled water cannot address in terms of providing safe water for showers (Fig. 34), laundry, food preparation/clean-up and general sanitation, which could also include medical triage. It is also envisioned that WOW carts could be pre-deployed to critical institutions such as nursing homes, hospitals and prisons, where relocating residents presents a considerable health and financial risk.

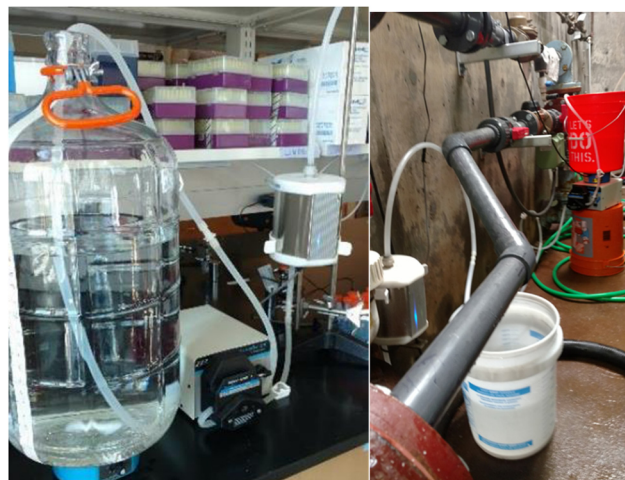
Fig. 35 UV LED reactor disinfection performance was assessed under varying conditions at bench scale (left) to develop a predictive model that was used to assess performance during challenge testing after pilot installation (right).

One objective of this research was to validate UV LED reactor disinfection performance at bench scale across a range of flow rates and UV transmittances to develop a predictive model for disinfection (Fig. 35). In the second objective, the LED reactor was installed in the first long-
