Cite this: *EES Sol.*, 2025, 1, 580

Three decades, three climates: environmental and material impacts on the long-term reliability of photovoltaic modules†

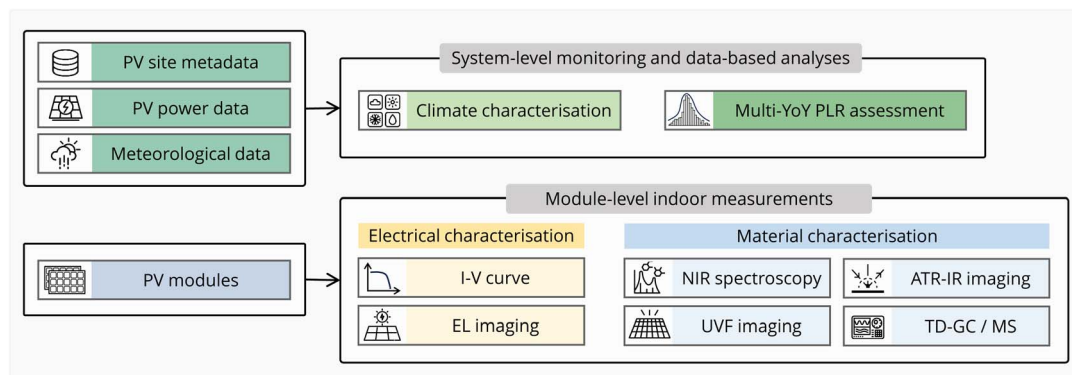
Fig. 1 Flowchart illustrating the analysis methods in this study, combining system-level monitoring for climate characterisation and long-term performance assessment, and module-level indoor measurements for electrical and material characterisation. Abbreviations: PV (photovoltaics), multi-YoY (multi-annual year-on-year), PLR (performance loss rate), *I*–*V* curve (current–voltage characteristic), EL (electroluminescence), NIR (near-infrared), UVF (ultraviolet fluorescence), ATR-IR (attenuated total reflection infrared), TD-GC/MS (thermo-desorption gas chromatography/mass spectrometry).

To complement the long-term monitoring data, a sample of PV modules was randomly selected and removed from the specified systems (Table 1). These modules were then subjected to indoor laboratory measurements (Fig. 1), and compared to the two reference SM55 modules that were not exposed to outdoor conditions. These tests provide a more in-depth investigation into the physical and electrical degradation mechanisms affecting the modules after prolonged field exposure. The following sections outline the methodologies applied across two main areas: electrical and material characterisation.

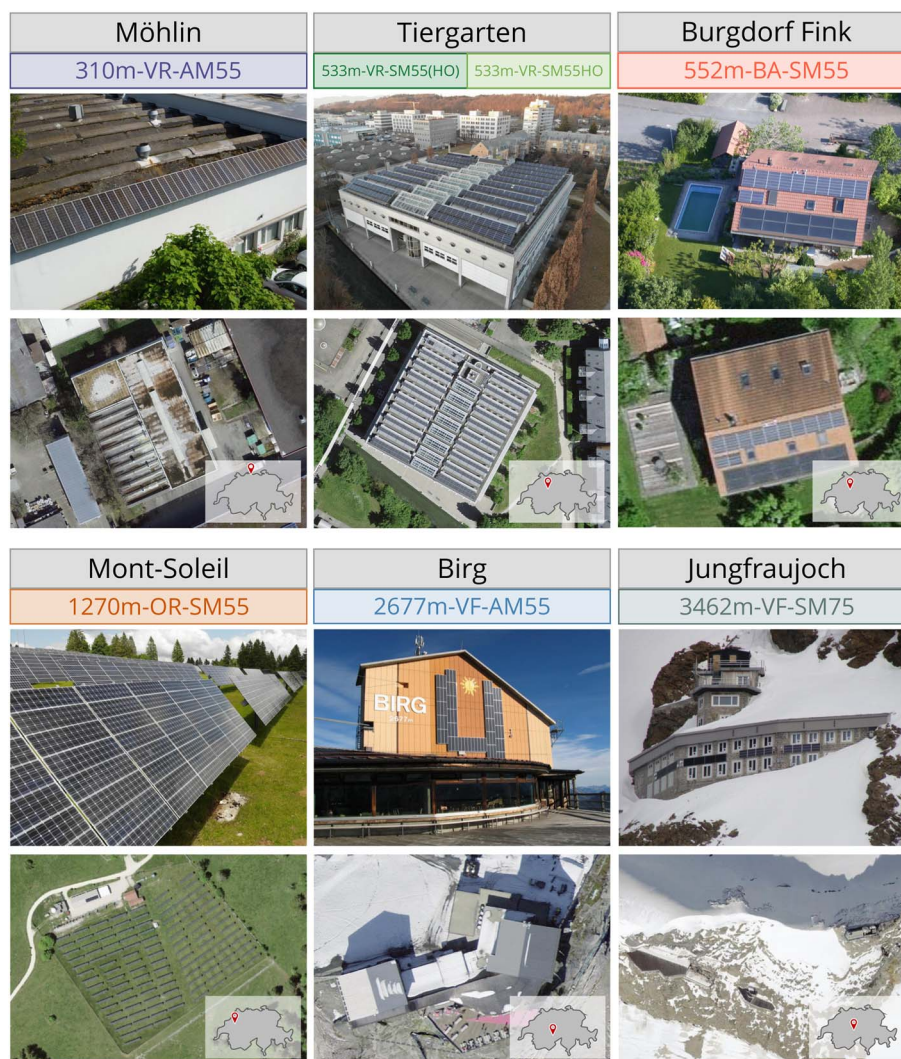
Fig. 2 System photos, showing the profile view (top) and aerial view (bottom). Approximate location in Switzerland is indicated in the bottom right corner. The Tiergarten system is separated in the East and West parts of the rooftop in the data and results. Site IDs are indicated below the system name, following the defined format: [Altitude]–[Mounting Config.]–[Module Type], see Table 1.

The plant layouts, module types, and locations are illustrated in Fig. 2, while a summary of PV system metadata is provided in Table 1.^{14,15} Each system is assigned a unique Site ID, constructed using the format [Altitude]–[Mounting Config.]–[Module Type], which will be used throughout the paper. The studied PV systems are classified into three altitude zones: low-altitude (<600 m), mid-altitude (1000–1500 m), and high-altitude (>2500 m), each corresponding to distinct Köppen-Geiger (KG) climate classifications: Cfb (temperate, no dry season, warm summer), Dfb (Cold, no dry season, warm summer), and ET (Polar, tundra).¹⁶ The low-altitude sites include Switzerland's first private grid-connected PV system in Möhlin (310m-VR-AM55), Tiergarten East and West in Burgdorf

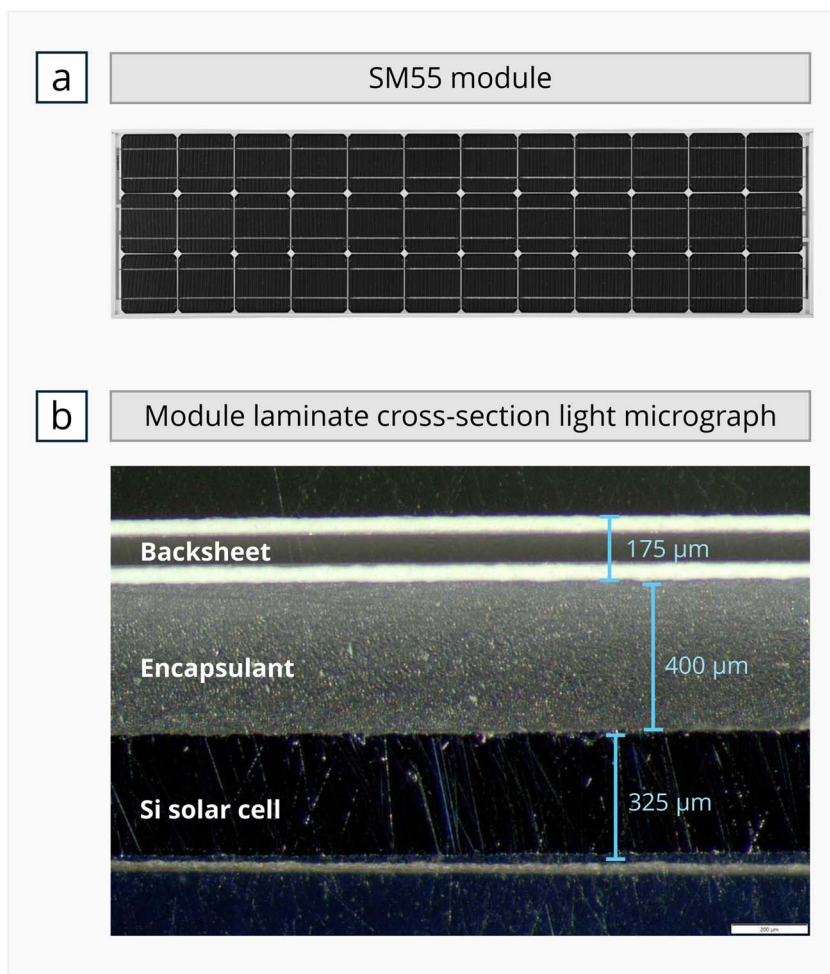
Fig. 3 (a) Photograph of a Siemens SM55 module. (b) Light micrograph of the cross section of part of the module laminate: 3-layer backsheet, back encapsulant and Si-solar cell.

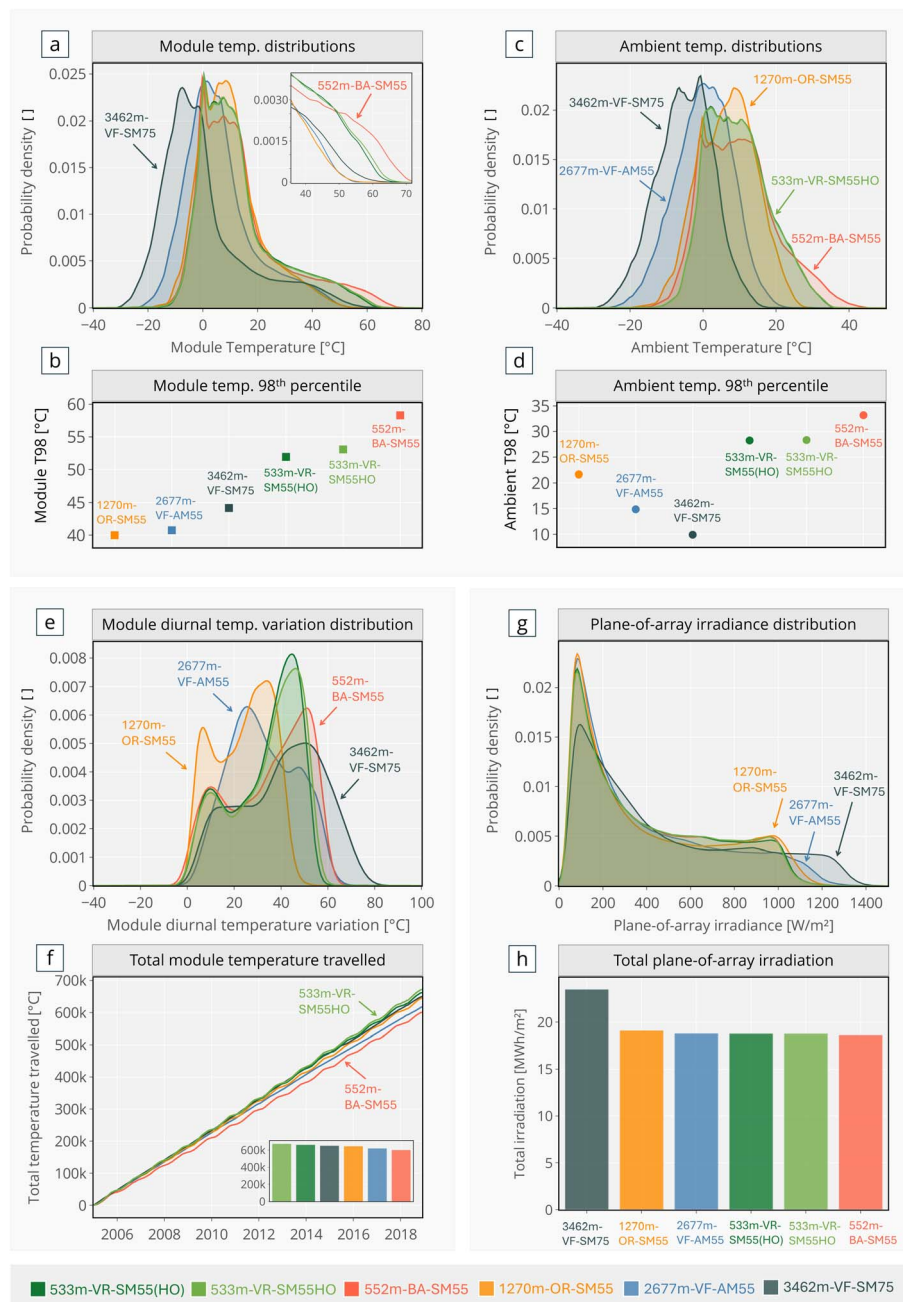
Fig. 4 Statistical analysis of the meteorological data. (a)–(d) Thermal stress: module and ambient temperature distributions and 98th percentile temperatures. (e) and (f) Thermo-mechanical stress: diurnal temperature variation distributions and total temperature travelled. (g) and (h) Irradiance stress: plane-of-array irradiance distribution (values 50 W m^{-2} filtered out to avoid nighttime and low irradiance) and total irradiation. All datasets are filtered between 2005–2018 to compare the same time periods and number of years.

The probability density of diurnal temperature variation at the module level and the total temperature travelled are used to evaluate thermo-mechanical stress (Fig. 4e and f). Diurnal temperature variations reflect intra-day thermo-mechanical stress in module components due to differences in thermal expansion coefficients. Results indicate that the highest-altitude site (3462m-VF-SM75) experiences the greatest day-night temperature variations, likely due to freezing nighttime temperatures. In the mid- and low-altitude range, the BAPV system (552m-BA-SM55) exhibits the largest diurnal temperature variations, which may be attributed to reduced ventilation compared to open-rack or ventilated roof configurations. On top of day-night temperature fluctuations, total accumulated thermo-mechanical stress is estimated by the total temperature travelled. Interestingly, low-altitude ventilated roofs show the highest temperature travelled, likely due to faster cooling rates and thus lower thermal inertia. In contrast, the BAPV system has the lowest total temperature traversed, reflecting higher thermal inertia. Overall, frequent temperature ramping events

induce material stress, with thermo-mechanical stress appearing more pronounced in low- to mid-altitude systems with partial ventilation.

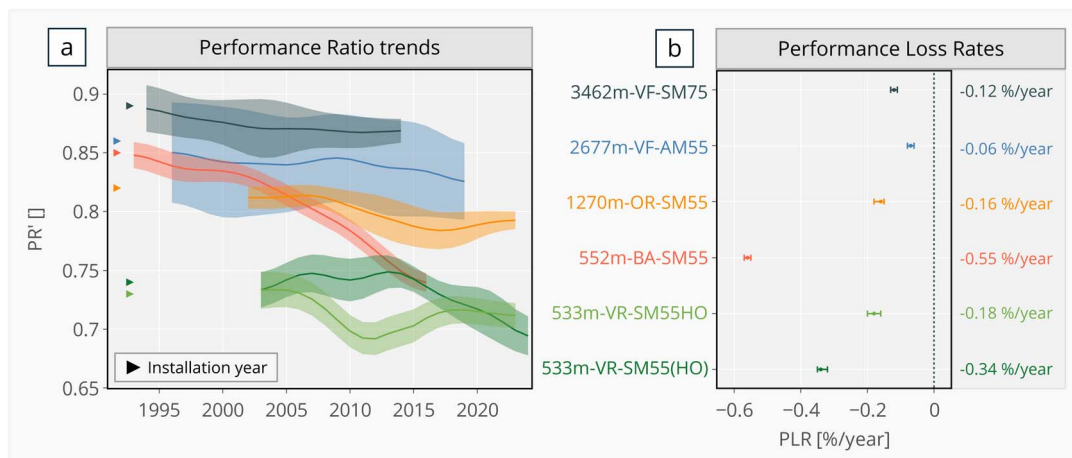
Fig. 5 (a) Temperature-corrected performance ratio (PR') trends, using yearly data aggregation and smoothed with a Gaussian filter ($\sigma = 2$). The CI is computed using one standard deviation of the yearly averaged data. (b) PLR results with 95% CI from the daily aggregation results of the multi-YoY method. All systems with long-term performance data are included.

using yearly aggregation show the relative system performances over time (Fig. 5a). The PV system installation dates are indicated with arrows (the initial PR' value is not based on a measurement but simply placed as a visual reference), to show the extent of outdoor module exposure relative to the monitoring data available for the PLR assessment. The final PLR value and 95% CI are based on the daily aggregation results which feature the lowest uncertainty (Fig. 5b). The detailed multi-YoY results per system are shown in the Appendix (Fig. A.1, ESI),[†] with the PLR results for daily, weekly, monthly and yearly aggregation strategies.

The PR' trend results highlight clear differences in PR' for the various locations, module types and mounting configurations (Fig. 5): (i) higher altitude systems tend to have higher average PR' , with values ranging from 0.7 to 0.89 for the alpine facade 3462m-VF-SM75; (ii) facades seem to experience higher seasonal variations in performance, visible with the wider standard deviation; (iii) non-linearities can be observed in the low-altitude systems, which is mostly due to soiling and cleaning events, as identified and studied in previous work on the same installation,¹³ and may also be linked to non-linear degradation;^{45,46} (iv) the highest PR' trend decline is observed for the low-altitude building-applied system, although no indication of soiling was detected. Unfortunately no indoor measurements are available to further correlate this to actual degradation or reversible loss effects. In terms of PLR values, all systems exhibit remarkable stability considering more than 30 years of operation, with values ranging from -0.55% per year for the low-altitude BAPV system, to -0.12% per year for the high-altitude ventilated facade. These system-level PLRs are significantly lower than the commonly reported values of -0.75% per year for older PV systems^{47–49} and -1% per year for more recent installations,⁵⁰ with an average PLR of only $-0.24 \pm 0.16\%$ per year.

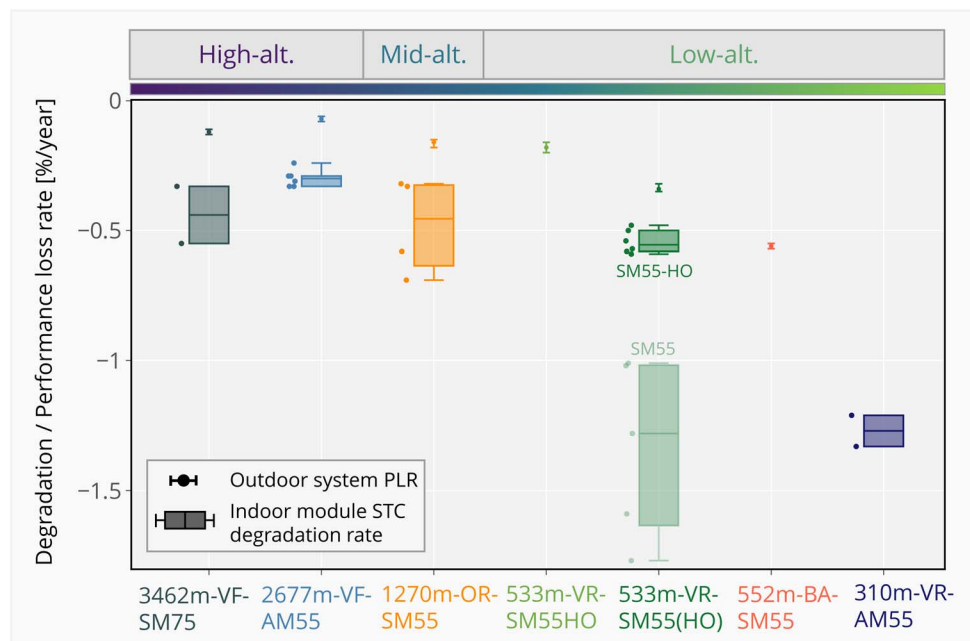
Fig. 6 Overview of indoor and outdoor measurement results for all analysed systems. The figure shows: (i) the module degradation rates of P_{mp} based on indoor $I-V$ measurements (box plots with underlying data points), and (ii) the system PLR calculated from outdoor monitoring data using the multi-YoY method, with 95% CI. Systems are ordered by altitude zones indicated at the top. For the site 533m-VR-SM55(HO), which is composed of 94% SM55-HO modules and 6% SM55 modules, both types are shown for the indoor $I-V$ results. The minority type is displayed in a faded colour for clarity as it is less representative of the system behaviour.

3.2.1.2 Möhlin and Tiergarten West (310m-VR-AM55 and 533m-VR-SM55(HO)): modules SM55 and AM55. Recurring solder bond failures, initially identified in EL images of SM55 modules from the 533m-VR-SM55(HO) system, were also observed in the AM55 modules of the 310m-VR-AM55 system, as shown in Fig. 9. These failures similarly contributed to performance degradation of the AM55 modules, confirmed with I - V measurement results in the form of increased series resistance and decreased FF. This results in a median module degradation rate of -1.27% per year (Fig. 6).

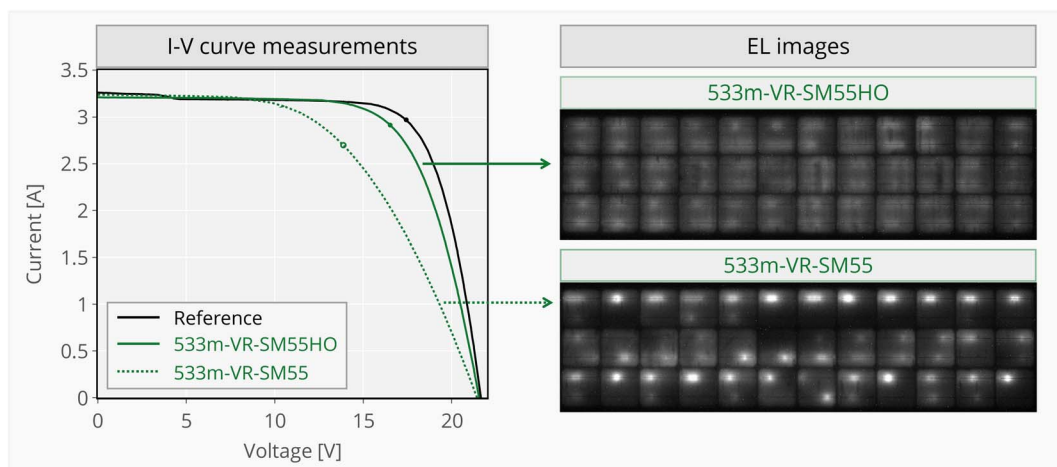
Fig. 7 $I-V$ curves of the reference, SM55, and SM55-HO modules from the 533m-VR-SM55(HO) site, along with EL images taken after approximately 30 years of outdoor operation. The SM55 module exhibits increased series resistance and reduced fill factor due to recurring solder bond failures, visible as dark areas near cell edges and bright spots along the ribbons in the EL images.

observed in all five modules of this type, resulting in increased series resistance and a decrease in fill factor (FF), visible in the I - V curve and EL image of the SM55 module (Fig. 7). The solder interconnections between the ribbons and the busbars seem to have developed cracks starting at the cell edges and progressing towards the centre of the busbars. This results in darker areas near the cell edges and bright spots at the centre of the ribbons. In some severe cases, solder interconnections between ribbons and busbars appear to have completely cracked, leading to entirely dark areas without bright spots along the ribbons. Similar patterns of recurring solder bond failure in this type of module have been documented in previous studies.^{51,52} The consistent occurrence of solder bond failures suggests potential inadequacies in production processes and quality control measures. Based on energy dispersive X-ray spectroscopy (EDX) element analysis of the solder interconnection area (Sn-Pb), Han *et al.*⁵¹ suggest that solder interconnection fatigue is caused by repeating temperature cycles,⁵³ coupled with possible chemical corrosion and the formation of intermetallics.

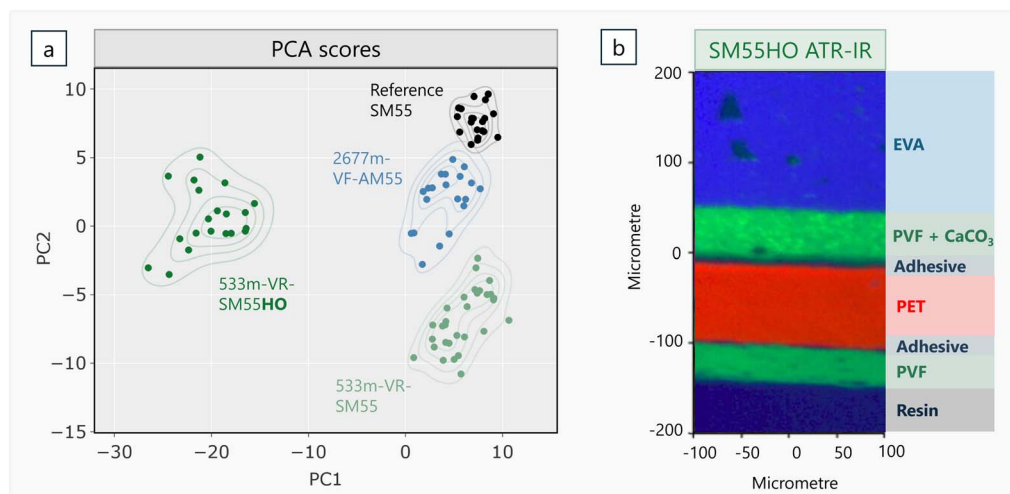
Fig. 8 (a) PCA scores obtained from PCA clustering analysis of the whole NIR spectra, highlighting a clear distinction of the SM55-HO module type. (b) ATR-IR image of the cross-section of the backsheet of a SM55-HO module showing the CaCO_3 filler.

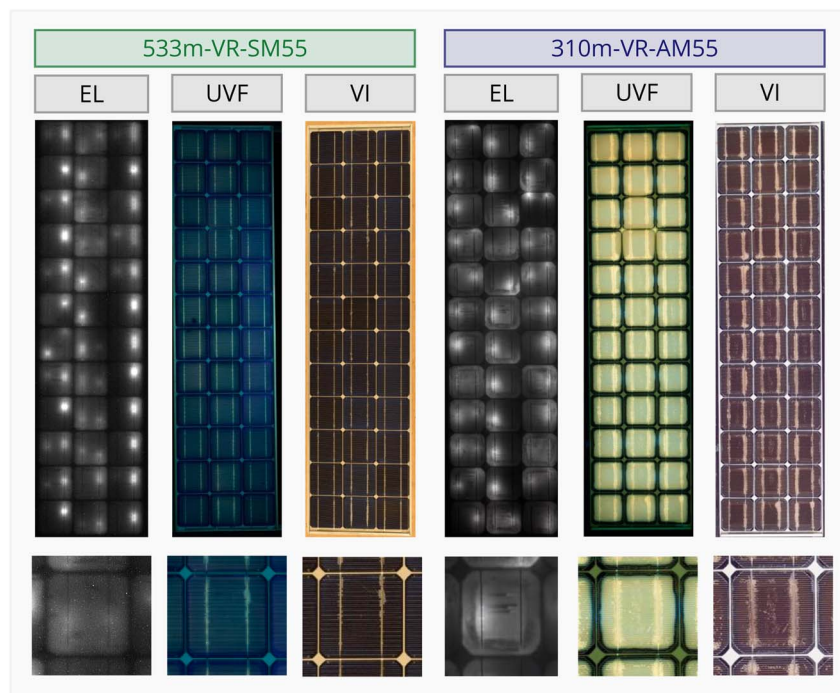
Fig. 9 Electroluminescence (EL), ultraviolet-fluorescence (UVF) and visual inspection (VI) images of the modules from the 533m-VR-SM55 and 310m-VR-AM55 systems.

Two major differences between the SM55 and AM55 modules from the 533m-VR-SM55(HO) and 310m-VR-AM55 systems, respectively, were identified through UVF and visual inspection (VI) imaging. In the UVF images, the encapsulant in the AM55 module exhibits a different emission colour and intensity, suggesting potential variations in additives or encapsulant composition (Fig. 9). In the VI images, both module types show delamination of the encapsulant along the ribbons, with the AM55 module displaying more severe delamination compared to the SM55 module. In addition, the AM55 module shows discolouration of the encapsulation material. These modules are the oldest of those examined (manufactured in 1987) and were manufactured before the introduction of UV-stabilisation of EVA for PV applications. The discolouration can be explained by photo-oxidative degradation. Encapsulant quality improved after 1987 by stepwise stabilisation of the polymer

with UV-stabilisers and anti-oxidants, thus effectively reducing discolouration. A noticeable lack of discolouration and fluorescence is observed at the cell edges, likely caused by photo-bleaching, a competing process to the discolouration and fluorescence of EVA in the presence of oxygen permeating through the backsheet.⁵⁵

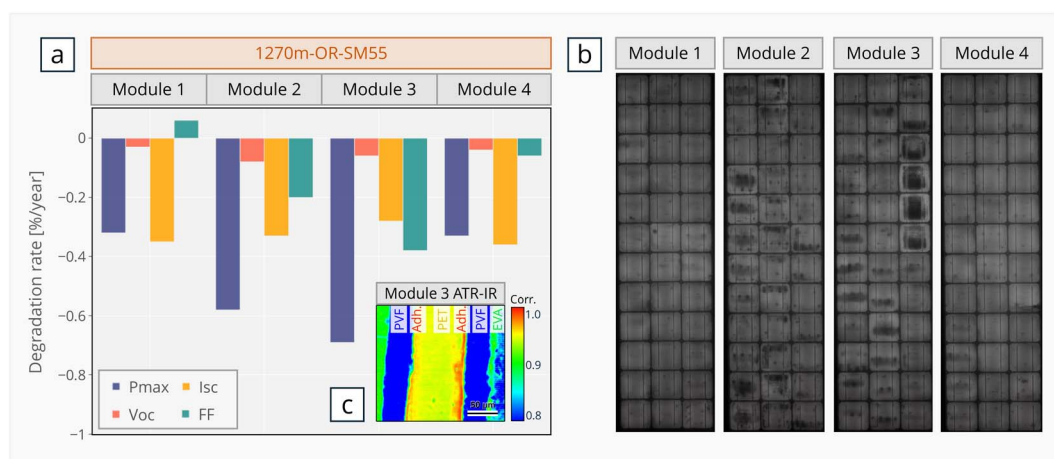
Fig. 10 (a) Degradation rates of the module I - V parameters (indoor) and (b) EL images of four modules from the 1270m-OR-SM55 system. (c) ATR-IR image, shown as an inset in the figure, highlights the dark area of Module 3 with compare-correlation analysis with the IR spectrum of the unaged adhesive.

shown in Fig. 10a, all modules exhibited a reasonable decrease in I_{sc} , yet they have different FF trends: two modules experienced a reduction in FF, while the remaining two showed no significant change.

EL imaging revealed that modules with higher FF loss exhibited dark areas in some cells, whereas no dark areas were observed in the other modules (Fig. 10b). Encapsulation materials, extracted destructively from Module 1 and from both the dark and non-dark areas of Module 3, were analysed for their degradation product content by thermo-desorption GC-MS. The

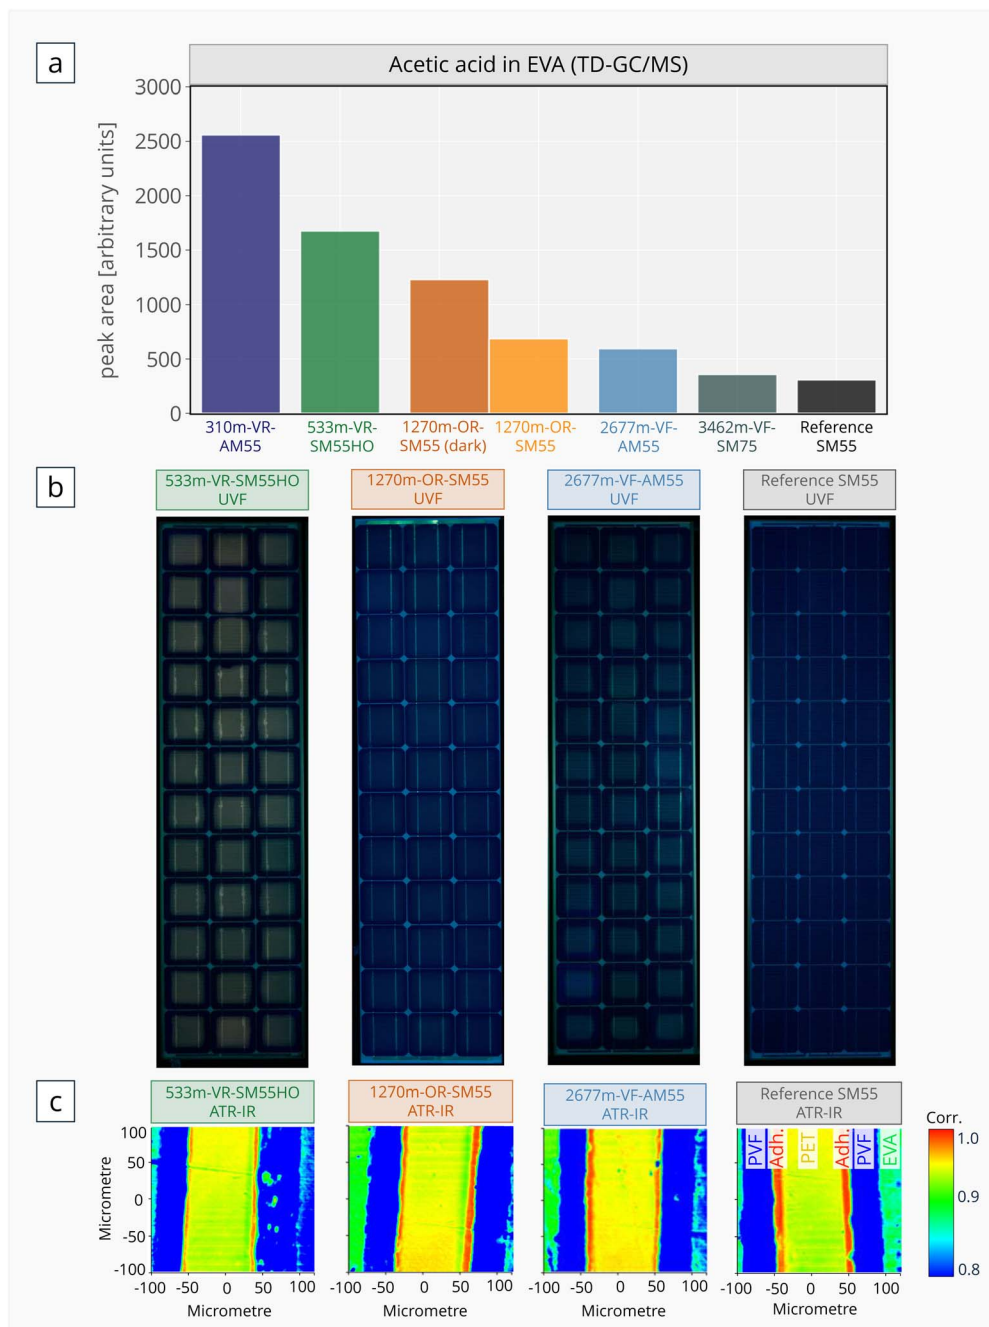
Fig. 11 (a) Amount of acetic acid detected in the EVA with TD-GC/MS. (b) UVF images of the modules after 30 years of outdoor exposure, alongside a UVF image of a non-weathered reference SM55 module. (c) ATR-IR images of the cross-sections of backsheets after compare-correlation with the IR spectrum of the unaged adhesive (high correlation = red).

acetic acid detected in EVA from the dark areas of Module 3 was approximately twice the amount found in the non-dark areas of the same module (Fig. 11a). In fact, the acetic acid concentration in the non-dark areas of Module 3 was similar to that of the less degraded Module 1 (not shown). This suggests a locally higher rate of degradation and acetic acid formation in the dark areas likely due to locally higher temperatures. Acetic acid is known to cause corrosion of the silver (Ag) fingers and reduce the conductivity of the Ag finger,^{56–58} thereby increasing the

the laminate.⁴³ In the unaged reference module, the adhesive layer is well-defined, with a thickness of approximately 5–7 μm , and exhibits a high correlation with the original adhesive spectrum (Fig. 11c, where red areas indicate high spectral accordance). However, in the dark regions observed in the EL image of Module 3, the adhesive layers appear indistinct, with the outer layer degrading almost completely (Fig. 10c). In addition to the corrosion of the Ag fingers leading to dark areas in the EL images, this additional degradation route also suggests significantly higher thermal stress in these areas.

acid content in the low-altitude modules than in the high-altitude modules (Fig. 11a). As discussed in Section 3.2.1, the acetic acid produced can react with the Ag and lead (Pb) in the cell fingers and solder of the connectors, causing corrosion and poor electrical conductivity, resulting in cell degradation performance losses.
