Cite this: *Energy Environ. Sci.*,  
2025, 18, 264Removal of residual contaminants by minute-level  
washing facilitates the direct regeneration of  
spent cathodes from retired EV Li-ion batteries†Yi Guo,<sup>‡a</sup> Yang Li,<sup>‡bcd</sup> Kai Qiu,<sup>d</sup> Yan Li,<sup>e</sup> Weijing Yuan,<sup>b</sup> Chenxi Li,<sup>b</sup> Xinyu Rui,<sup>a</sup>  
Lewei Shi,<sup>b</sup> Yukun Hou,<sup>a</sup> Saiyue Liu,<sup>a</sup> Dongsheng Ren,<sup>\*a</sup> Tiening Tan,<sup>\*d</sup>  
Gaolong Zhu,<sup>d</sup> Languang Lu,<sup>a</sup> Shengming Xu,<sup>idf</sup> Biao Deng,<sup>g</sup> Xiang Liu<sup>id</sup><sup>\*b</sup> and  
Minggao Ouyang<sup>id</sup><sup>\*a</sup>

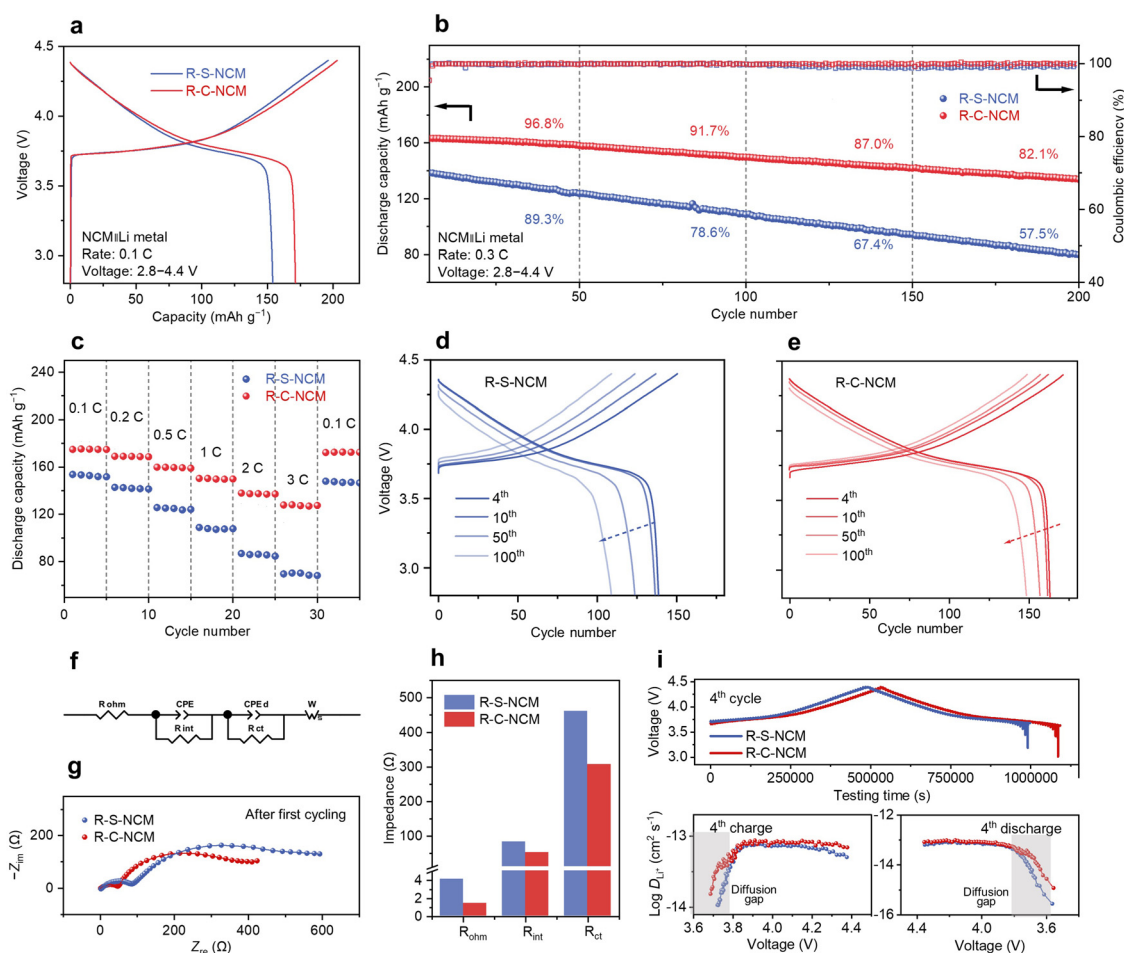
**Fig. 4** Electrochemical deterioration for the regenerated NCM cathodes with impurity residue. (a) Initial galvanostatic charge–discharge curves of R-S-NCM and R-C-NCM at 0.1C (1C = 150 mA h g<sup>−1</sup>) and (b) long cycling test and capacity retention in a half-cell. (c) Rate capabilities of R-S-NCM and R-C-NCM. Charge–discharge curves of (d) R-S-NCM, (e) R-C-NCM in the voltage range of 2.8–4.4 V (vs. Li/Li<sup>+</sup>) at different cycles. (f) Equivalent circuit applied in the EIS measurements. Nyquist plots of (g) R-S-NCM and R-C-NCM and (h) fitting results showing the Ohmic resistance ( $R_{ohm}$ ), interface resistance ( $R_{int}$ ), and charge-transfer resistance ( $R_{ct}$ ). (i) GITT curves and the calculated  $Li^+$ -diffusion rate of R-S-NCM and R-C-NCM for the 4th cycle number after activation in the same charge–discharge period. The shadow area indicates low  $Li^+$  diffusion in a certain voltage range.

As shown in Fig. 4a and Fig. S30 (ESI<sup>†</sup>), the initial discharge capacity increased from 154.1  $\text{mA h g}^{-1}$  for R-S-NCM to 171.4  $\text{mA h g}^{-1}$  for R-C-NCM after the purifying treatment, although this was slightly lower than for P-NCM. In Fig. 4b and Fig. S31 (ESI<sup>†</sup>), the R-C-NCM cathode exhibit 91.7% and 82.1% capacity retention after 100 cycles and 200 cycles, respectively, compared with 91.6% and 78.3% for P-NCM, and 78.6% and

57.5% for R-S-NCM, indicating the R-C-NCM cathode had better cycling stability, even compared to the pristine one. As for the rate performance, the R-C-NCM cathode demonstrated a better high-rate capability (Fig. 4c and Fig. S30, ESI†) at 3C ( $127.8 \text{ mA h g}^{-1}$ ) compared to R-S-NCM ( $69.8 \text{ mA h g}^{-1}$ ) and P-NCM ( $108.9 \text{ mA h g}^{-1}$ ), which was commonly observed on the regenerated NCM cathodes and may be attributed to appropriate F element doping.<sup>12,47</sup> The plateau at  $\sim 3.6 \text{ V}$  in the voltage profiles (Fig. 4d and e and Fig. S30, ESI†) for R-S-NCM nearly disappears after 100 cycles, suggesting that R-S-NCM had a rising polarization after long-term cycling. Based on the cyclic voltammetry curves at different scan rates and calculations (Fig. S31 and Table S12, ESI†), the fitting line slope for R-S-NCM was found to be the lowest among all the samples. According to the equivalent circuit (Fig. 4f), the calculated impedance values ( $R_{\text{ohm}}$ ,  $R_{\text{int}}$ , and  $R_{\text{ct}}$ ) of R-C-NCM (Fig. 4g and h) were 1.4, 51.1, and  $307.1 \Omega$ , respectively, and were smaller than that of R-S-NCM. These results indicate the deteriorated kinetics of  $\text{Li}^+$  transportation due to the residual impurities, especially on the surfaces of the regenerated cathodes. According to the chemical state of the electrode surface (Fig. S32, ESI†), R-C-NCM exposed less inorganic fluoride and more lattice oxide, leading to the suppressed interfacial resistance growing during the long-term cycling. Furthermore, the galvanostatic intermittent titration technique (GITT) test also revealed the kinetic characteristics of the solid phase. The current pulse profile and calculated Li-ion diffusion coefficient ( $D_{\text{Li}^+}$ ) after activation are shown in Fig. 4i. The average  $D_{\text{Li}^+}$  values of R-C-NCM and R-S-NCM were calculated to be  $5.78 \times 10^{-14}$  and  $2.99 \times 10^{-14}$  for the charge process (and  $4.56 \times 10^{-14}$  and  $4.29 \times 10^{-14}$  for the discharge process), suggesting that residual impurities penetrating the interior bulk after regeneration hamper  $\text{Li}^+$  hopping within the lattice of the NCM cathode, as supported by the observed F element (Fig. 3c and Fig. S27, ESI†).
