Environmental Science Advances

PAPER

Impact of wildfires on the drinking water catchment for the capital area of Iceland — a case study†

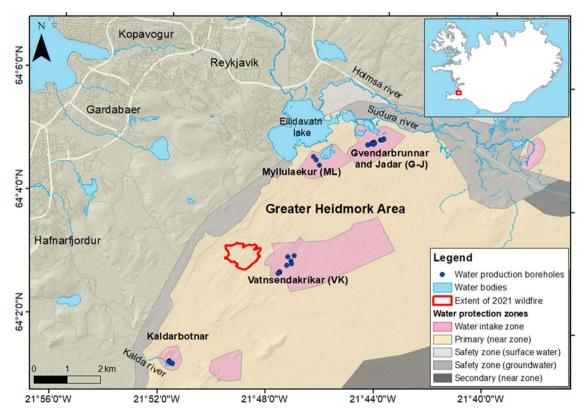
Fig. 1 The greater Heidmork area – the water protection area for the capital region. Drinking water production boreholes are shown. The wildfire area is marked as red (based on data from the Icelandic Institute of Natural History).

The groundwater resources for drinking water for the capital region of Iceland are in the greater Heidmork area (see Fig. 1). The area supplies water to six municipalities—Reykjavik, Kopavogur, Gardabaer, Hafnarfjordur, Mosfellsbaer, and Seltjarnarnes—serving 64% of the population of Iceland (about 230 thousand residents) and is harnessed by six publicly owned water utilities with a yearly average of about 1100 l s⁻¹.44 Furthermore, the area is designated as a nature reserve and serves as the largest outdoor recreational area in the vicinity of the city, covering approximately 32 square kilometers. Almost 90% of the area is vegetated land, of which about 20% is cultivated woodland and 20% is wild birch forest and scrub. 45 According to the NDVI (Normalized Difference Vegetation Index), measured since 1982, there has been a great increase in vegetation in the northern latitudes, including Iceland, since the 1980s.40,46

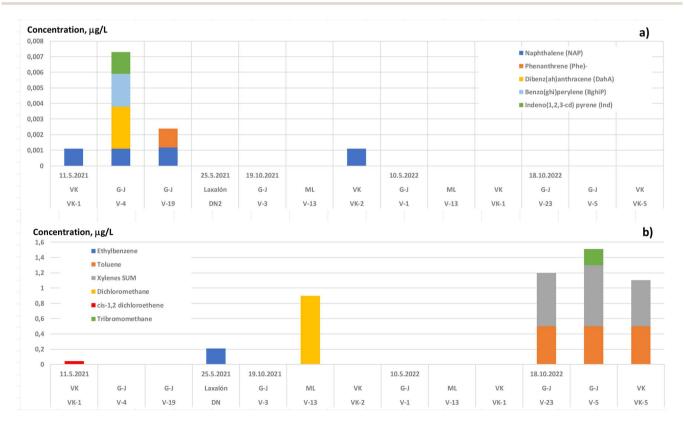
Fig. 2 PAHs (a) and VOCs (b) detected in samples from 11.5.2021 until 18.10.2022 (VK = Vatnsendakrikar, G-J = Gvendarbrunnar-Jadar, DN = distribution network, and ML = Myllulaekur).

Results from sampling taken a week after the fire (May 11) from boreholes in the two water intake zones VK and G–J showed various PAHs and some VOCs following the fire (Fig. 2 and Table 4). Although the analysis of organic compounds is part of the routine monitoring program at the Heidmork production site, the detection limits of the employed methods were, most often, up to an order of magnitude higher prior to the wildfire compared to post-wildfire. The detection limit for all organic chemicals is shown in the ESI† to this article. None of the prefire samples exceeded the detection limits for PAHs.

Five of the 16 priority PAHs were above the detection limit in zones G–J and VK within weeks of the wildfire (ML was not measured then). These include naphthalene (NAP) and phenanthrene (Phe) with two or three benzene rings; these are

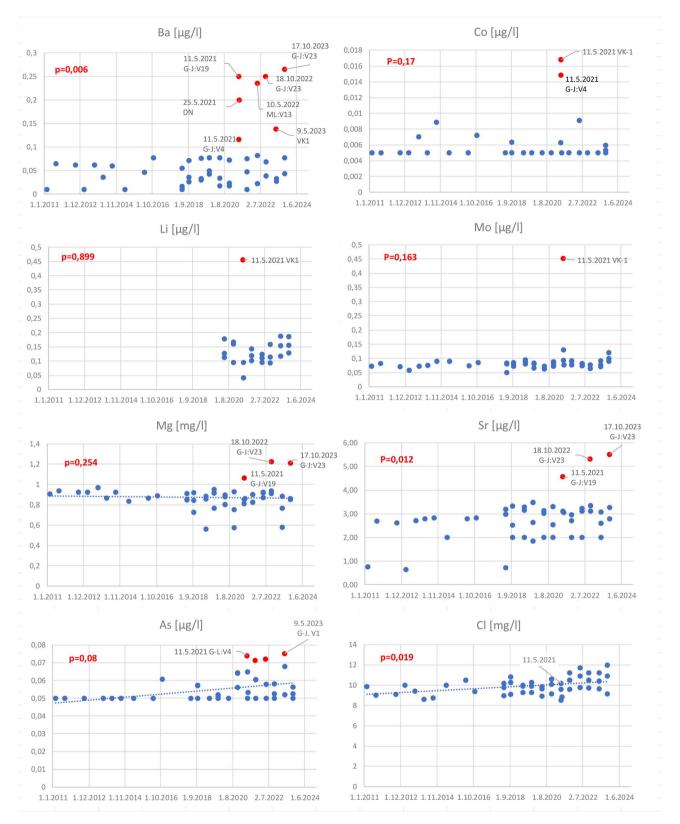
Fig. 3 Eight elements measured in samples taken between 2011 and 2023 showing either a temporary increase after the fire or a significant postfire increase.

Six metals, barium (Ba), cobalt (Co), lithium (Li), molybdenum (Mo), magnesium (Mg) and strontium (Sr), were measured in two to nearly six-fold higher concentrations after the fire compared to the median value (Fig. 3 and Table 3). Some increases were short-lived, namely Co, Li, Mg and Mo, while Ba and Sr showed a tendency for longer-lasting impacts and there was a significant post-fire increase in concentration in both (p < 0.05). Arsenic (As) and chloride (Cl) also have significantly higher post-fire concentrations. However, this does not seem to be related to the wildfire as shown in Fig. 3. It is noted that the elevated concentration of

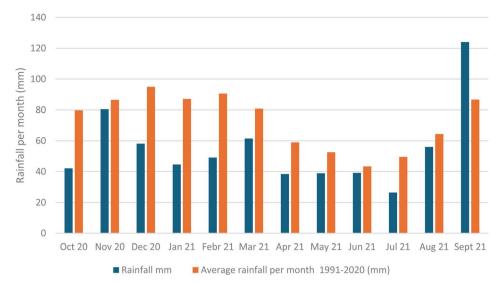
Fig. 4 Monthly rainfall in Reykjavik from 1.10.2020 to 1.10.2021 compared to the average monthly rainfall for the period 1991–2020.

Meteorological measurements clearly show the impact of the drought on the hydrology (Fig. 4). The average precipitation in December, January and February preceding the fire was approximately half the monthly average (90 mm). This resulted in a low volumetric water content in the soil in the open field of the water intake zone at ML and an exceptionally low groundwater level in boreholes at VK. The volumetric water content in soil was low for the late winter period leading up to the fire, fell significantly at the beginning of January and did not recover to the normal stage until after the heavy rain incident on May 29th (Fig. 5). The groundwater level in borehole VK-1 was low in the first months of 2021 compared to the daily average (2008–2020) and exceptionally low in the weeks leading up to the fire (Fig. 6). These measurements demonstrate the importance of systematically monitoring the hydrometeorological parameters to provide early warning for potential wildfires.

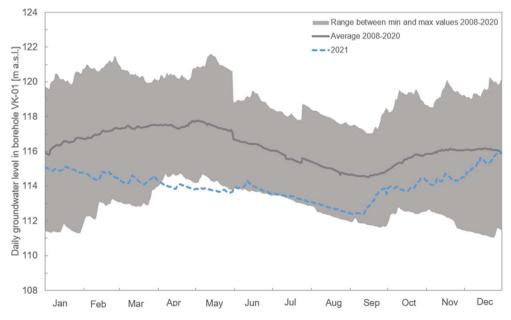
Fig. 6 Average groundwater level for VK-1 for the period 2008–2020, where the shaded area shows the range of the max mean values. The blue line shows the level for 2021.
